**INFRASTRUCTURE CONDITIONS  
ASSESSMENT**

**AMERICA'S CENTRAL PORT**

**MADISON, VENICE, AND  
GRANITE CITY, ILLINOIS**

December 30, 2021

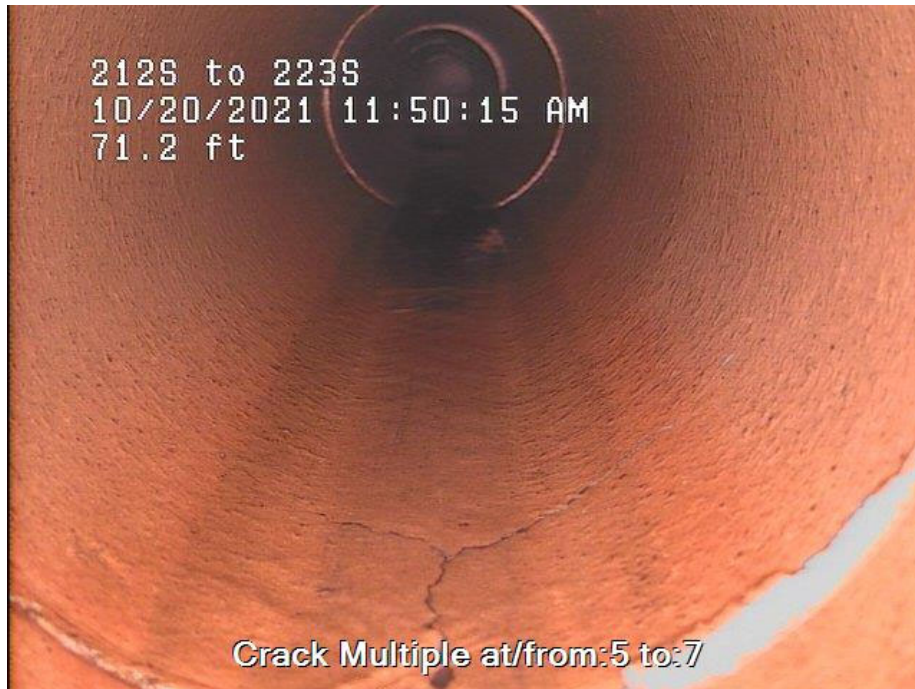
**Example: Multiple Cracks**

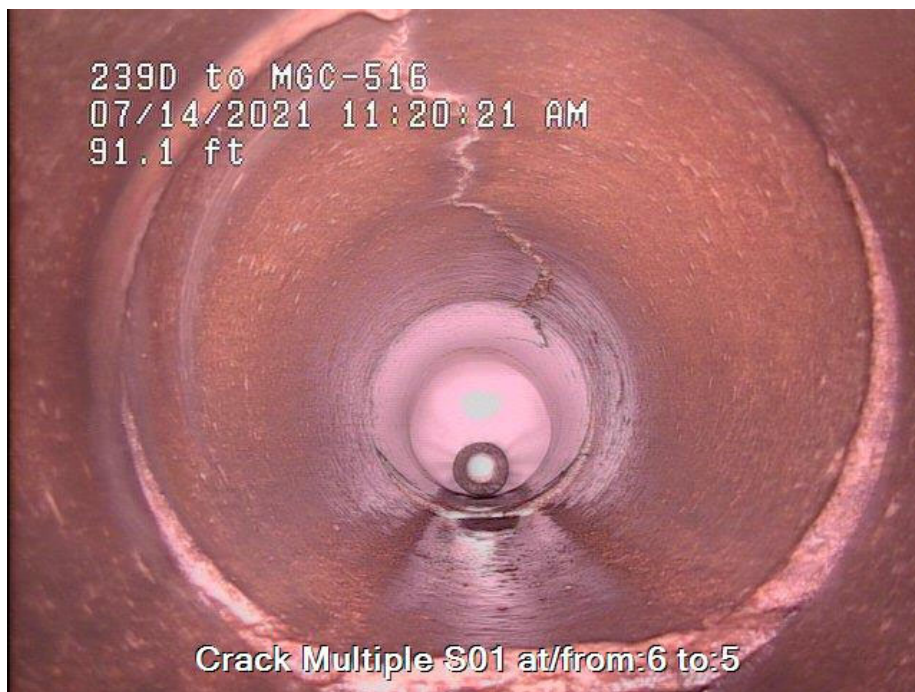
**Example: Multiple Cracks**

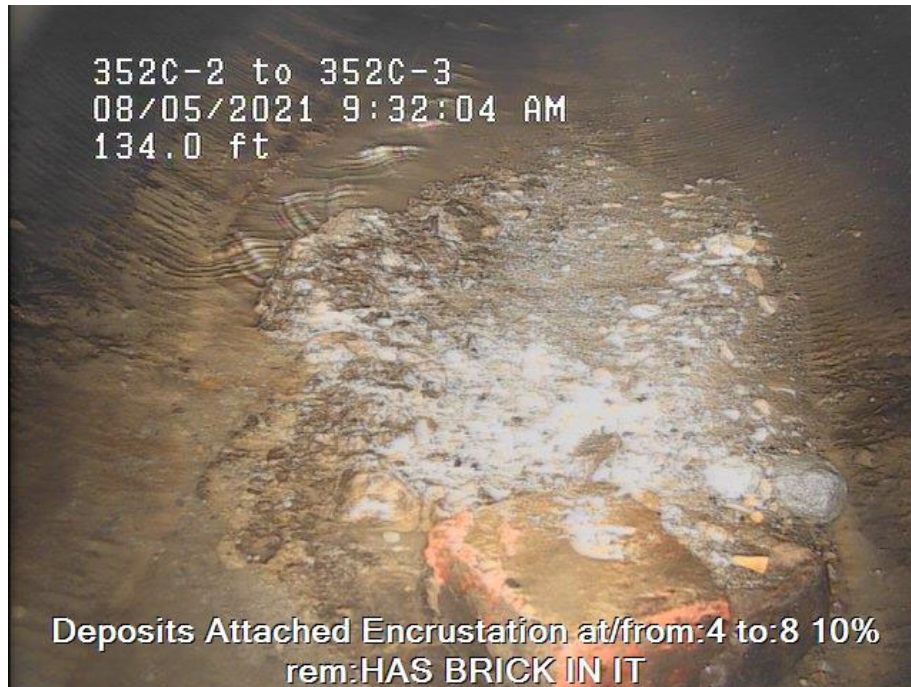
**Example: Deposits with Attached Encrustation**

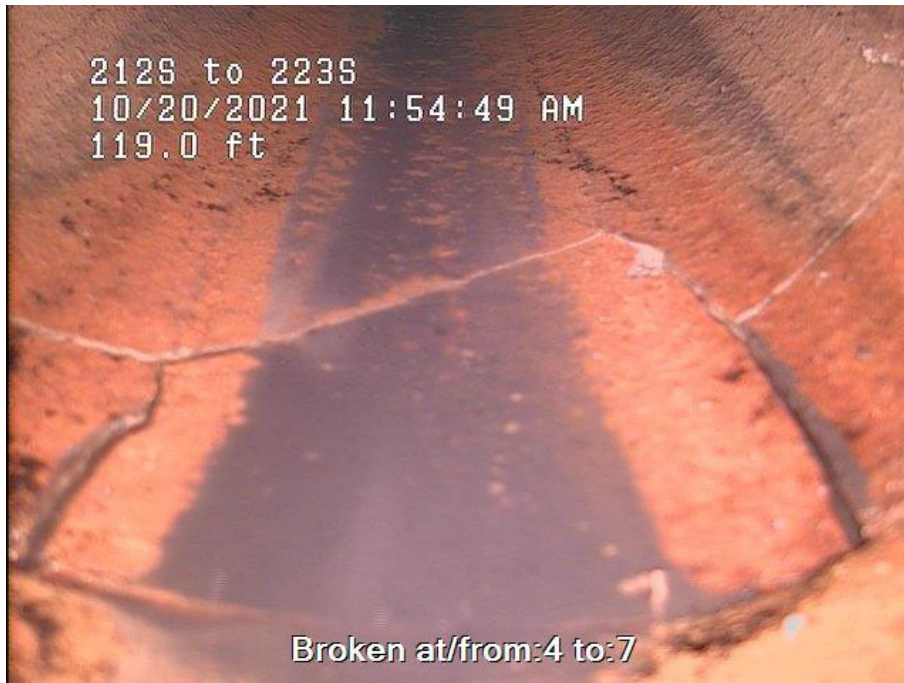
**Example: Broken Pipe**

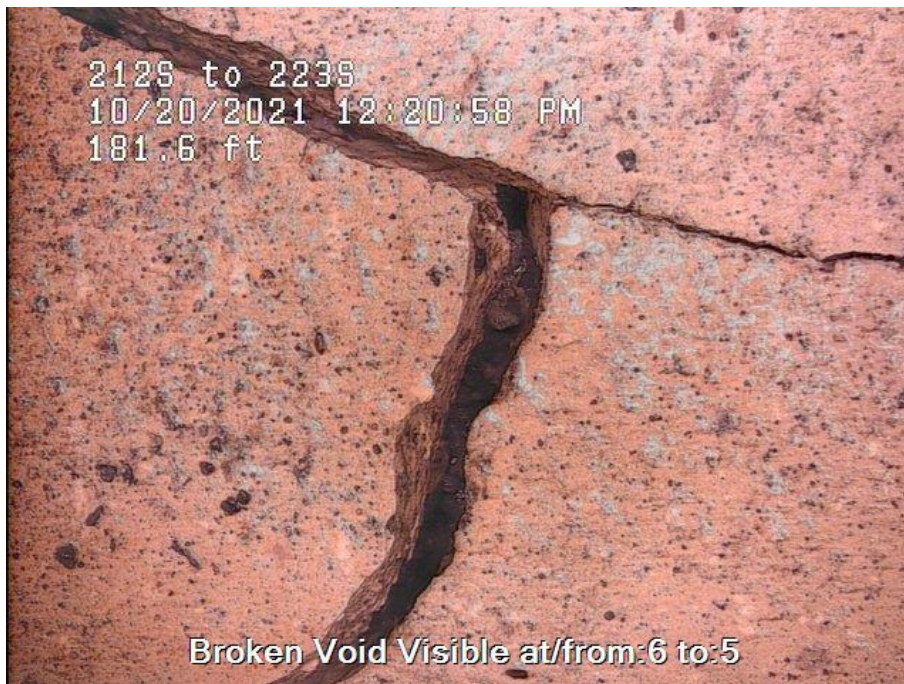
**Example: Broken Pipe – Void Visible**

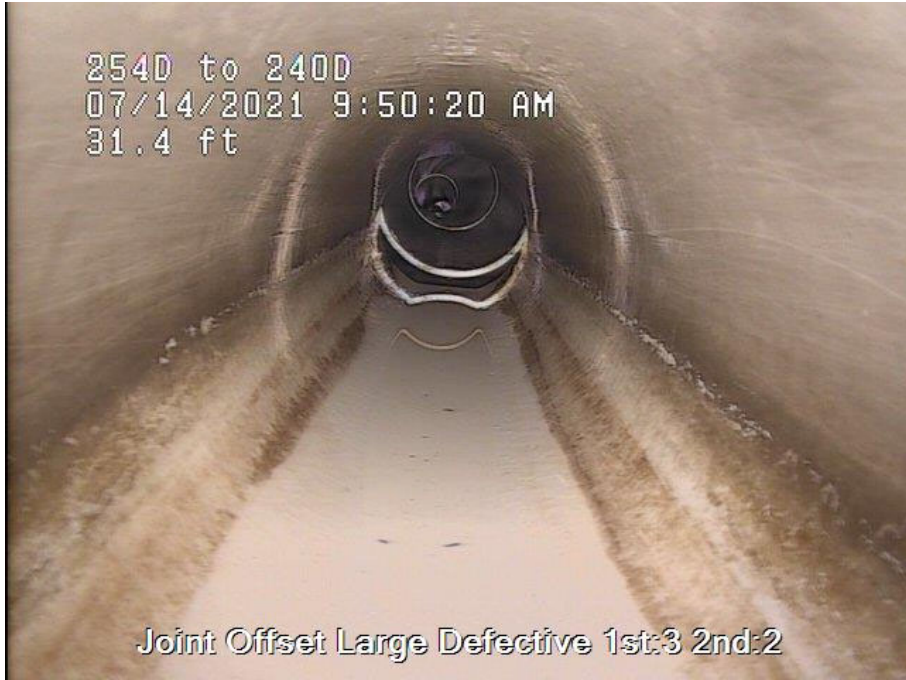
**Example: Joint Offset – Large**

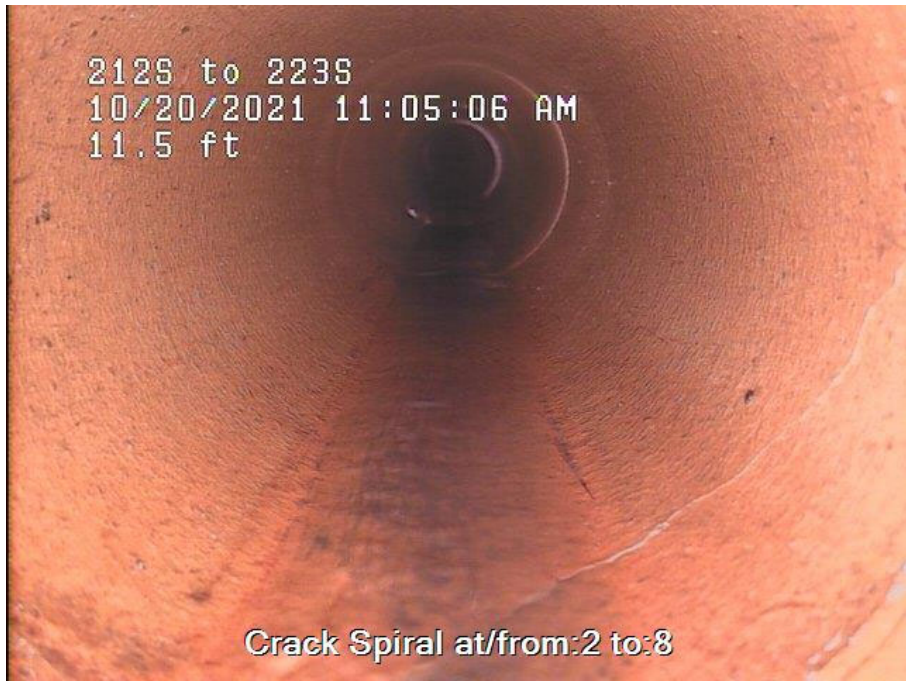
**Example: Spiral Crack**

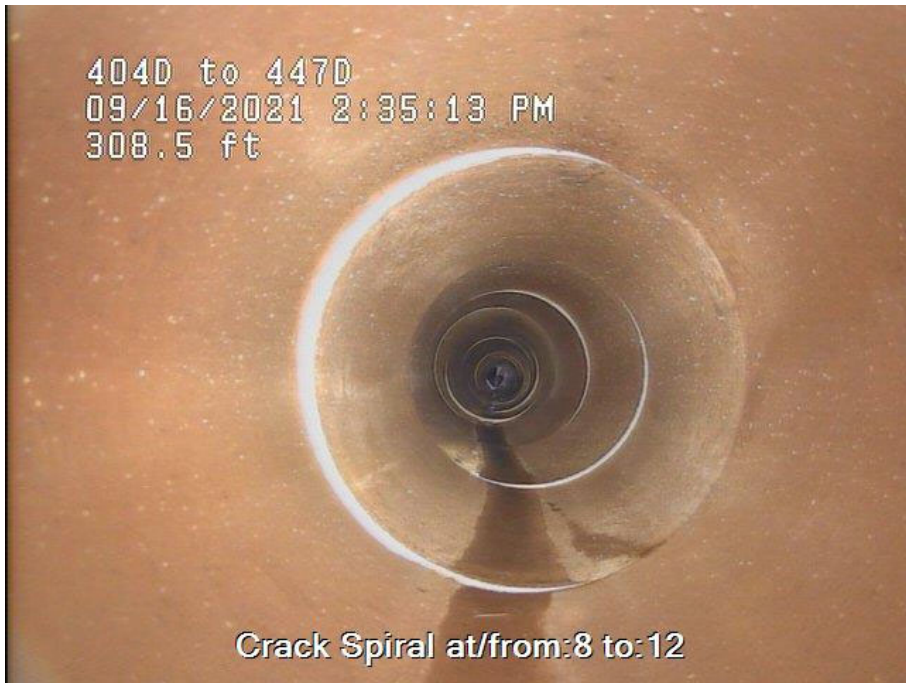
**Example: Spiral Crack**

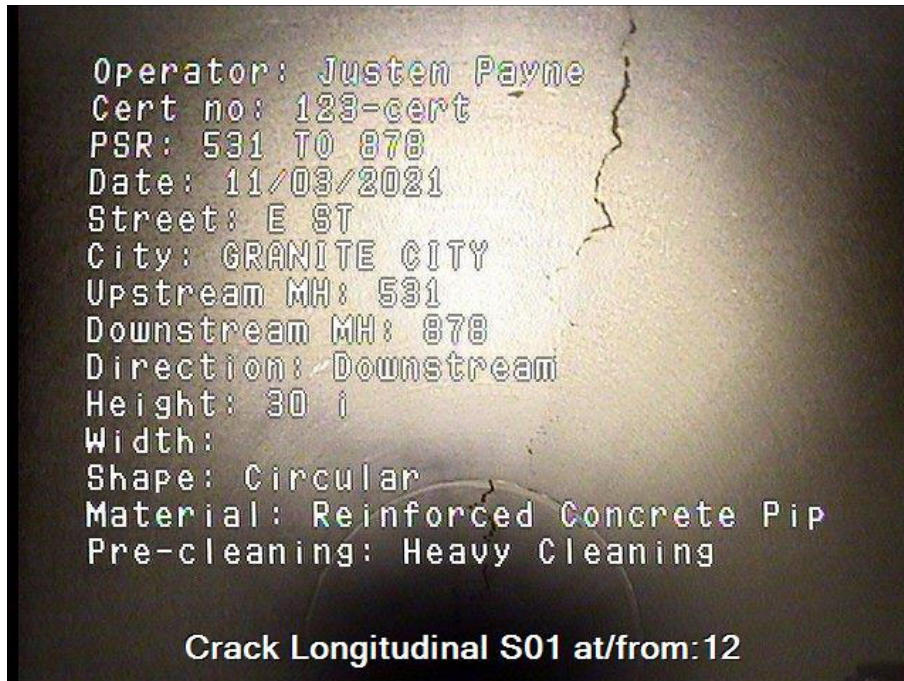
**Example: Longitudinal Crack**

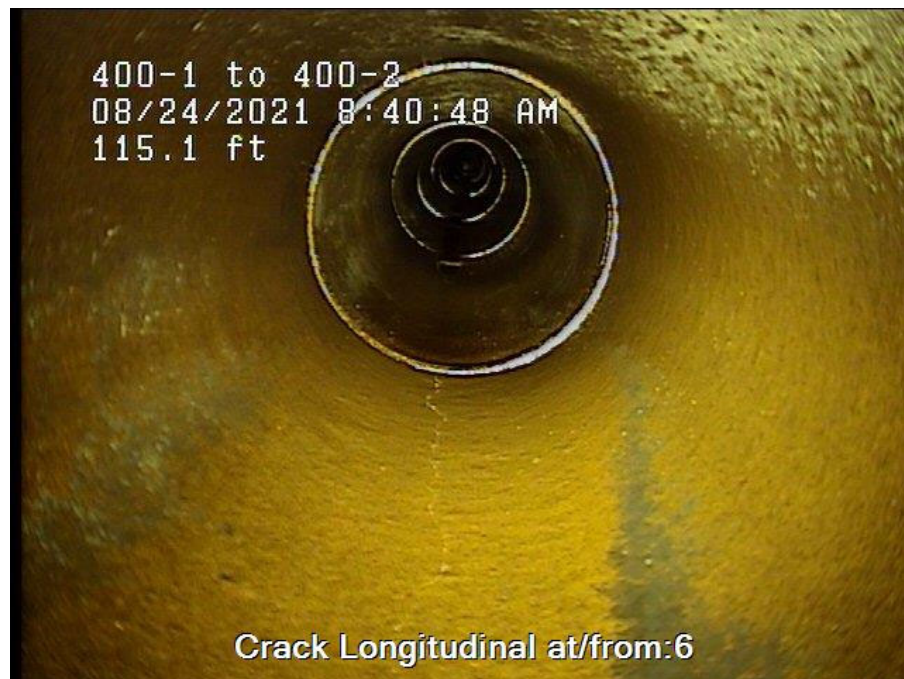
**Example: Longitudinal Crack**

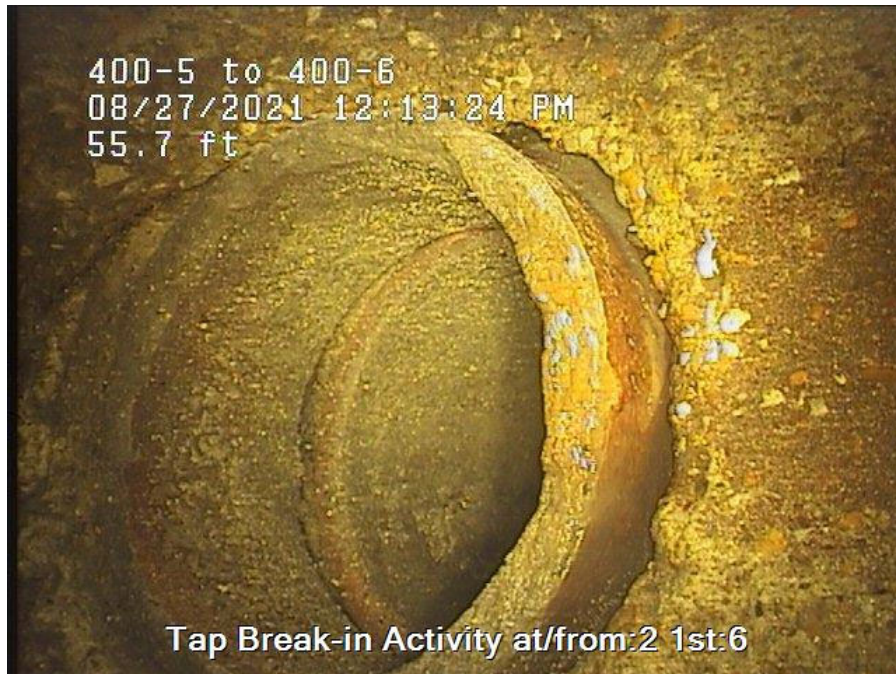
**Example: Tap Break-In Activity**

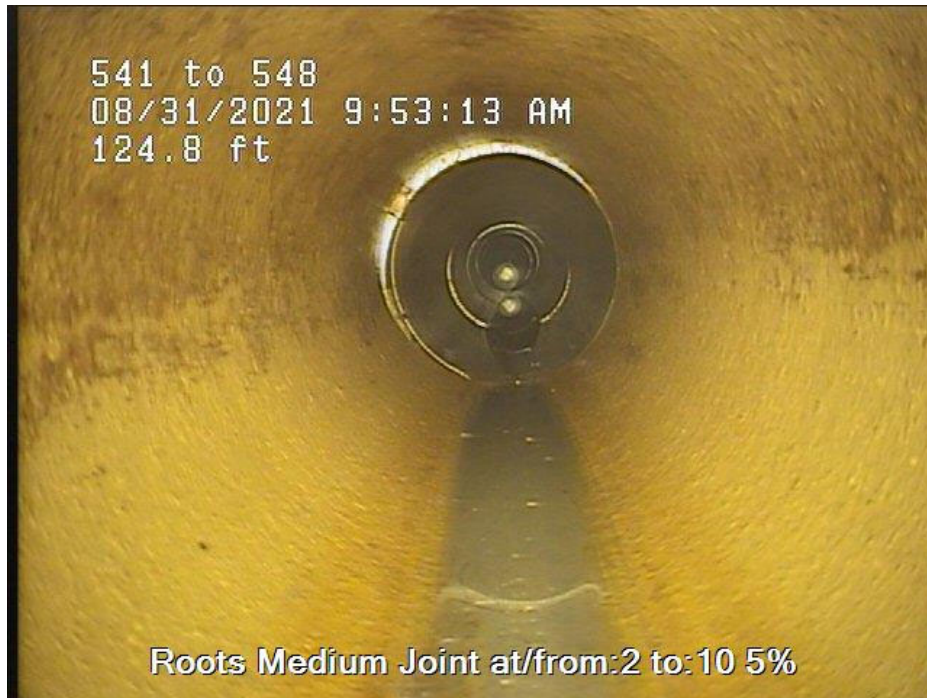
**Example: Root Infiltration**

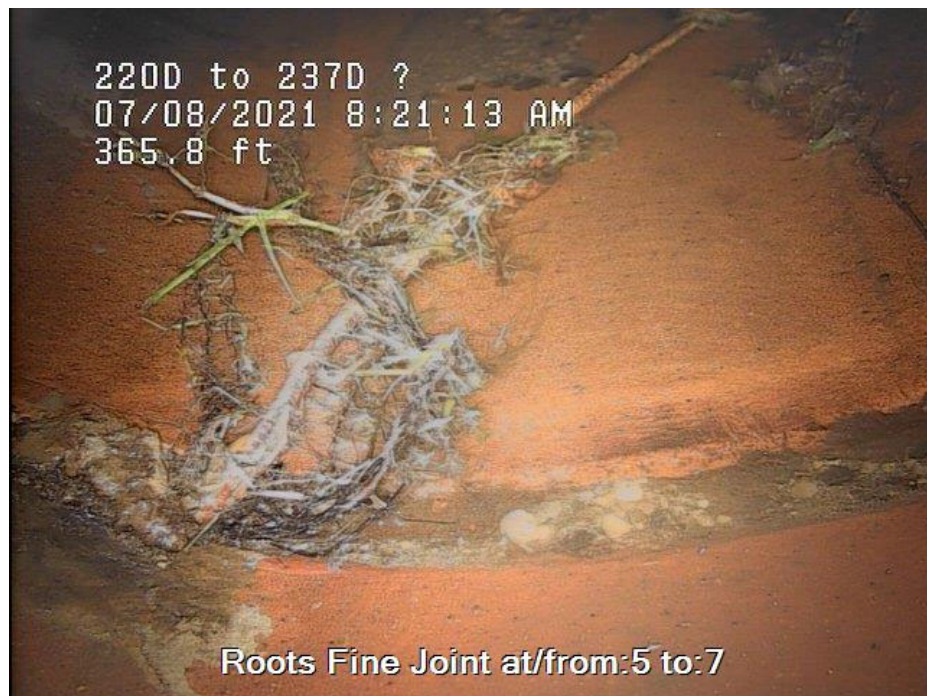
**Example: Root Infiltration**

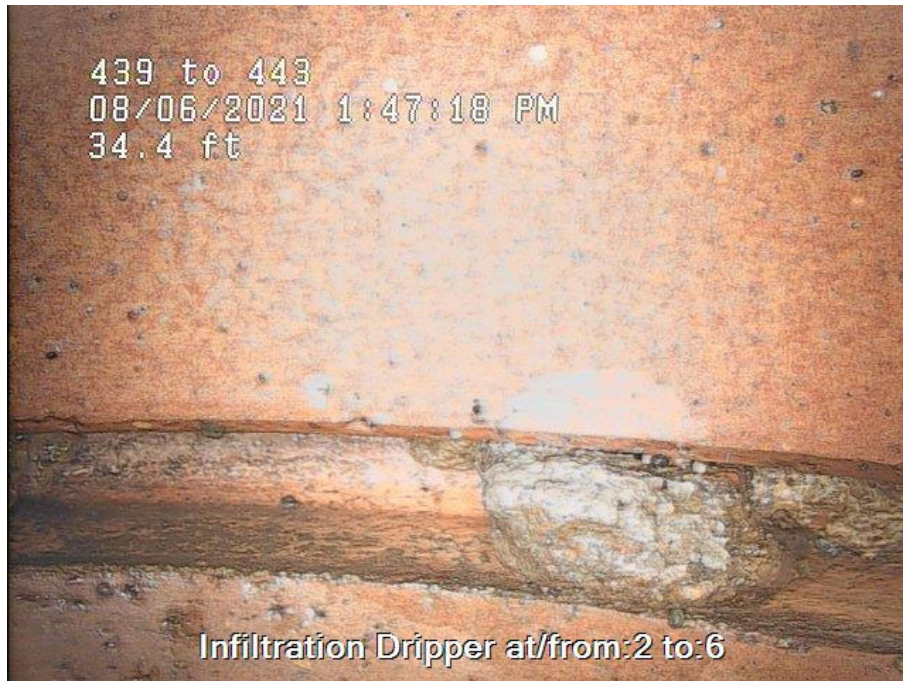
**Example: Infiltration / Dripping**

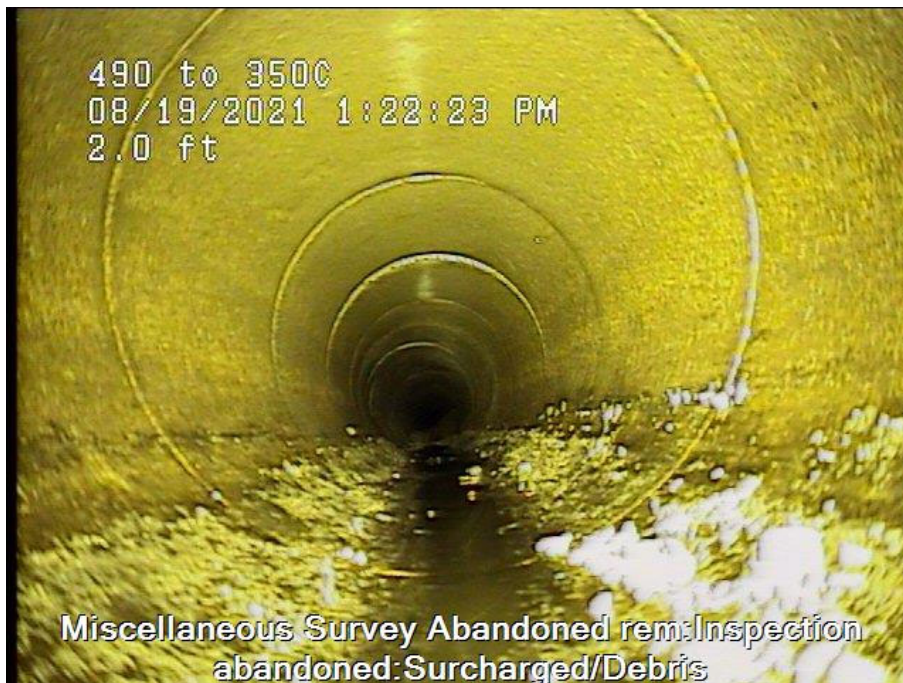
**Example: Surcharge Debris**

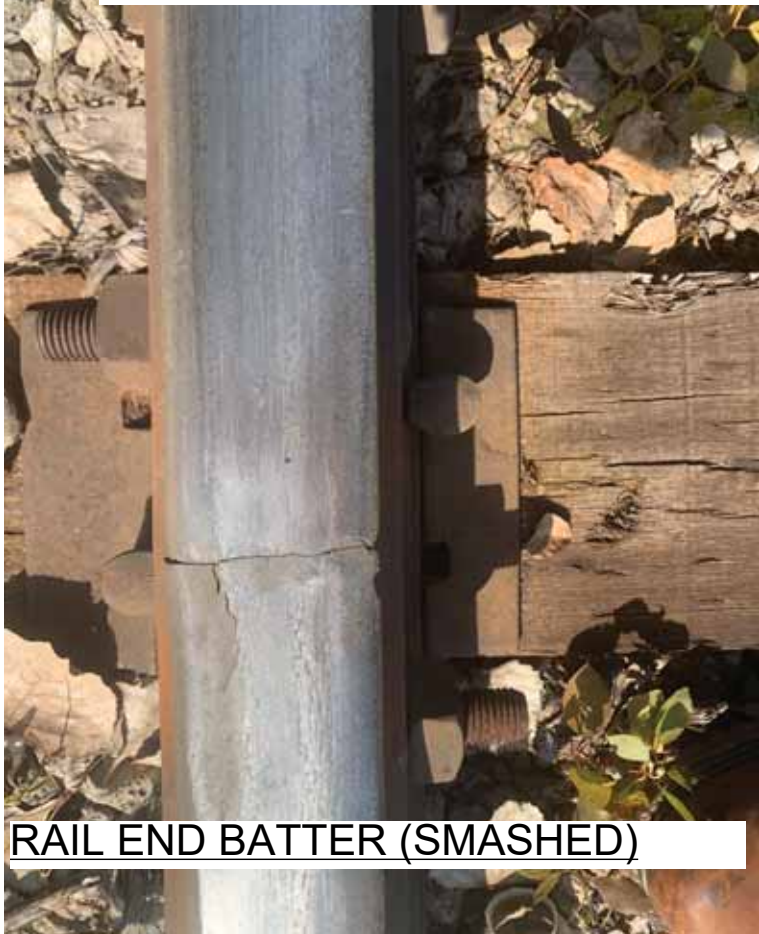
RAIL END BATTER (SMASHED)

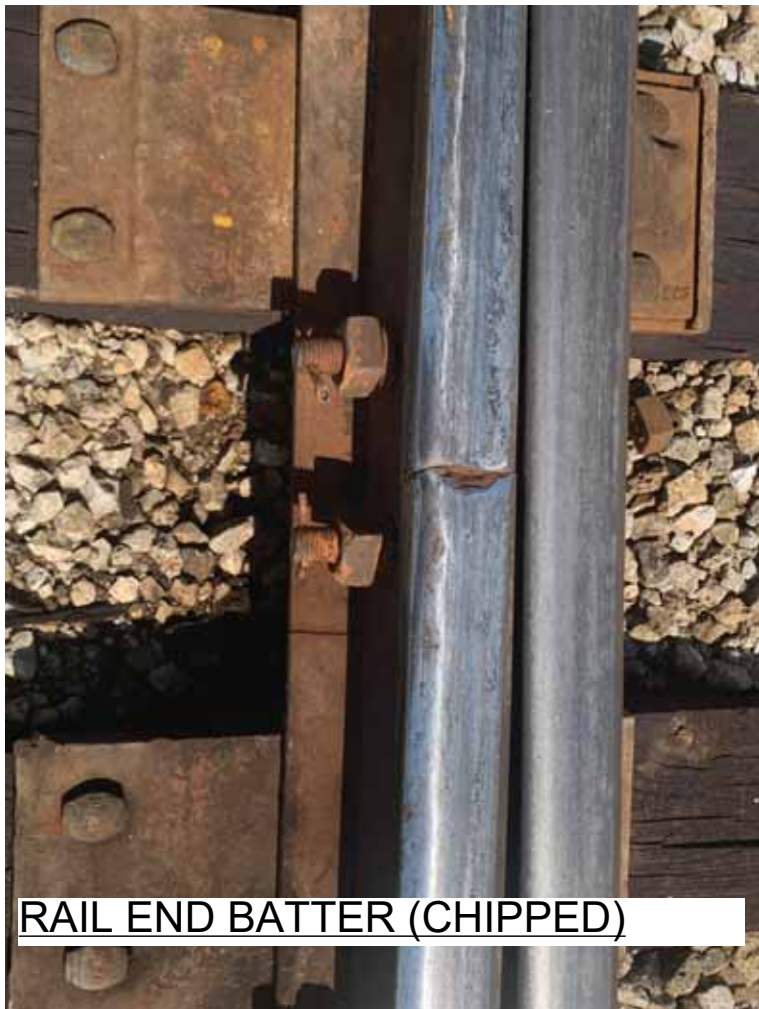
RAIL END BATTER (CHIPPED)

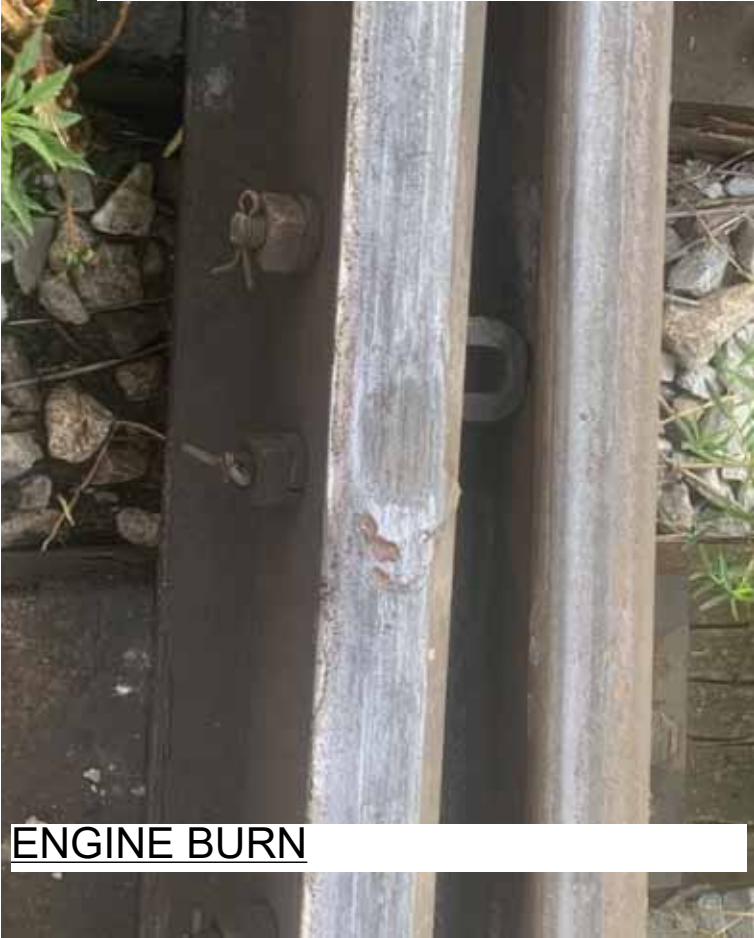
ENGINE BURN

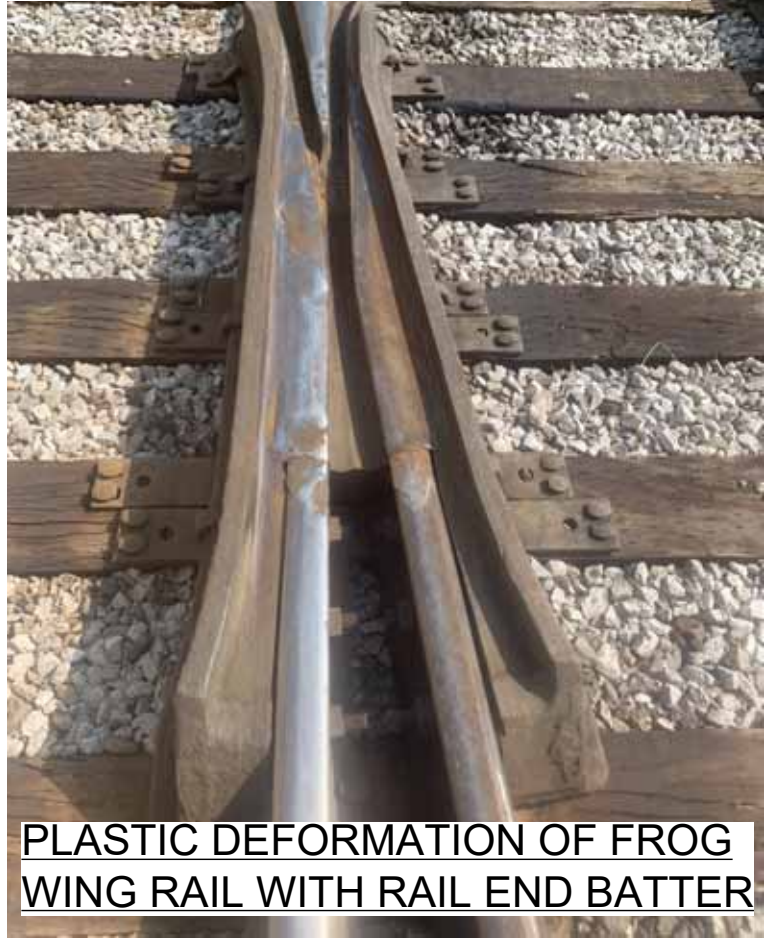
PLASTIC DEFORMATION OF FROG WING RAIL WITH RAIL END BATTER

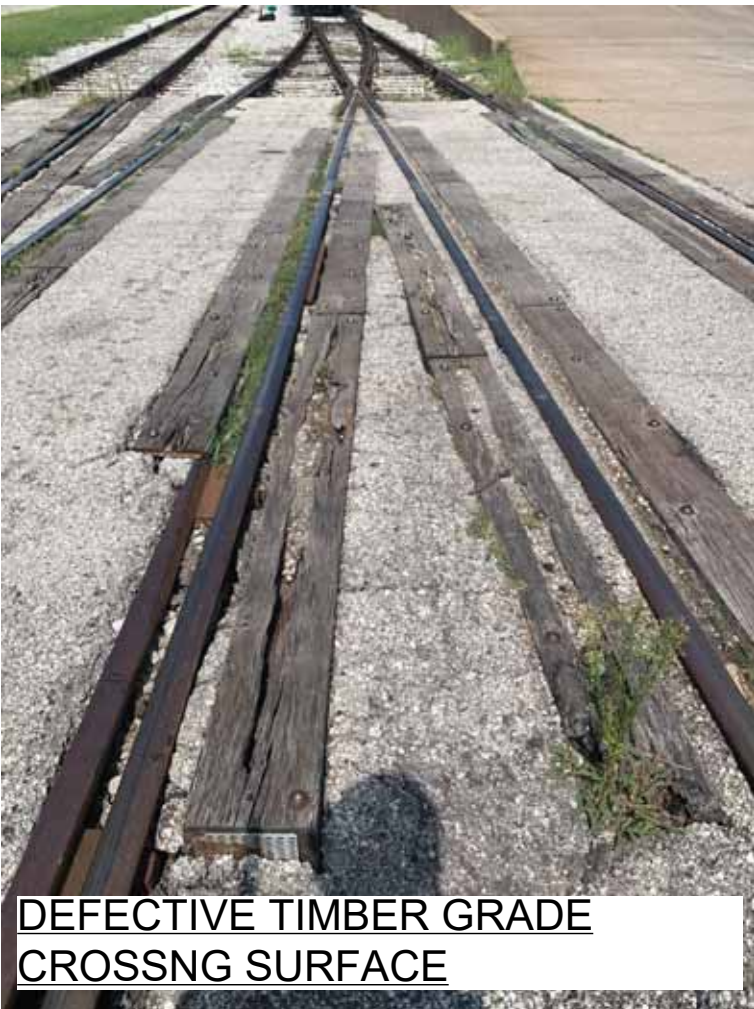
DEFECTIVE TIMBER GRADE CROSSING SURFACE

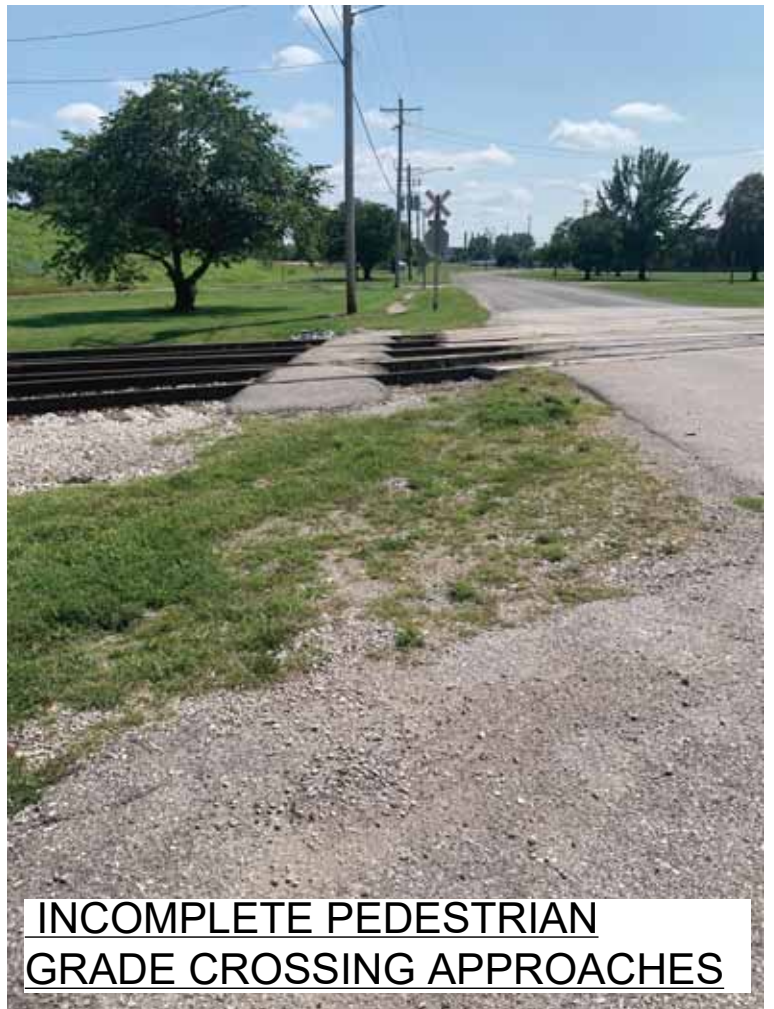
INCOMPLETE PEDESTRIAN GRADE CROSSING APPROACHES

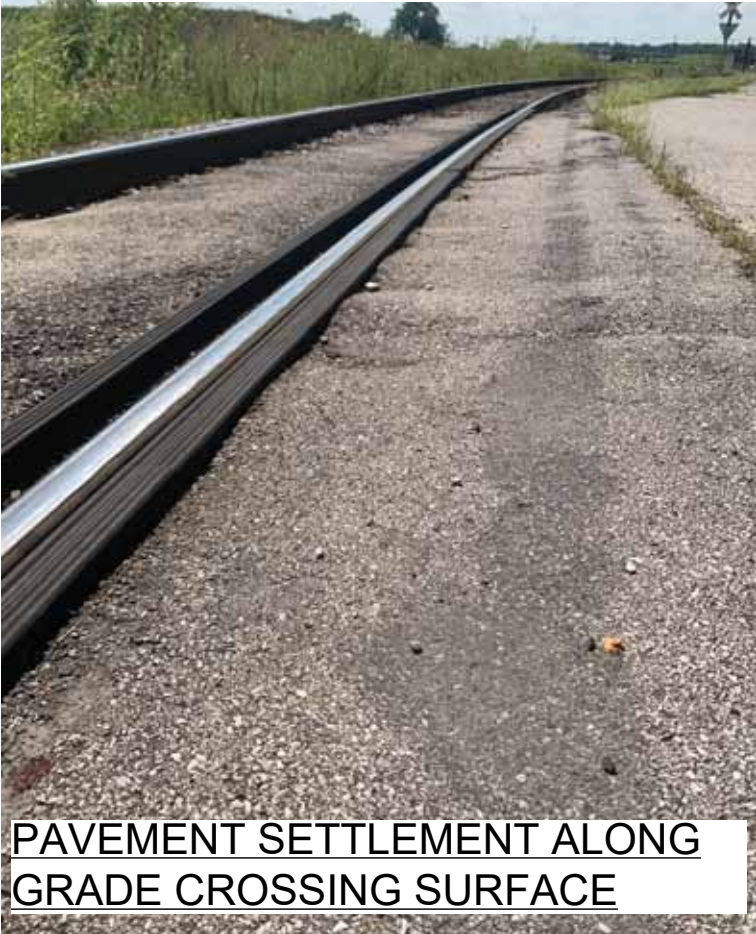
PAVEMENT SETTLEMENT ALONG GRADE CROSSING SURFACE

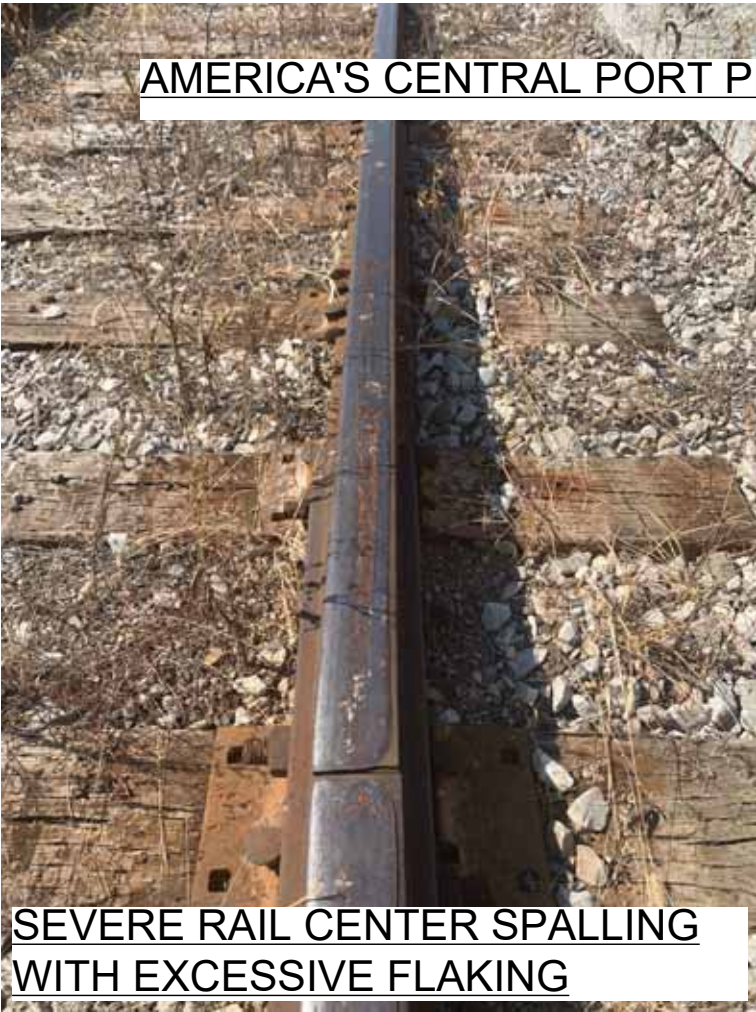
SEVERE RAIL CENTER SPALLING WITH EXCESSIVE FLAKING

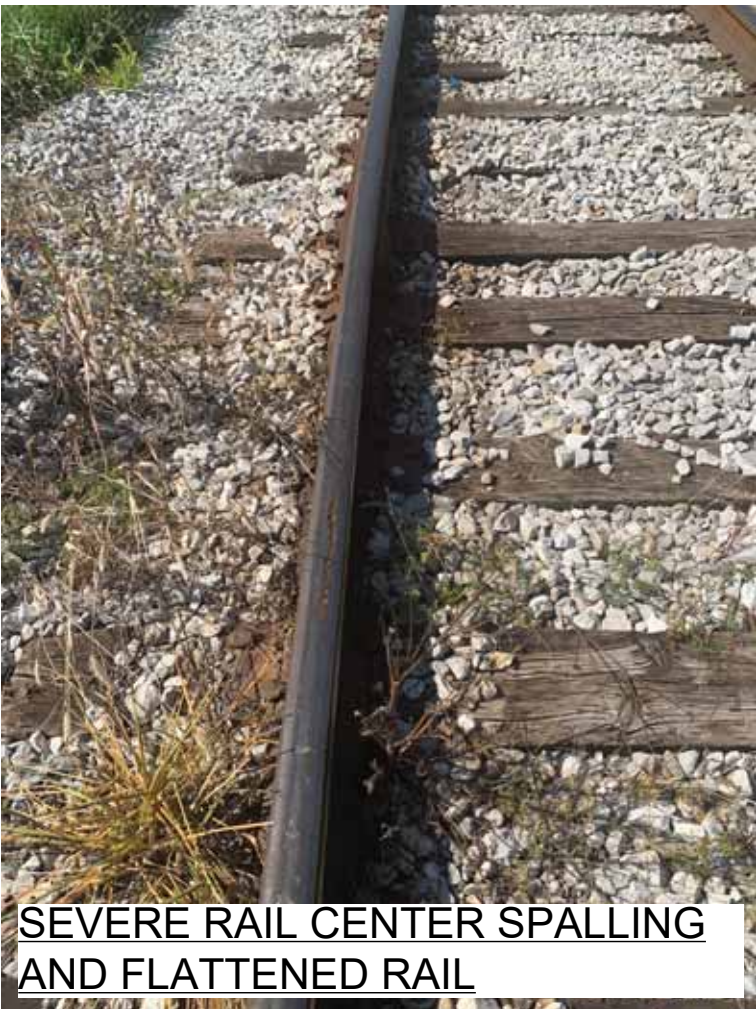
SEVERE RAIL CENTER SPALLING AND FLATTENED RAIL

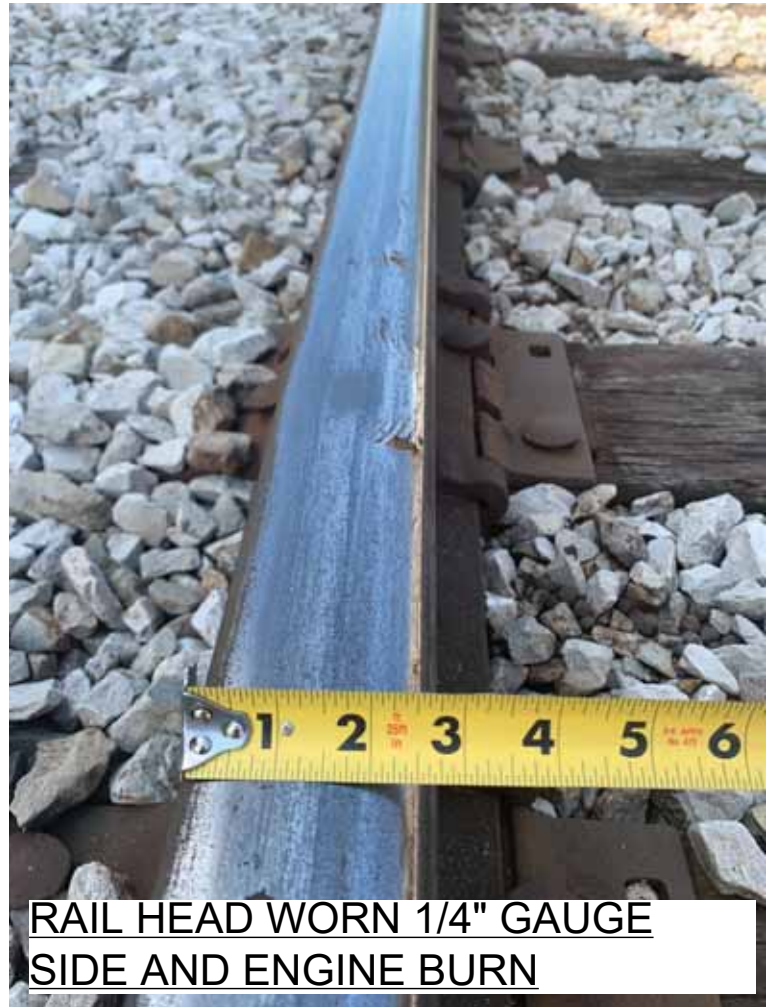
RAIL HEAD WORN 1/4" GAUGE  
SIDE AND ENGINE BURN

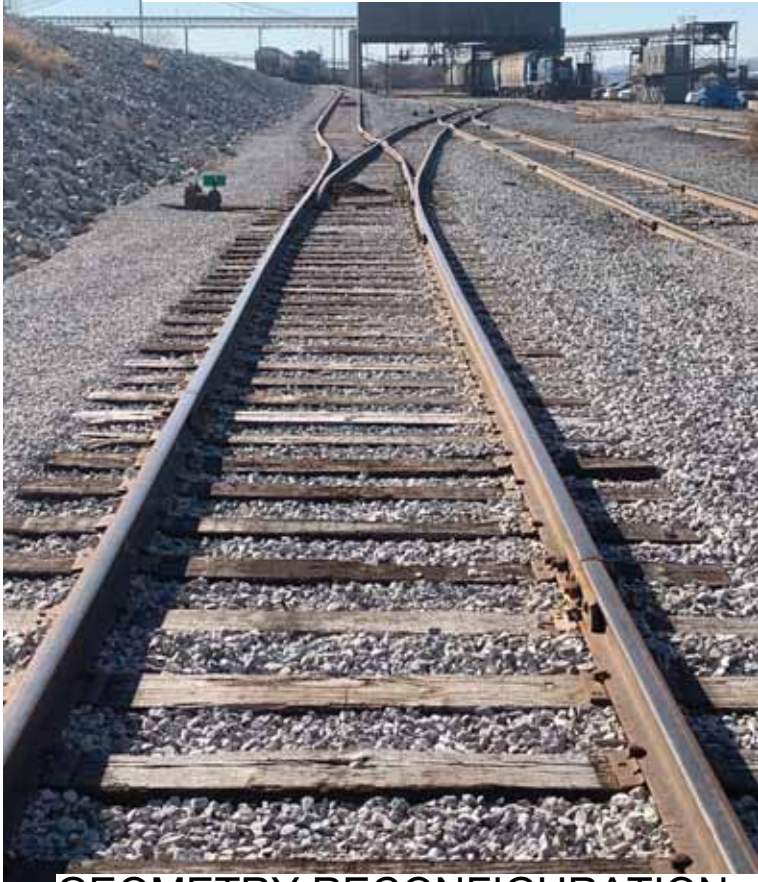
GEOMETRY RECONFIGURATION
