Design, Construction, and Analysis of CRCP Patching Techniques

Physical Research Report No. 124

March 1998

Illinois Department of Transportation
Bureau of Materials and Physical Research

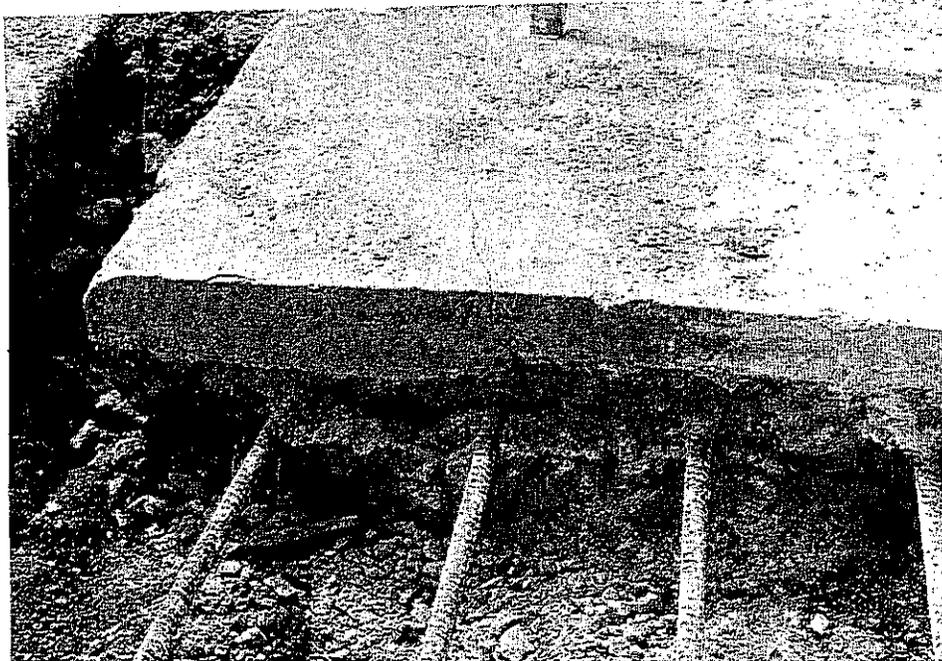
Photo 2. Corner break and undercutting from use of Skid-steer loader mounted jackhammer.

- Skid steer loader mounted jackhammers can cause excessive damage (nicking or bending) to the rebar to be lap-spliced, as well as the adjacent pavement. The equipment can also cause corner breaks. If not being used with care, skid steer loader mounted jackhammers should be removed from the job. The use of a skid steer loader mounted jackhammer is currently allowed through the use of the Special Provision for Class A Patches (Skid Steer Loader Equipped with a Hydraulic Hammer) which is checkmarked to allow its use on most contracts.

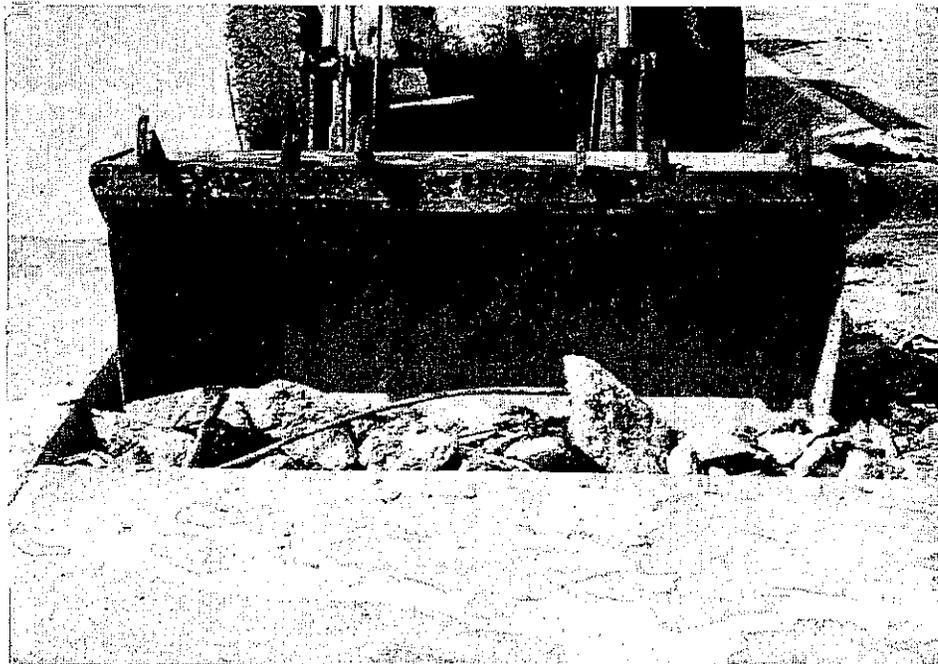
Photo 4. Backhoe bucket for concrete removal is not permitted. Procedure causes damage to adjacent pavement.

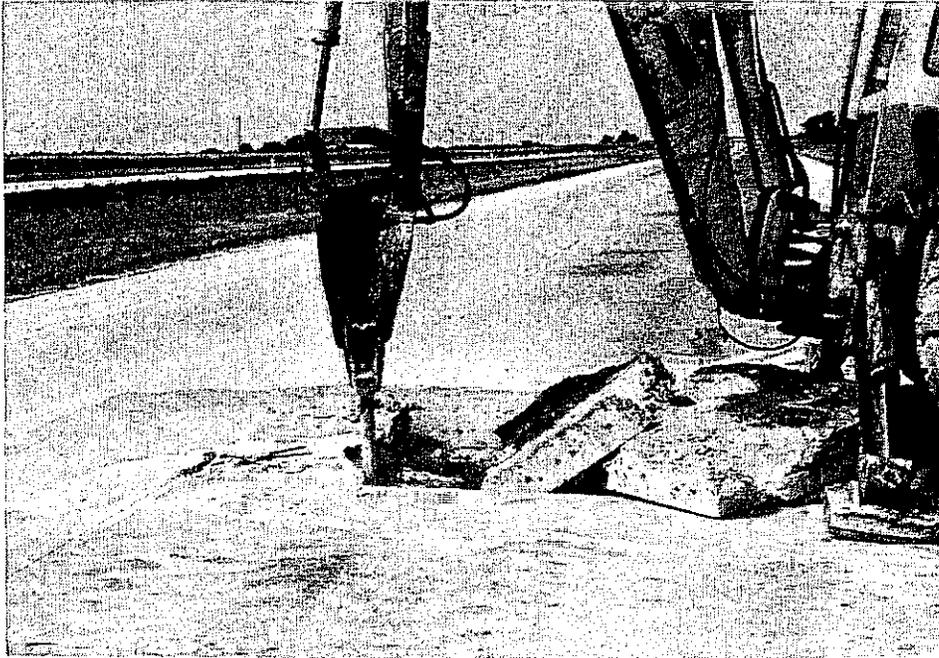
Photo 5. Backhoe mounted jackhammer is not permitted.
Causes damage to adjacent pavement and subbase.

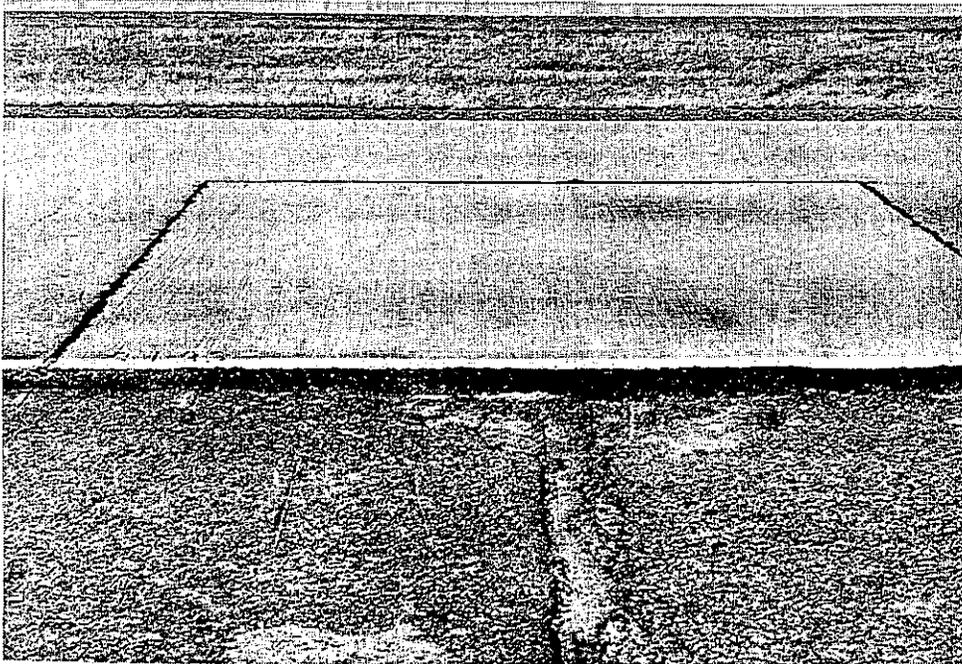
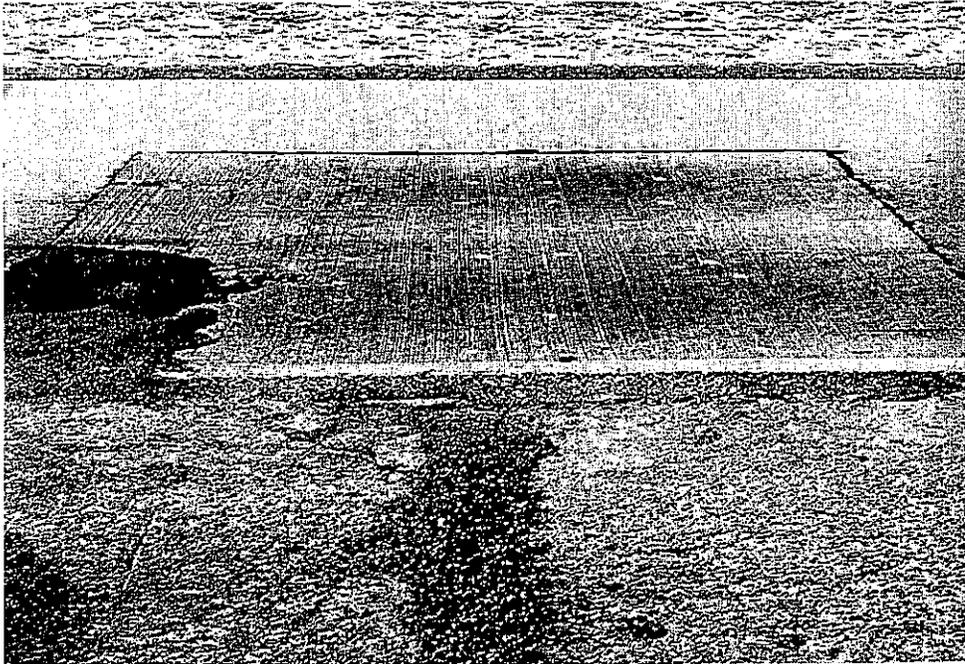
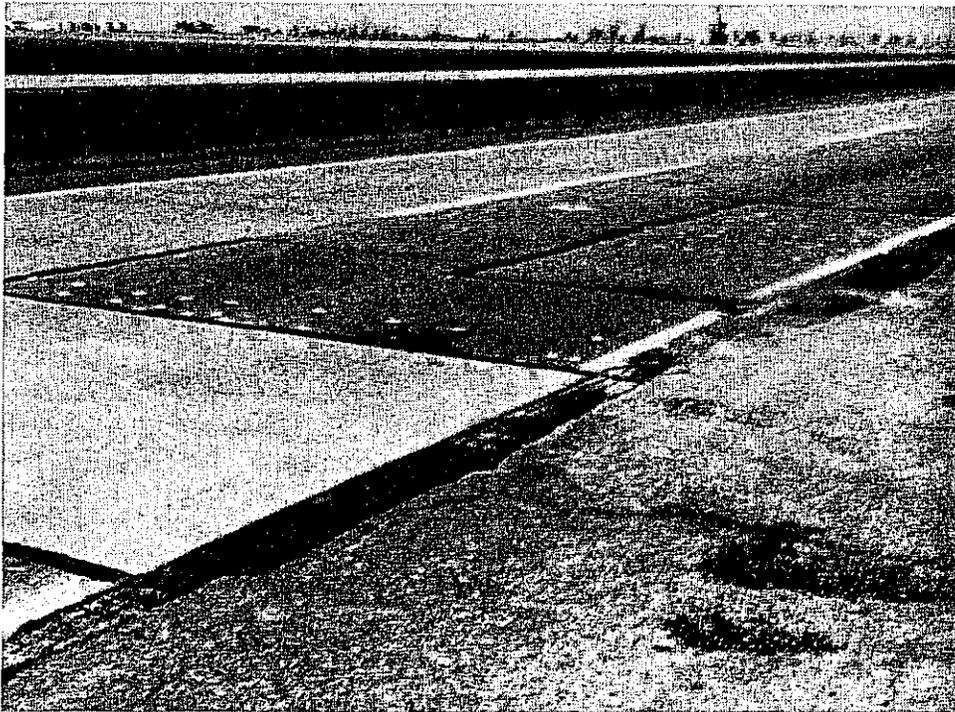
This design is more costly and time consuming than the average rate for the conventional Class A patch. There were 13 patches constructed and studied using this procedure. These patches were located at Site 5 in Douglas County. This site consisted of a highly deteriorated 180 mm (7-inch) thick CRCP, as shown in Figure 4. Survey data analysis indicates a 92% patch failure rate after 2 years. Inconsistencies in subbase support is believed to be the cause of failures. Due to the low number of patches constructed, the performance of this design may not be representative of statewide experience. Typical failures are shown in Photos 8-10.

Photo 8. Remove and replace subbase with 4 inches of PCC.
Age: 1 month

Photo 9. Remove and replace subbase with 4 inches of PCC.
Age: 4 months.

Photo 10. Remove and replace subbase with 4 inches of PCC.
Age: 1 year.

Repairs which included removal of the existing subbase performed poorly. Failure rates of replaced subbase sections ranged from 25% to 92% within 2 years. For this reason, existing subbase material should be disturbed as little as possible.

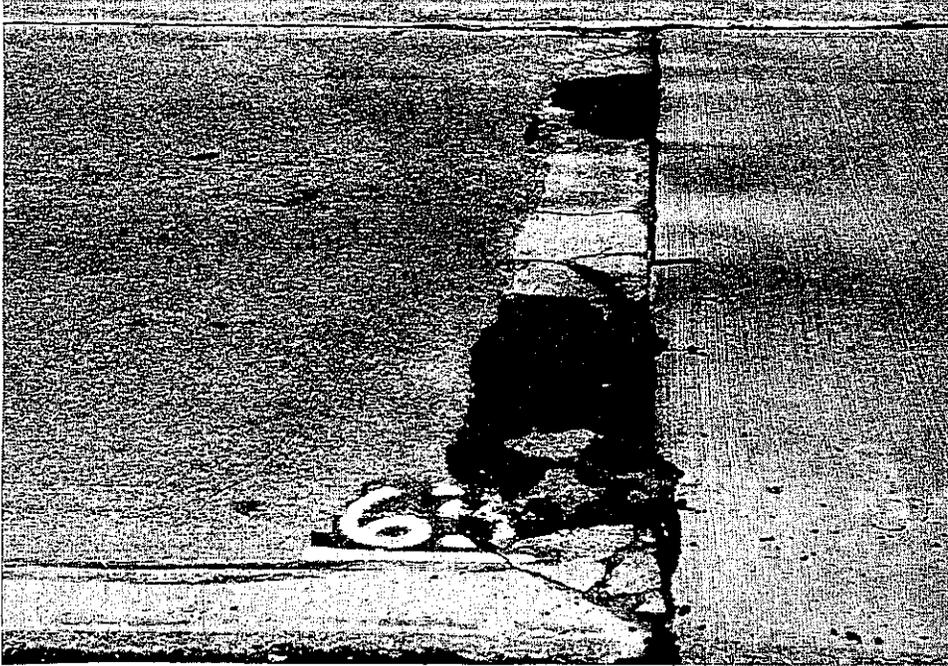
Patch distresses at all sites were remarkably similar and started at the drilled-tied ends in the old pavement (see Photo 11). Failures at the center of the patch were uncommon after the bars in the adjacent pavement became loose. The debonding of the existing concrete from the tie bars made them visible from the surface of the pavement. It was noted the shorter in length the patch was, the better the survival rate was. It was apparent that loading stresses were directly transferred to the patch joint that proved to be weaker than the patch concrete. This became the main mode of failure, which was repeated from patch to patch. Highly irregular transverse crack patterns of 0.15-4.5 m (0.5-15 feet) at Site 2 in Macoupin County caused an increase in patch distresses. Deeper tie-bar anchoring into the existing concrete has been used by others with limited success (see Reference 3).

Photo 11. Drilled-tied experimental design. Age: 4 months.

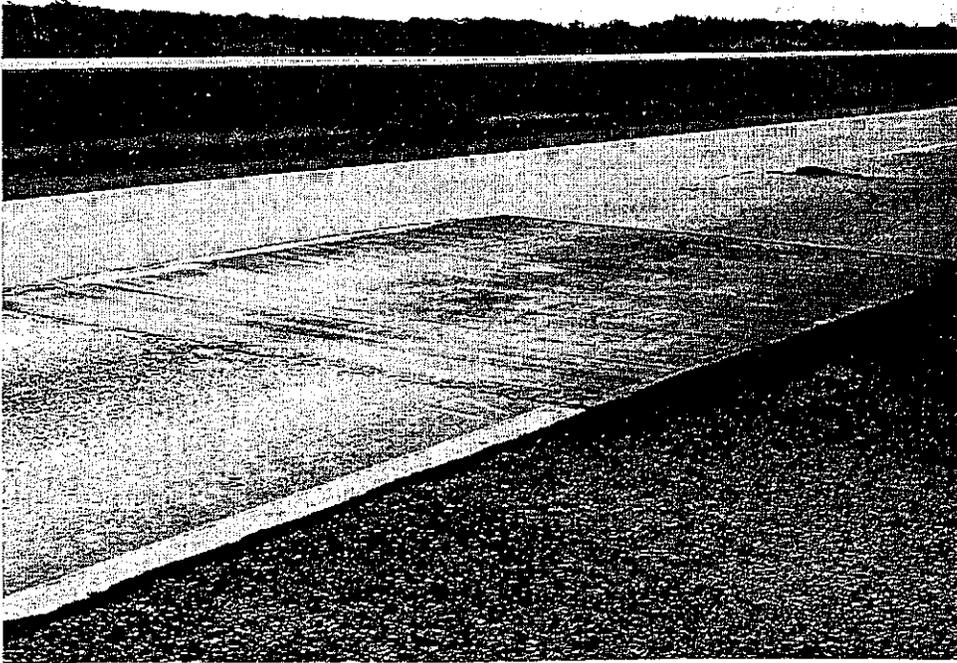
Patch joints were sealed using ASTM D 3405 hot poured sealant for 90 of the 132 patches. Refer to Special Provision for Joint Sealing Continuously Reinforced Concrete Patches. Photos 12 through 14 illustrate the hot poured sealant procedure. The 90 sealed patches were able to withstand large impact forces resulting from traffic loadings at all sites, but most notably, Site 1 in Logan County. Figure 7 shows a very low percentage of patch failures (4.5% after 18 months). Unlike other experimental CRCP patch designs in this study, the transverse rebar design did not have a high failure rate immediately after construction (see Photo 15).

Photo 15. Transverse rebar experimental design.
Age: 6 months.

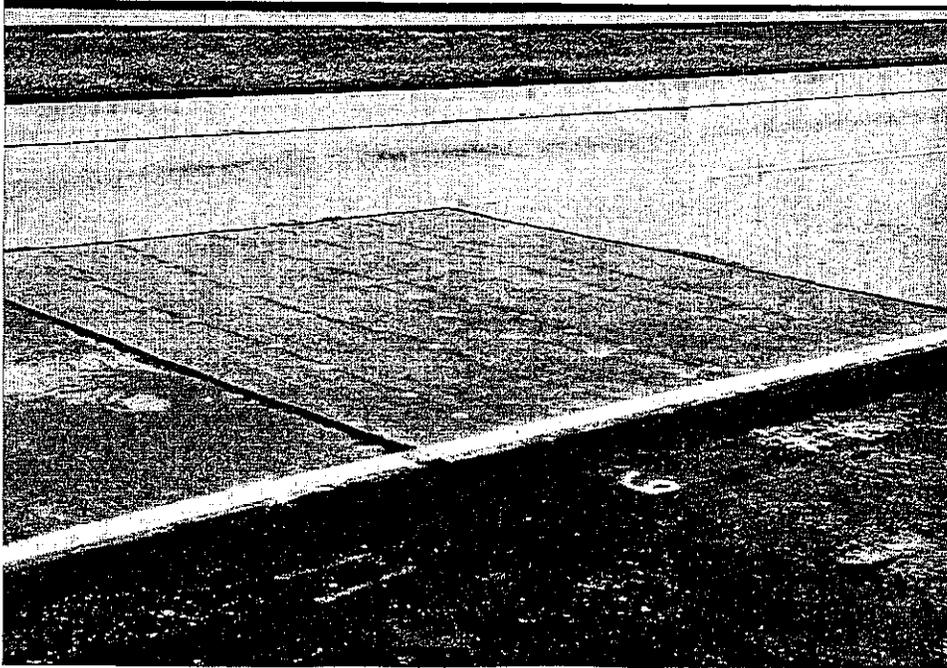
patches showed minimal distress at 2 months. Patches at Site 4 in Sangamon County contained only 44.5 Kg/cu. meter (75 lb/cu. yd) of steel fibers. These patches showed no improvement in performance over the conventional Class A patches. Patches of 7-inch CRCP at Site 5 in Douglas County contained 118.7 kg/cu. meter (200 lb/cu. yd) of steel fibers. These patches showed only marginal improvement (20% after 18 months) over the conventional Class A patches (see Figure 9). A reduced pavement thickness may have offset the strength gain of the steel fibers. The failure mode for the steel fiber modified concrete CRCP patch design was the formation of wide longitudinal and transverse cracks followed by punch outs, as depicted in Photo 16.

Photo 16. Steel fiber modified concrete experimental design.
Age: 6 months.

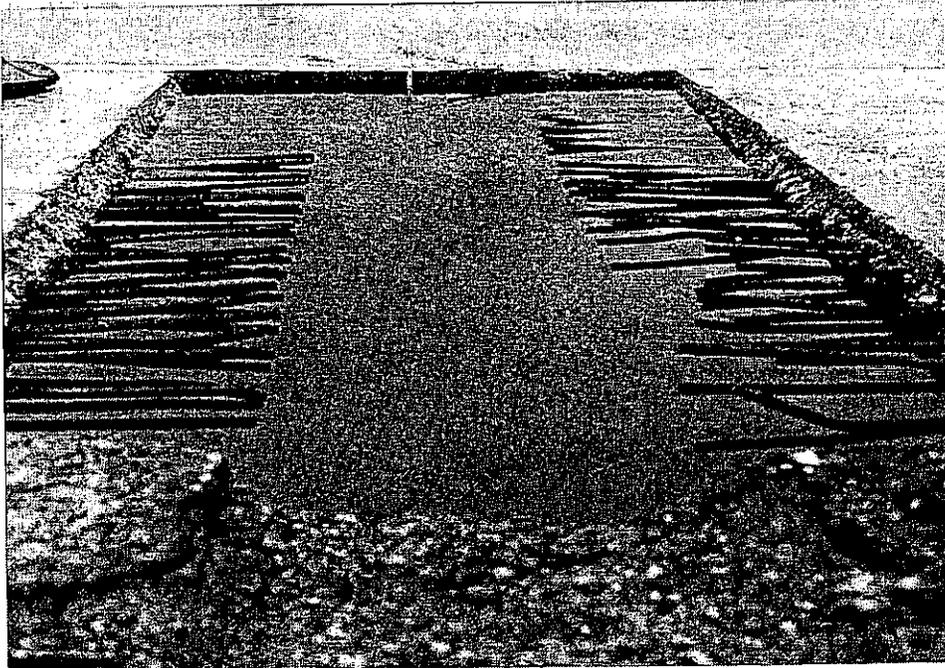
Photo 17. A weakened subgrade resulted from a saturated condition.

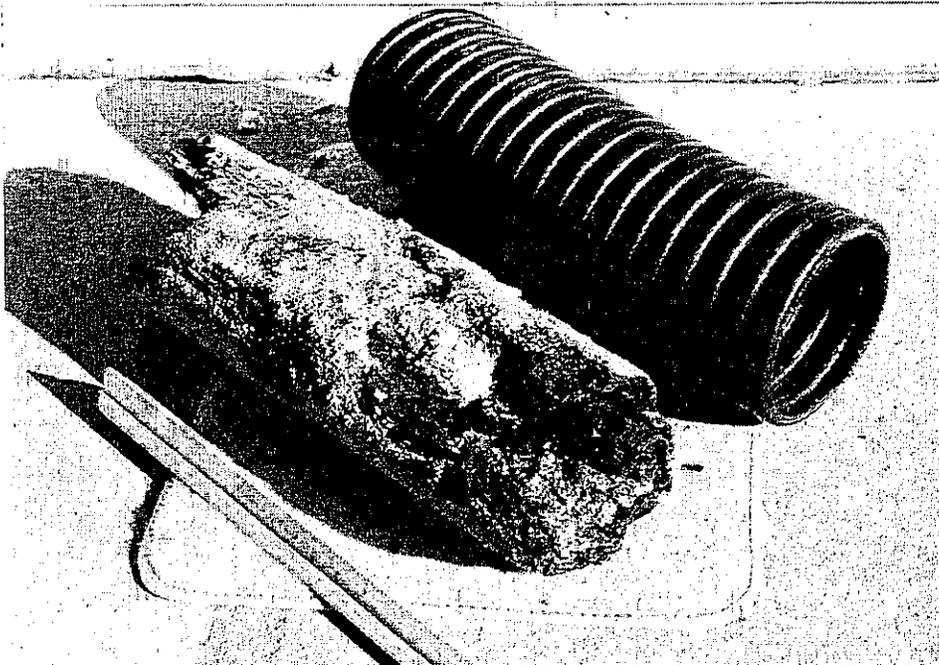
Photo 18. Deteriorated bituminous underdrain recovered during construction.

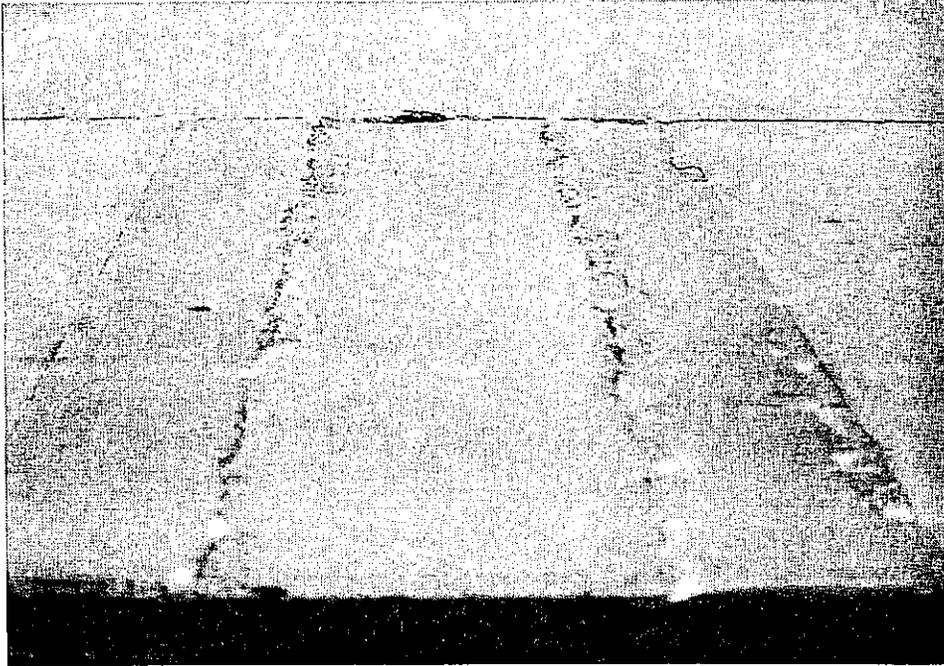
Survey data analysis indicates that over 75% of the patches failed completely in the two-year study period. Patch distresses ranged from spalling and longitudinal cracking to punch outs and pumping of fines. The design exhibited unexpected results with respect to the purpose of drainage. Figure 10 reveals an extremely high rate of patch failures. The fracture pattern of the majority of these patches showed that the excavation of the subbase between the rebar to be lap-spliced resulted in a loss of support between the rebar severed ends (see Photos 19-20). Drainage under the patch caused migration of subgrade fines, which washed through the underdrain network regardless of drain type. The drainage features actually allowed water to remain in the pavement, resulting in weakened subbase/subgrade support as indicated from CBR readings taken after the concrete was removed. It became evident that disturbance of the subbase/subgrade was responsible for the failures.

Photo 19. Drainage layer experimental design.
Age: 6 months

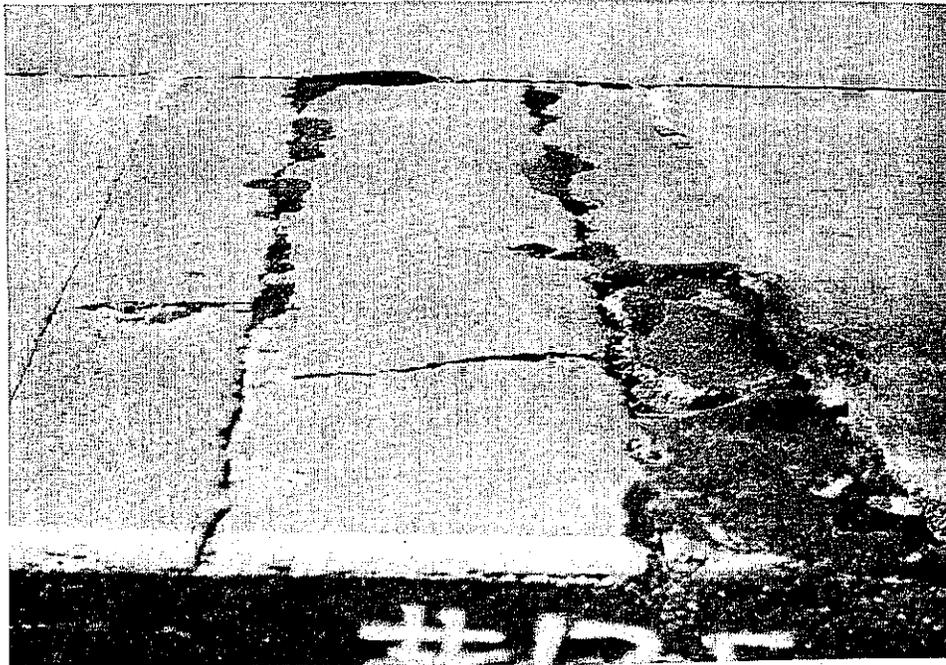
Photo 20. Drainage layer experimental design.
Age: 8 months
