# **Investigation of Rack and Pinion**

## **Alignment of the Cass Street**

### **Movable Bridge in Joliet, Illinois**

**Physical Research Report No.129**

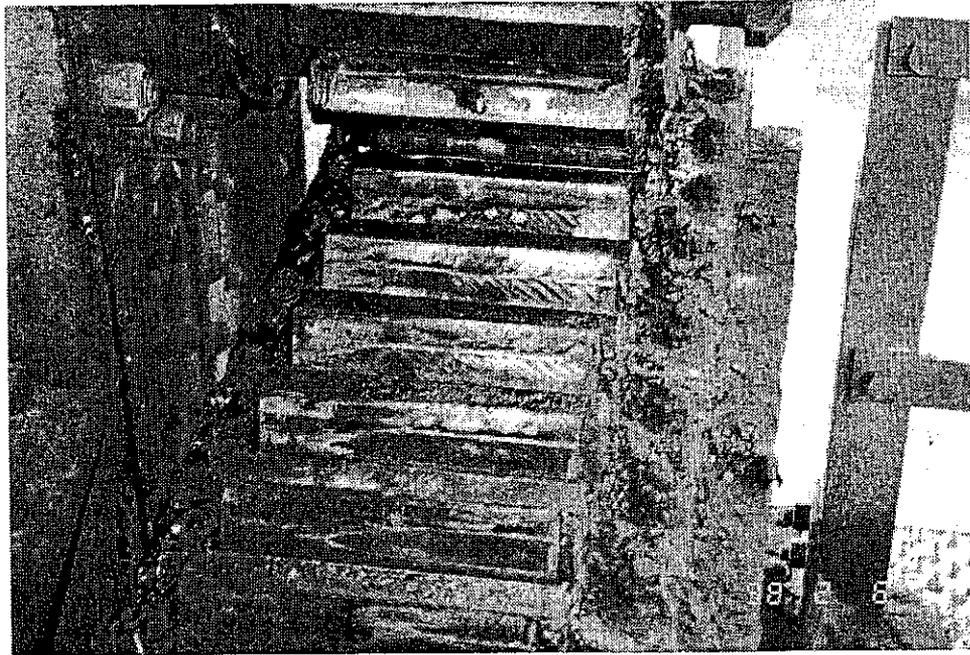
Based on the wear pattern as shown in *Figure 4*, the pinion is not correctly aligned with respect to the rack. Pinion orientation changed after the shims used in the retrofit of 1985-6 had fallen out, because the bolt holes had enlarged and bolt preload had dissipated. The steel shims were C-shaped, and were not passively captured by use of any epoxy or silicone rubber sealants. The collar was bolted to a series of rough, hot-rolled structural plates. These plates were not machined flat, nor were they spot-faced (made flat only in area of contact), nor was the bearing collar apparently reworked during the 1986 retrofit. Coincident with the 1997 rack and pinion problems were center lock misfit problems. Subsequent work in late 1997 apparently corrected the center lock interference problem, but the rack wear problem still remains.

**a. Abnormal Wear on Rack Teeth.** The racks, particularly in the northeast corner of the bridge, have experienced abnormal wear after the pinion bushing collar bolts were replaced due to hole expansion and incidental bolt breakage in 1997. The west side collars were welded into place with capture plates. The west side racks have not experienced significant wear damage like the east side. Broken collar bolts on the east side were removed, replaced and tightened in late 1997. Afterwards, the northeast rack developed a grooved wear pattern developed on the forward rack elements within a few weeks, as shown in *Figure 4*.

*Figure 4.* Wear pattern on the northeast forward (river side) rack segment which sustained the greatest wear pattern. Pattern indicates poor tooth contact and pinion misalignment.

**a. Tooth Contact.** Tooth contact between the face of the pinion gear and the rack was not proper. The pinion gear shaft was skewed, and was not perfectly level. This condition apparently developed after the C-shaped shims lost their preload and fell out after bolt loosening or breakage.

The orientation of the X, Y and Z axes for the rack and pinion are shown in *Figure 9*. The observed wear pattern appears to indicate that the pinion shafting axis is tilted with respect to the X-axis, and is also rotated a few degrees, placing the pinion's transverse plane out of alignment with respect to the Z-axis.

Exchange the essentially unused rearward 17-tooth rack segment with the worn forward (river side) rack segment. Place the forward rack segment to the rear, with worn teeth at the end of the rack.

a. The worn river side 17-tooth rack element should be exchanged with the virtually unused rearward rack element on the NE corner of the bridge.

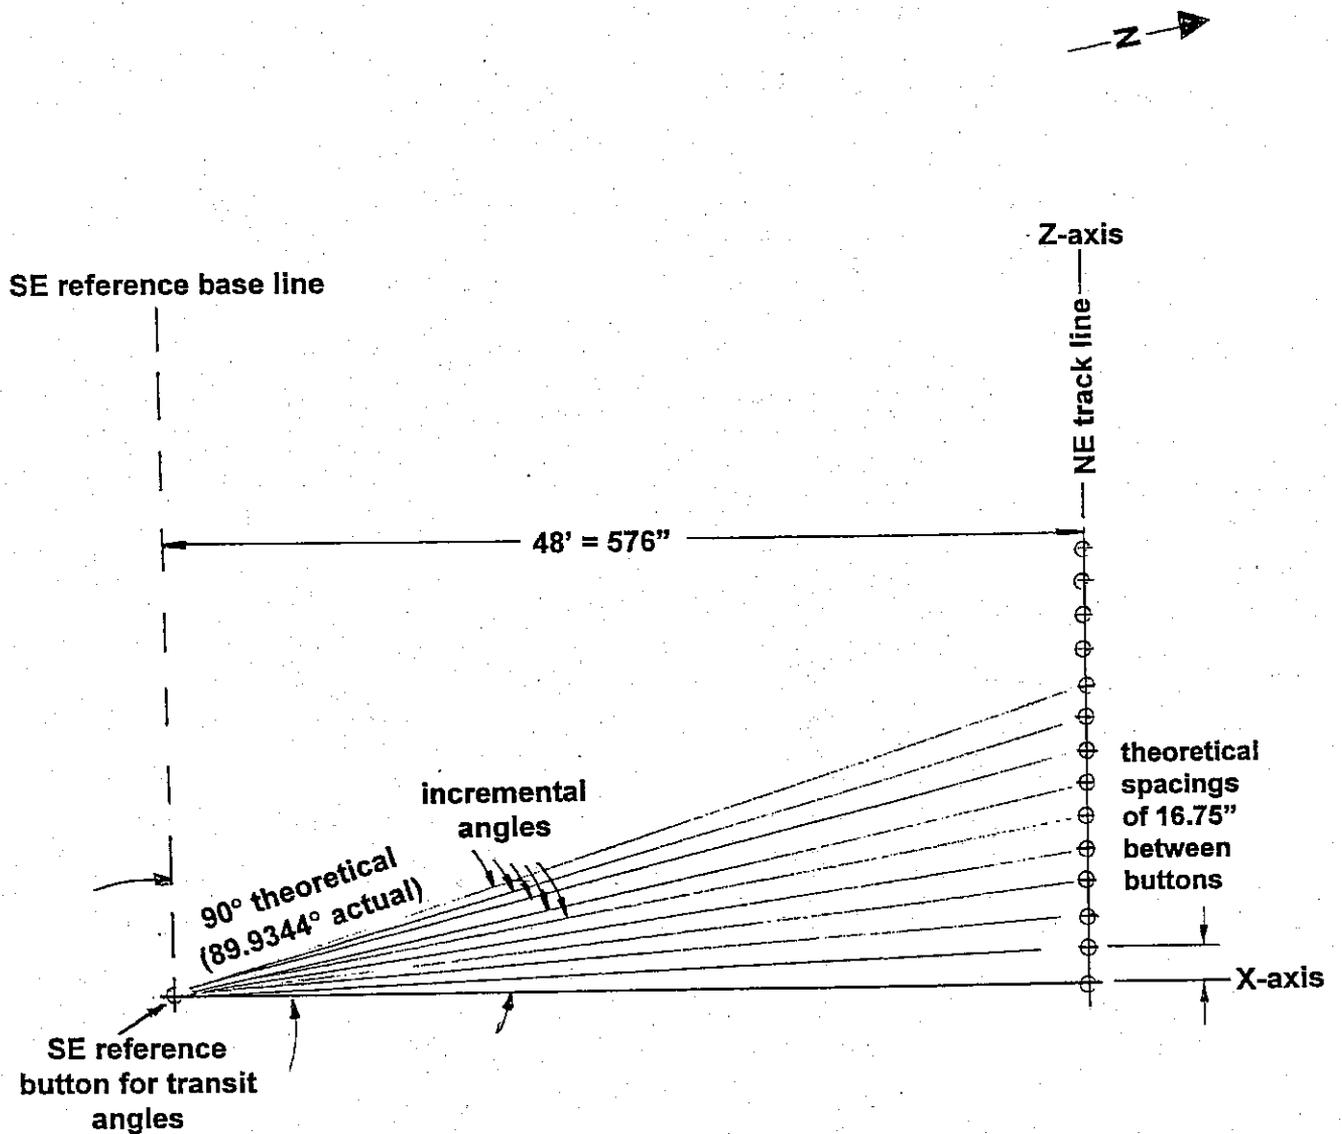
**c. Survey Results.** Key results are summarized in *Table 1*. The track survey indicates that the buttons were set in a straight line, with their centers deviating from linearity by no more than 2 mm. Spacing between each button center hole should be 16.75"; however, measurable variances in spacing were found. The range of spacing error for the NE track was +0.032" to -0.089"; for the SE track, +0.031" to +0.119". The maximum amount of shift of 0.121" can be accommodated by the 0.250" oversizing of the tread plate sockets.

*Figure 5.* A Geodimeter Model 600 transit accurate to 1 second was centered over the SE corner button tooth bolt and angles turned for respective buttons on the opposite track. Procedure was reversed on the NE corner bolt. Linearity of SE and NE bolt lines was also measured. Average deviation from a straight line was approximately 2 mm.

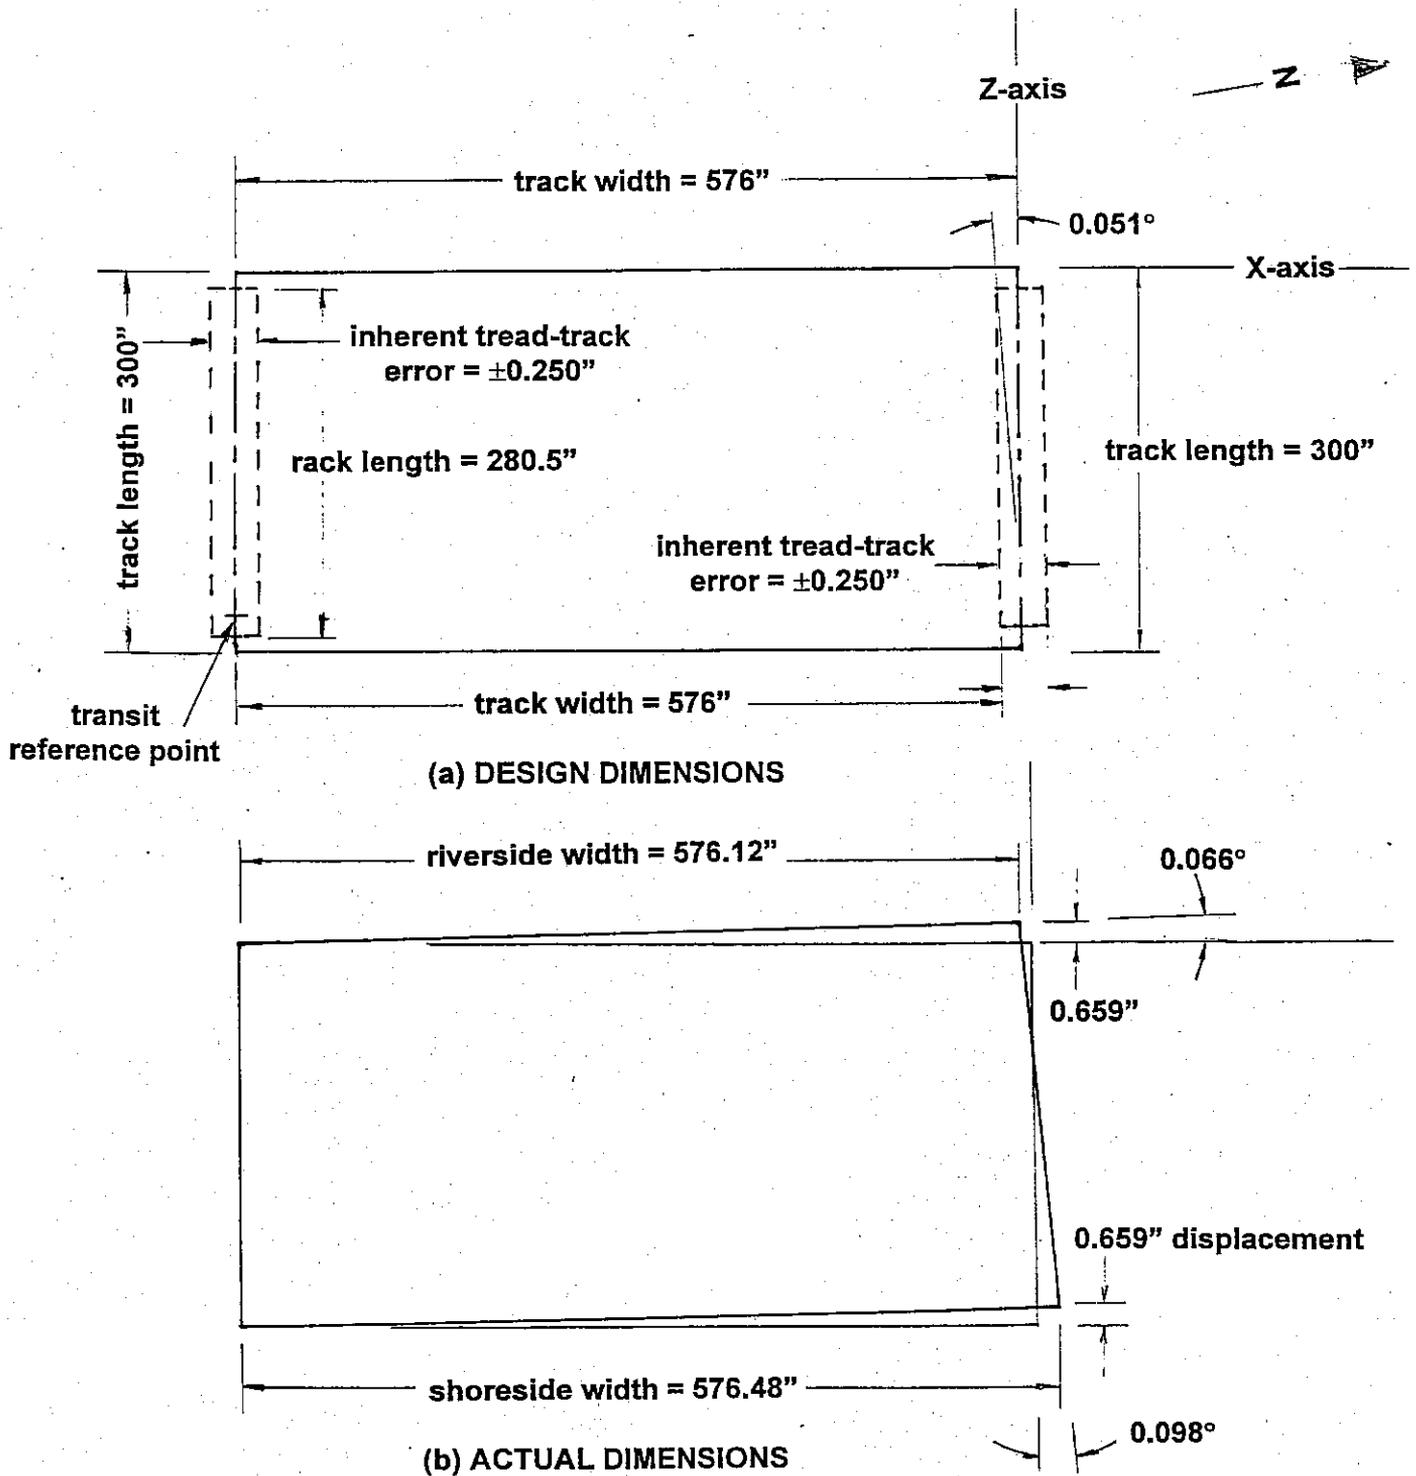
Although individual track linearity and button spacings were satisfactory, track lines were not parallel and buttons lacked proper correspondence. The NE button line was shifted toward the river by 0.659". This was confirmed by setting the SE track button line as a reference, and then turning the transit sight by  $90.000^\circ$ . It was found that the opposite button was not at  $90^\circ$ , but off by approximately  $0.06^\circ$ . Although  $0.06^\circ$  appears to be insignificant, this angle is over a distance of 576", resulting in a riverside displacement of 0.659", which exceeds the oversized socket hole accommodation of 0.250". Moreover, it skews the entire leaf span slightly, partially accounting for the center lock misfit.

Lastly, a 100 ft tape in 0.01' increments was stretched across both ends of the NE and SE tracks. The width dimension should be 48' = 576"; however, the riverside dimension was 576.12" and the shoreside was 576.48". Dimensional variations from design geometry are shown in *Figure 6*.

The oversized tread socket holes generate an inherent misalignment of 0.051°, based on 0.250" lateral deviation over 280.5" of rack length. The difference in width of 0.36" from 576.12" to 576.48" adds another potential 0.074° of misalignment along the rack's long axis (the Z-axis). These dimensional variations could cause a cumulative potential misalignment of 0.125° along the Z-axis.

The riverside displacement of the track buttons by 0.659" results in misalignment along the long axis of the pinion (the X-axis). Over 576" of track width, this can cause a misalignment of 0.066°. At the NE rack, a cumulative angular misalignment of [0.051° + 0.074° + 0.066°] = 0.191° is theoretically possible, but 0.164° misalignment is more probable because of tread socket oversize. Even when mating spur gears of significant size and coarse pitch, such misalignment is clearly undesirable. These inherent design and construction misalignments must be rectified in future track and rack modifications.

Figure 6. Design dimensions for the track (a) are compared with actual dimensions as measured by direct survey (b). Scale of distortion in (b) is greatly magnified for effect. Because of the oversize of the tread sockets by 0.250", the tread can deviate from true linearity by  $\pm 0.250$ ".

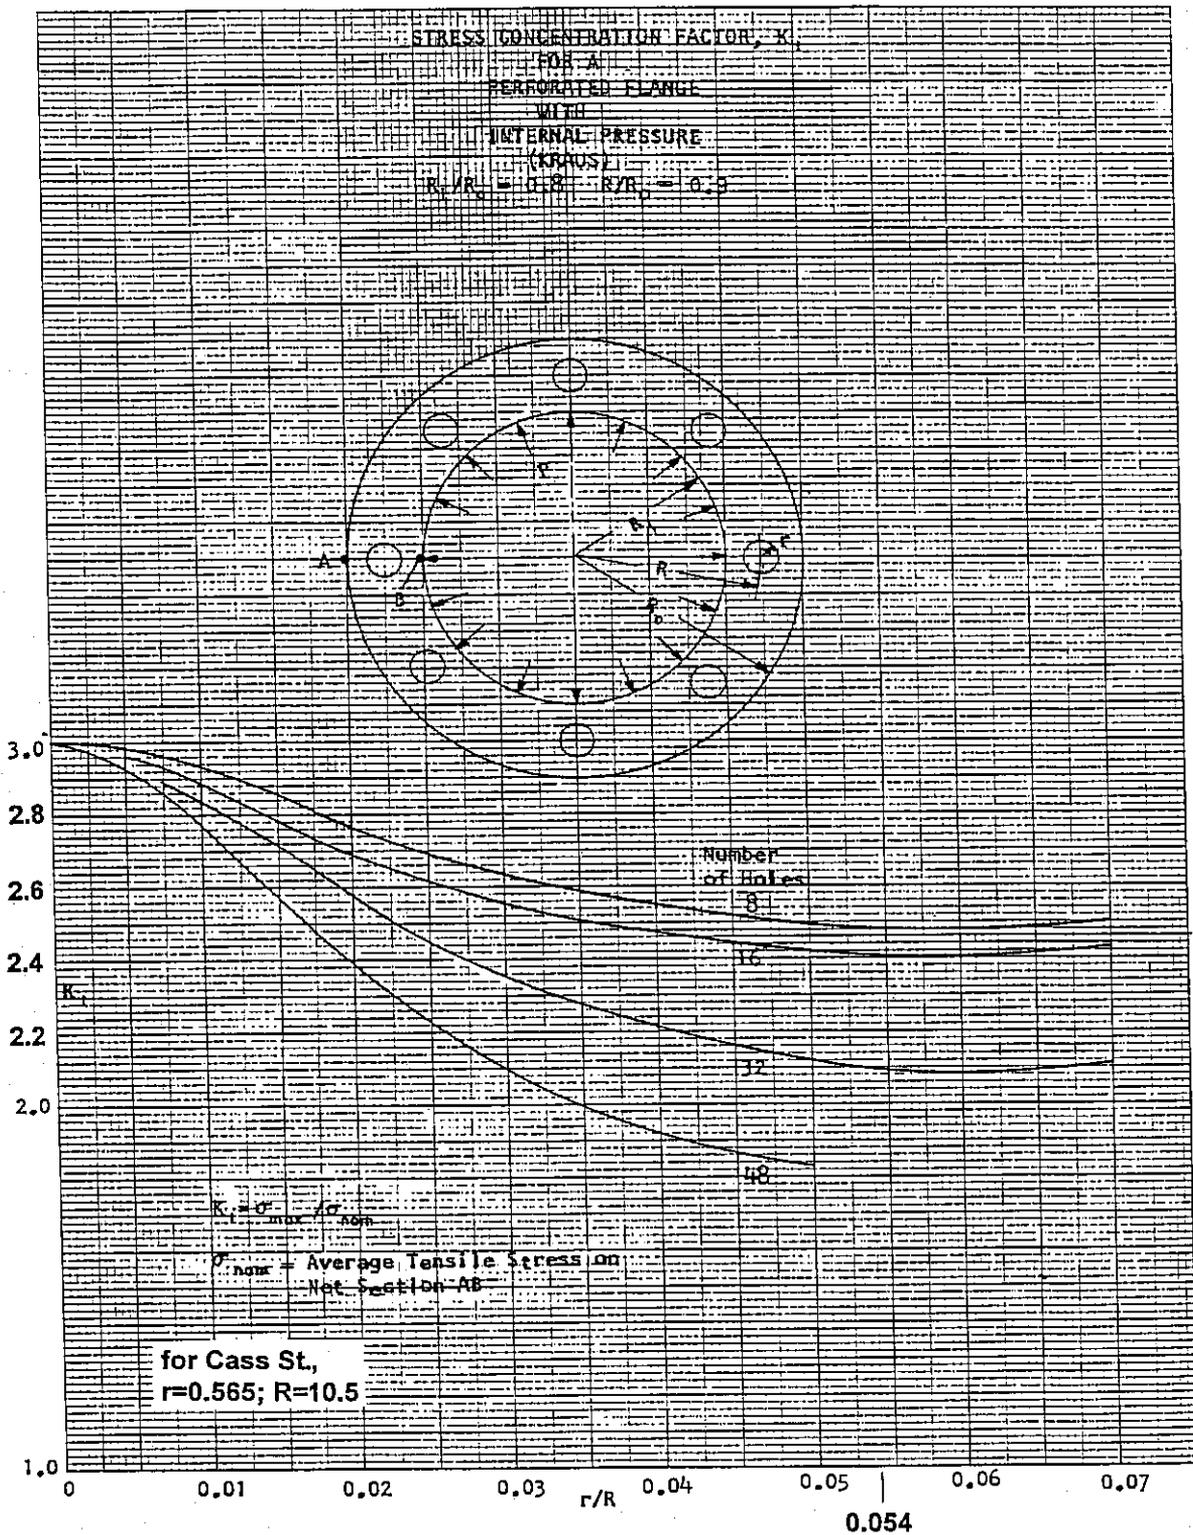
Stress concentrations in a perforated flange with internal pressure have been studied by Kraus (as summarized by Peterson) [Reference 6]. The graphical solution for the Cass St. Bridge conditions is shown in *Figure 8*. For the Cass St. Bridge, the bolt hole radius  $r$  is 0.565", and the bolt circle radius  $R$  is 10.50", resulting in an  $r/R$  ratio of 0.54. For six bolts, the stress concentration factor  $K_t$  is about 2.5 in the collar bolt holes.

Uniformly distributing 105,830 lbs of force among six bolt holes results in 17,638 lbs/hole. If this force exerts pressure on one side of a 1.125" diameter hole of 1.5" depth, 23,455 psi bearing pressure results. Because of stress concentrations, peak stresses can potentially rise to 58,600 psi, which exceeds the probable yield strength of 35,000 psi for the casting and plates. Holes on the castings and plates for both Cass St.

*Figure 8.* The graphical solution of Kraus for stress concentrations in a perforated flange with internal pressure. In the Cass St. Bridge pinion bearing, the shear and bending forces on the shaft provide the internal pressure. The  $K_t$  for 6 bolt holes was estimated as 2.5; and for 11 bolt holes,  $K_t \approx 2.4$ . Source: R. Petersen, *Stress Concentration Factors*, Wiley-Interscience, New York, 1974, p 192.

and Jefferson St. Bridges exhibited elongation when reworked in 1985-6. These holes were redrilled from their original diameters of 1.063" to 1.125" at that time. If the number of collar bolts were increased to 11 bolts, nominal bearing stress decreases to 12,800 psi. Stress concentration factor  $K_t$  drops slightly to 2.4. Peak bolt hole stresses also decline to 30,100 psi, which is slightly less than the probable casting or plate yield strength of 35,000 psi.

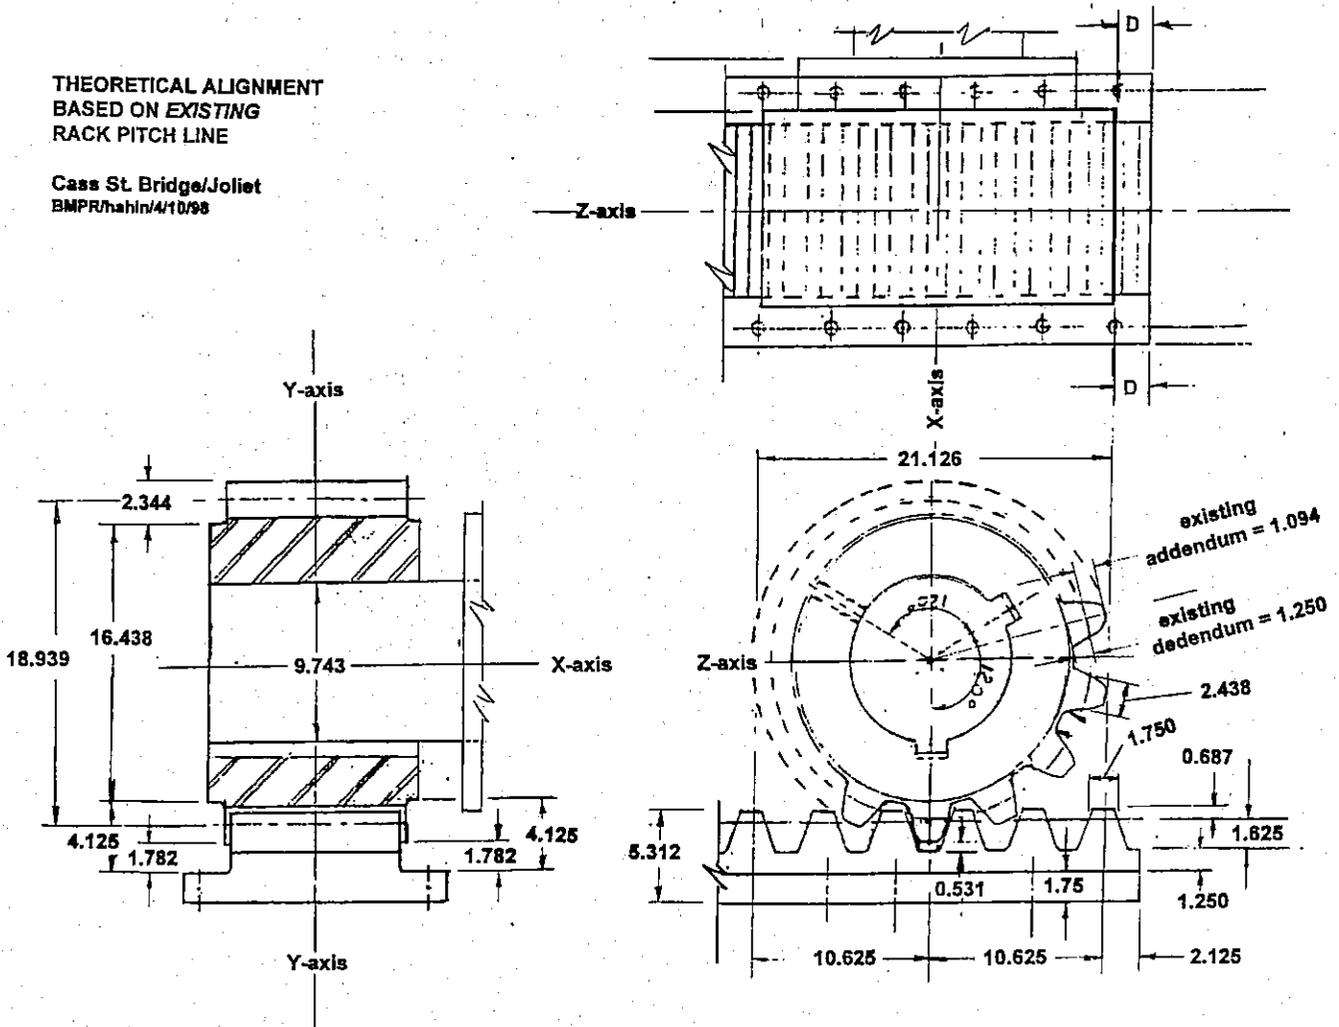
**Figure 9.** Orientation of the X, Y and Z-axes for alignment of the pinion and levelness of the rack, and other general dimensions. Reference dimensions are the clearance between the rack and pinion teeth; rack pitch line and pinion pitch line alignment; levelness of the pinion, and "D" distance equality on both sides of the rack and pinion.

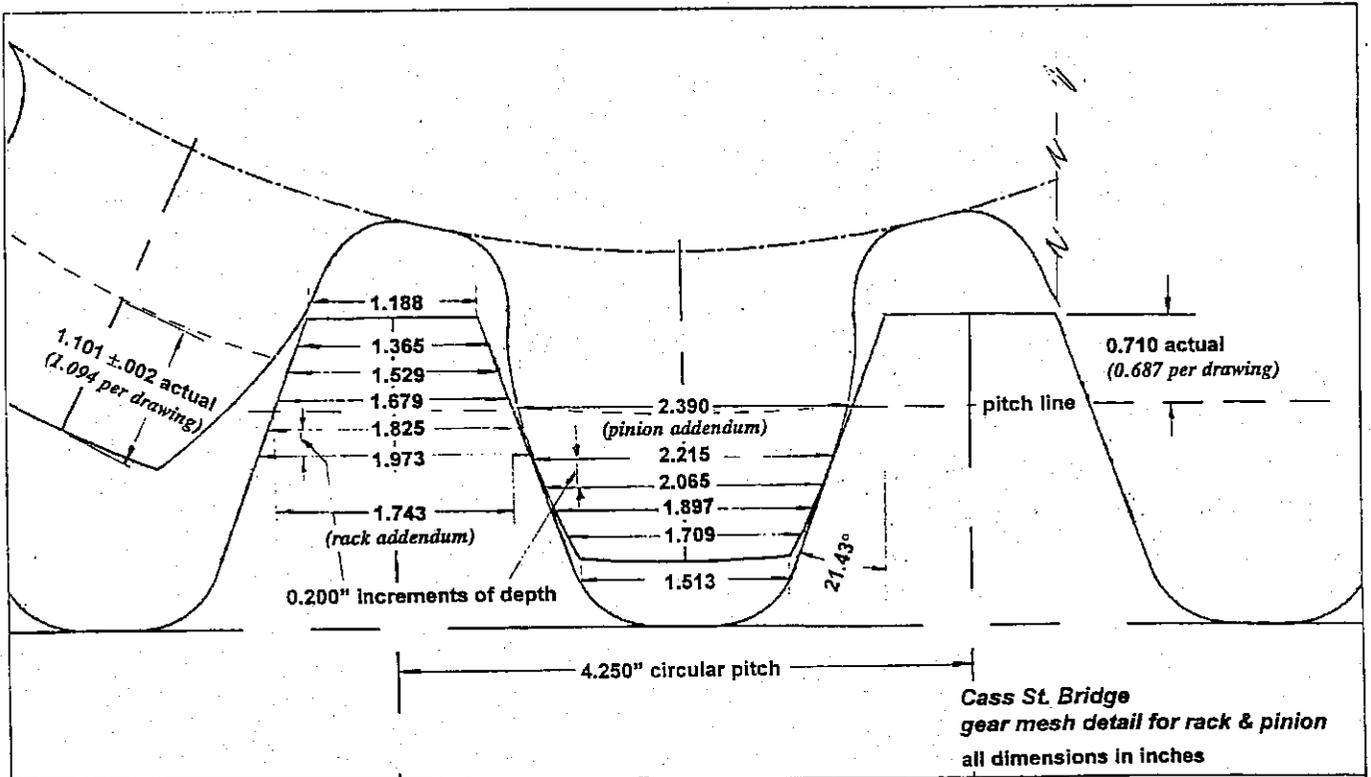
**Figure 10.** Actual gear mesh at the original design pitch line, showing actual dimensions taken by a tooth thickness vernier of the racks and pinions retrofitted in 1986 at various depths.

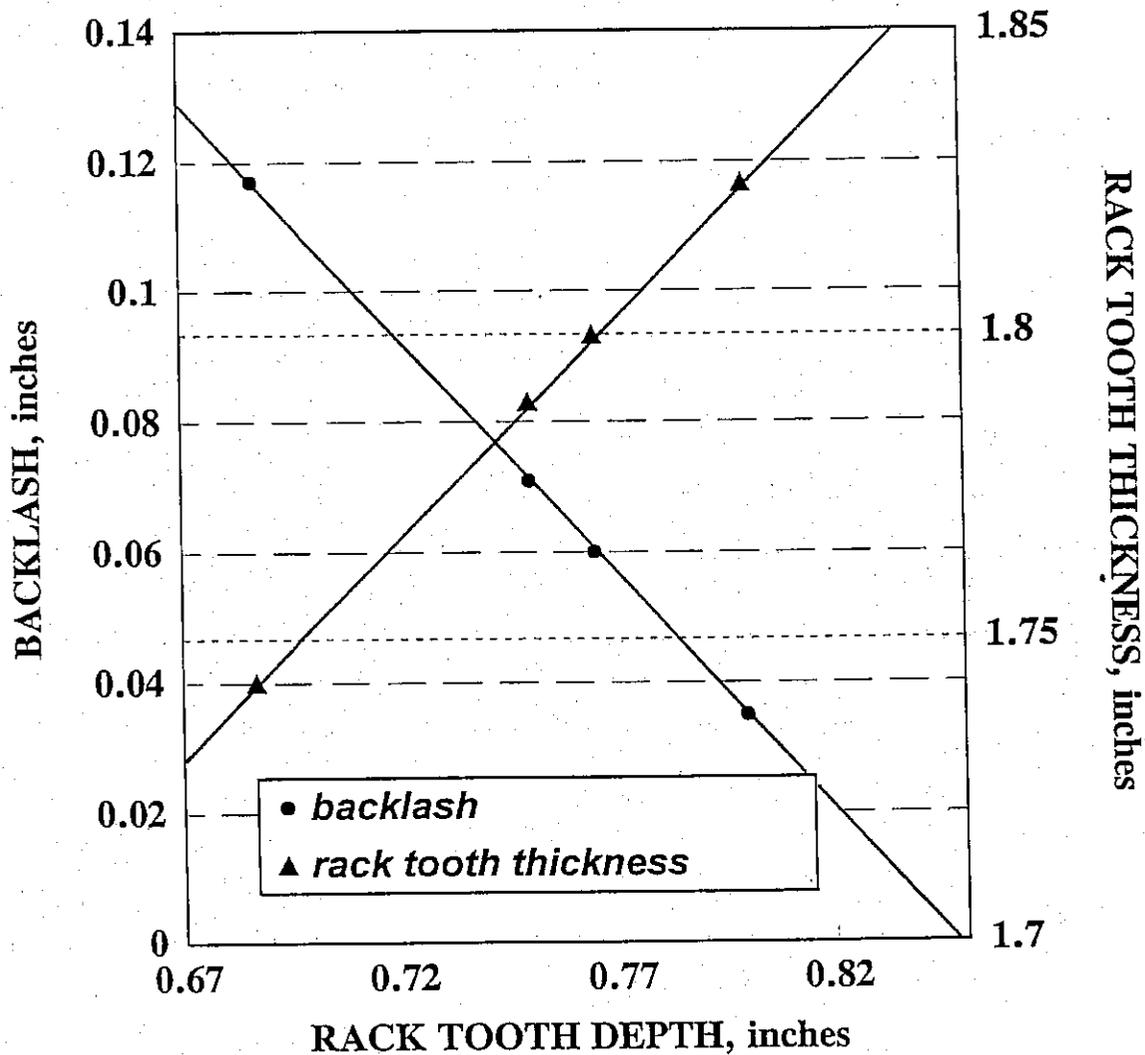
Figure 11. Plot of the amount of backlash available as the pinion addendum progressively moves downward below the rack pitch line. This graph assumes that the thickness of the pinion addendum is 2.390", the actual mean dimension obtained from field measurements with a gear tooth thickness vernier.
