An Evaluation of Engineering Fabric in Pavement Rehabilitation (IHD-21)

Physical Research Report No. 88

AN EVALUATION OF ENGINEERING
FABRIC IN PAVEMENT REHABILITATION
IHD-21

FINAL REPORT

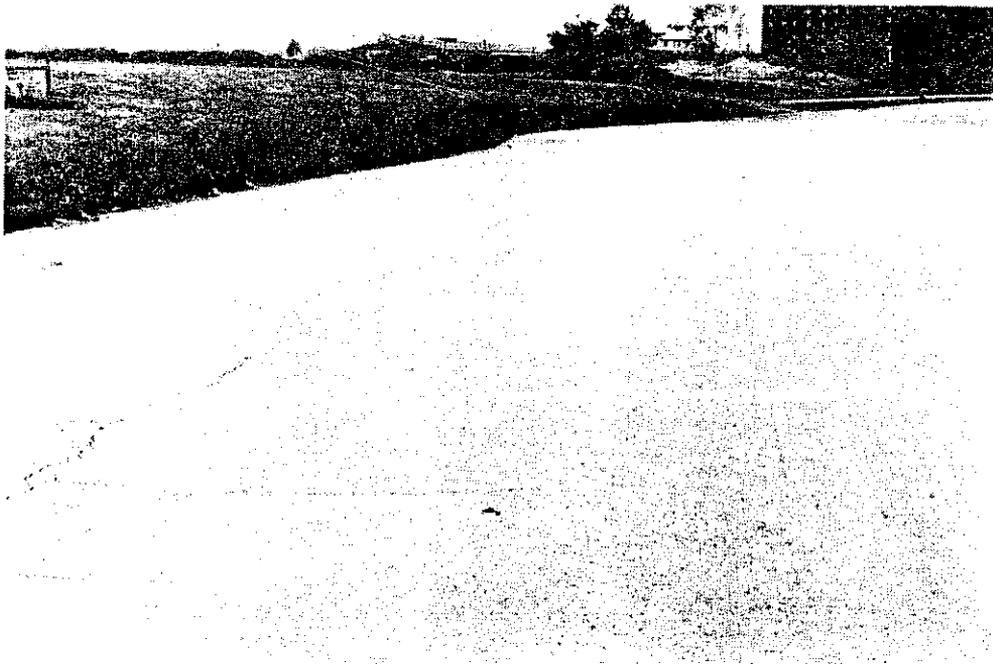
After sixty months of service, a few newer transverse cracks were noted in both the test and control sections. However, they appeared to be less in number and severity in the test section as shown in Figures 1 to 4.

Figure 2. Typical Crack in Control Section, Urbana.

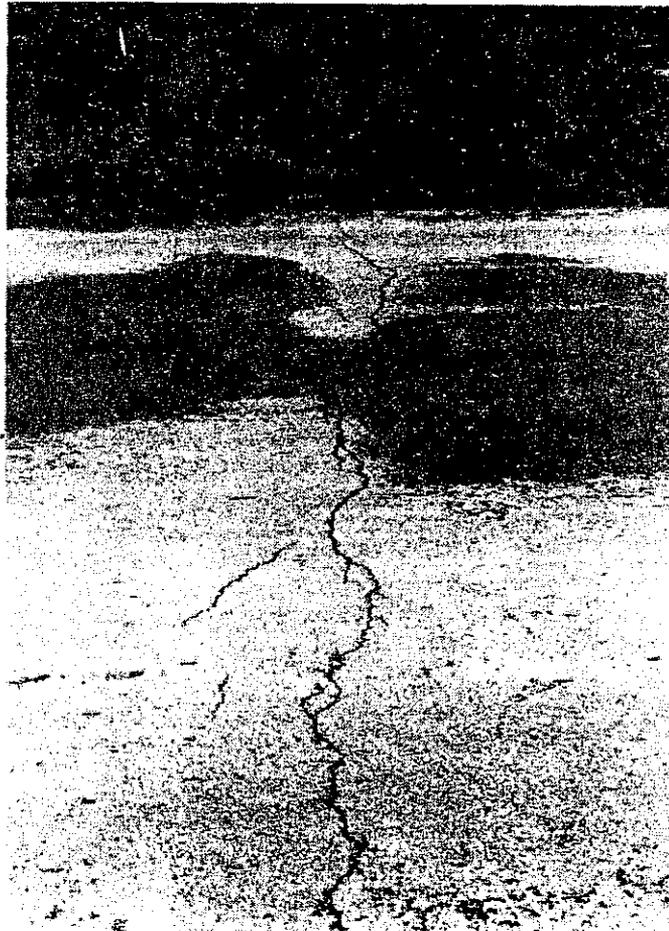
Figure 3. Typical Crack Opening in Petromat Test Section, Urbana.

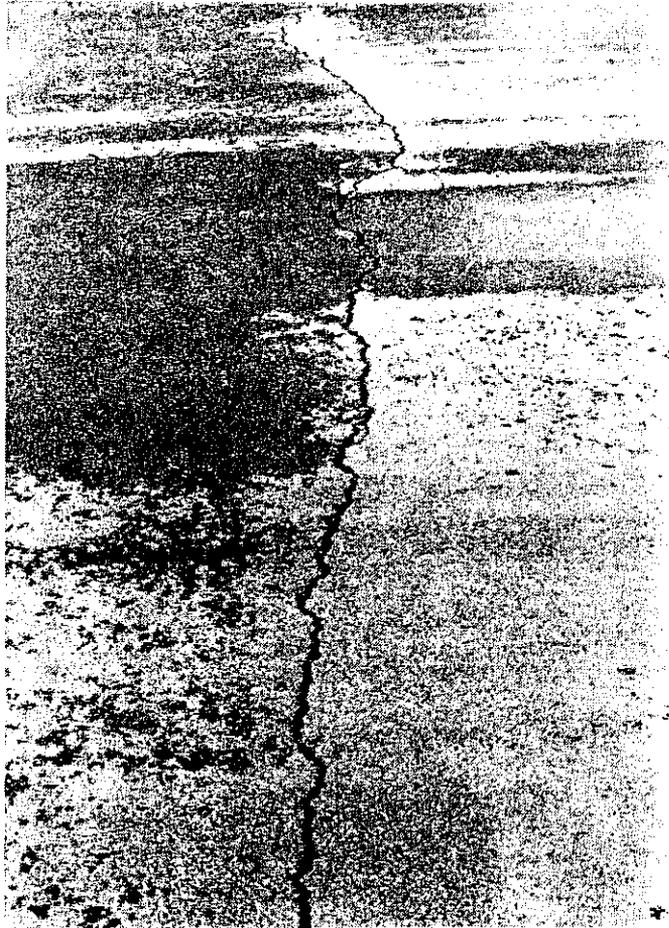
Figure 4. Typical Crack Opening in Control Section, Urbana.

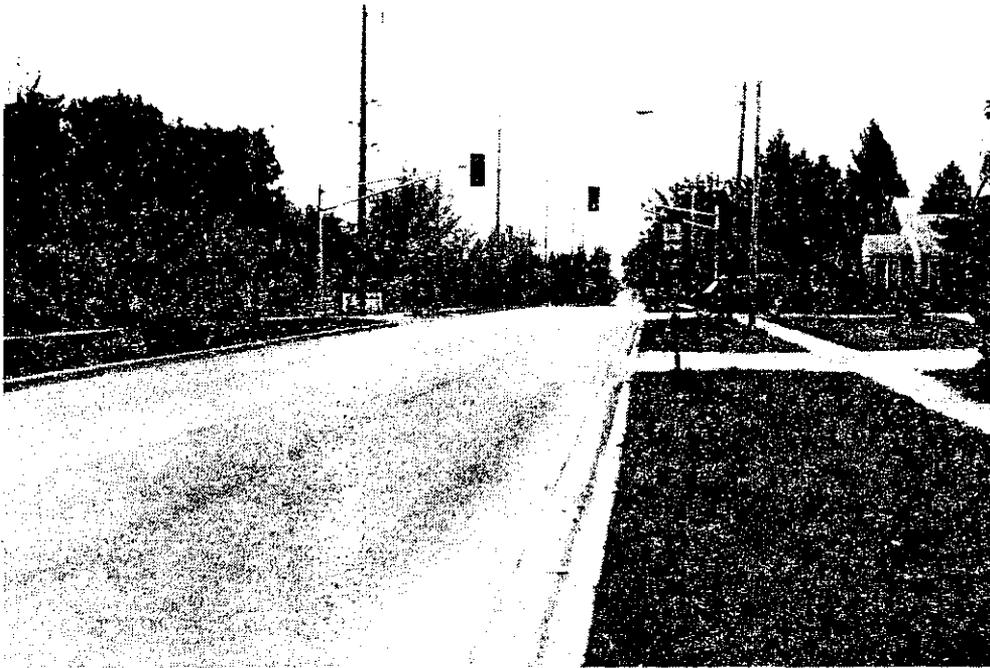
After almost three years of service, twenty one cracks were noted in the test section and twelve in the control section. Some cracks are more prominent than others but the pavement surface is still in excellent condition as shown in Figure 5 and 6. Figure 7 shows a closeup of a typical crack in the test section.

Figure 5. General view of Petromat Test Section, Moline.

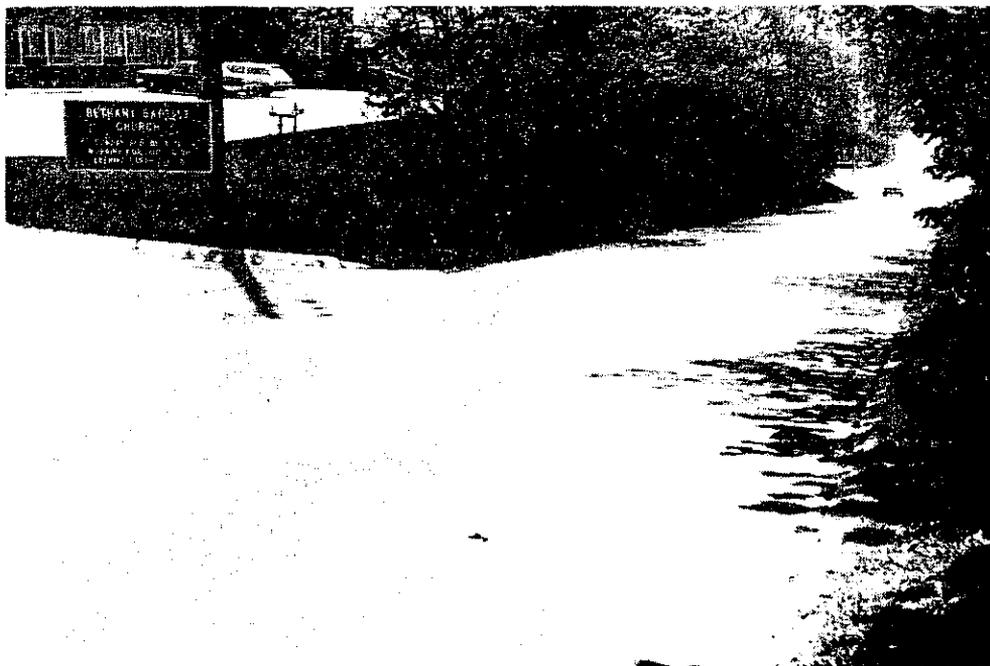
Figure 6. General view of Control Section, Moline.

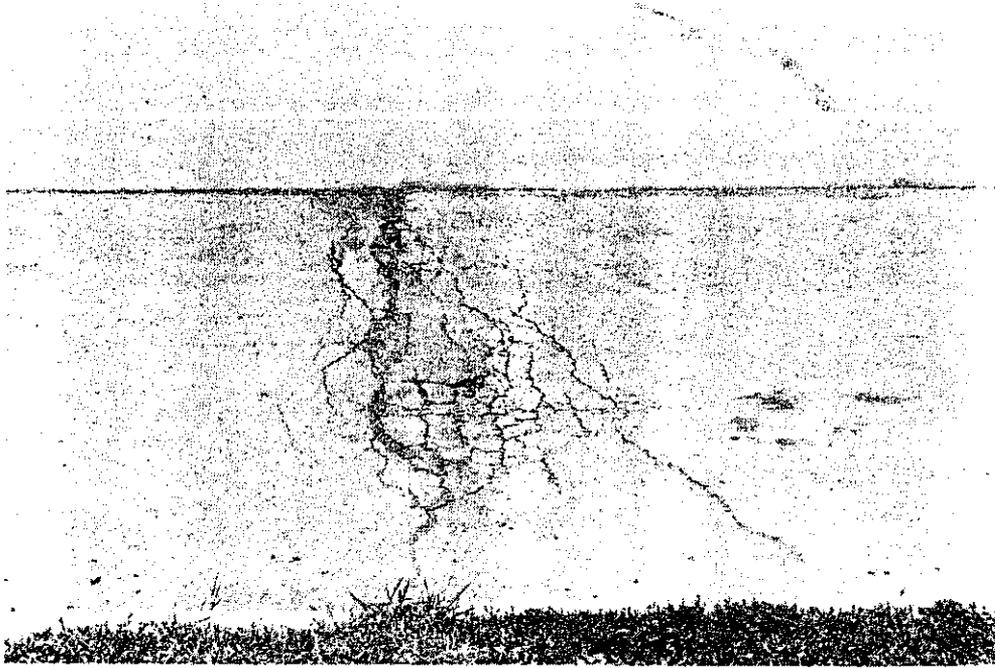
The latest inspection of both sections after 2 1/2 years of service revealed that almost all of the original cracks had reflected, including some longitudinal cracks. Secondary cracking and raveling also has developed at several transverse cracks as shown in Figure 8.

In this project it appears that the fabric had little effect in retarding the development of reflective cracking.

Figure 8. Badly Deteriorating Crack in Petromat Test Section, Elmhurst.

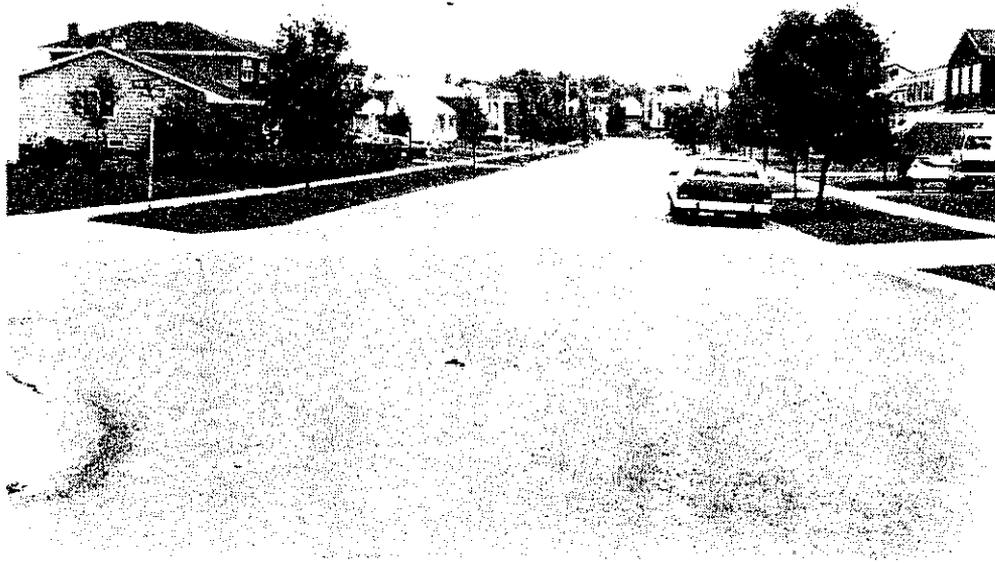
Performance. After 21 months of service under relatively light local traffic, the test section is performing very well with only two minor cracks. The fabric seems to be effective in controlling reflective cracking of a

rather unstable pozzolanic base. Figures 9 & 10 show general views of Prince Charles Lane and Prince Charles Court, which are in excellent condition.

Figure 9. General View of Petromat Test Section, Schaumburg.

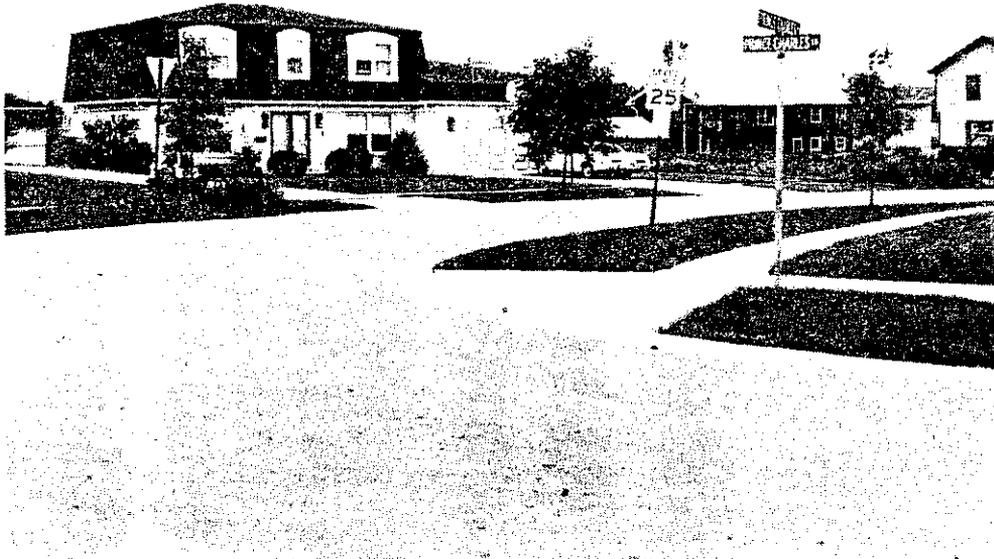
Figure 10. Another View of Petromat Test Section, Schaumburg.

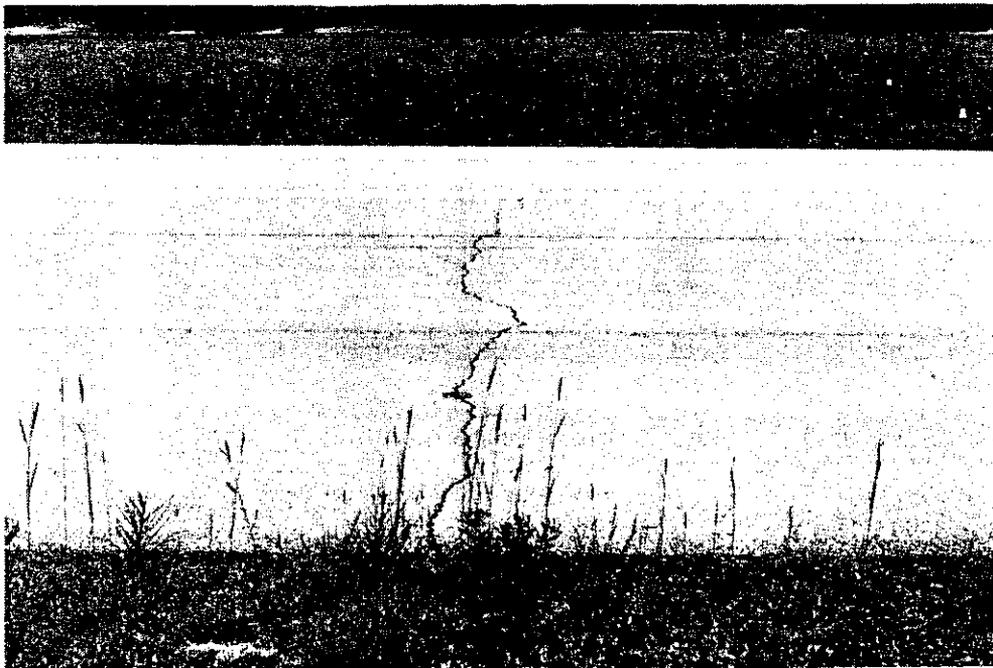
Most of the reflective transverse cracks were wide open (1/4") and extended all the way across the runway surface as shown in Figure 11. To determine if the fabric was intact and retarding the flow of surface water, cores were taken at three locations directly over the cracks. Figure 12 shows the location of a core previously taken when the crack was tight.

Figure 11. Typical Crack in Petromat Test Section, Beardstown Airport.

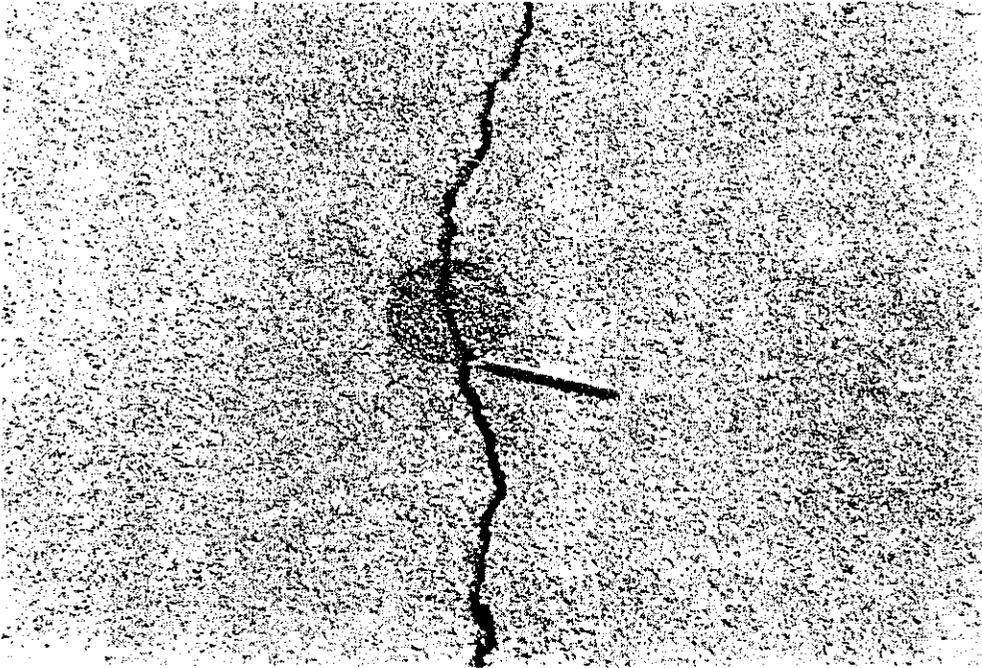
Visual examination of the cores showed the fabric was not broken over the cracks. Permeability tests were run on the cores by waxing a plastic graduate to the surface. A constant head of 1 3/4 inches was maintained for five minutes. Although the cracks were not water tight, the rate at which water passed through the fabric was reduced as compared to an open crack.

Figure 12. Closeup of Crack at Core Sampling Location, Beardstown Airport.

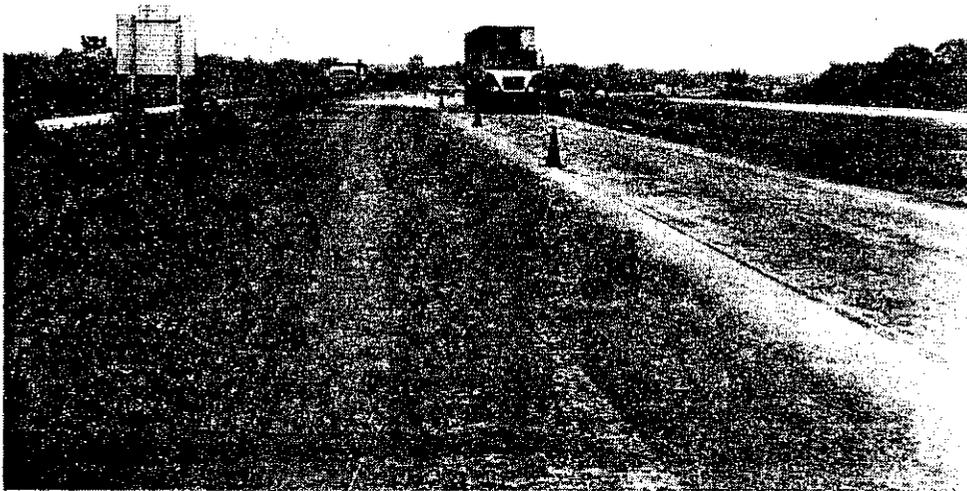
The surface course was not placed until five days after the installation of the fabric and sand blotter because of bad weather prevailing during that period. Meanwhile traffic was allowed on the fabric as shown in Figure 13. The fabric held up very well and no sign of tearing, wear, or traffic pick-up was noted during paving of the surface. I-80 at this point has an ADT of 13,600 on four lanes including 2900 trucks.

Figure 13. Sand-Blotted Petromat Fabric Surface Opened to Traffic, I-80.

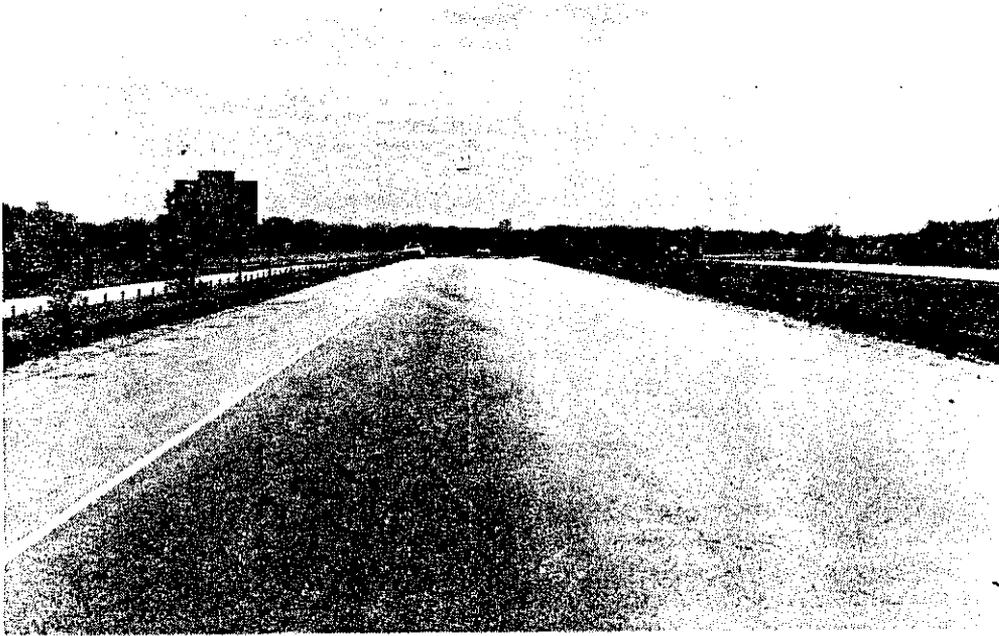
Performance. Inspection made of the installation after two years of service indicates that the test section is performing very well with no signs of any surface distress or reflective cracking as shown in Figure 14. The results could be reasonably expected because of the rigid CRC pavement underneath that permits only negligible vertical displacement along its closely spaced transverse cracks. As long as these cracks are prevented from further deterioration and are held together by the heavy reinforcing bars, reflective cracking in this project should be minimal.

Figure 14. General View of Petromat Test Section, I-80.

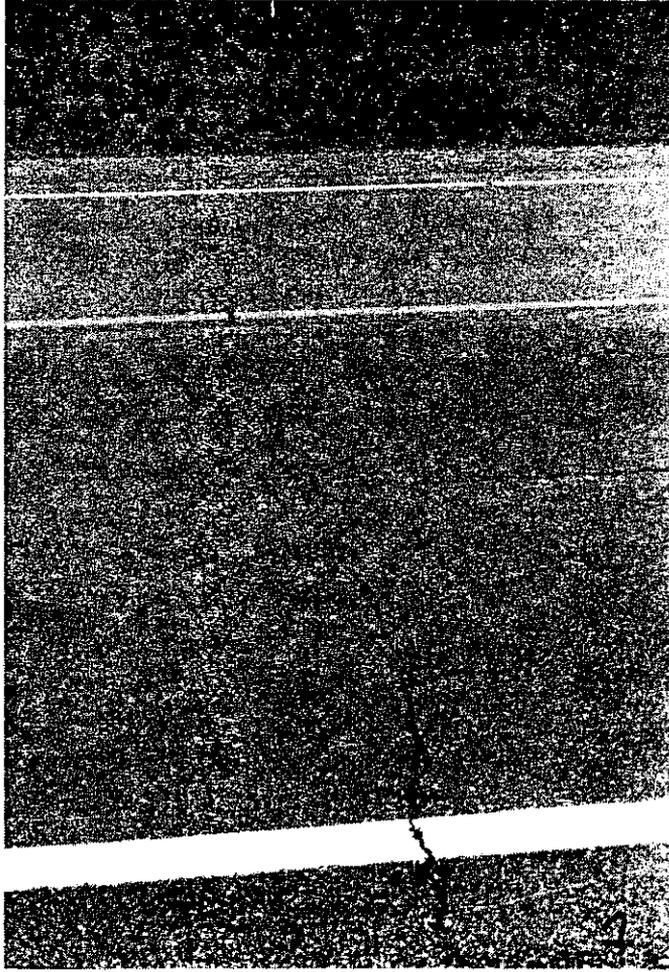
H. D. Bituthene Test Section. Ten out of 16 full pavement width transverse cracks or joints have reflected full width and wide open as shown in Figure 15. No reflective cracking has occurred over the widening joints, but most of the untreated longitudinal centerline joint has reflected.

Figure 15. Typical Crack in Heavy Duty Bituthene Test Section, Ill. 48.

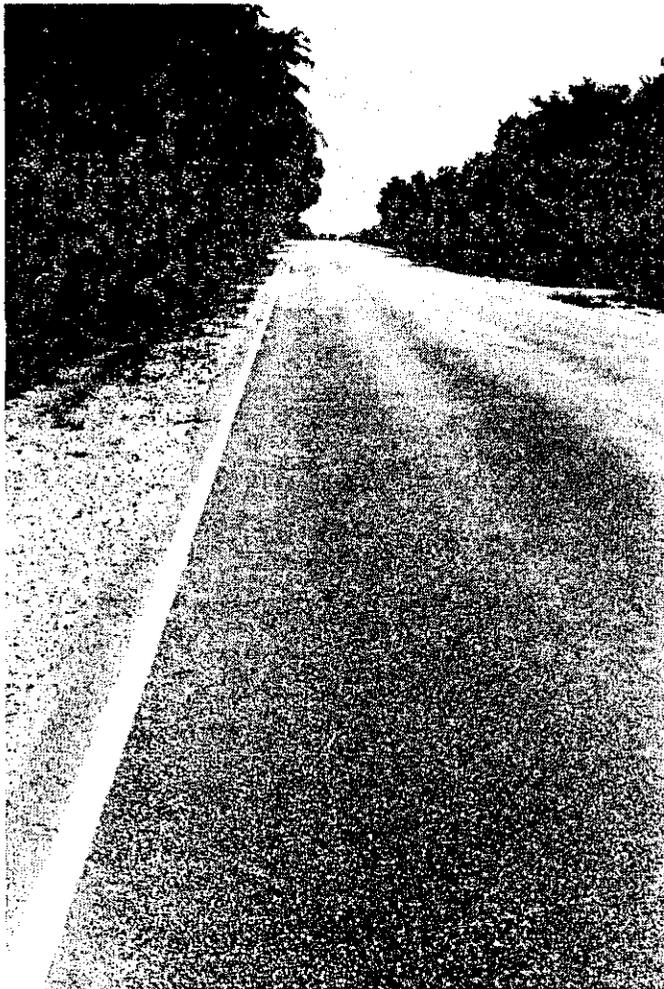
Petromat Test Section. The Petromat was placed only on the east widening joint and no reflective cracking was found over it. About 400 feet (17%) of the widening joint has reflected in the control side as shown in Figure 17.

Figure 17. Reflective Cracking on Widening Joint of Control Section.
(None in Petromat Section), III. 48.

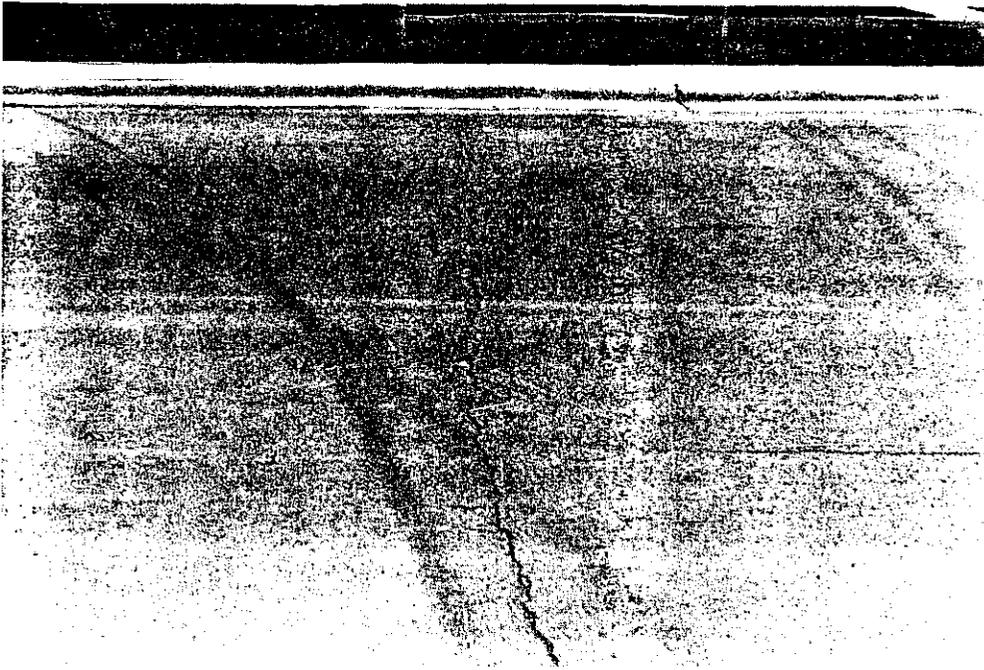
After almost two years of service, the test section has 65 reflective transverse cracks and 3 longitudinal cracks as shown in Figure 18 and 19. These cracks are well defined and wide open. The pavement in general still looks good.

Figure 18. Typical Crack in Petromat Test Section, Douglas St., Freeport.

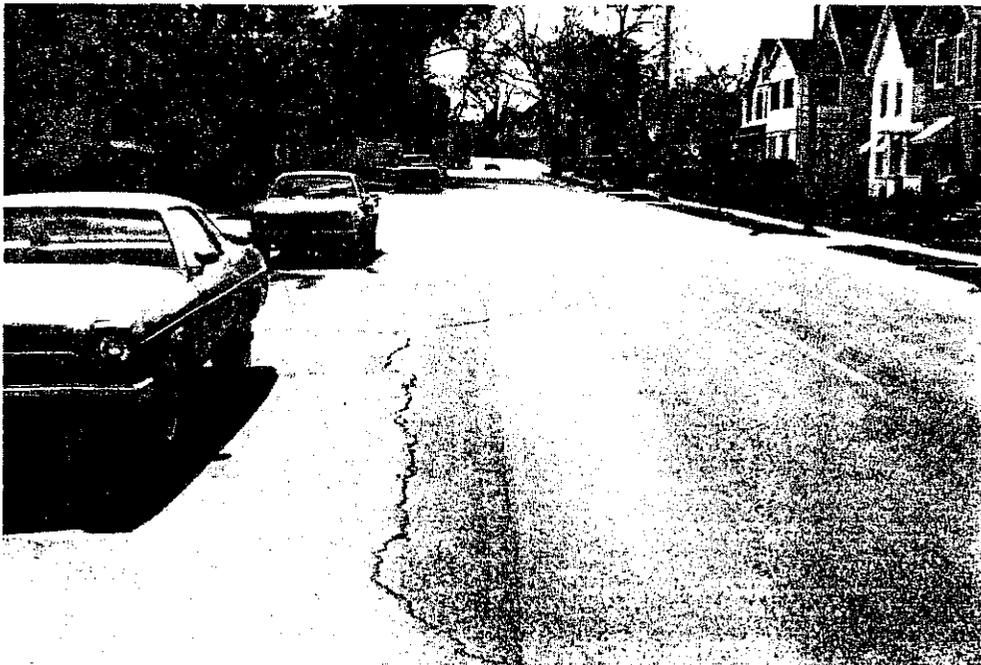
Figure 19. Longitudinal Crack in Petromat Test Section, Douglas St., Freeport.

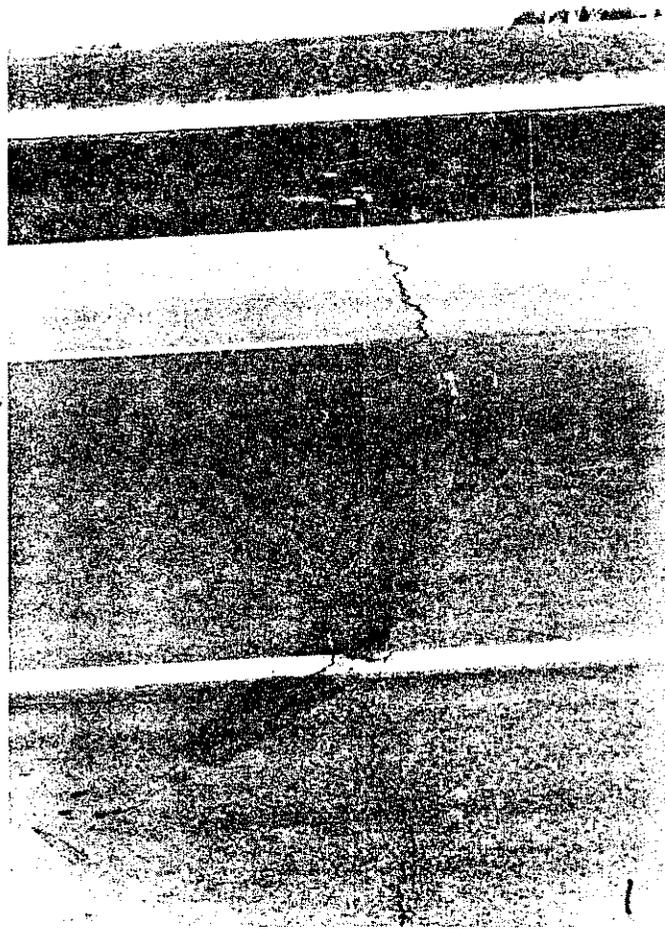
Performance. Inspection of the installation after almost one year since the bituminous concrete surface course was completed and opened to traffic indicates no difference in the amount and severity of reflective cracking between the Petromat test section and the control section. The reflective transverse cracks are mostly in patched areas as shown in Figure 20. This

Figure 20. Typical Crack in Petromat Test Section (Patched Area in CRC Pavement), I-57.

seems to be an indication of movement of the patch, either laterally or vertically or both.

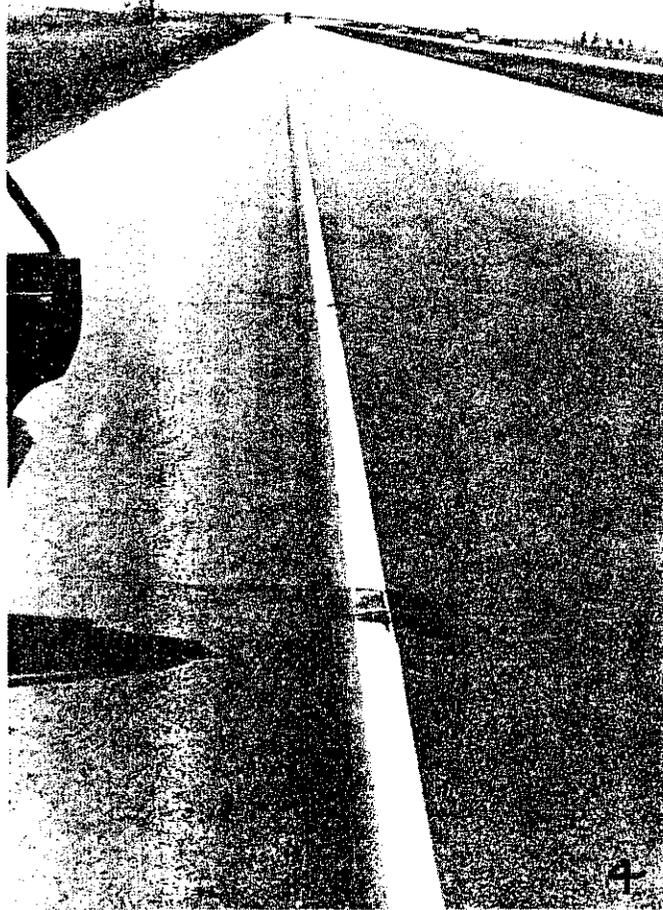
Longitudinal reflective cracks also were noted at the pavement-shoulder joint in the test section. It is interesting to note that the shoulder joint crack does not continue through the patch as shown in Figure 21. This seems to be a case where the CRC pavement and the patch area have separated thereby isolating the patch from any significant movement of the pavement structure.

Figure 21. Pavement-Shoulder Joint Crack in Petromat Test Section.
(No Crack in Patched Area), I-57.

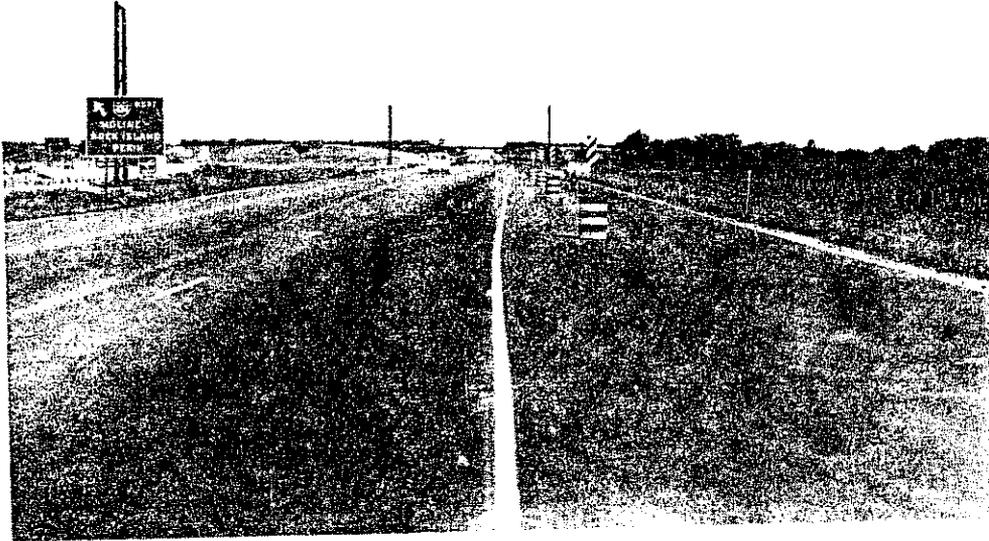
Performance. Inspection of the installation after nine months of service indicates no reflective cracking in the widening area as shown in Figure 22 & 23. With 5 inches of bituminous resurfacing, early reflective cracking was not anticipated; however, the fabric will probably retard the development of reflective cracking in the area. It is much too early to draw conclusions about the performance of the fabric in this project.

Figure 22. View of Petromat Test Section (Divergence Area), I-474.

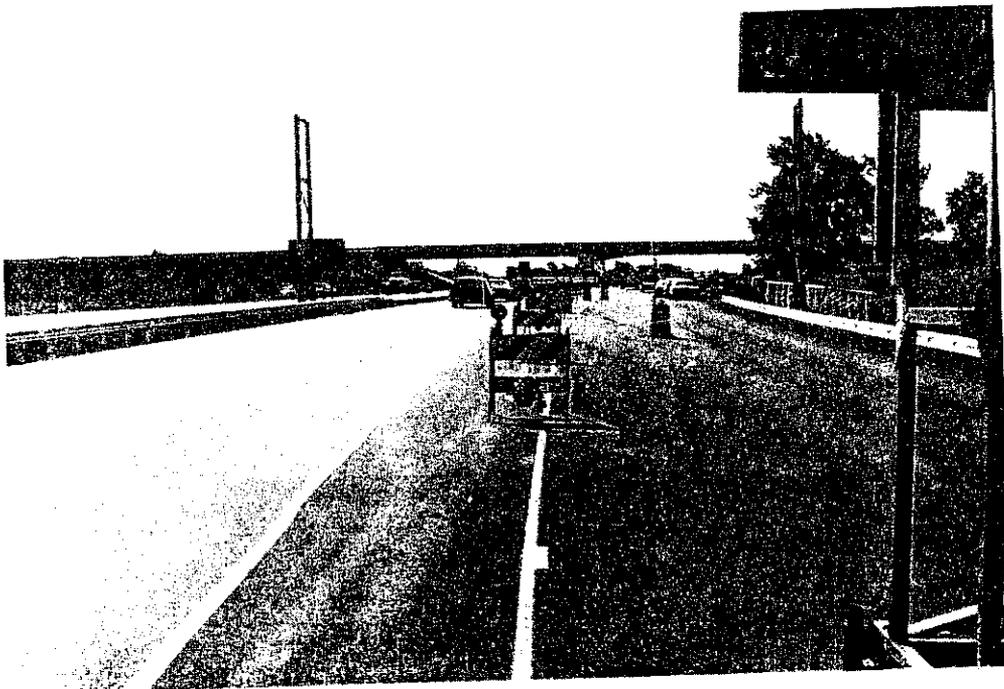
Figure 23. View of Petromat Test Section (Convergence Area), I-474.
