State of Illinois
DEPARTMENT OF PUBLIC WORKS AND BUILDINGS
Division of Highways
Bureau of Research and Development

DRILLED-HOLE LIME TREATMENT OF FILL

Final Report

March 1971

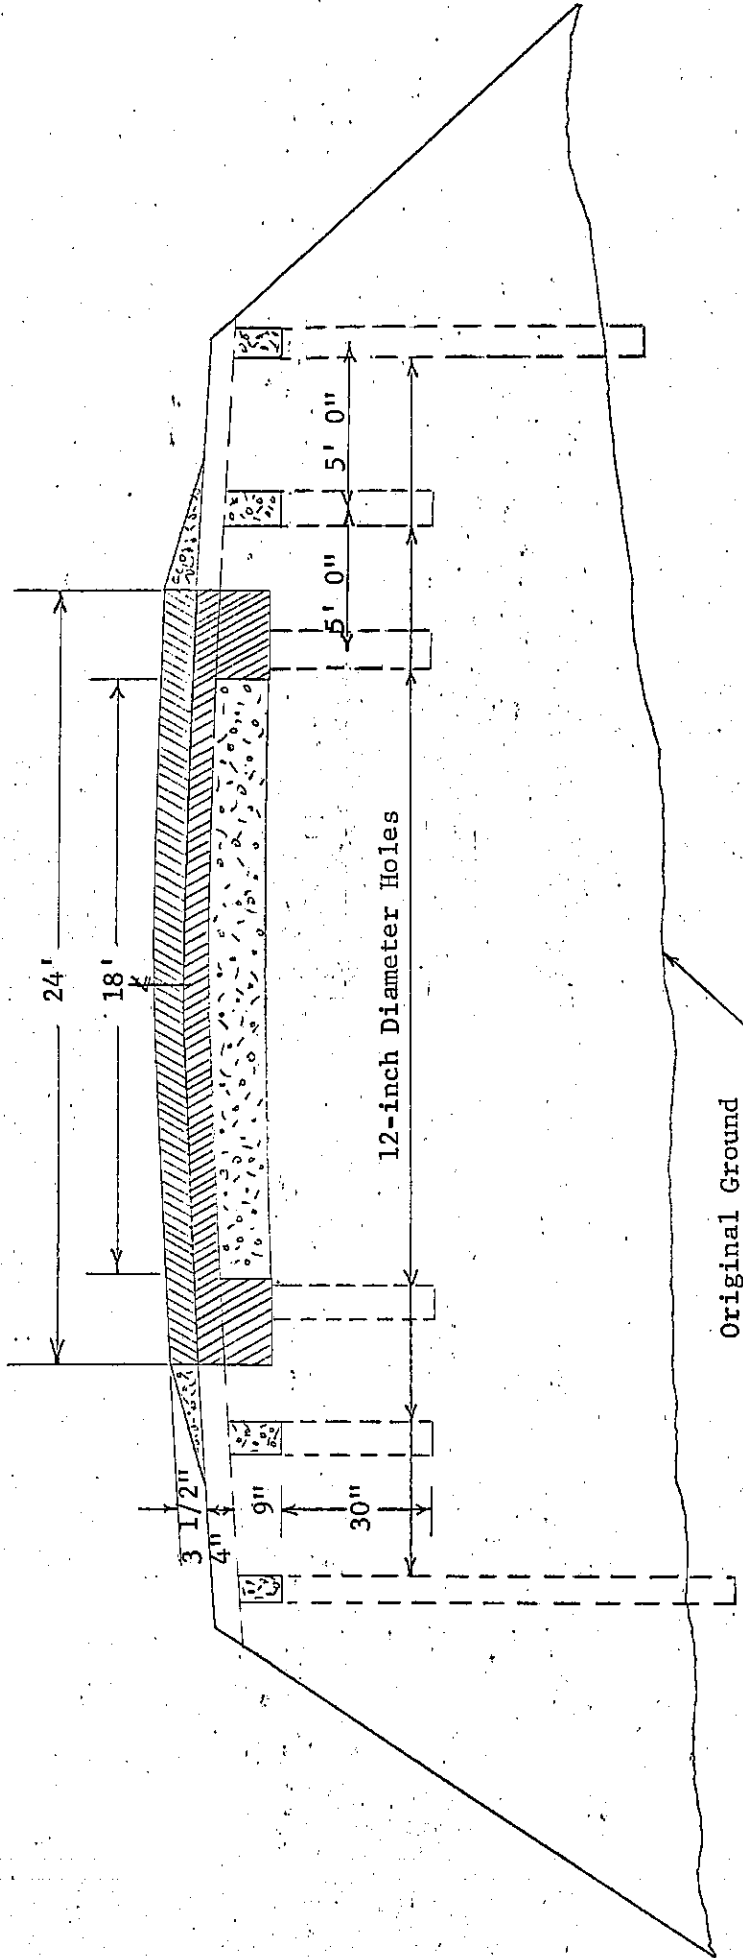
Figure 3. Design for most of fill.

Two typical cross sections of the completed test area are included as Figures 3 and 4. Hydrated lime was tamped into holes drilled in the shoulders at 5-foot centers. The outer row of 12-inch diameter holes in each shoulder was established 10 feet from the old pavement edge. Other rows of holes were drilled 5 feet from the edge and at the pavement edge with the holes of adjoining rows in a diagonal pattern. For 150 feet each way from the two bridges, 6-inch holes 39 inches deep were made by star drill and auger through the pavement near the center of each lane and at the centerline of the pavement at 5-foot intervals (Figure 5). The depth of holes in the outside row in the shoulders ranged from 2 1/2 to 27 feet. Their depths were determined by depth of fill plus approximately 1 foot. This depth was easily recognized by a layer of black high-organic muck from the buried topsoil and humus of the swampy timbered area. The other rows of holes in the shoulders were 39 inches deep.

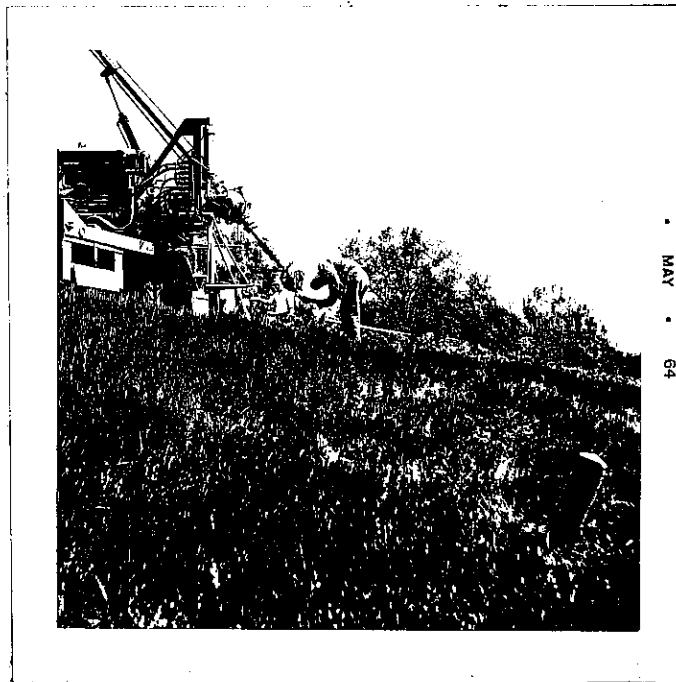
Figure 6. Day Labor's drill 245A was used on all 39-inch depth holes and others to 6-foot depth.

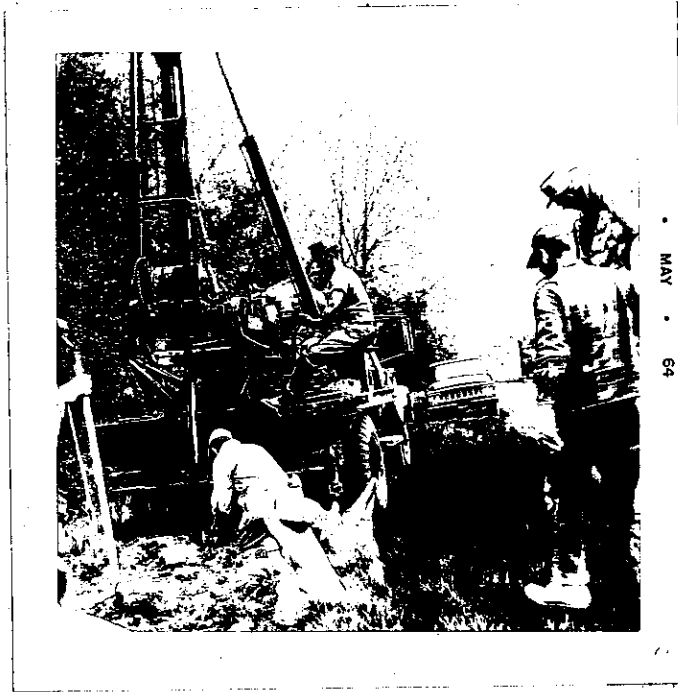
The drilling crews at first had difficulty getting the augers to shed the wet clay. This problem was helped by dusting hydrated lime on the auger and into the hole while drilling as shown in Figure 7.

Figure 7. Drilling crew dusted hydrated lime into hole and an auger to aid in keeping the clay from sticking to auger. The previous hole is being tamped with lime backfill.

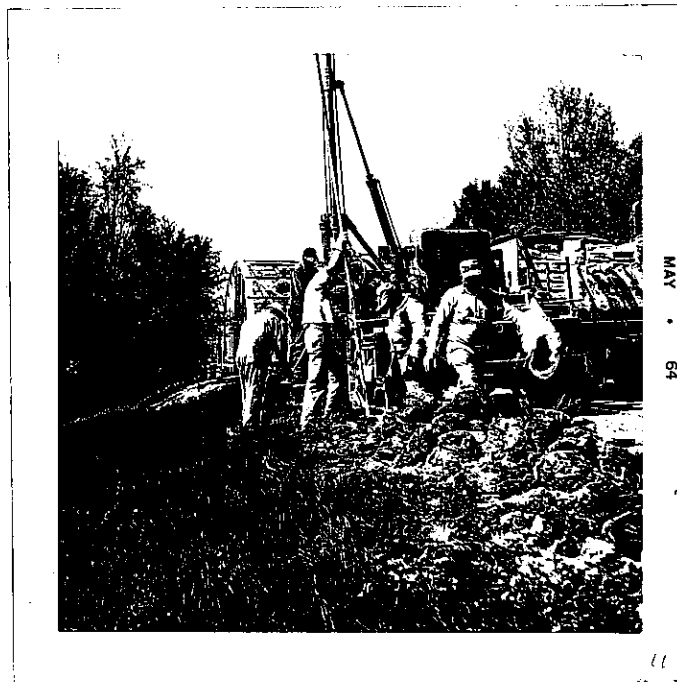
The cone-shaped piles of clayey auger peelings over the lime-filled holes (Figure 8) showed considerable granulation and settlement into the holes following several heavy rains during the last two weeks of April. When the wheels of a motor patrol were run down the rows of settled piles, the excess soil was pressed into the holes or spread to near the original elevation with slight ridging and rutting.

Figure 8. Cone-shaped piles of clayey auger peelings were made over the lime filled holes.
