FINAL REPORT

EVALUATION OF BRIDGE DECK DELAMINATION INVESTIGATION METHODS

Project IC-H1, 95/96

Report No. ITRC FR 95/96-1

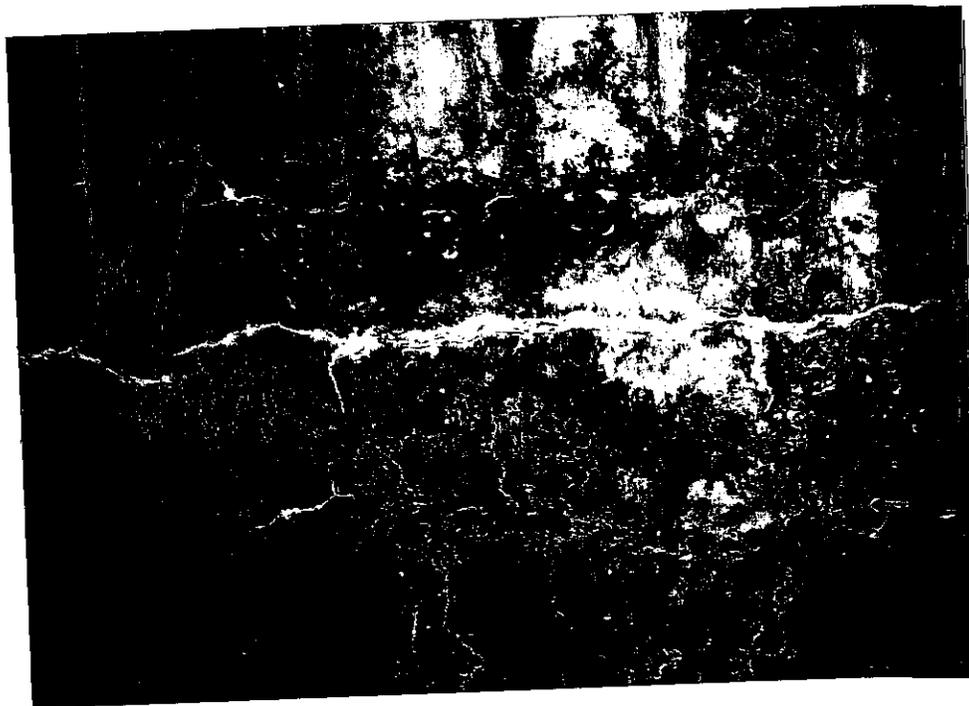
Figure 1.13 Underside of Marion Structure Number 100-0005 showing corrosion of superstructure and leaching of salts through transverse cracks in bridge deck.

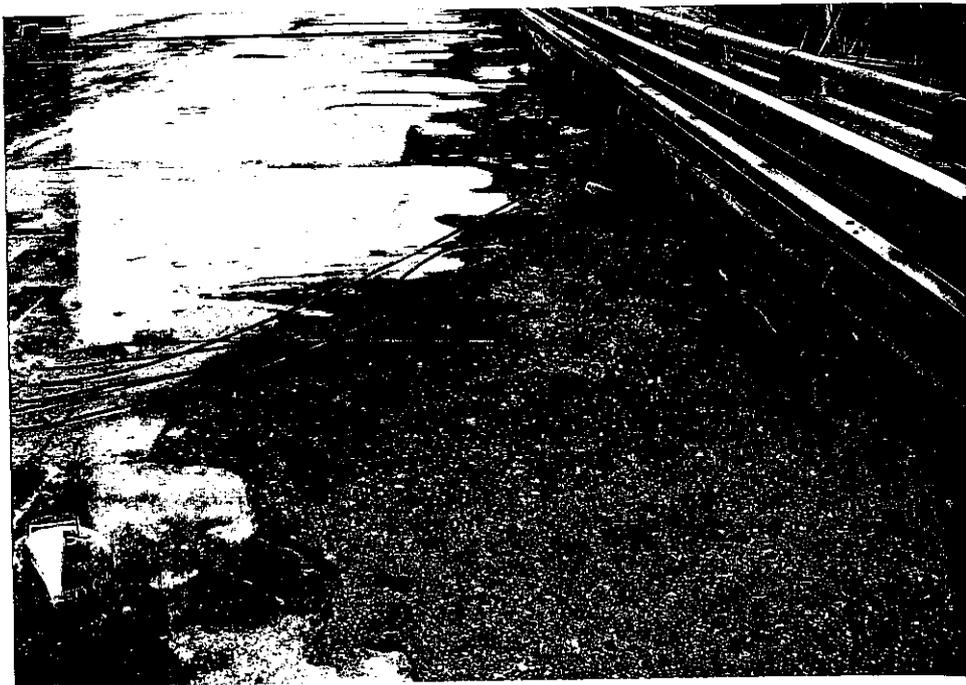
Figure 4.2 Corroded and broken reinforcing bars on Bloomington Structure Number 057-0088 deck.

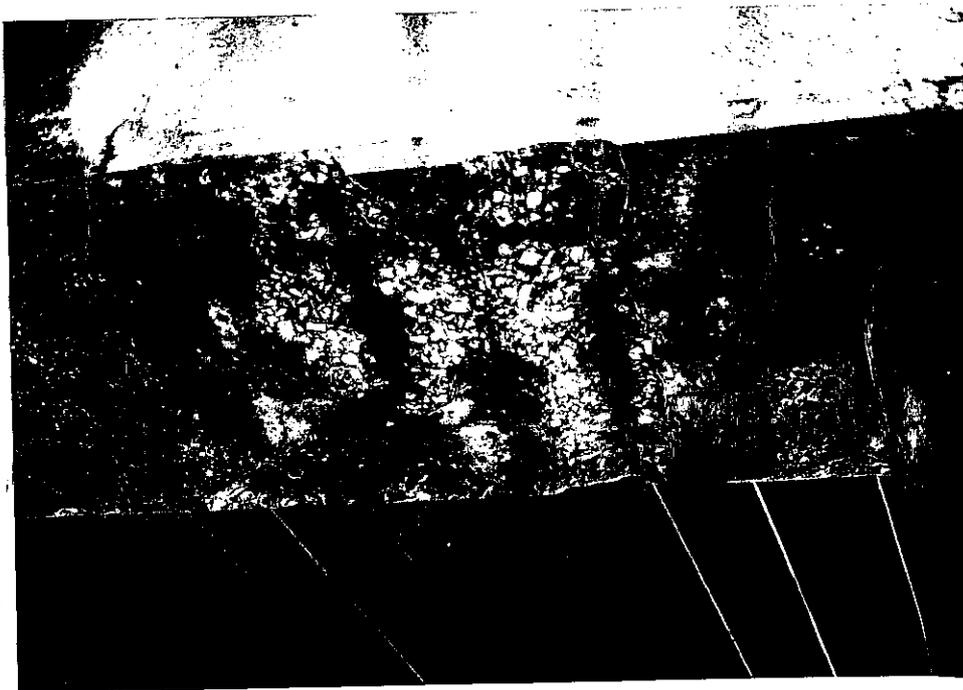
Figure 4.4 Underside of Bloomington Structure Number 057-0088 deck showing corrosion of the superstructure.

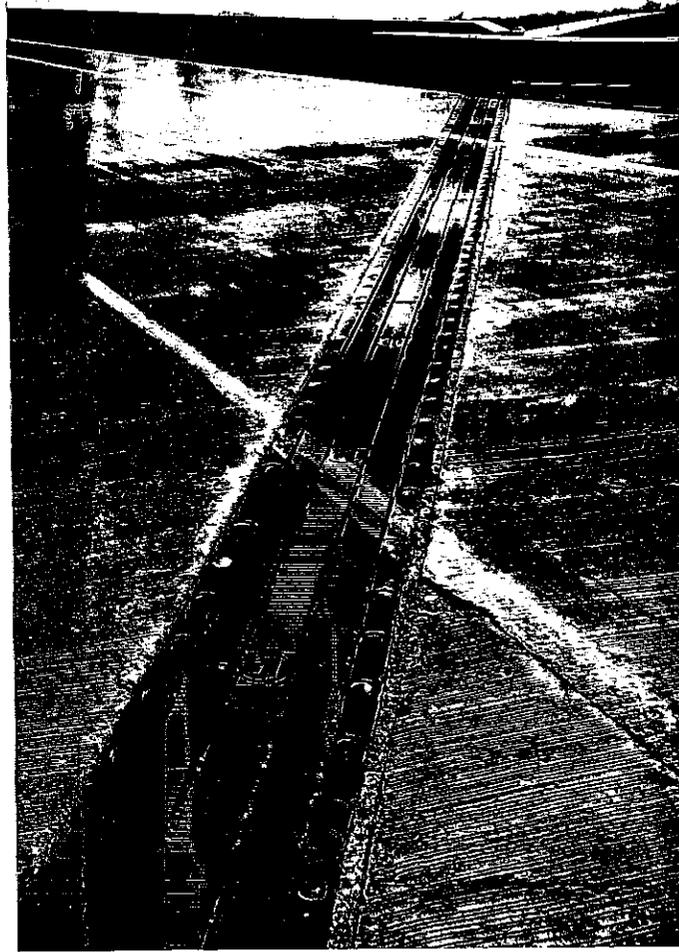
Figure 4.6 Peoria Structure Number 090-0118 deck showing excellent condition of pavement surface and abutment joint.

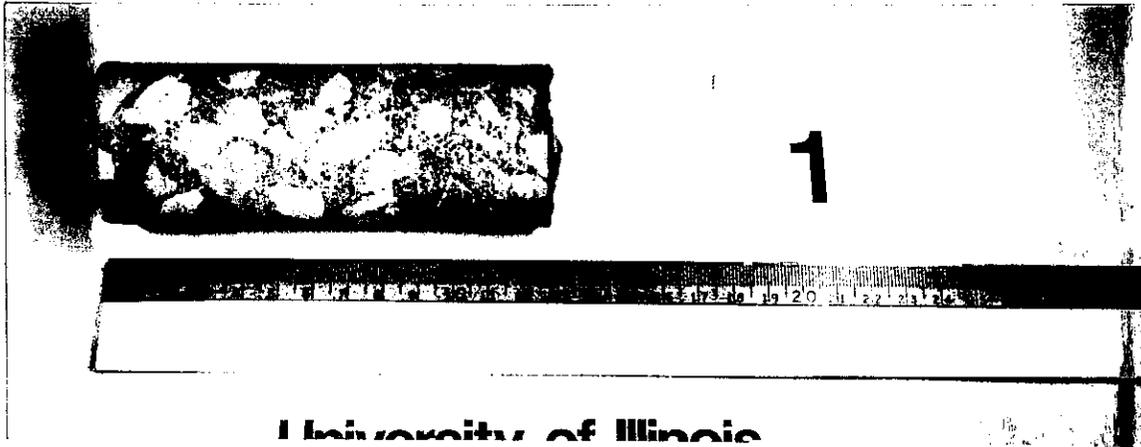
Figure E-1. Core #1 from Peoria Structure Number 090-0118—solid (from Rust final report⁸⁷).

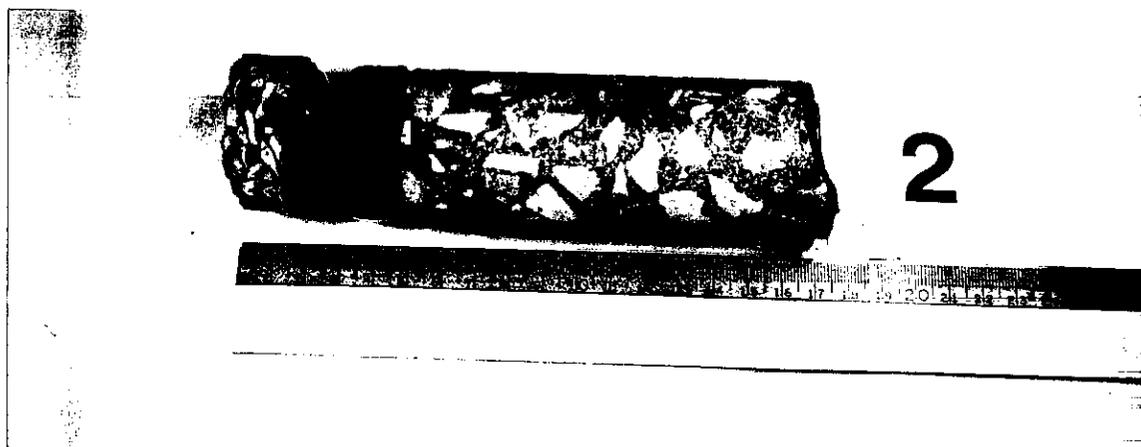
Figure E-2. Core #2 from Peoria Structure Number 072-0109—debonded (from Rust final report⁸⁷).

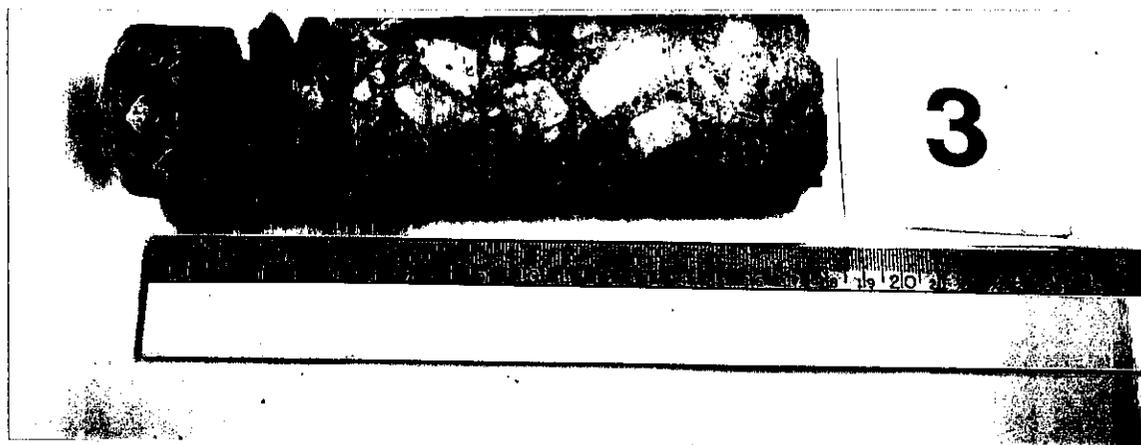
Figure E-3. Core #3 from Peoria Structure Number 072-0109—debonded and delaminated (from Rust final report⁸⁷).

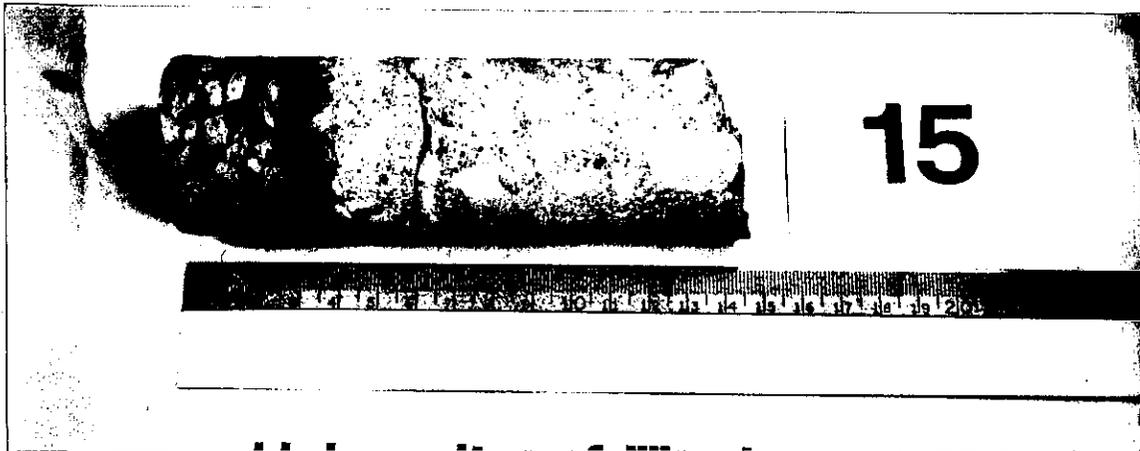
Figure E-15. Core #15 from Peoria Structure Number 072-0110—delaminated (from Rust final report⁸⁷).

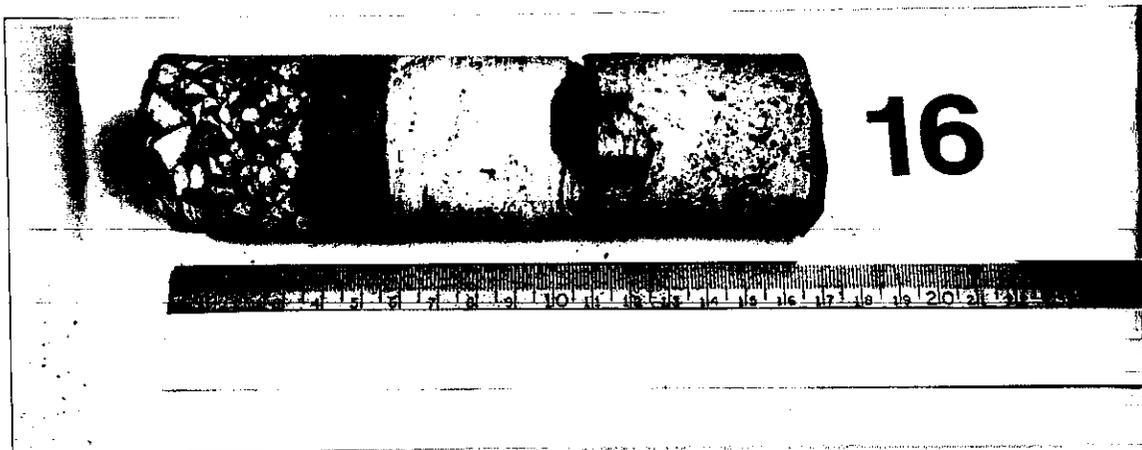
Figure E-16. Core #16 from Marion Structure Number 100-0005—delaminated (from Rust final report⁸⁷).

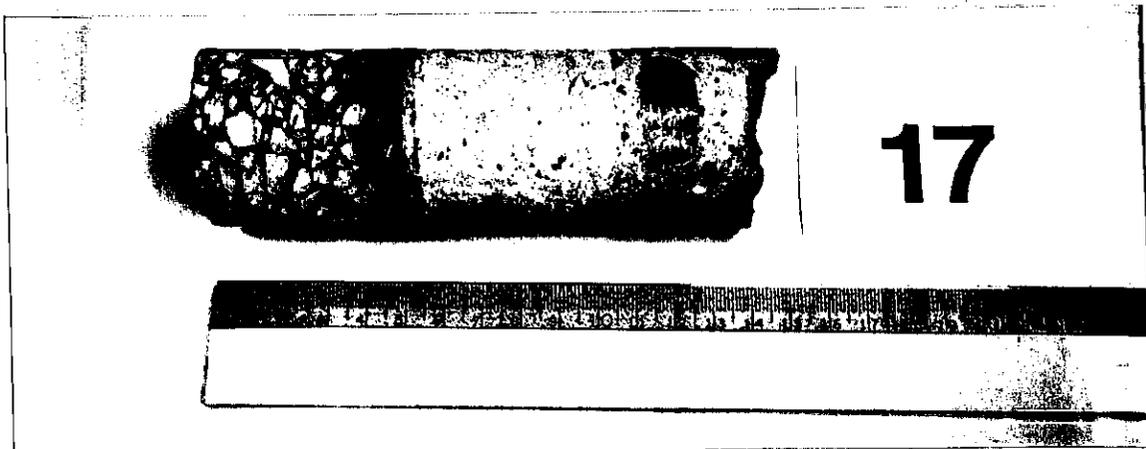
Figure E-17. Core #17 from Marion Structure Number 100-0005—solid (from Rust final report⁸⁷).

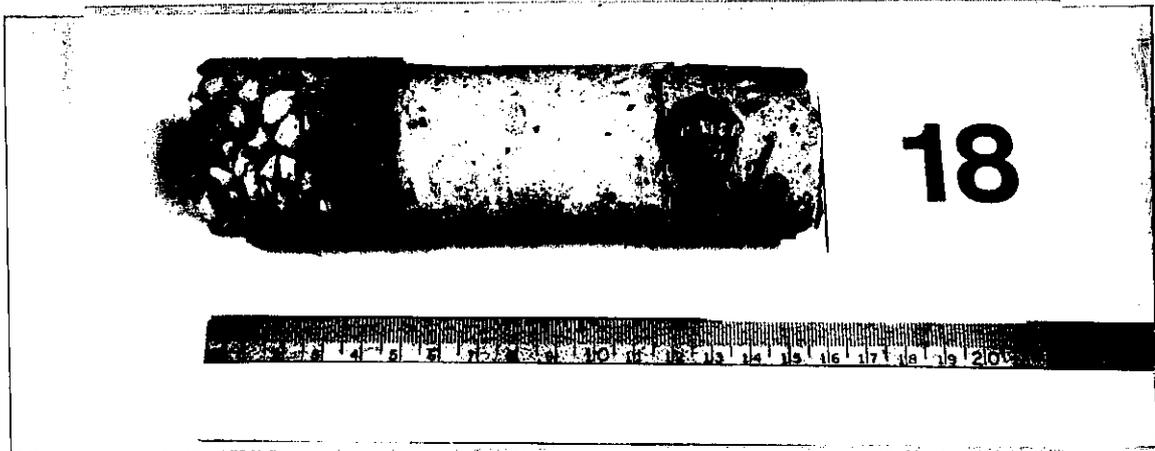
Figure E-18. Core #18 from Marion Structure Number 100-0005—debonded (from Rust final report⁸⁷).

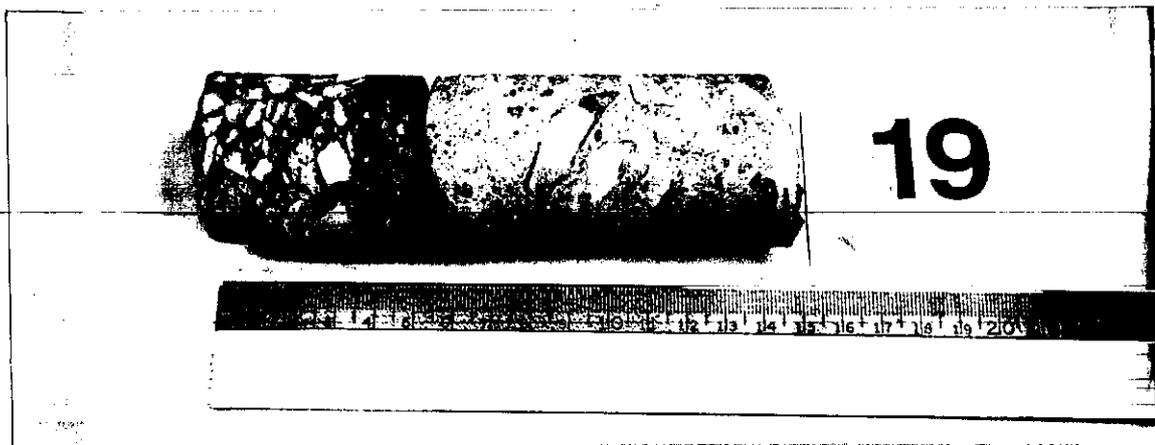
Figure E-19. Core #19 from Marion Structure Number 100-0005—delaminated (from Rust final report⁸⁷).

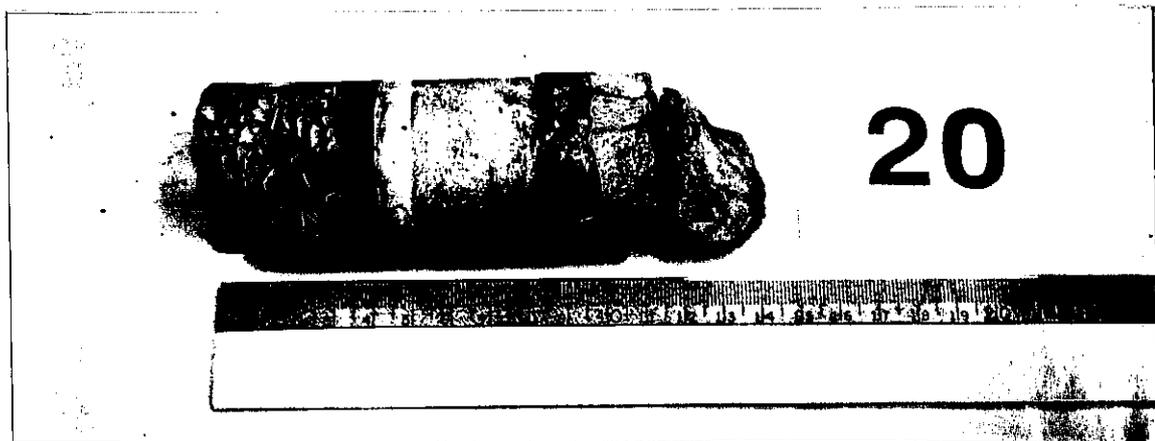
Figure E-20. Core #20 from Bloomington Structure Number 057-0088—delaminated (from Rust final report⁸⁷).

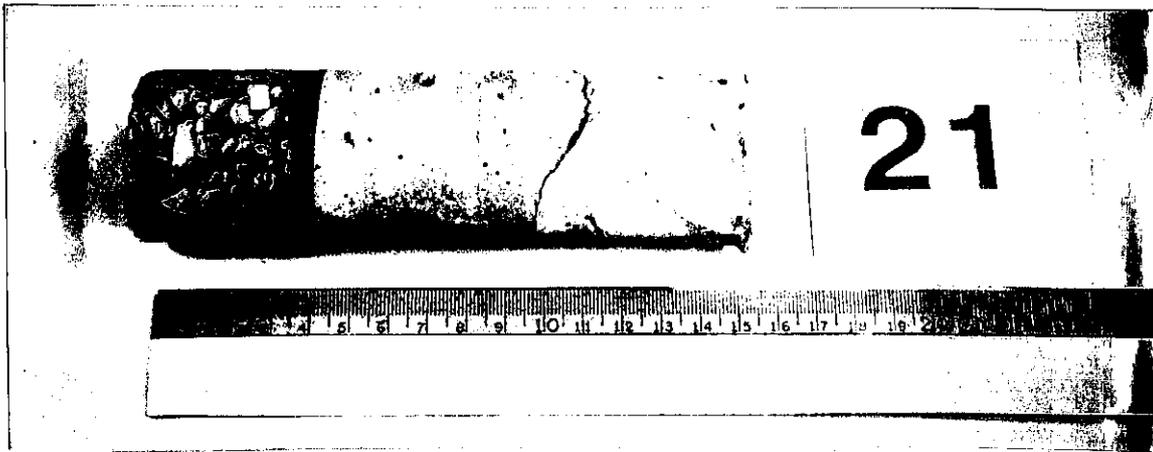
Figure E-21. Core #21 from Bloomington Structure Number 057-0088—solid (from Rust final report⁸⁷).
