State of Illinois
DEPARTMENT OF PUBLIC WORKS AND BUILDINGS
Division of Highways
Bureau of Research and Development

Research and Development
Administrative Report No. 35A

PERFORMANCE EVALUATION
OF
BITUMINOUS SHOULDERS FOR RESURFACED PAVEMENTS

A Highway Problem Investigation

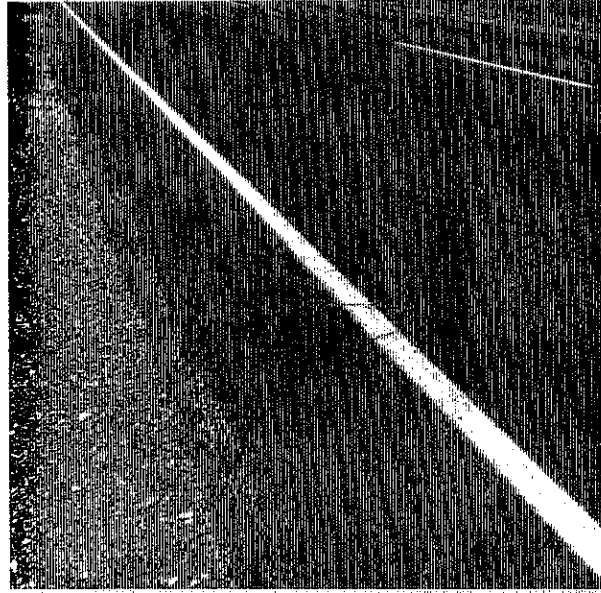
Similarly, no major distress was found on any of the 11 sections which employed the 6-inch shoulder thickness (Detail (b)). Longitudinal cracking, however, was found at the pavement-shoulder joint on several of the sections with the 6-inch shoulder thickness. Typical examples of this defect are shown in Photos 1 and 2. These photographs also reveal deviations from the designed cross section. The distinct change in slope between the pavement and shoulder shown in Detail (b) is not present. In addition, the pavement in Photo 2 has been incorrectly edge striped with the stripe being placed on the bituminous shoulder. One or both of these conditions was found at all locations where a significant amount of longitudinal cracking was noted.

Photo 1. A typical longitudinal crack along the pavement-shoulder joint. The present resurfacing is the first resurfacing over the old PCC pavement.

(1) Care should be taken to assure that the distinctive change in slope at the pavement-shoulder joint as called for in the resurfacing standard is achieved.

(2) Care should be exercised to assure that the edge stripe is properly located inside the pavement edge.

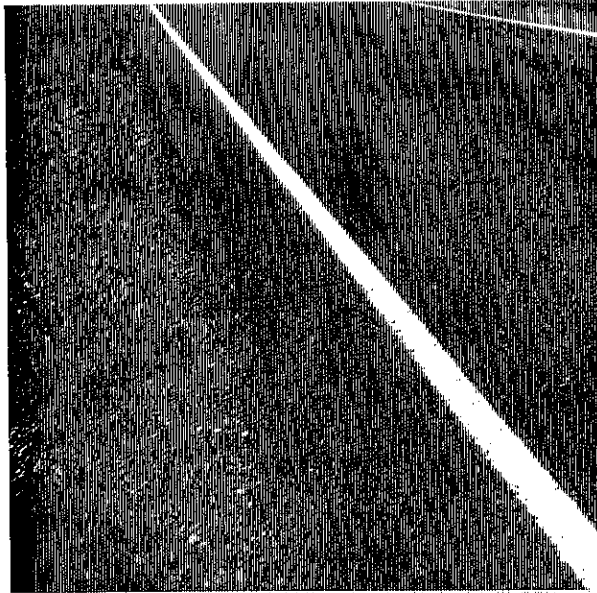
Only a minor amount of pavement-shoulder joint cracking was noted on those sections where edge striping and shoulder slope details were followed. A typical example of this is shown in Photo 3.

Photo 3. A short length of longitudinal cracking occasionally found on pavements with multiple resurfacings.

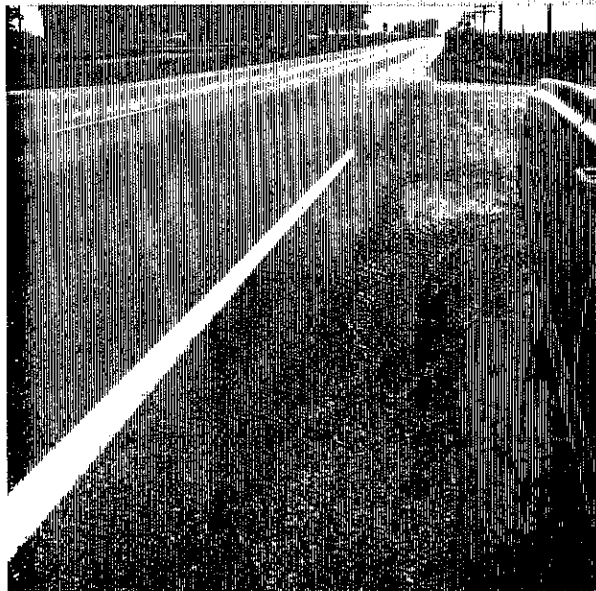
Little or none of this cracking was observed on pavements with multiple resurfacings. Photo 4 shows a typical example of the six-inch shoulder on a pavement resurfaced a second time. The location shown is also in an area where obvious traffic movements across the shoulder have not caused any visible distress.

Photo 4. A more typical view of the shoulder adjacent to a pavement with multiple resurfacings. This area is at a crossroad and has been subjected to numerous turning movements.

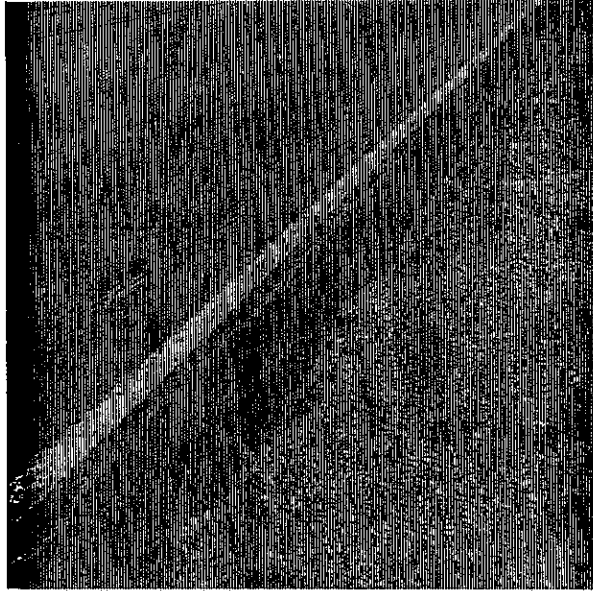
The two sections with the three-inch bituminous concrete shoulder design of Detail (a) showed many areas of severe distress, pointing out the inadequacy of the original three-inch design. A typical example of this distress is shown in Photo 5. It should be pointed out, however, that areas of little distress, such as in Photo 6, were also present.

Photo 5. A typical view of the distress on the three-inch bituminous concrete shoulder design.

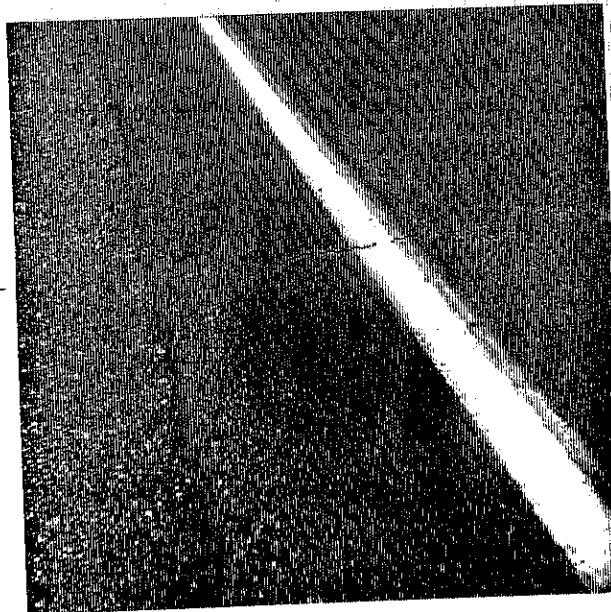
Photo 6. A three-inch bituminous concrete shoulder showing little distress at the present time.
