# Experimental Joint Sealants for Hot Mix Asphalt Pavements and Overlays

**CONSTRUCTION REPORT**  
**PHYSICAL RESEARCH REPORT NO. 169**  
**April 2019**

**Illinois Department of Transportation**

## EXPERIMENTAL JOINT SEALANTS FOR HOT MIX ASPHALT PAVEMENTS AND OVERLAYS

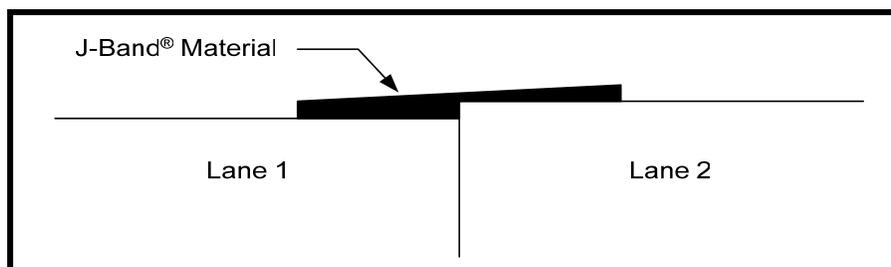
Figure 5  
Lane to Lane Elevation Difference With J-Band® Placement

The placement of the J-Band® material presented a couple of problems. Even with sweeping the pavement surface at the joint, sand sized rocks remained that caught the strike-off plate and left a track mark in the material. More critical, however, was the difference in elevation between the two lanes of leveling binder on either side of the longitudinal joint. This difference in elevation resulted in thick and thin areas of material placement depending on the location of the strike-off plate with relation to the joint.

Figure 5 illustrates the elevation difference and the resultant problems with the sealant material placement.

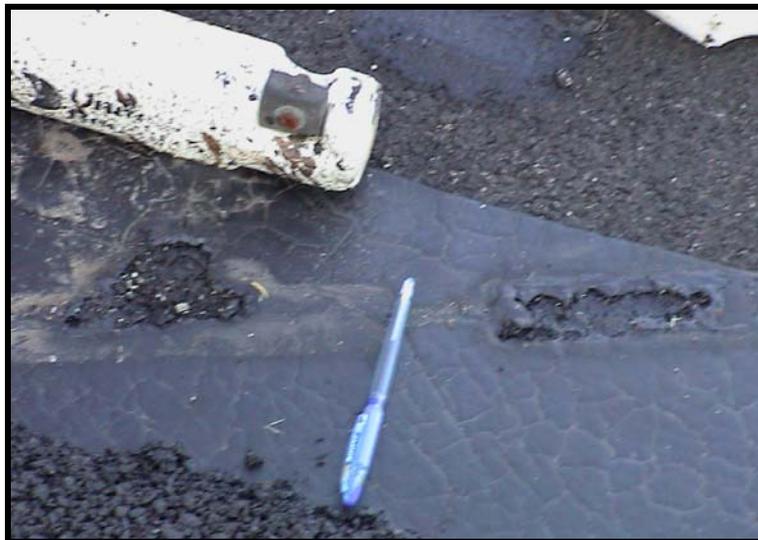
It was also noted that once placed, and cooled, the material remained pliable enough to deform and pick up under the static weight of a traffic barricade. Figure 6 illustrates how the material deformed and picked up in chunks once adhered to another surface.

J-Band<sup>®</sup> Material Pick Up Under Traffic Barricade

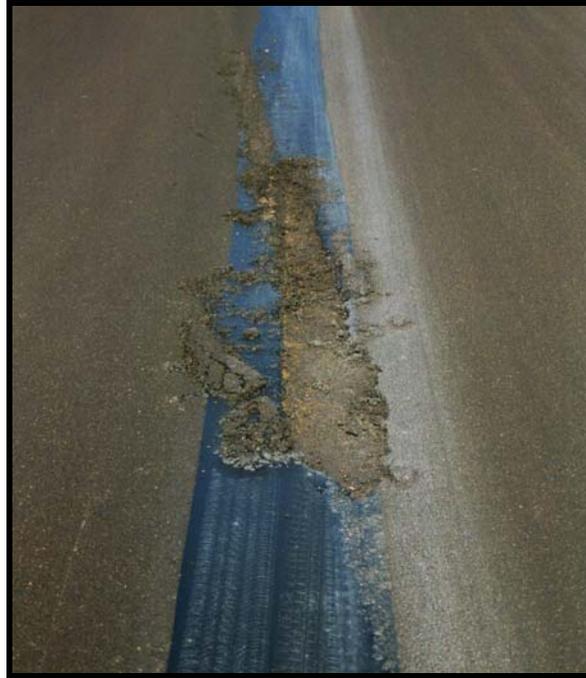
The J-Band<sup>®</sup> material was placed at approximately 300° Fahrenheit and required about 10 to 15 minutes to cool. Flagmen were used to control traffic and prevent vehicles from crossing the material before it was solidified. However, at a couple of locations a vehicle did manage to cross the material before it cooled, and the material did track onto the vehicle tires. Figure 8 illustrates the amount and condition of the material when it tracks onto a vehicle tire. A thin layer of lime dust was spread over the material at all cross roads and driveway entrances to prevent tracking when vehicles did cross the material. Figure 9 illustrates the application of lime dust at a crossroad intersection to prevent tracking.

Figure 8  
Tracking of J-Band® material

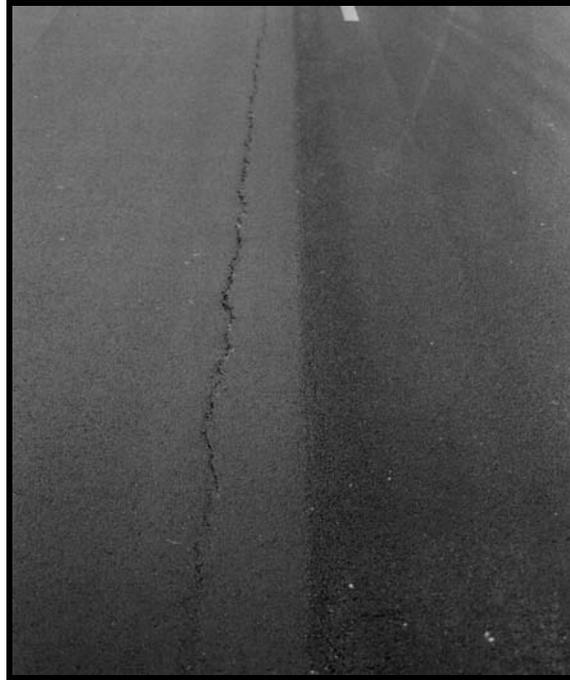
The first problem noted occurred at the start of paving in the area of a butt joint to a mainline bridge. The existing pavement was milled down to bare concrete, and the J-Band<sup>®</sup> material was placed directly on the concrete. The first few loads of surface HMA material arrived at the project around 310° Fahrenheit. The elevated temperature of the HMA, and the impermeable concrete below, forced the sealant material to migrate through to the surface of the pavement. The action of the vibratory break down roller caused the vertical edge of the centerline joint to slough and flow under the roller. Once the rolling patterns were completed and the extra rich material at the centerline joint sloughed, a crack developed in the surface of the pavement at the outside edge of the J-Band<sup>®</sup> material.

Additional cracks of this nature were noted throughout the length of the J-Band<sup>®</sup> experimental section. However, it is believed that these cracks were introduced more by the rolling pattern of the vibratory roller, as these cracks developed in areas where a leveling binder was placed below the surface lift. In these areas, the sealant material did not migrate to the surface. The cracks were believed to be created by a distinct boundary line between asphalt cement contents within the surface lift. The surface lift material placed directly over the J-Band<sup>®</sup> material absorbed the sealant material and changed physical properties in relation to the surface material adjacent to it. The two materials responded differently to the action of the vibratory roller. Another contributing factor is the relatively low “N” design number of 50 (less stable mixture) for the overlay. Cracks also developed along the confined edge at the boundary between the J-Band<sup>®</sup> material and regular surface HMA. An example of this boundary cracking may be found in Figure 10.

Figure 10  
J-Band® Boundary Cracking

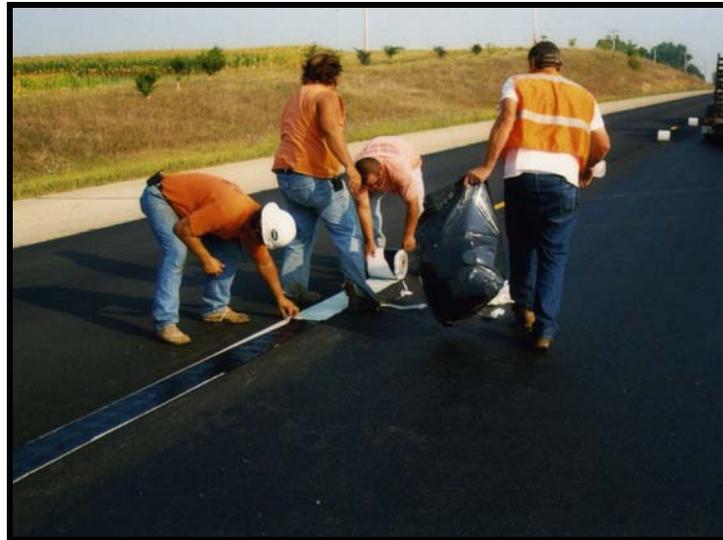
pieces of wax paper was extremely tedious and time consuming, however, necessary to prevent impurities and the creation of a slippage plane for the overlay materials. Once the wax paper was removed and the material was positioned along the centerline joint, the plastic backing material was removed from the top of the material. Again, this material ripped and left small fragments behind that had to be cleaned off. The tedious, time consuming, effort to remove the small fragments of plastic may be seen in Figure 11.

Figure 11  
Removal of QuickSeam<sup>®</sup> plastic backing

A trial and error process was used to establish a better method for removing the plastic backing once the material was placed on the pavement. Eventually, a utility knife was used to cut the plastic backing into two separate halves. The halves were then easily peeled off the material from the center towards the outer edges. This process eliminated the small fragments of plastic that were left on the material at the material edges. This process also increased the placement rate for the QuickSeam<sup>®</sup> material. The average placement rate for the first pass of the material was approximately 800 linear feet per hour. The entire first pass took approximately six hours to place.

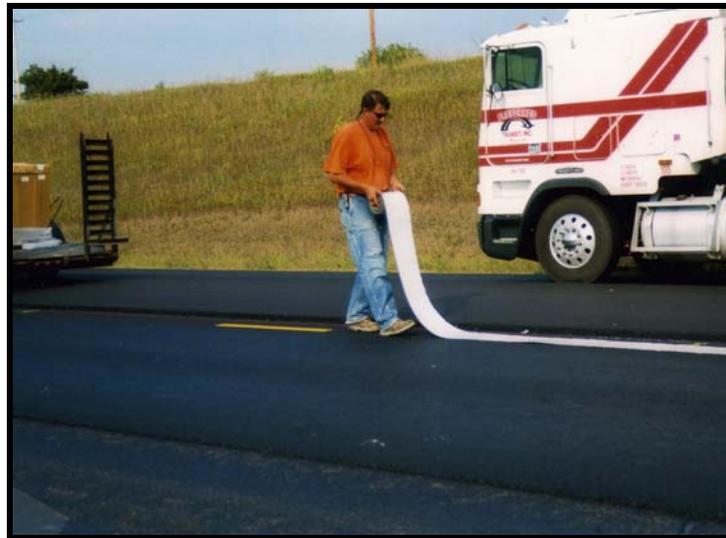
Figure 12

Preparation of the QuickSeam<sup>®</sup> material for placement

The problem still remained of peeling the wax paper backing off the material before placing it onto the pavement. Eventually, it was determined that the material could be completely unrolled upside down and the wax paper backing cut into halves with the utility knife. Once cut, the two halves of wax paper were peeled off from the center towards the outer edges. Three to four people were then used to flip the material right side up and place it along the centerline joint all at once. This process dramatically improved the placement rate. Placement of the second pass of the sealant material was done at a rate of approximately 1,500 feet per hour. The second pass of the material was placed in approximately three hours. Illustrations of this placement method may be found in Figures 12 and 13.

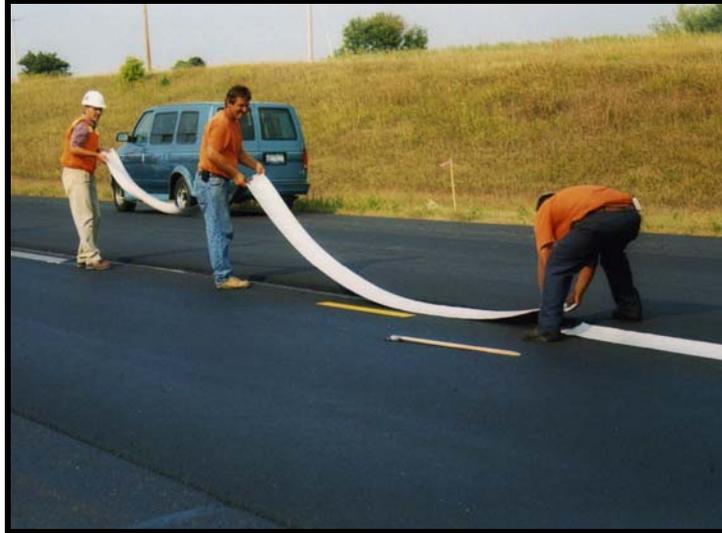
Figure 13

Placement of the QuickSeam<sup>®</sup> material

process was used to develop a solution for placement. The best method determined was to place the material against the adjacent HMA surface and press it into place by foot.

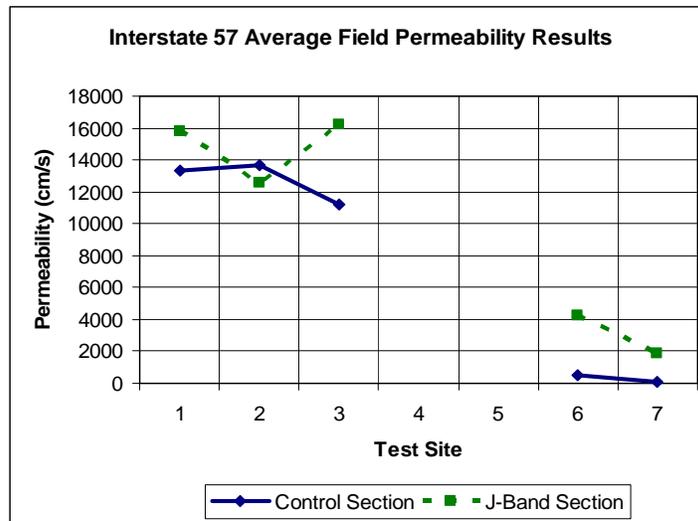
Figure 20  
Interstate 57 Average Field Permeability Test Results

The initial permeability test results for the Interstate 57 project are similar to those on Illinois Route 50. The control section and J-Band<sup>®</sup> section have very similar results, and in several cases, the J-Band<sup>®</sup> section was more porous than the control section.
