1 IDOT-NBI Calibration Course

LOCAL AGENCY ISSUES

Local Agency Issues to Highlight

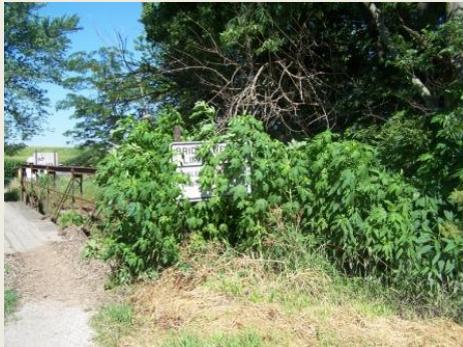
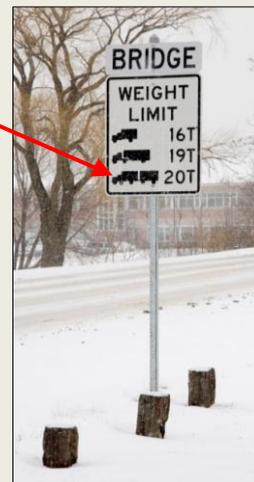
E-15

- If you can't see it, it's not posted.
- Flaws in improper signage can be subtle.

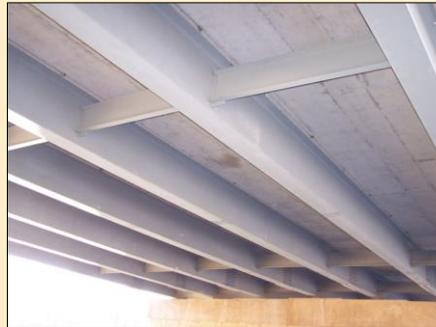
I-3

- Various standard sizes:
 - 18" – 36" depths common in bridges (3" increments)
 - 40" & 44" also available
- May have bearing stiffeners
- Common in short to mid span steel bridges

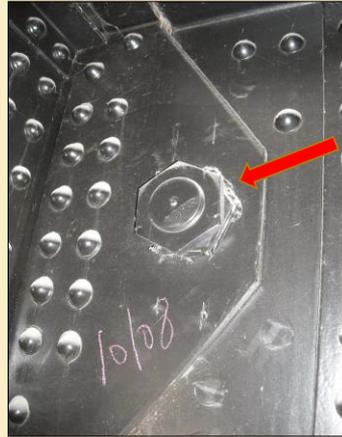
I-11

Single pin used without hanger bars to allow rotation only

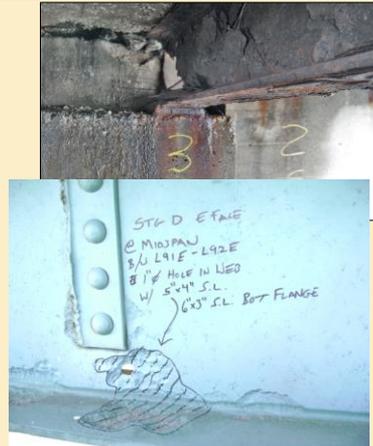
I-13

- Section loss at beam ends
- Section loss along the bottom of the web and top of the bottom flange
- Section loss around diaphragm connections

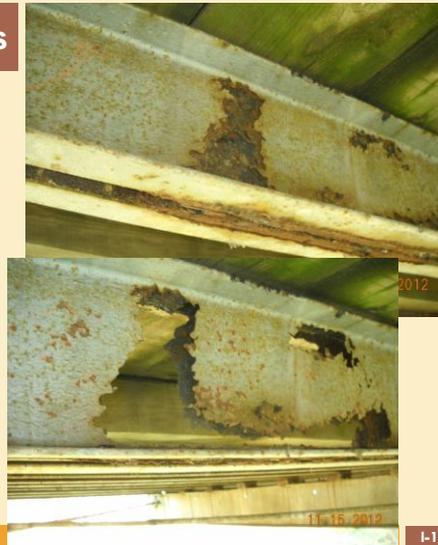
I-14

Defects Hidden by Pack Rust

- Superstructure rating had just been lowered from a 5 to a 4!
- The condition of the floor stringers was not considered in the rating.
- New super rating was a 1.

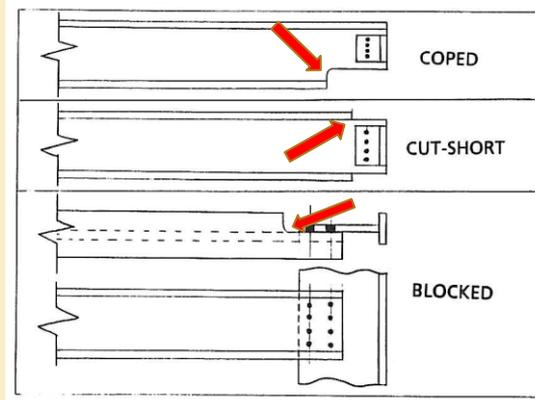
I-15

Cracks at Copes

- Connection may have been designed as a pinned connection
- The web may be carrying moment due to stiffness resulting from the depth of the connection

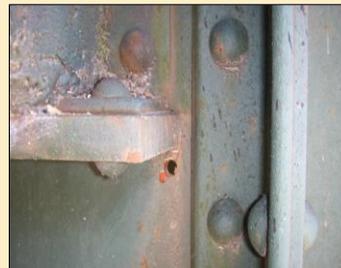
I-16

Cracks can occur at rigid connections of transverse members to thin webs due to out-of-plane bending

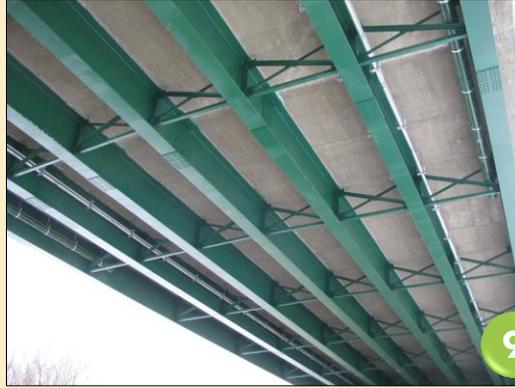
I-21

No deficiencies

New superstructure – Typically first inspection only

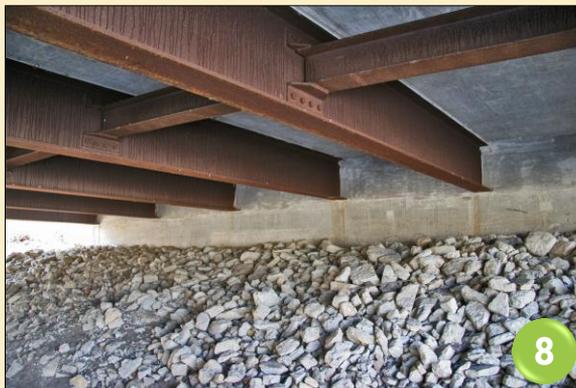
**Very Good
Condition**

- No deficiencies
- Not new construction
- Note: Weathering Steel**

VERY GOOD. No "excessive" rust.

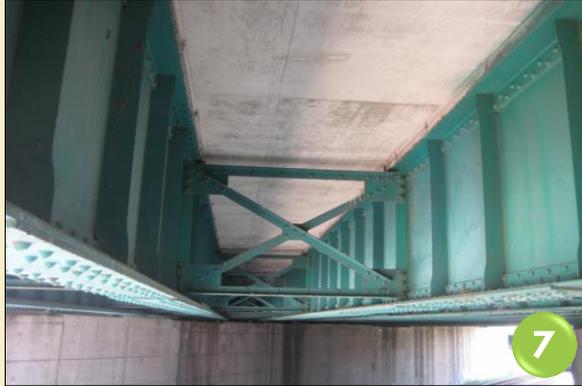
Good Condition

- Minor rust on the bottom flanges
- No section loss

GOOD. Some rust may be present but without any section loss.

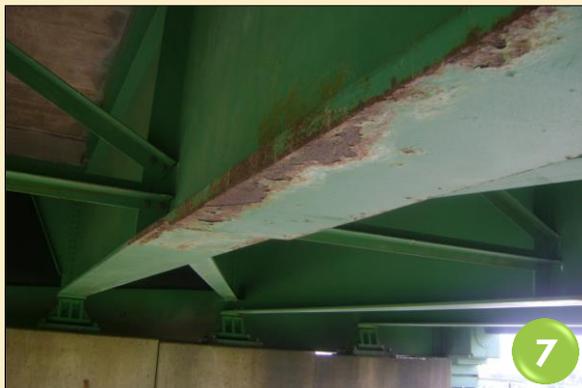
Good Condition

- Minor rust on bottom flange
- No section loss

GOOD. Some rust may be present but without any section loss.

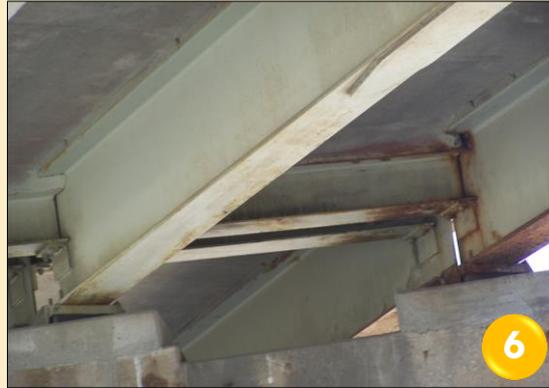
Satisfactory Condition

- Initial section loss in non-critical area of bottom flange
- Rust stains on web resulting from rust on secondary member

SATISFACTORY. Initial **section loss** (minor pitting, scaling, or flaking) in non-critical areas.

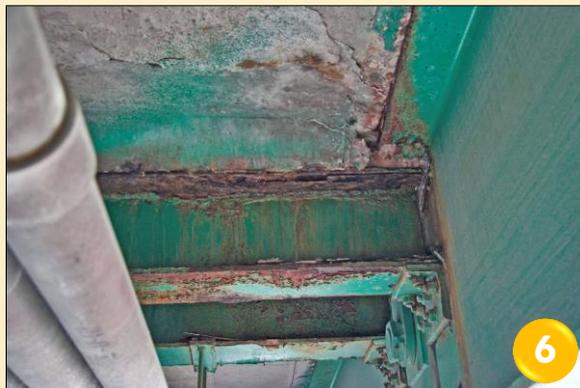
Satisfactory Condition

- Section loss on flanges of diaphragm (Secondary Member)
- No section loss on girder web

SATISFACTORY. Initial **section loss** (minor pitting, scaling, or flaking) in non-critical areas.

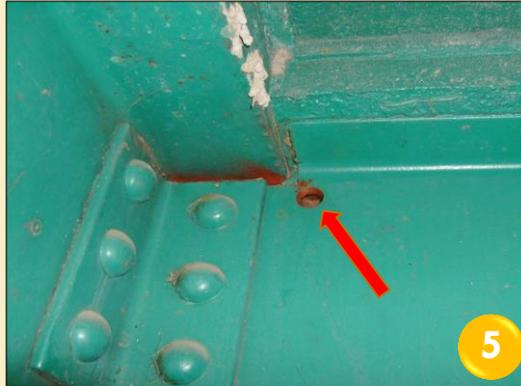
Fair Condition

- Minor cracks
- Arrester holes have been drilled in web to prevent further progression of cracks

FAIR. Initial **section loss** up to 10% in critical areas, fatigue or out-of-plane bending **cracks** may be present in secondary members, arrested fatigue **cracks** may be present in primary members, hinges may be showing minor corrosion problems.

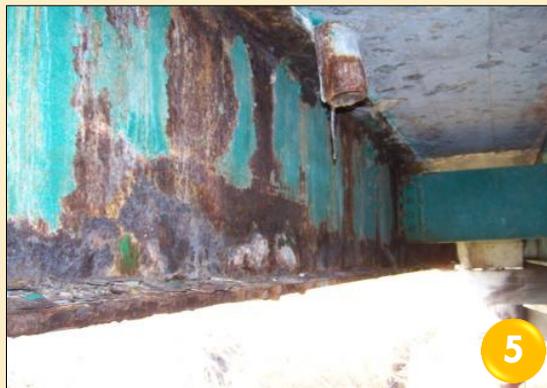
Fair Condition

8% section loss at bottom flange and on web of girder

FAIR. Initial **section loss** up to 10% in critical areas, fatigue or out-of-plane bending **cracks** may be present in secondary members, arrested fatigue **cracks** may be present in primary members, hinges may be showing minor corrosion problems.

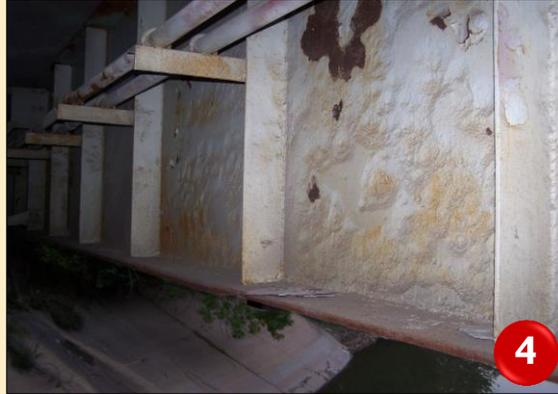
Poor Condition

25% section loss
in the web of the
girder

POOR. Section loss up to 30% in critical area, fatigue or out-of-plane bending cracks may be present in primary members, previously arrested fatigue cracks propagating beyond arresting holes in primary members.

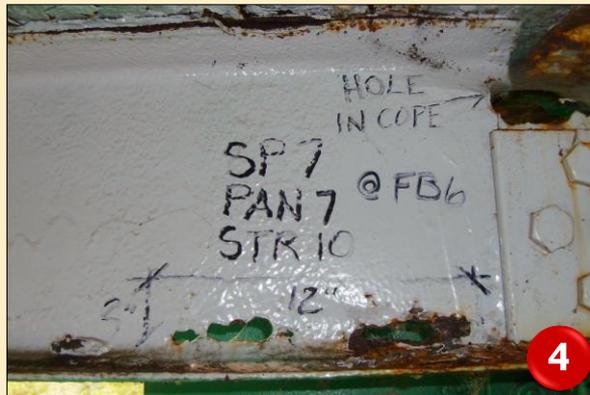
Poor Condition

- 25% section loss in web
- Hole at cope

POOR. Section loss up to 30% in critical area, fatigue or out-of-plane bending cracks may be present in primary members, previously arrested fatigue cracks propagating beyond arresting holes in primary members.

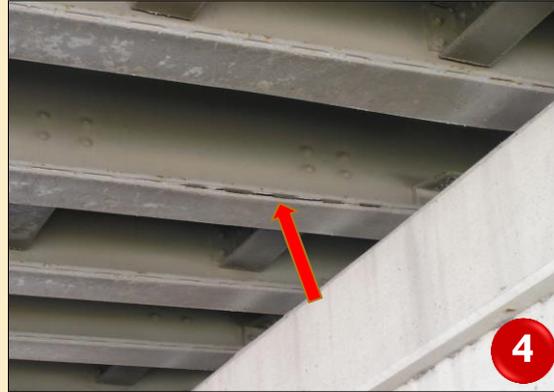
Poor Condition

Cracked intermittent welds along edge of cover plate
(cover plate area = 28% of bottom flange)

POOR. **Section loss** up to 30% in critical area, fatigue or out-of-plane bending **cracks** may be present in primary members, previously arrested fatigue cracks propagating beyond arresting holes in primary members.

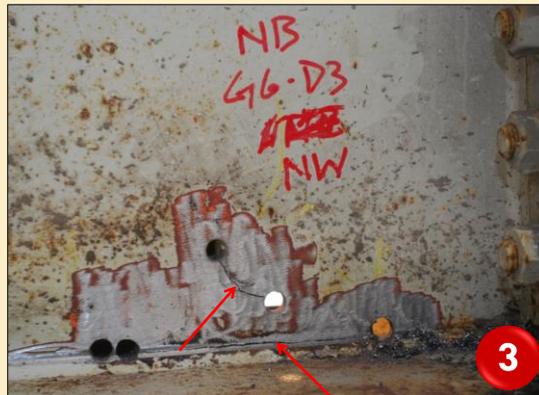
Serious Condition

- 15% section loss in lower portion of web
- Arrested crack perpendicular to stress in web
- Cracks in web along bottom flange

SERIOUS. Advanced **section loss** up to 50%, extensive perpendicular to stress, fatigue, or out of plane bending **cracks** in primary members.

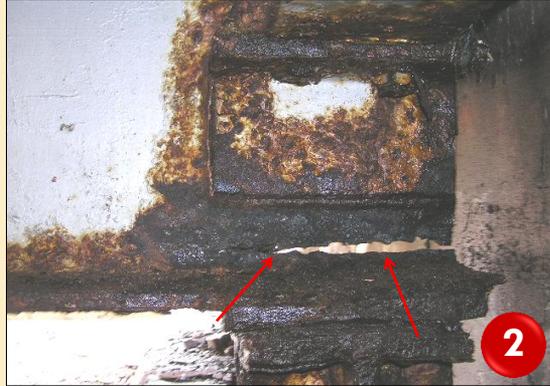
Critical Condition

CRITICAL. Severe **section loss over 50%** requires special inspections, temporary supports or repairs may be required to remain open to traffic. The Bureau of Bridges and Structures shall be notified immediately.

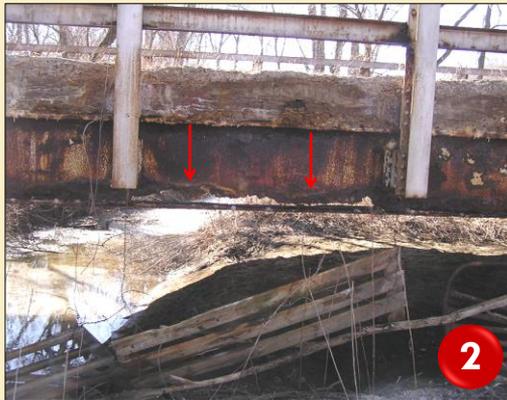
Critical Condition

CRITICAL. Severe **section loss over 50%** requires special inspections, temporary supports or repairs may be required to remain open to traffic. The Bureau of Bridges and Structures shall be notified immediately.

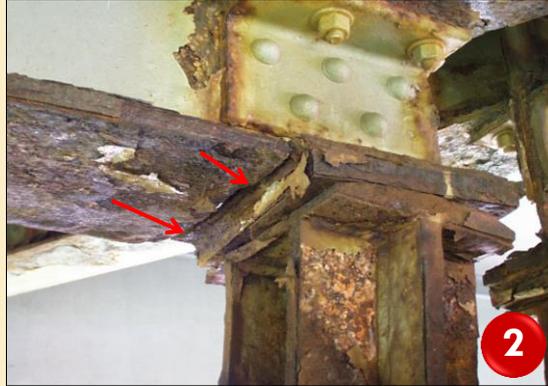
Critical Condition

Bottom flange cracked at bearing

CRITICAL. Severe **section loss over 50%** requires special inspections, temporary supports or repairs may be required to remain open to traffic. The Bureau of Bridges and Structures shall be notified immediately.

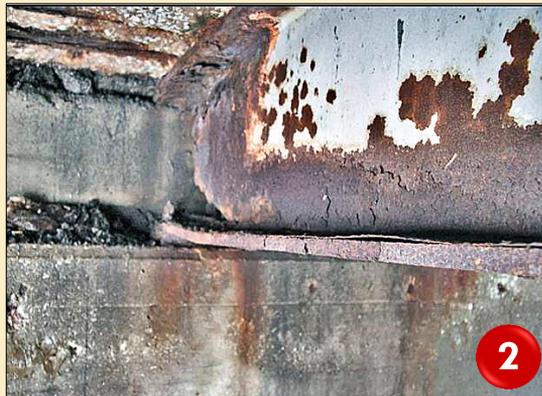
Critical Condition

CRITICAL. Severe **section loss over 50%** requires special inspections, temporary supports or repairs may be required to remain open to traffic. The Bureau of Bridges and Structures shall be notified immediately.

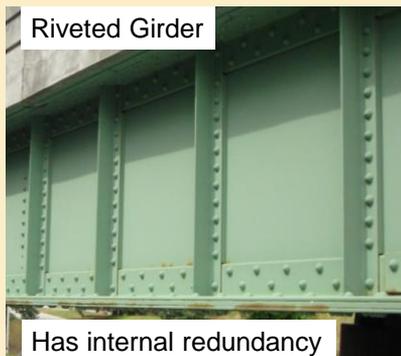
I-6

Internal Redundancy – a member configuration containing 3 or more elements mechanically fastened together (by rivets or bolts) to form multiple independent load paths

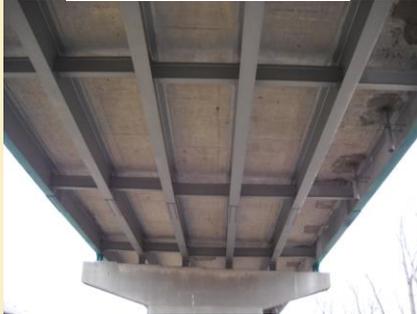
Load Path Redundant

Load Path Redundancy – having 3 or more main load carrying members between substructure units

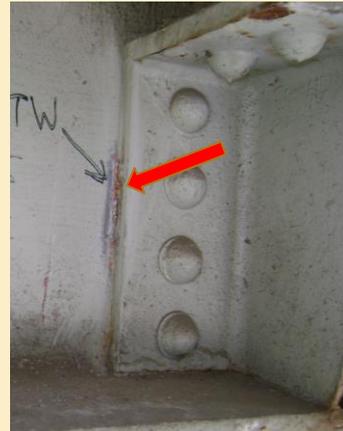
I-17

- Field & intersecting welds are more susceptible to flaws
- Flawed welds cause increased strain
- Fatigue cracks can initiate more easily at these locations
- Field, intersecting, tack and plug welds are included
- Any weld in a tension zone found on a FCM that is not part of the original design should be documented and brought to the attention of a structural engineer for evaluation

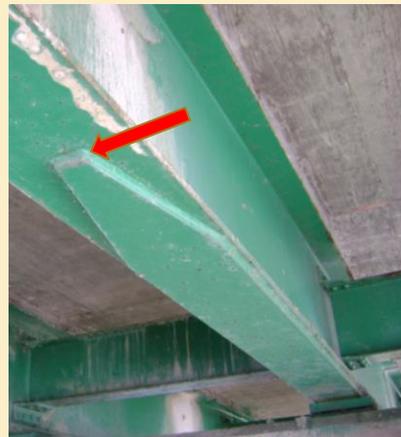
I-18

- Sudden changes in cross section cause stress increases
 - Cover plate terminations
 - Changes in plate size
- These are susceptible locations for fatigue cracks to initiate

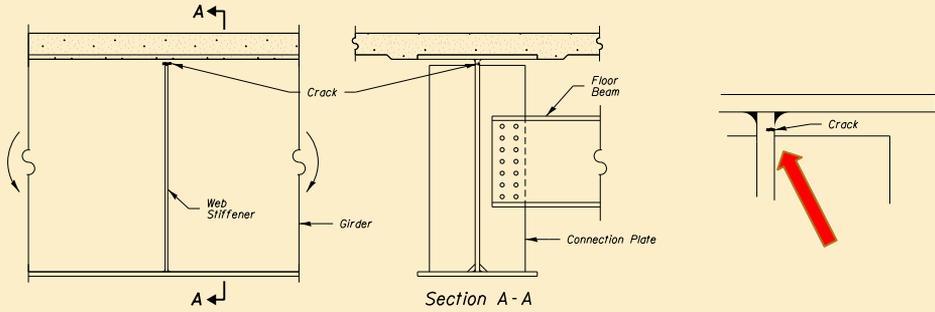
Schematic of a Crack in the Girder Web at the Floor Beam Connection Plates

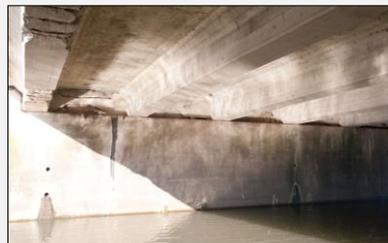
J-4

- Common in 1930's - 50's
- Monolithic deck and stem system formed in the shape of the letter "T"
- Cast-in-place is most common constructed type
- Top flange is considered the Deck (Item 58)
- Deck and stem act together as superstructure (Item 59)

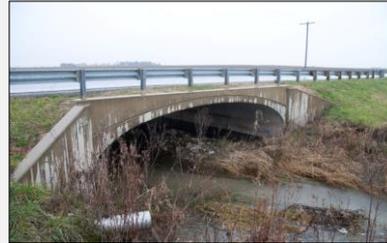
J-7

- Top may be arched or flat
- Most common version is precast concrete
- Top is considered the Superstructure (Item 59)
- Sides are considered the Substructure (Item 60)
- Deck (Item 58) is coded “N”

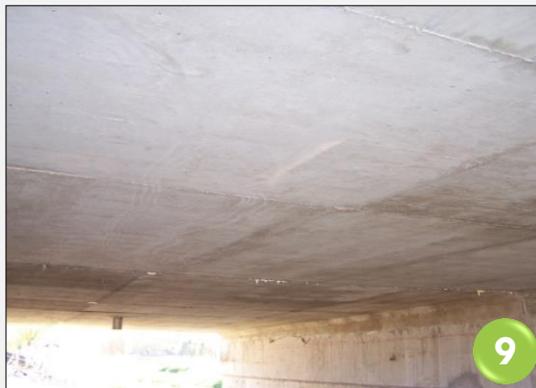
New superstructure – Typically first inspection only

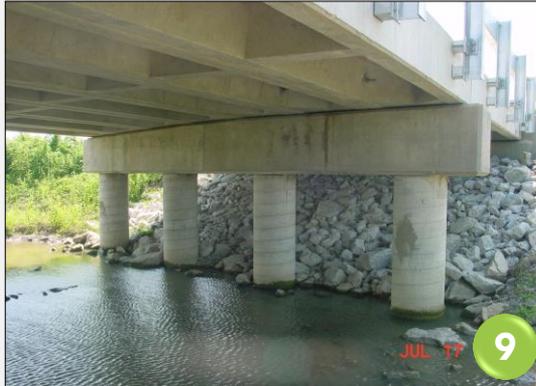
New superstructure – Typically first inspection only

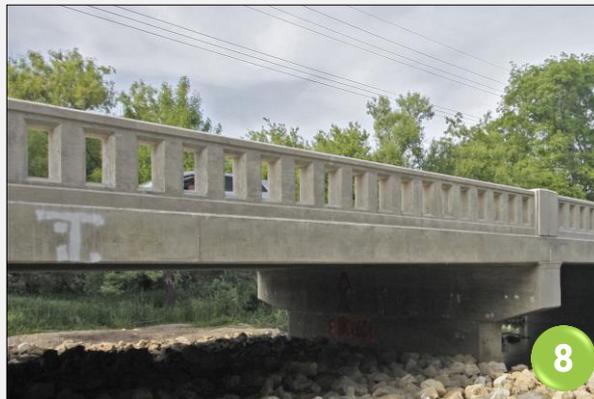
VERY GOOD. No significant defects, very minor shrinkage **cracks**, surface **scaling, spalling** or pop-outs which do not expose reinforcing steel.

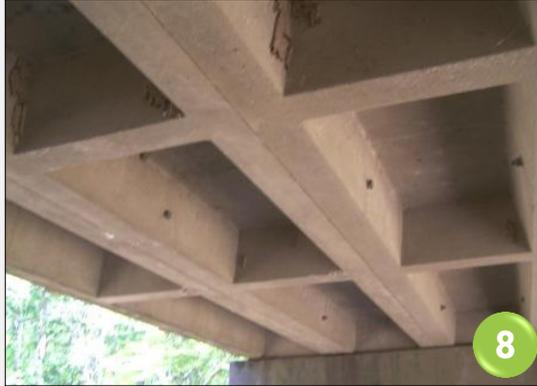
VERY GOOD. No significant defects, very minor shrinkage **cracks**, surface **scaling, spalling** or pop-outs which do not expose reinforcing steel.

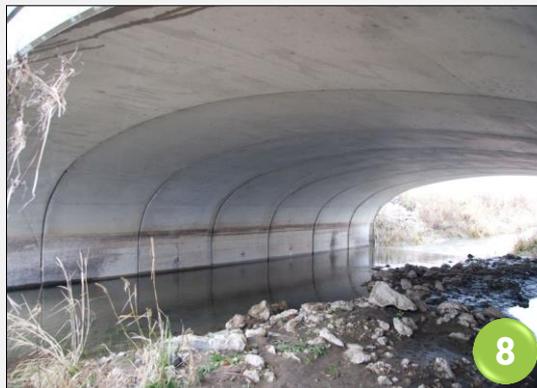
VERY GOOD. No significant defects, very minor shrinkage **cracks**, surface **scaling, spalling** or pop-outs which do not expose reinforcing steel.

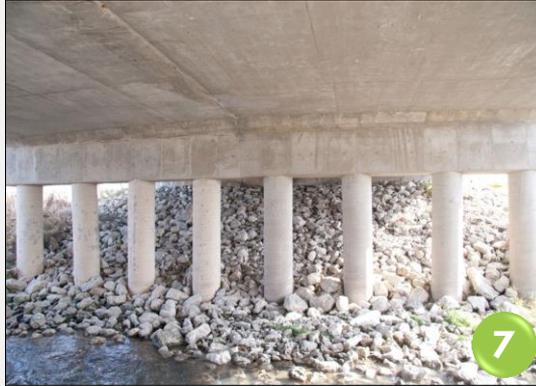
GOOD. Isolated non-structural **cracks** up to 0.03", minor pop-outs or **spalls** without exposed primary reinforcing steel, stirrups may be exposed in a few locations.

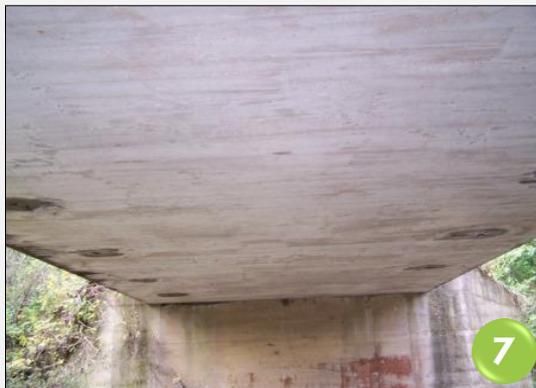
GOOD. Isolated non-structural **cracks** up to 0.03", minor pop-outs or **spalls** without exposed primary reinforcing steel, stirrups may be exposed in a few locations.

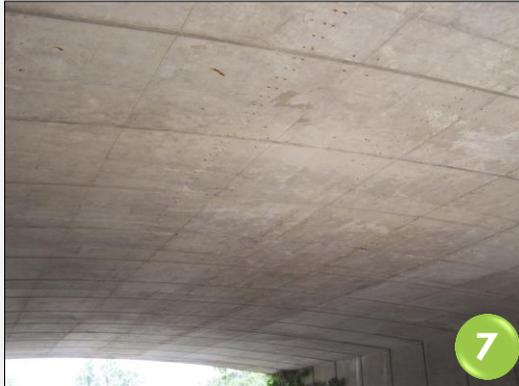
GOOD. Isolated non-structural **cracks** up to 0.03", minor pop-outs or **spalls** without exposed primary reinforcing steel, stirrups may be exposed in a few locations.

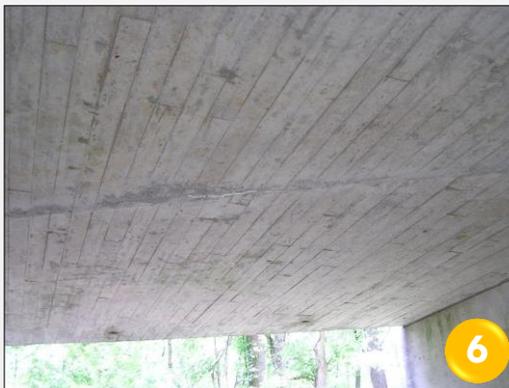
J-18

- Slab
- Non-structural cracks less than 0.06" present
- 7% of surface area is delaminated with leaching present

SATISFACTORY. Extensive non-structural **cracks** up to 0.06", **spalls** and delaminations may be present on up to 5% of the surface areas with exposed primary reinforcement with surface rust only, up to 10 % of the surface area may be map **cracked**, **spalled** and delaminated.

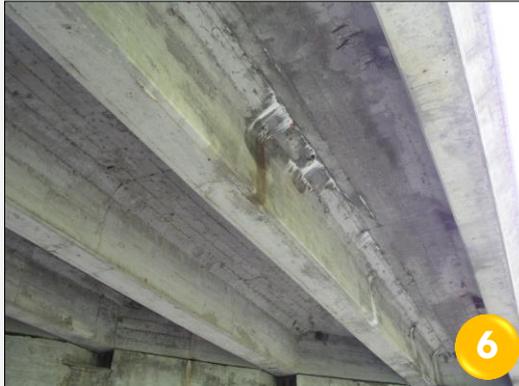
J-19

- T-Beam
- Non-structural cracks less than 0.06" present
- 9% of surface area with spalls, delaminations, and leaching present

SATISFACTORY. Extensive non-structural **cracks** up to 0.06", **spalls** and delaminations may be present on up to 5% of the surface areas with exposed primary reinforcement with surface rust only, up to 10 % of the surface area may be map **cracked, spalled** and delaminated.

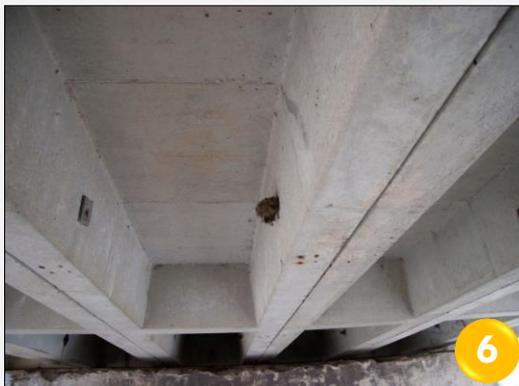
J-20

- Channel Beam
- Non-structural cracks less than 0.06" present
- 5% of surface area has delaminations and map cracking present

SATISFACTORY. Extensive non-structural **cracks** up to 0.06", **spalls** and delaminations may be present on up to 5% of the surface areas with exposed primary reinforcement with surface rust only, up to 10 % of the surface area may be map **cracked, spalled** and delaminated.

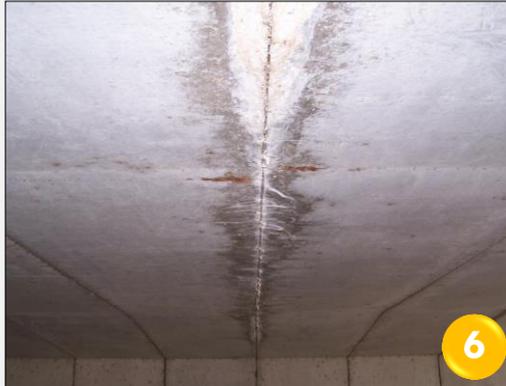
J-21

- 3-Sided Precast
- Tight non-structural cracks less than 0.06" present
- Leaching keyway

SATISFACTORY. Extensive non-structural **cracks** up to 0.06", **spalls** and delaminations may be present on up to 5% of the surface areas with exposed primary reinforcement with surface rust only, up to 10 % of the surface area may be map **cracked**, **spalled** and delaminated.

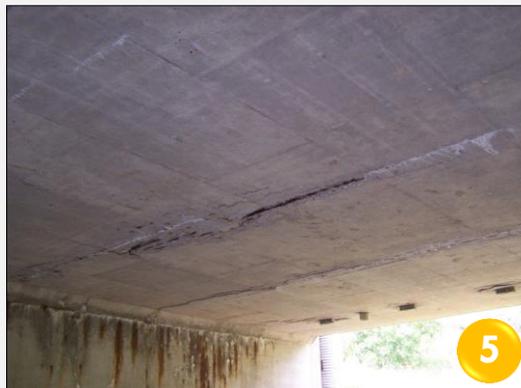
FAIR. Non-structural **cracks** greater than 0.06", isolated structural **cracks** up to 0.03", **spalling** with minor **section loss of reinforcing steel up to 10%**, up to 10% of compression surface area **spalled** or delaminated.

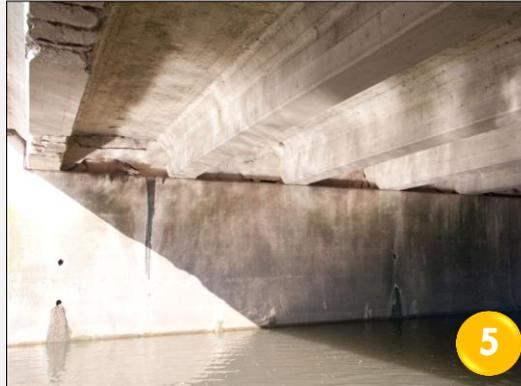
FAIR. Non-structural **cracks** greater than 0.06", isolated structural **cracks** up to 0.03", **spalling** with minor **section loss of reinforcing steel up to 10%**, up to 10% of compression surface area **spalled** or delaminated.

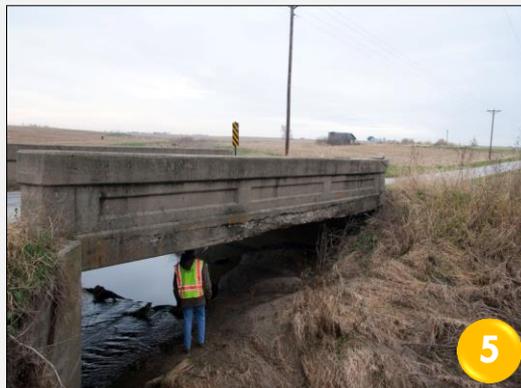
FAIR. Non-structural **cracks** greater than 0.06", isolated structural **cracks** up to 0.03", **spalling** with minor **section loss of reinforcing steel up to 10%**, up to 10% of compression surface area **spalled** or delaminated.

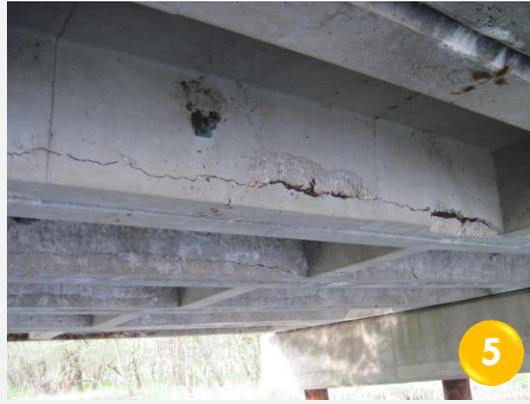
FAIR. Non-structural **cracks** greater than 0.06", isolated structural **cracks** up to 0.03", **spalling** with **minor section loss** of reinforcing steel up to 10%, up to 10% of compression surface area **spalled** or delaminated.

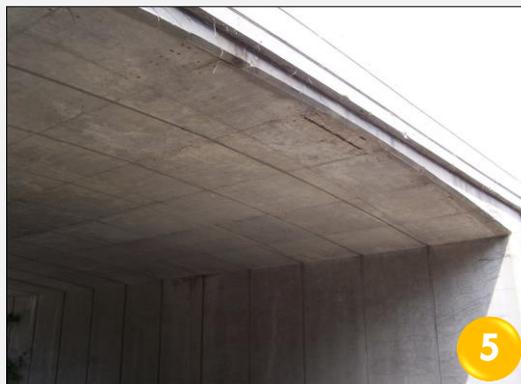
J-26

- 3-Sided Precast
- 8% of surface area is spalled or delaminated
- 6% section loss in reinforcement

FAIR. Non-structural **cracks** greater than 0.06", isolated structural **cracks** up to 0.03", **spalling** with **minor section loss of reinforcing steel up to 10%**, up to 10% of compression surface area **spalled** or delaminated.

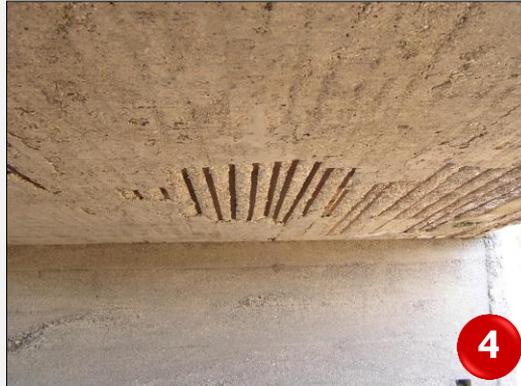
POOR. Flexural or shear cracks up to 0.06", primary reinforcing steel exposed with significant section loss up to 30%, up to 25% of the compression surface area spalled or delaminated, channel beams spalled or delaminated around the bottom primary reinforcement steel but not within 4' of beam ends.

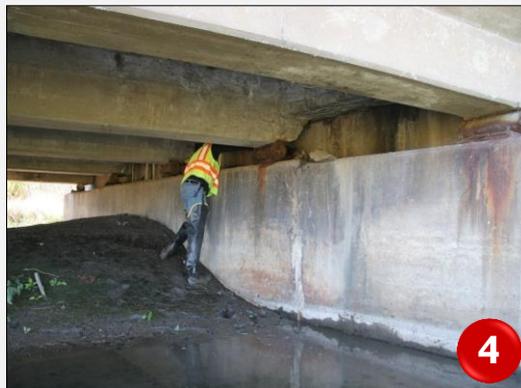
POOR. Flexural or shear cracks up to 0.06", primary reinforcing steel exposed with significant section loss up to 30%, up to 25% of the compression surface area spalled or delaminated, channel beams spalled or delaminated around the bottom primary reinforcement steel but not within 4' of beam ends.

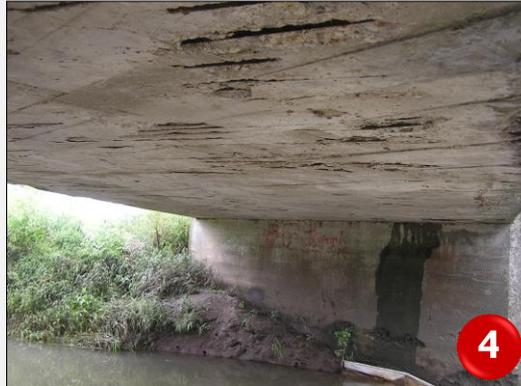
POOR. Flexural or shear cracks up to 0.06", primary reinforcing steel exposed with significant section loss up to 30%, up to 25% of the compression surface area spalled or delaminated, channel beams spalled or delaminated around the bottom primary reinforcement steel but not within 4' of beam ends.

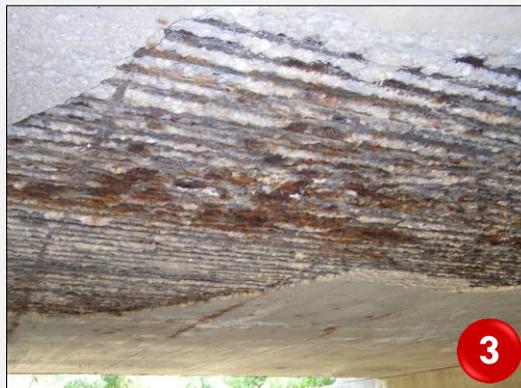
SERIOUS. Primary reinforcing steel exposed with section loss up to 50%, channel beams spalled or delaminated around the bottom primary reinforcement steel within 4' of beam ends.

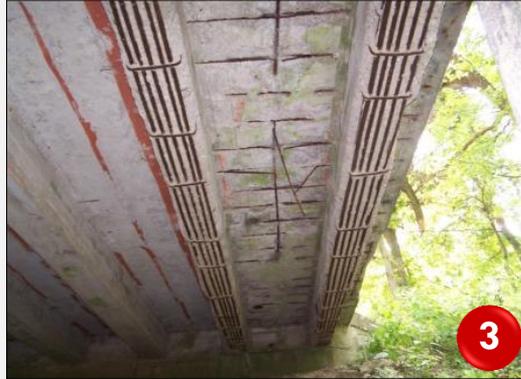
J-31

- T-Beam
- Concrete spalling with reinforcement exposed
- 40% section loss in exposed primary reinforcement

SERIOUS. Primary reinforcing steel exposed with **section loss up to 50%**, channel beams spalled or delaminated around the bottom primary reinforcement steel within 4' of beam ends.

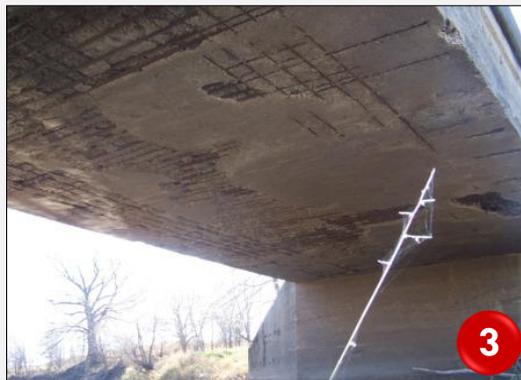
J-32

- Through Girder
- Concrete spalling with reinforcement exposed
- 35% section loss in exposed primary reinforcement

SERIOUS. Primary reinforcing steel exposed with **section loss up to 50%**, channel beams spalled or delaminated around the bottom primary reinforcement steel within 4' of beam ends.

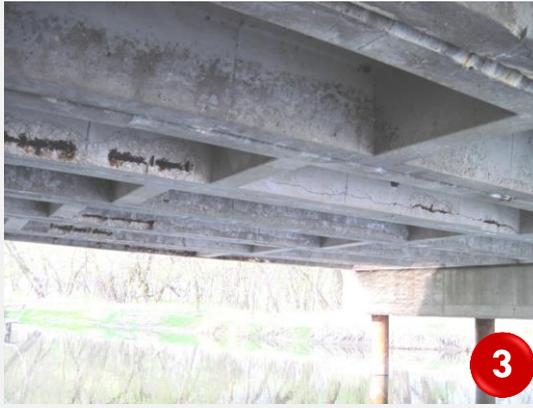
SERIOUS. Primary reinforcing steel exposed with **section loss up to 50%**, channel beams spalled or delaminated around the bottom primary reinforcement steel within 4' of beam ends.

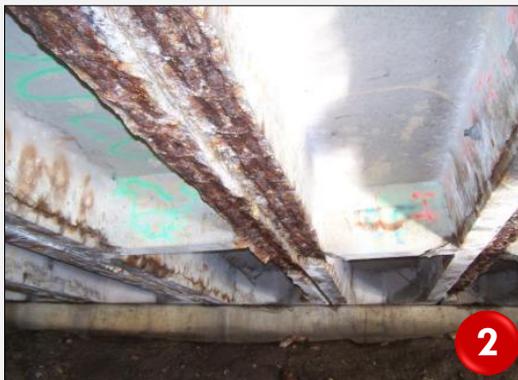
J-34

- Channel Beam
- Concrete spalling with reinforcement exposed
- 40% section loss in primary reinforcement
- Broken stirrups at beam ends
- Bureau of Bridges and Structures should be notified immediately!

CRITICAL. Similar to the description for a condition rating of "3" although more extensive with over **50% loss of reinforcing steel**, channel beams fully delaminated or **spalled at ends** with **broken stirrups**, requires special inspections, temporary support or repairs may be required to remain open to traffic. The Bureau of Bridges and Structures shall be notified immediately.

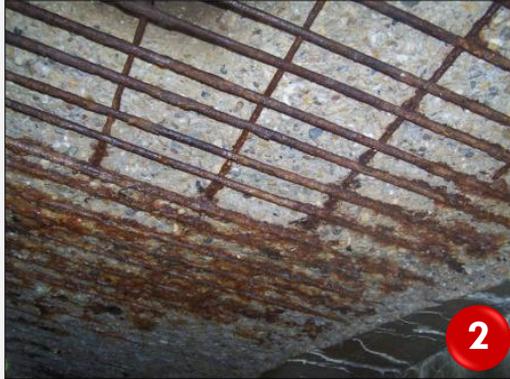
J-35

- Slab
- Large spall with two layers of exposed reinforcement
- 50% section loss in bottom reinforcement
- Full-depth hole through slab above reinforcement
- Middle third of soffit is delaminated and sagging

CRITICAL. Similar to the description for a condition rating of “3” although more extensive with **over 50% loss of reinforcing steel**, channel beams fully delaminated or **spalled** at ends with broken stirrups, requires special inspections, temporary support or repairs may be required to remain open to traffic. The Bureau of Bridges and Structures shall be notified immediately.

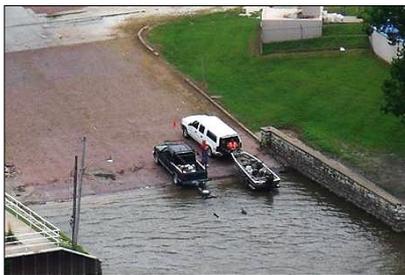
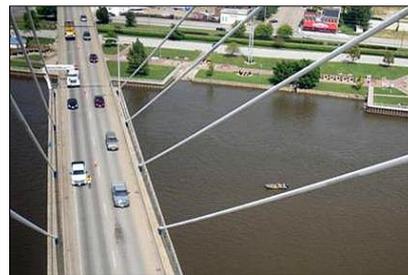
Boat

Boats also provide access for water-level inspections including soundings for scour measurements.

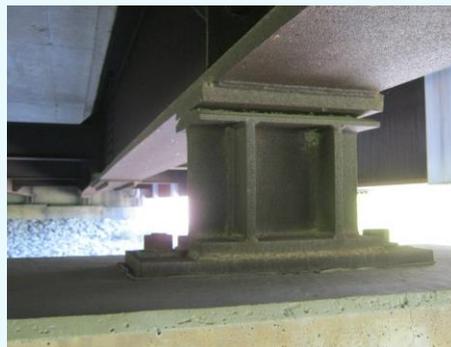
Low Profile Fixed Bearing

High Profile Fixed Bearing

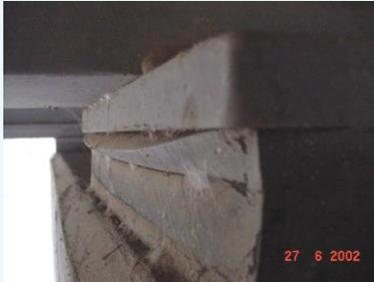
Elastomeric Bearing

Excessive bulging

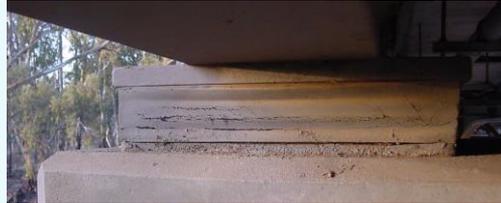
Cracking & splitting

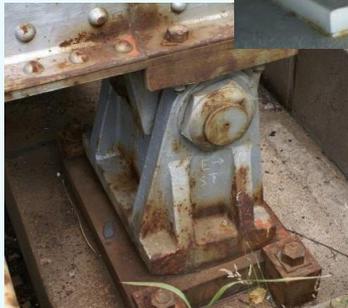
Inspect For:

- Alignment & tilt angle
- Freedom of movement
- Full bearing surface contact
- Excessive section loss
- Anchor bolt condition

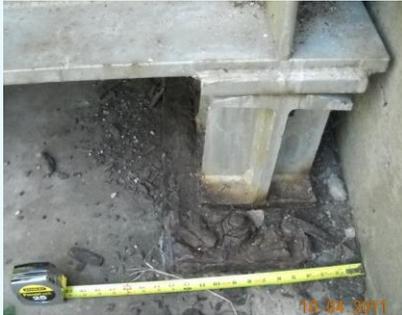
Rocker Bearing

Poor alignment w/ masonry PL

Heavy section loss

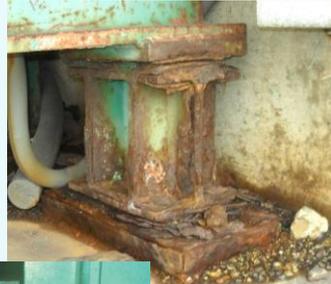
Excessive tilt

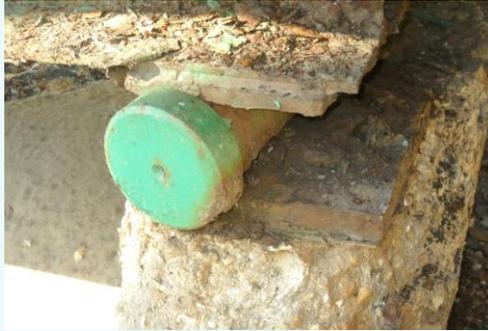
Roller Bearing

Section loss, rotated out of position
& loss of bearing area

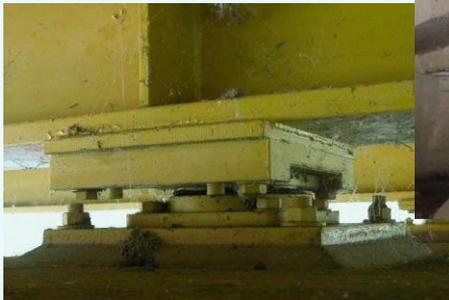
Pot

Bearing at extension limit

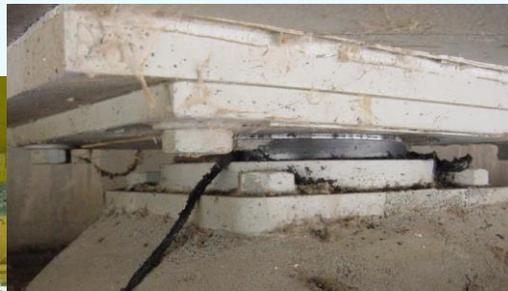
Excessive leakage of rubber

Damaged guide & rubber loss

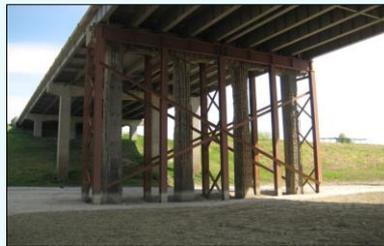
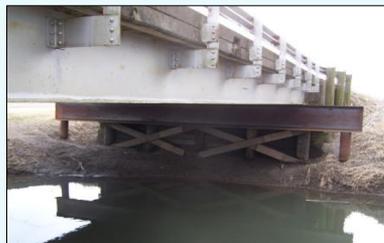
Temporary Shoring

- If left in place for 5 yrs. or more, temporary supports are considered the Substructure.
- The rating coded for Item 60 would be based on the criteria for the material used for the “temporary” support.
- Steel shoring, similar to the example in the lower photo, becomes a Fracture Critical Member in the context of the Substructure.

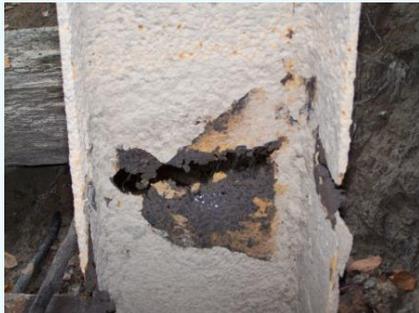
Steel H-piling

Heavy section loss

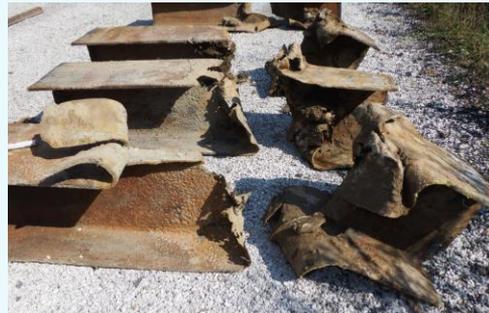
Failed pile sections

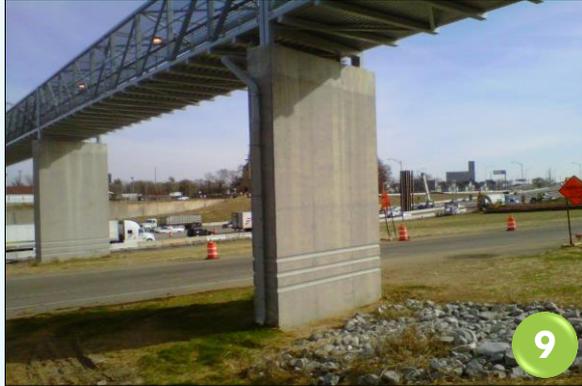
New substructure – Typically first inspection only

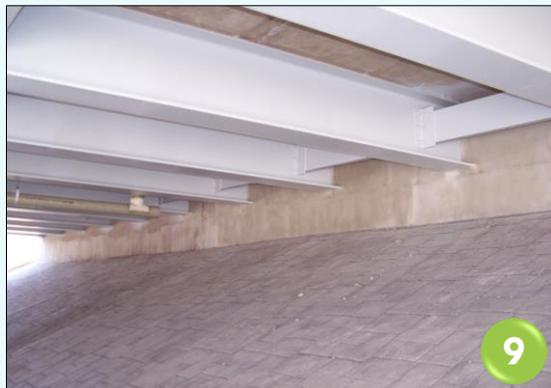
**New
Construction**

**Note Integral
Abutment**

New substructure.

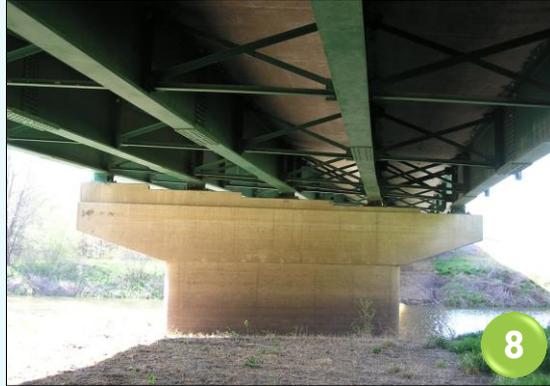
VERY GOOD. No significant defects. Shrinkage, cracks **very light surface scaling, spalling or pop-outs which do not expose reinforcing steel.** Insignificant damage caused by drift or collision with no misalignment and no corrective action warranted.

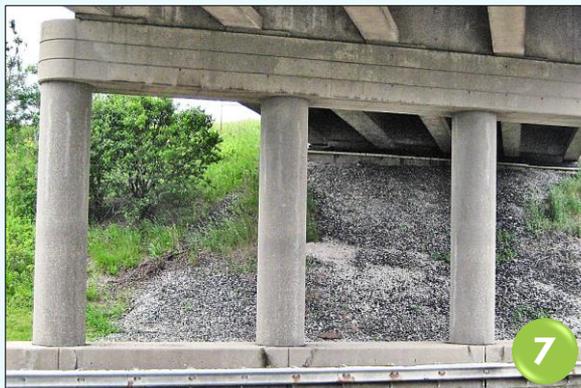
GOOD. **Minor cracking,** spalls or scaling with few incidences of exposed reinforcement with only surface rust. Minor scour may have occurred.

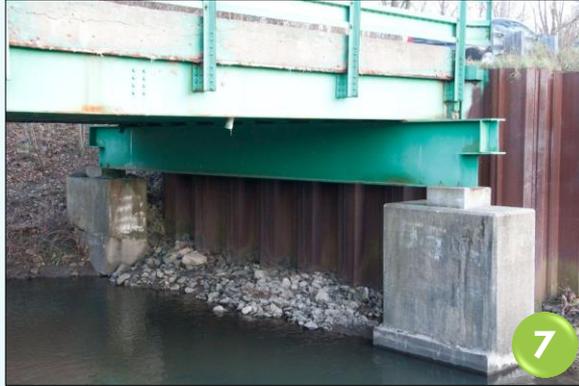
GOOD (Concrete). **Minor cracking, spalls or scaling** with few incidences of exposed reinforcement with only surface rust. Minor scour may have occurred.

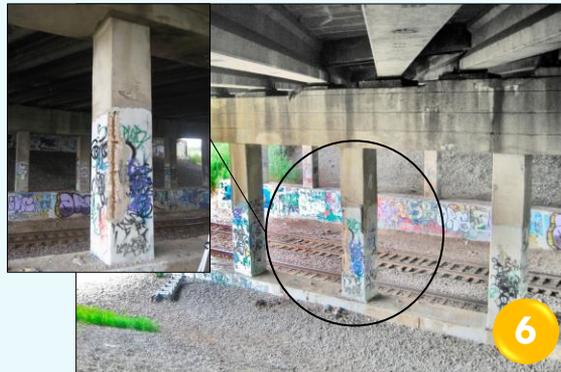
SATISFACTORY. **Moderate deterioration** or disintegration, **spalls, cracking** and leaching on concrete or masonry units with little or no loss of bearing area. Shallow, local scour may have occurred near foundations with exposure of top of pile supported footings.

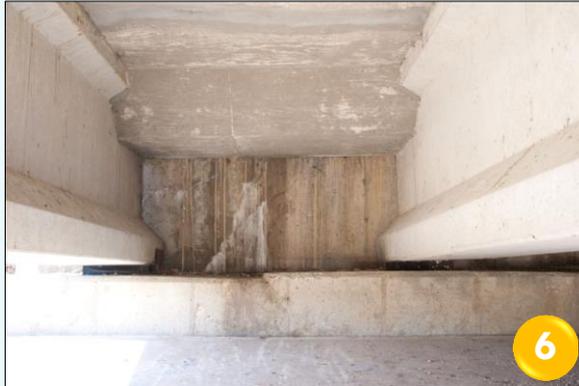
SATISFACTORY. Moderate deterioration or disintegration, spalls, cracking and leaching on concrete or masonry units with little or no loss of bearing area. Shallow, local scour may have occurred near foundations with exposure of top of pile supported footings.

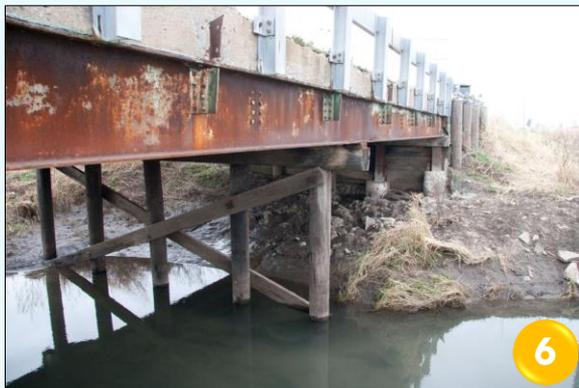
SATISFACTORY. Surface decay, cracking, splitting of timber, fire damage limited to surface scorching of timber with insignificant section loss, shallow, local scour may have occurred near foundations.

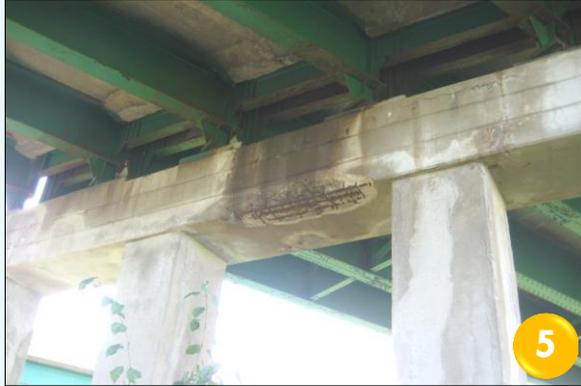
FAIR. Large portions of concrete or masonry units are spalling or scaling with exposed reinforcing steel possible, up to 10% loss of concrete (horizontal cross section), up to 10% loss of reinforcement steel, extensive map cracking with leaching, spread footings exposed with no undermining, less than 2' of exposed piles or seal coat below pile supported footings, less than 6' deep scour around piles with pile caps installed above the ground.

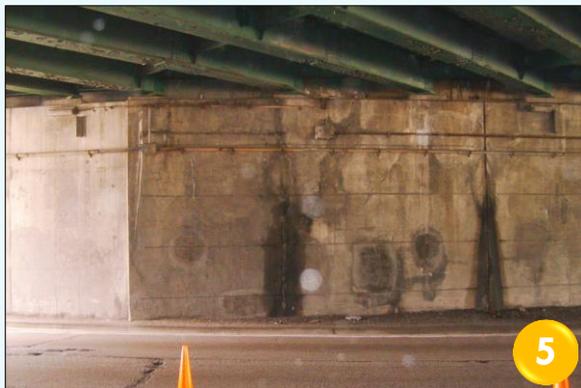
FAIR. Large portions of concrete or masonry units are spalling or scaling with exposed reinforcing steel possible, up to 10% loss of concrete (horizontal cross section), up to 10% loss of reinforcement steel, extensive map cracking with leaching, spread footings exposed with no undermining, less than 2' of exposed piles or seal coat below pile supported footings, less than 6' deep scour around piles with pile caps installed above the ground.

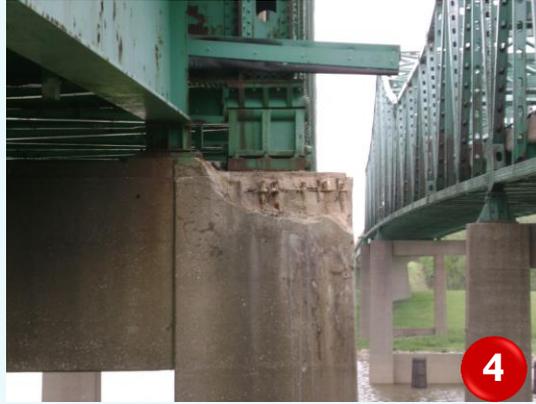
POOR. Active **cracks** in concrete and masonry units that indicate a reduction in the substructure unit's capacity to support the superstructure loads, **spalling is reducing the integrity of bearing seats with loss of bearing area**, section loss of primary steel reinforcement up to 30%. **Section loss of concrete up to 30%**, undermining of spread footing which may be affecting the stability of the unit but no significant settlement has yet occurred, worst condition or combination of deterioration stated in condition rating "5".

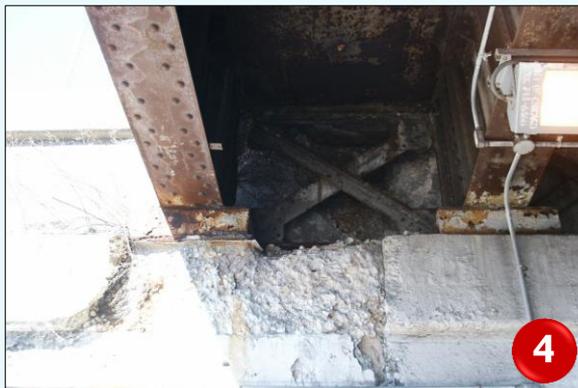
POOR. Active cracks in concrete and masonry units that indicate a reduction in the substructure unit's capacity to support the superstructure loads, **spalling is reducing the integrity of bearing seats with loss of bearing area**, section loss of primary steel reinforcement up to 30%. **Section loss of concrete up to 30%**, undermining of spread footing which may be affecting the stability of the unit but no significant settlement has yet occurred, worst condition or combination of deterioration stated in condition rating "5".

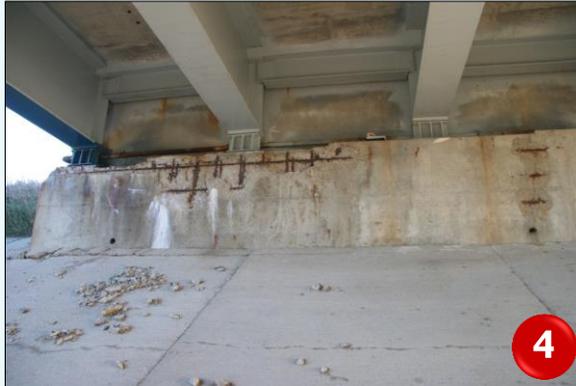
POOR. Active cracks in concrete and masonry units that indicate a reduction in the substructure unit's capacity to support the superstructure loads, **spalling is reducing the integrity of bearing seats with loss of bearing area, section loss of primary steel reinforcement up to 30%. Section loss of concrete up to 30%,** undermining of spread footing which may be affecting the stability of the unit but no significant settlement has yet occurred, **worst condition or combination of deterioration stated in condition rating "5"**.

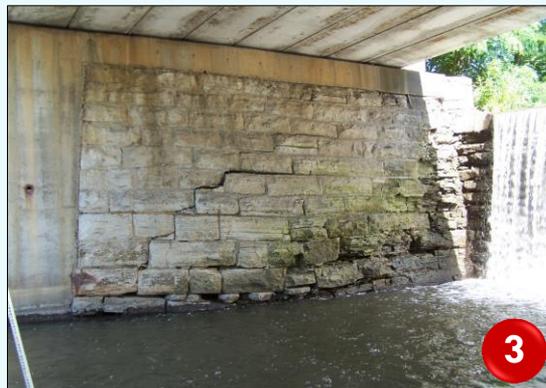
SERIOUS. Section losses up to 50%, loss of bearing seat area to cause more than 2" drop, adjacent column ties are broken causing the vertical reinforcement to be ineffective, **severe scour or undermining of footings affecting the stability of the unit with some settlement of the substructure.**

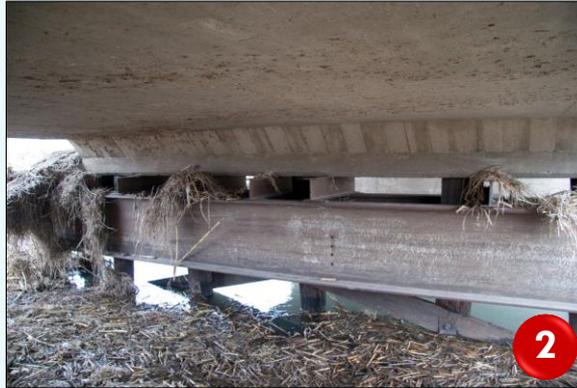
CRITICAL. Conditions worse than condition rating of “3”, **section loss greater than 50%**, special inspection is required to allow bridge to remain open, measurable lateral or vertical movement, unstable structures. **The Bureau of Bridges and Structures shall be notified immediately.**

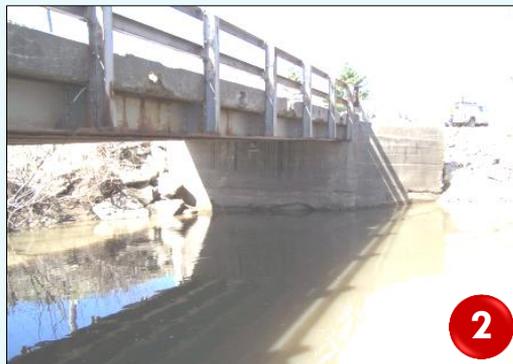
Critical Condition

- Abutment undermined by scour
- Abutment corner has settled approximately 6”

CRITICAL. Conditions worse than condition rating of “3”, **section loss greater than 50%**, special inspection is required to allow bridge to remain open, **measurable lateral or vertical movement, unstable structures.** **The Bureau of Bridges and Structures shall be notified immediately.**

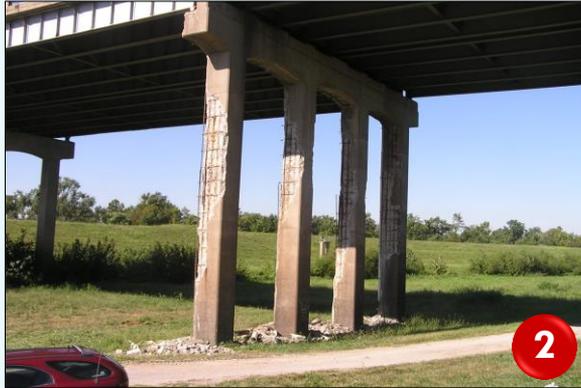
CRITICAL. Conditions worse than condition rating of “3”, **section loss greater than 50%**, special inspection is required to allow bridge to remain open, measurable lateral or vertical movement, unstable structures. **The Bureau of Bridges and Structures shall be notified immediately.**

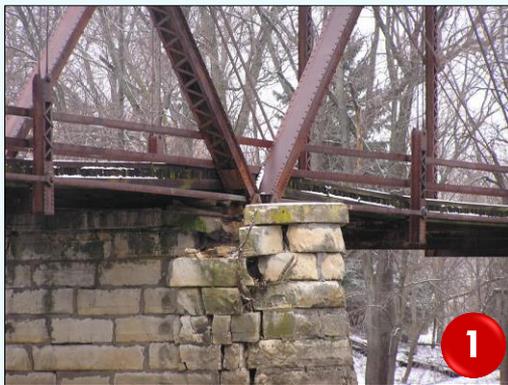
Failure Imminent

Substructure in “imminent failure” condition requiring bridge closure or temporary measures to allow structure to remain open.

Notify the Bureau of Bridges and Structures immediately

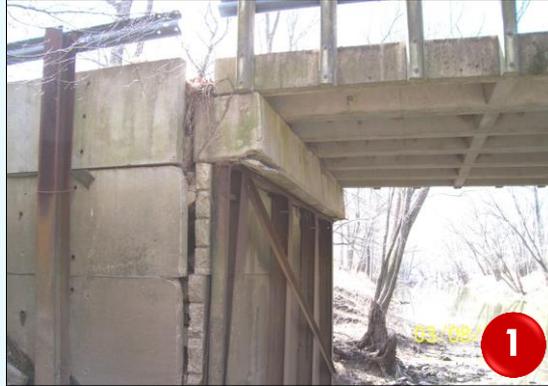
Substructure in “imminent failure” condition requiring bridge closure or temporary measures to allow structure to remain open.
