1 IDOT-NBI Calibration Course

LOCAL AGENCY ISSUES

Local Agency Issues to Highlight

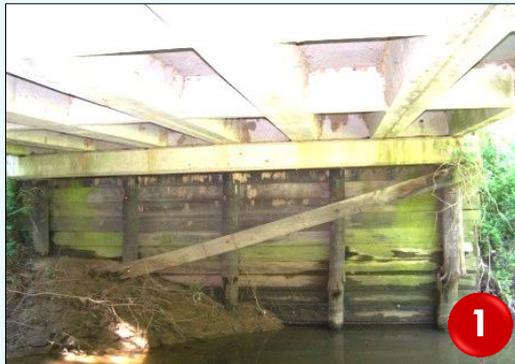
Failure Imminent

- 3 exposed piles have 100% section loss
- The 2 remaining piles are obscured by debris and may have similar loss of section
- Notify the Bureau of Bridges and Structures immediately

Substructure in “imminent failure” condition requiring bridge closure or temporary measures to allow structure to remain open.

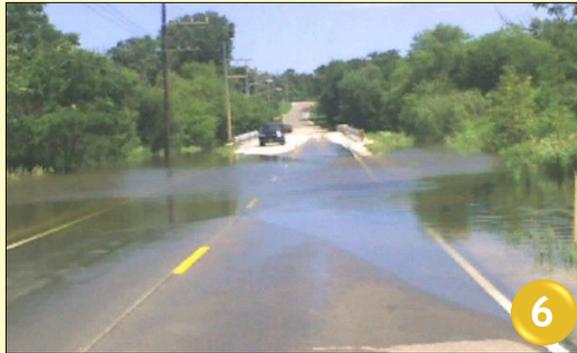
Item 71 – Waterway Adequacy

Principal Arterials - Interstates, Freeways, or Expressways	Other Principal and Minor Arterials and Major Collectors	Minor Collectors, Local	Description
4	5	6	Bridge deck above roadway approaches. Occasional overtopping of roadway approaches with insignificant traffic delays.

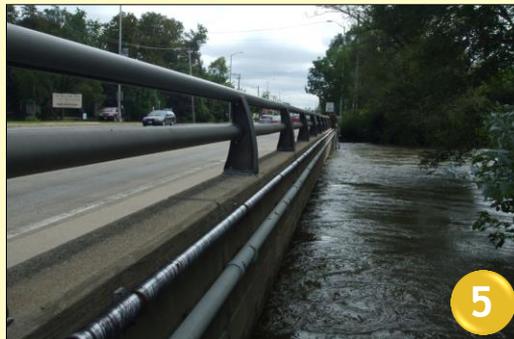
Item 71 – Waterway Adequacy

Principal Arterials - Interstates, Freeways, or Expressways	Other Principal and Minor Arterials and Major Collectors	Minor Collectors, Local	Description
3	4	5	Bridge deck above roadway approaches. Occasional overtopping of roadway approaches with significant traffic delays. *

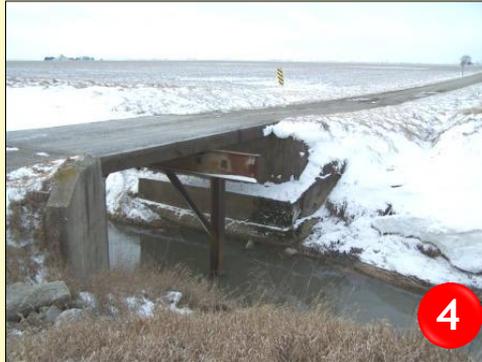
Item 71 – Waterway Adequacy

Principal Arterials - Interstates, Freeways, or Expressways	Other Principal and Minor Arterials and Major Collectors	Minor Collectors, Local	Description
2	3	4	Occasional overtopping of bridge deck and/or roadway approaches with significant traffic delays. *

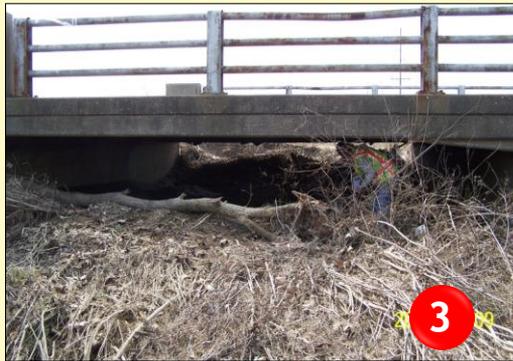
Item 71 – Waterway Adequacy

Principal Arterials - Interstates, Freeways, or Expressways	Other Principal and Minor Arterials and Major Collectors	Minor Collectors, Local	Description
2	2	3	Frequent overtopping of bridge deck and/or roadway approaches with significant traffic delays. *

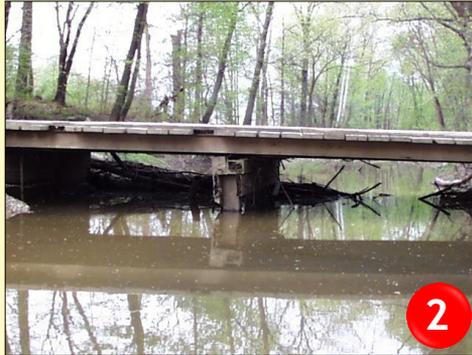
Item 71 – Waterway Adequacy

Principal Arterials - Interstates, Freeways, or Expressways	Other Principal and Minor Arterials and Major Collectors	Minor Collectors, Local	Description
2	2	2	Occasional or frequent overtopping of bridge deck and/or roadway approaches with severe traffic delays. *

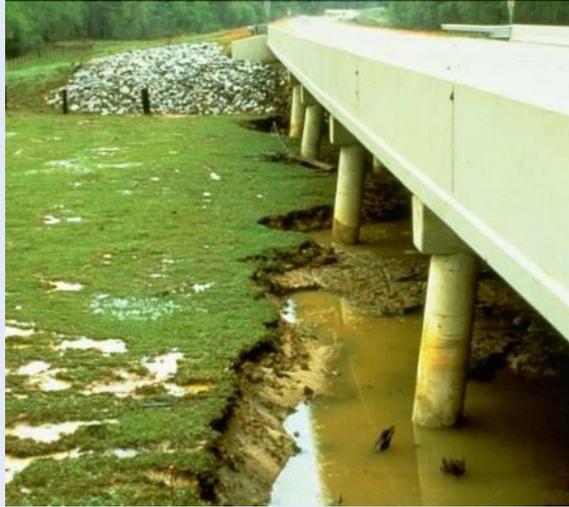
Contraction Scour

- This is the lowering of the streambed under the bridge only, resulting from accelerated stream flow due to reduced waterway opening
- Occurs when the bridge waterway opening is restricted
- Can be caused by:
 - Embankments
 - Debris or Vegetation
 - Substructure units
 - Ice

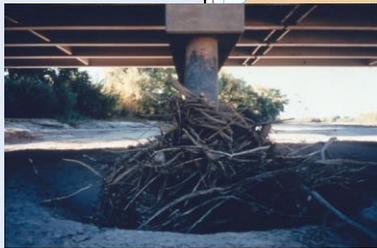
Local Scour

- This is the lowering of the streambed adjacent to an obstruction in the waterway.
- Often much greater than general scour (up to 10 times)
- Often caused by:
 - Abutments
 - Wide, long, unusually shaped or poorly skewed piers
 - Streamflow depth (as depth increases vortex action is magnified)
 - Debris or Ice accumulation

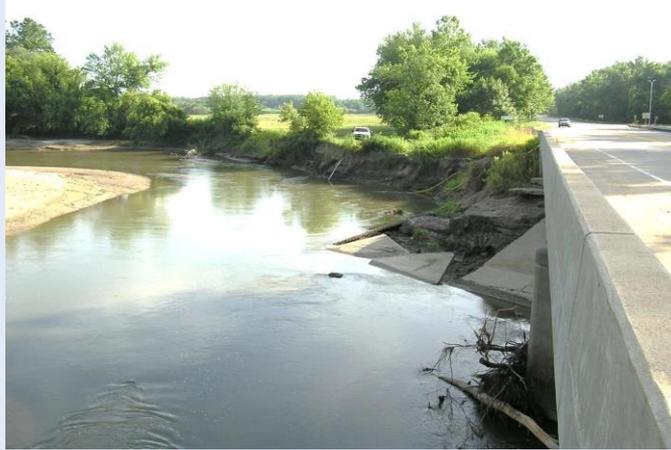
Lateral Stream Migration

- This is the relocation of the channel over time due to lateral scour of the embankment.
- Lateral stream migration process:
 - Bank damage
 - Sloughing bank
 - Undermined bank
 - Channel misalignment

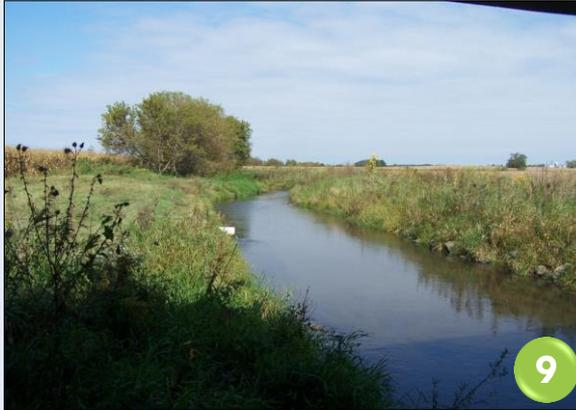
EXCELLENT. There are no noteworthy deficiencies that affect the condition of the channel.

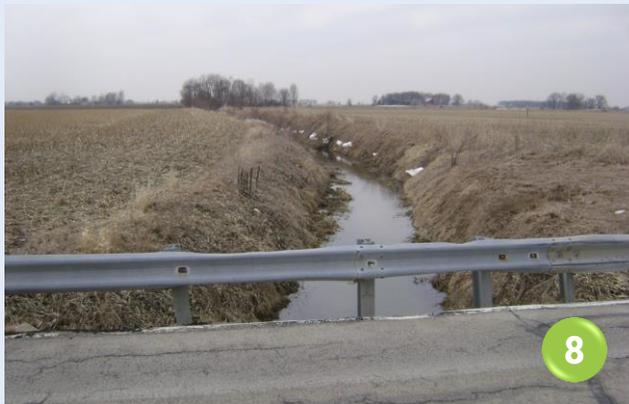
VERY GOOD. Banks are protected or well vegetated. River control devices such as spur dikes and embankment protection are not required or are in a stable condition.

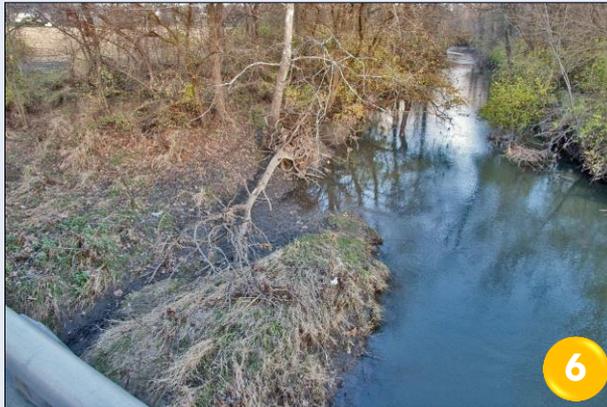
SATISFACTORY. **Bank is beginning to slump.** River control devices and embankment protection have widespread minor damage. There is minor **streambed movement** evident. Debris is restricting the waterway slightly.

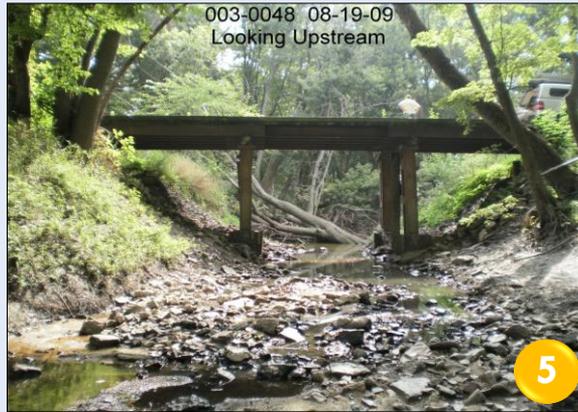
FAIR. Bank protection is being **eroded**. River control devices and/or embankment have major damage. Trees and brush restrict the channel.

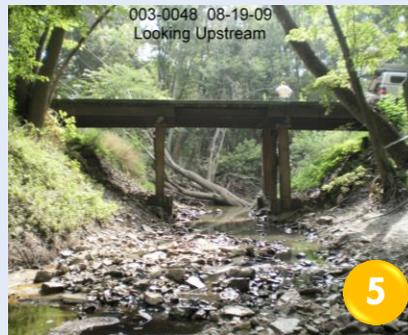
Trees and brush restrict channel.

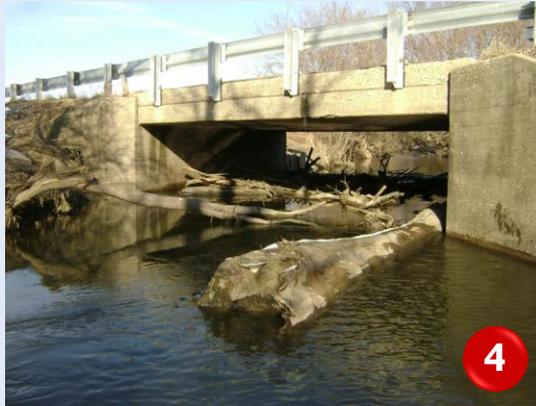
POOR. Bank and embankment protection is severely undermined. River control devices have severe damage. **Deposits of debris in the waterways are severely restricting the opening.**

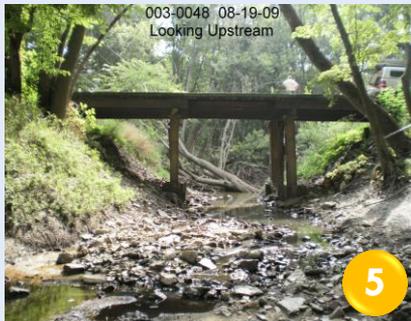
Bank protection is being eroded.

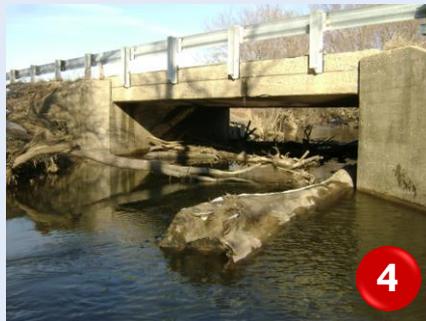
Debris is severely restricting the waterway.

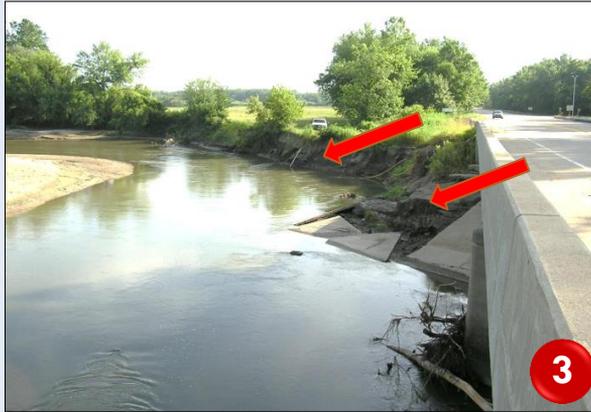
SERIOUS. Bank **protection has failed**. River control devices have been destroyed. Streambed aggradation, degradation or **lateral movement has changed the waterway to now threaten the bridge and/or approach roadway.**

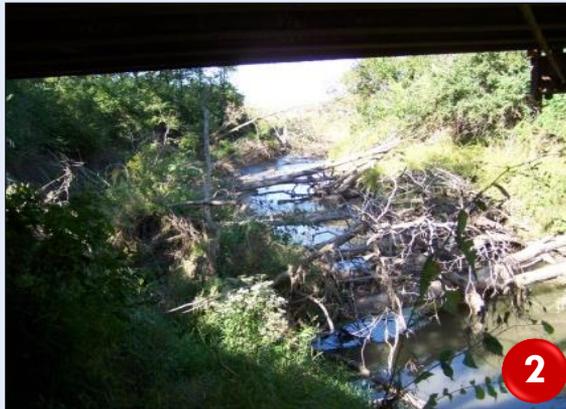
CRITICAL. The waterway has changed to the extent the bridge is near a state of collapse.

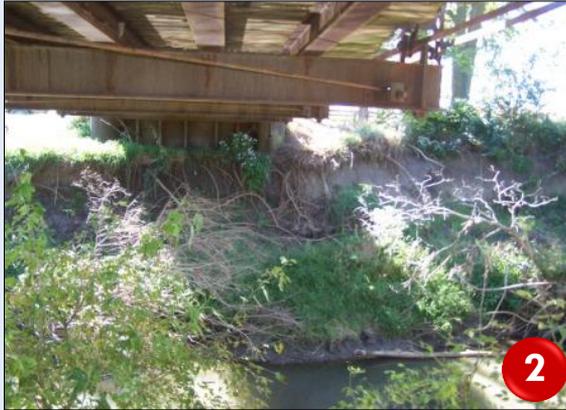
CRITICAL. The waterway has changed to the extent the bridge is near a state of collapse.
