**LEVEL II HYDROGEOLOGIC CHARACTERIZATION REPORT:  
EAST CAPE GIRARDEAU WETLAND MITIGATION SITE**

FAP 312 (IL 146)  
BDE SEQ. NO. 633A  
ALEXANDER COUNTY, ILLINOIS

**Open-File Series 2010-3**

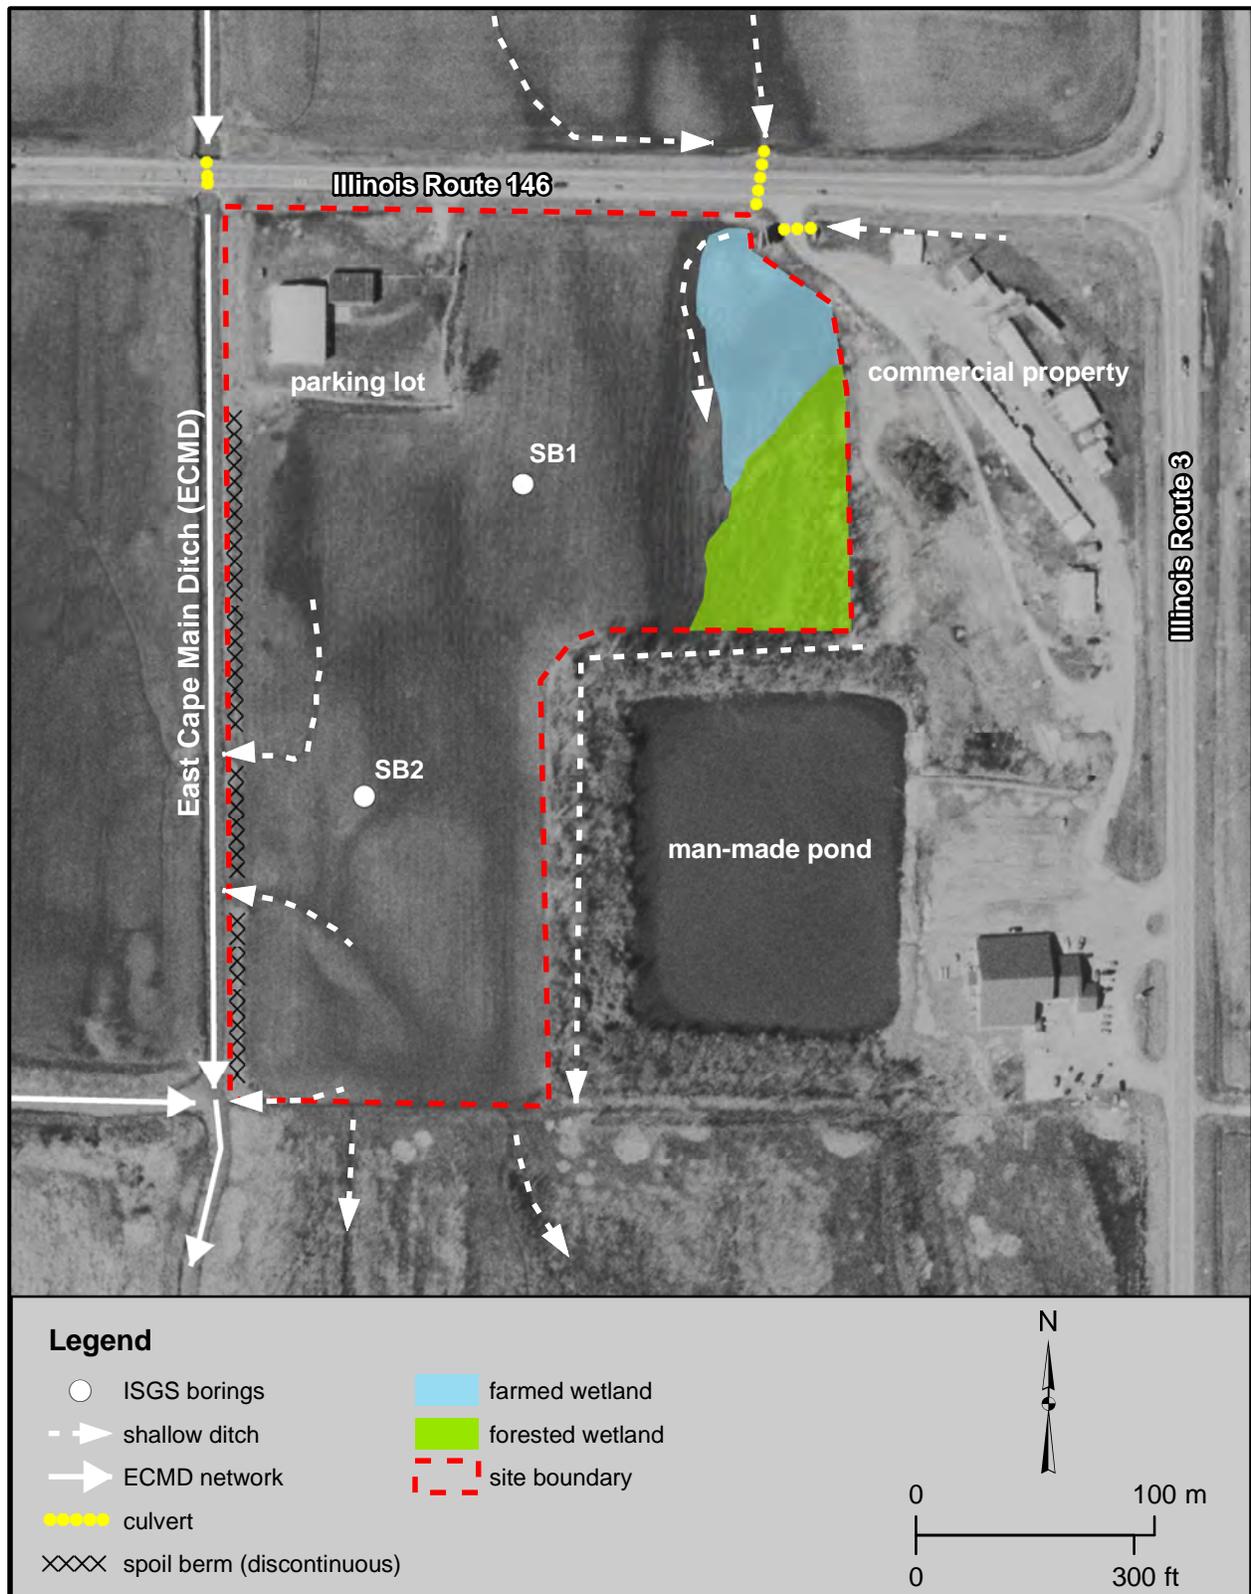
**Figure 2** Drainage features and the locations of INHS-delineated pre-existing wetlands and ISGS hand-augered borings at the East Cape Girardeau wetland mitigation site. Figure modified from Plankell et al. (2008).

- Several local and regional hydrologic alterations affect the hydrology at the site. Local alterations include several shallow ditches that drain excess water from the site either directly into the East Cape Main Ditch (ECMD) or onto the undeveloped land south of the site (Figure 2). Regional hydrologic alterations that affect the site include: 1) the leveeing-off of the Mississippi River from the floodplain, 2) the drainage of much of the floodplain west of IL 3 by the ECMD network, and 3) the construction of the elevated roadbeds of IL 3 and IL 146 and their associated ditches, resulting in water from the north and east being routed onto the northeast corner of the site through culverts under IL 146 and under the north entrance drive of the commercial property (Plankell et al. 2008; Figure 2).

Regionally, surface-water runoff south of Devil's Island and west of IL 3 is directed into the ECMD network, where it eventually drains into the mouth of Sexton Creek via a gravity drain located approximately 4.9 km (3.0 mi) south of the site, just west of the town of Gale, Illinois (Figure 3). Historical aerial photographs indicate that the ECMD network was in place by at least 1938. Locally, surface-water runoff from the agricultural field immediately north of IL 146 and from the roadside ditches surrounding the commercial property is directed toward the northeast corner of the site via culverts under IL 146 and under the northern entrance drive to the commercial property (Figure 2). This water, along with runoff from the northeastern portion of the site, collects in the forested wetland in the northeastern corner, though it occasionally overflows into a shallow ditch rimming the northern and western edges of the man-made pond, where it then drains to the undeveloped land to the south (Figure 2). Surface-water runoff from the western half of the site drains either into the ECMD or onto the undeveloped land south of the site via shallow ditches (Figure 2).

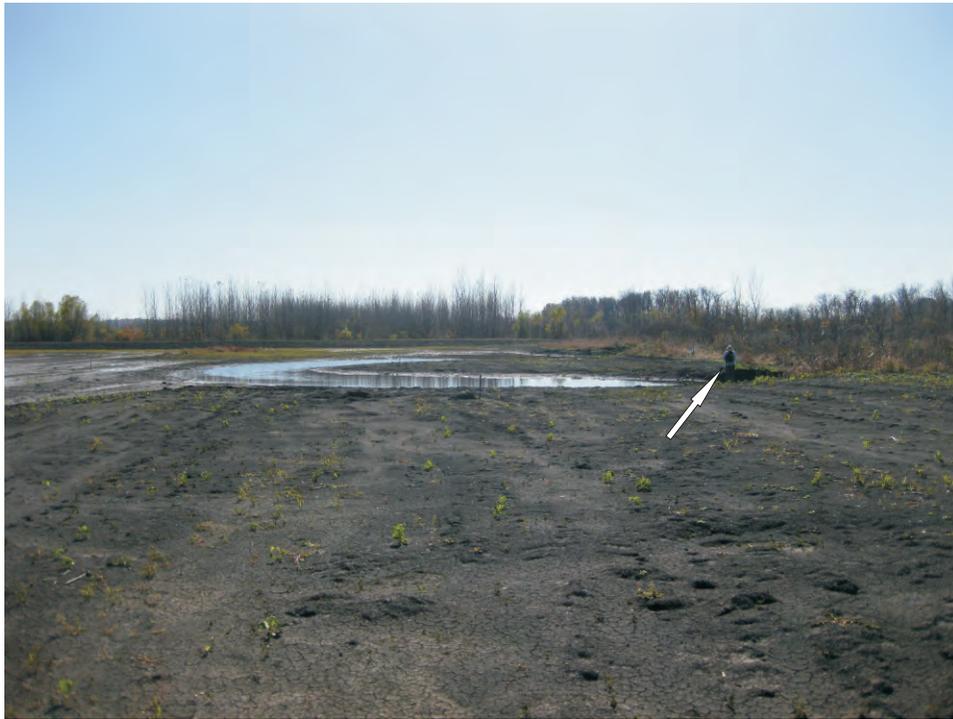
**Photograph 1** Water standing in the shallow excavation completed in the proposed emergent wetland area in the southwest portion of the site, view to the south. Note person standing in the location of the northernmost proposed drainage control structure (arrow). Photograph taken by C. Knight on November 4, 2009.

- Shallow excavation is planned both in the northeast and southwest portions of the site (Appendix A, Sheet 1). As of December 4, 2009, the two northernmost drainage ditches that empty into the ECMD (Figure 2) were connected via shallow excavation into a semicircular depression in the area proposed for created emergent wetland in the southwest portion of the site (Figure 5, Photograph 1 and Appendix A, Sheet 1). It did not appear that excavation in the northeast portion of the site, designed to enhance and expand existing wetlands, had begun.

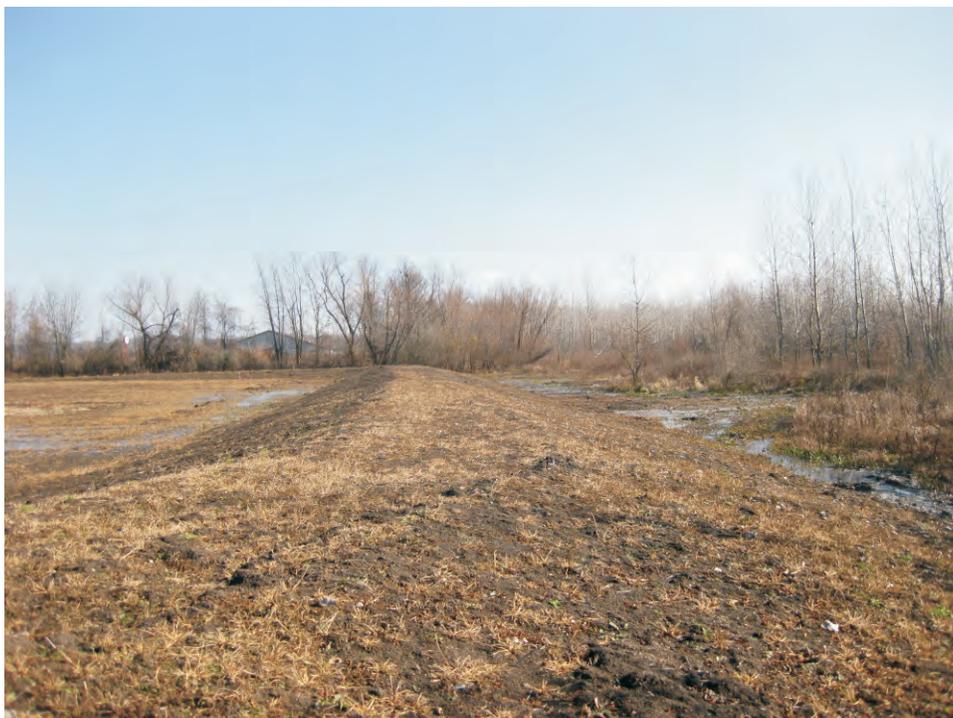
**Photograph 2** IDOT-constructed berm extending along the southern site boundary, as seen from the southwestern corner of the site. View is to the east, with the East Cape Girardeau wetland mitigation site on the left and undeveloped land on the right. Photograph taken by M. Campbell on December 4, 2009.

- A berm, with a planned elevation of 101.5 m (333.0 ft), has been constructed along the southern site boundary to restrict drainage from the site to the undeveloped land to the south, as well as to block off the southernmost outlet into the ECMD (Figure 5, Photograph 2 and Appendix A, Sheet 1).

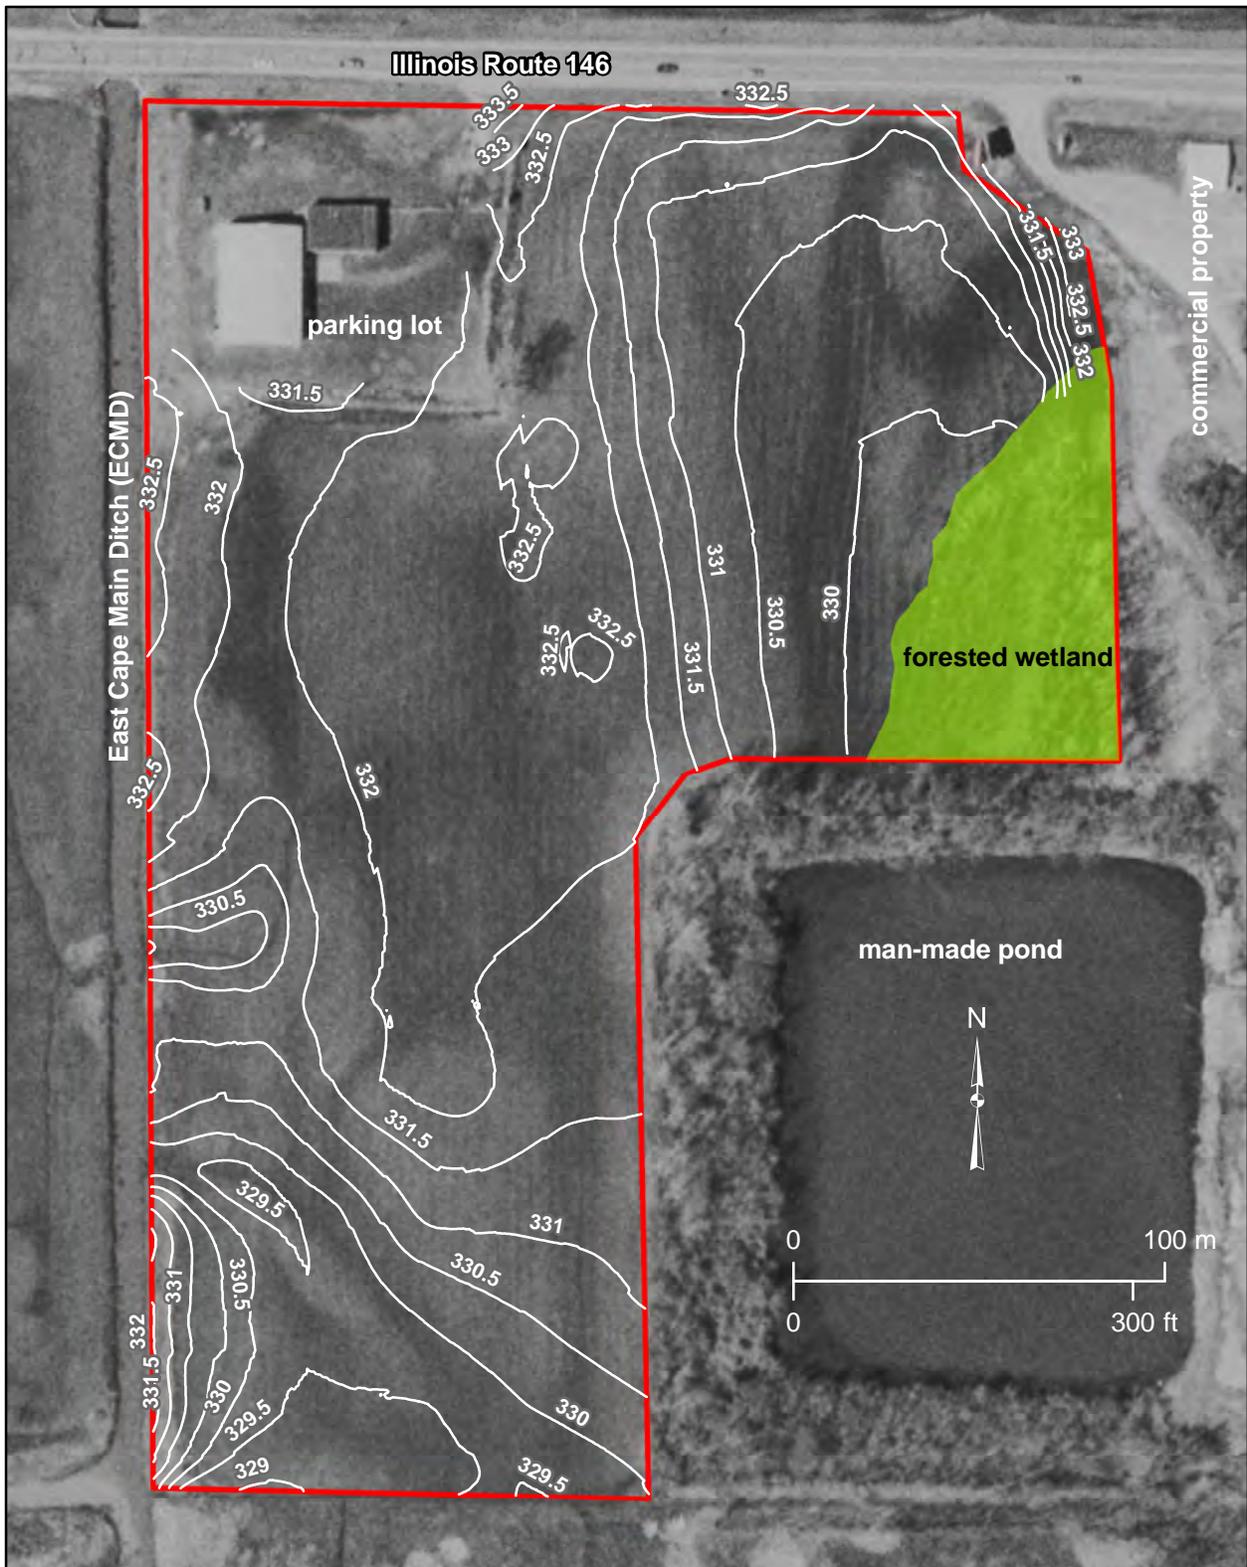
**Figure 7** Pre-construction topography at the East Cape Girardeau wetland mitigation site (contour interval = 0.5 ft). Topographic data collected by the ISGS on October 21, 2008. Map based on Figure 5 from Plankell et al. (2008).

According to topographic data collected by the ISGS, the site ranges in elevation from approximately 100.3-101.3 m (329.0-332.5 ft), not including the former parking lot at the northwest corner (Figure 7). The site is essentially divided into two low areas separated by a subtle ridge running from the southeast corner of the parking lot to the northwest corner of the man-made pond. The northeastern portion of the site slopes gently to the east-southeast, toward the forested wetland, while the western half of the site slopes gently toward the south-southwest, toward the undeveloped land south of the site. A subtle swale extends southward from the parking lot approximately 145 m (476 ft) before turning west and emptying into the ECMD through a break in the berm along the ditch (Figure 2 and Figure 7). A second break in the berm is located approximately 57 m (187 ft) further south, and directs flow into the ECMD from a well-developed drainage ditch that extends across the southern portion of the site.

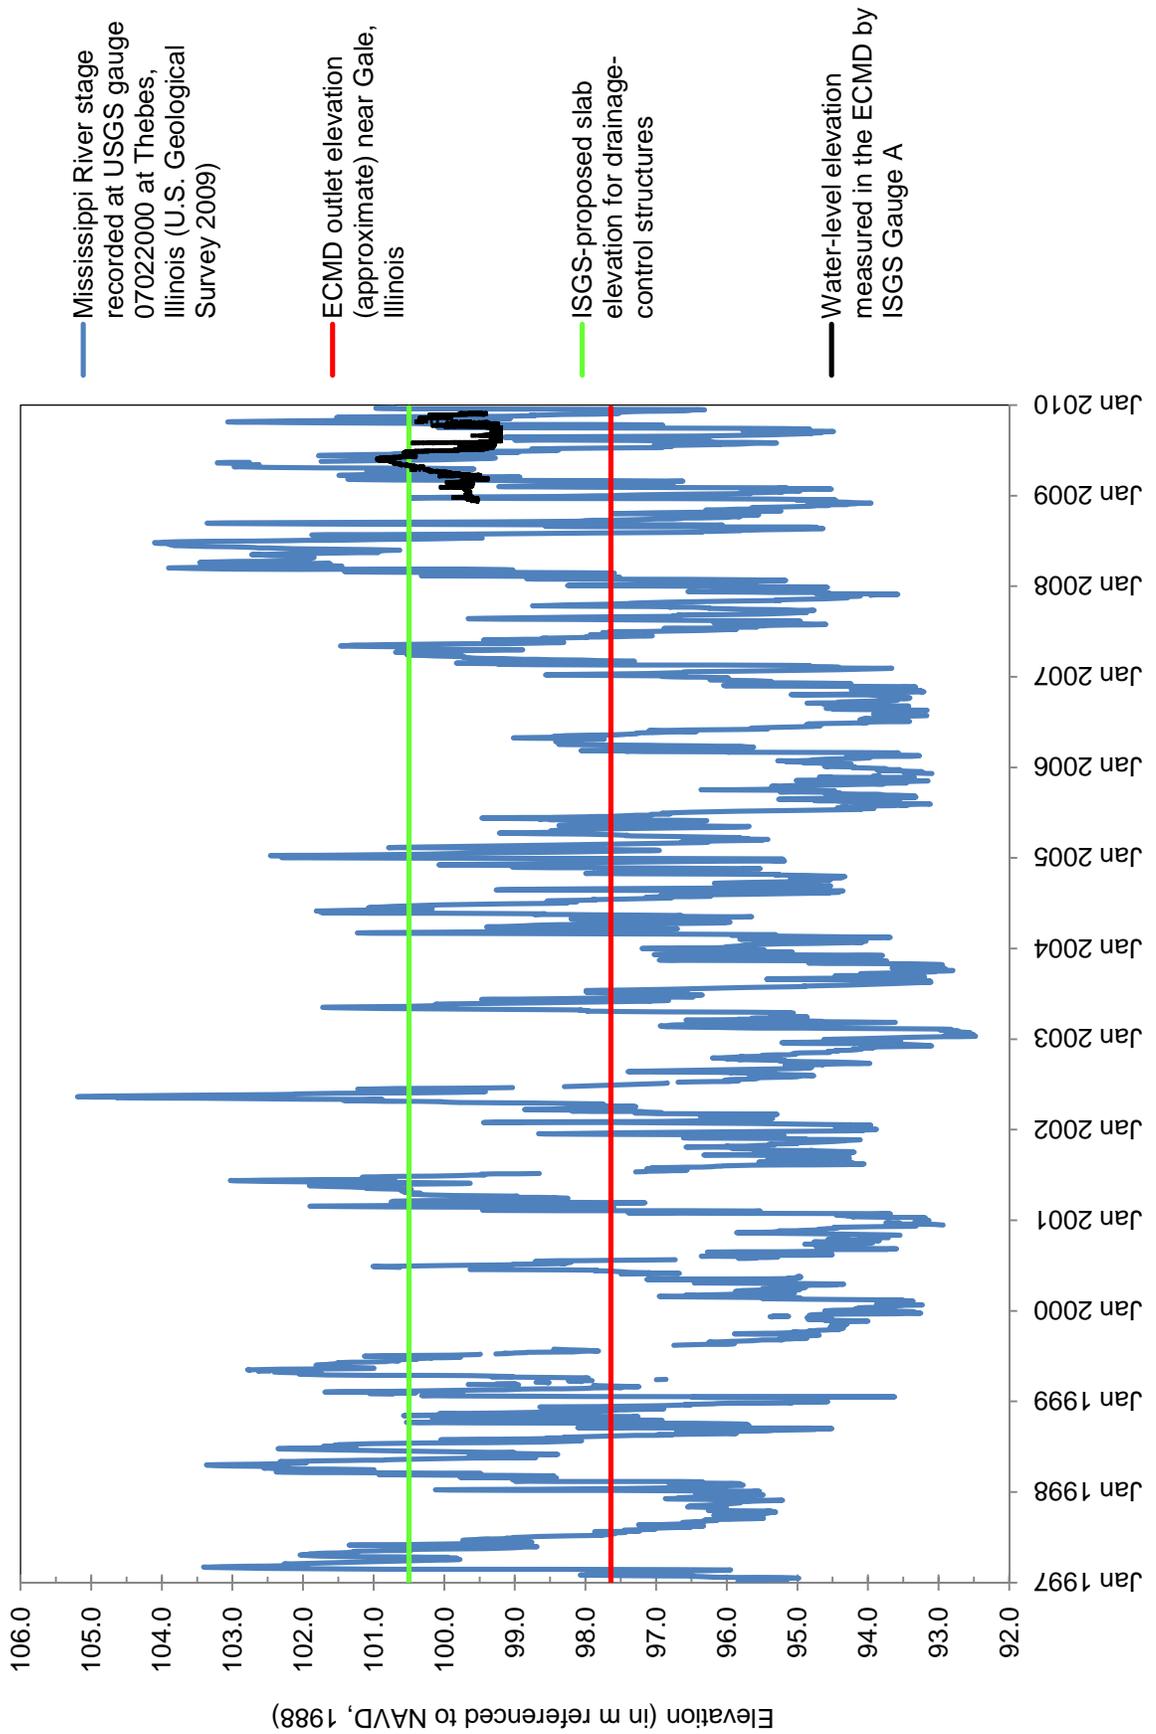
# APPENDIX F Flood-History Analysis of the Mississippi River at Thebes, Illinois

Results from a flood-history analysis of the Mississippi River at Thebes, Illinois indicate that there is a high likelihood of back-flooding on the ECMD during the growing season (Appendix F). The outlet elevation for the ECMD gravity drain is mapped at approximately 97.64 m (320.35 ft), and when river stage exceeds the outlet elevation, the gate is closed and no drainage through the ECMD occurs. The analysis shows that river stage has exceeded the ECMD outlet elevation during the growing season in 13 of the last 13 years. Additionally, the analysis indicates that river stage can exceed the outlet elevation multiple times during the growing season, as well as prior to the beginning of the growing season in some years. Whether or not water in the ECMD will back up to levels sufficient to flood the East Cape Girardeau site depends primarily on the amount of runoff generated by precipitation falling within the regional watershed when the gate is closed, which in turn is controlled by the precipitation total and rate, the antecedent soil moisture conditions, the percent of vegetative cover, the timing of the precipitation events relative to seasonal evaporation and transpiration rates, and other factors. Additionally, as water levels on the Mississippi River rise above the elevation of the floodplain, regional groundwater discharge may occur in the lower reaches of the floodplain, and thus contribute to rising surface-water levels across the region. It is unknown how often back-flooding in the ECMD spills over onto the site, but flooding did occur at the site during the growing season in 2009, over a period of slightly higher than average precipitation in April and May.
