INITIAL SITE EVALUATION
PROPOSED WETLAND COMPENSATION SITE NEAR FAIRMONT CITY, IL
ST. CLAIR COUNTY Site 1 of 2
FAIRMONT CITY GOLF COURSE
(Along Collinsville Rd north of Fairmont City, St. Clair County, Illinois)

November 3, 1999

Initial Site Evaluation – St. Clair County, Site 1 of 2, Fairmont City

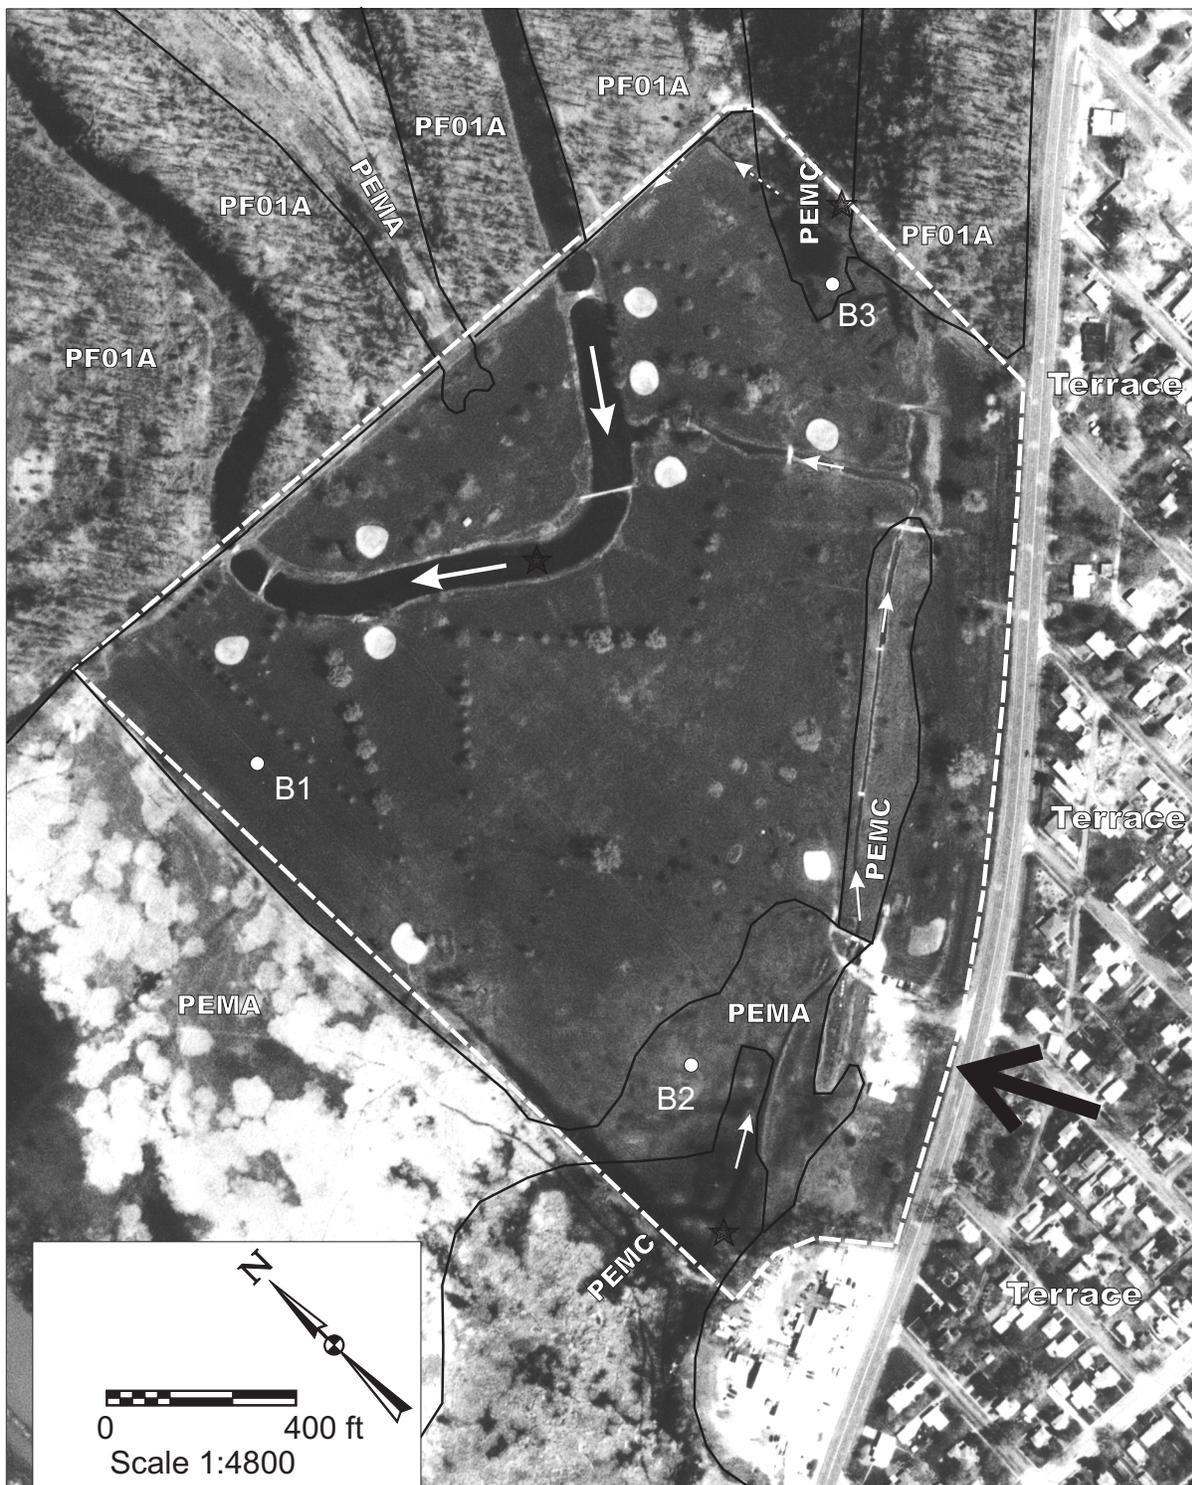
Figure 2: Details of the Fairmont Golf Course. Circles marked B1 through B3 indicate shallow borings. Solid arrows represent flow directions. Dashed arrows show inferred flow directions. Mapped wetlands are taken from USFWS 1988. Aerial photography from IDOT, Spring 1998, NAPP 44-469.

- The hydrogeologic success of future wetland compensation activities on the Fairmont City Golf Course is estimated to be high.
- Wetlands are depicted on NWI maps (USFWS 1988) along the south and east sides of the site and inside the meander bend of Old Cahokia Creek (figure 2). Hydric-soil indicators were observed in soil-probe borings in these areas. The property owner stated that these areas are usually too wet to mow until late in the summer.

- The parcels west, north, and east of the site are depicted on NWI maps as being entirely wetland (figure 2). The primary difference between these areas and the site appears to be land use.

- The identifiable hydrologic alterations to the site include the drainage ditches along the south and east site boundaries (figure 2) and raised cart paths, tees, and greens. Also, Old Cahokia Creek is lower than the surrounding landscape though it is not leveed. Evidence of drainage tile was not observed. Filling in or blocking the drainage ditches may allow surface water from adjacent wetlands to migrate onto the site.

Drainage ditches along the south and east sides of the site appear to be channeling surface water from adjacent wetlands to Old Cahokia Creek (figure 2). During our site visit, surface water was observed in the forested (PF01A) and emergent (PEMC) wetlands east of the site and in the southwest corner of the site. Filling or blocking the ditches may allow surface water from adjacent wetlands to migrate onto the site.

Six wetlands are mapped on site (figure 2) (USFWS 1988). Three are located along the south drainage ditch, two along the east side of the site, and one on the north side. Three of the wetlands are classified as palustrine, emergent, semipermanently flooded (PEMC), two are classified as palustrine, emergent, temporarily flooded (PEMA), and one as palustrine, forested, temporarily flooded (PF01A). Five of the wetlands appear to be extensions of wetlands from adjacent parcels of land.

In their investigation, the Illinois Natural History Survey (INHS) found hydrophytic vegetation along the drainage ditch west of the clubhouse. This corresponds to the area identified as PEMA on the NWI map (figure 2). The soil boring in this area (B2, figure 2) revealed that the texture was silty clay. The property owner also stated that this area was too wet to mow in the spring. Therefore, this area may meet the USACE three-parameter definition of jurisdictional wetlands (USACE 1987).

The other mapped wetlands on the site appear to lack either vegetation or hydrology. The area along the east side of the site mapped as PEMC (figure 2) was also identified by the property owner as being too wet to mow in the spring. The soil boring in this area (B3, figure 2) revealed that the texture was silty clay. In their report, the INHS did not identify this area as wetland, however, the soil texture and wetness suggest that the only parameter missing is vegetation.

The parcels to the west, north, and east of the site are entirely mapped as wetlands on the NWI (USFWS 1988). These areas include emergent wetlands (PEMA and PEMC) to the west, and forested wetlands (PF01A) to the north and east (figure 2). The presence of these wetlands suggests that most of the site may have been wetland at one time. The primary difference between the adjacent parcels and the site appears to be land use.

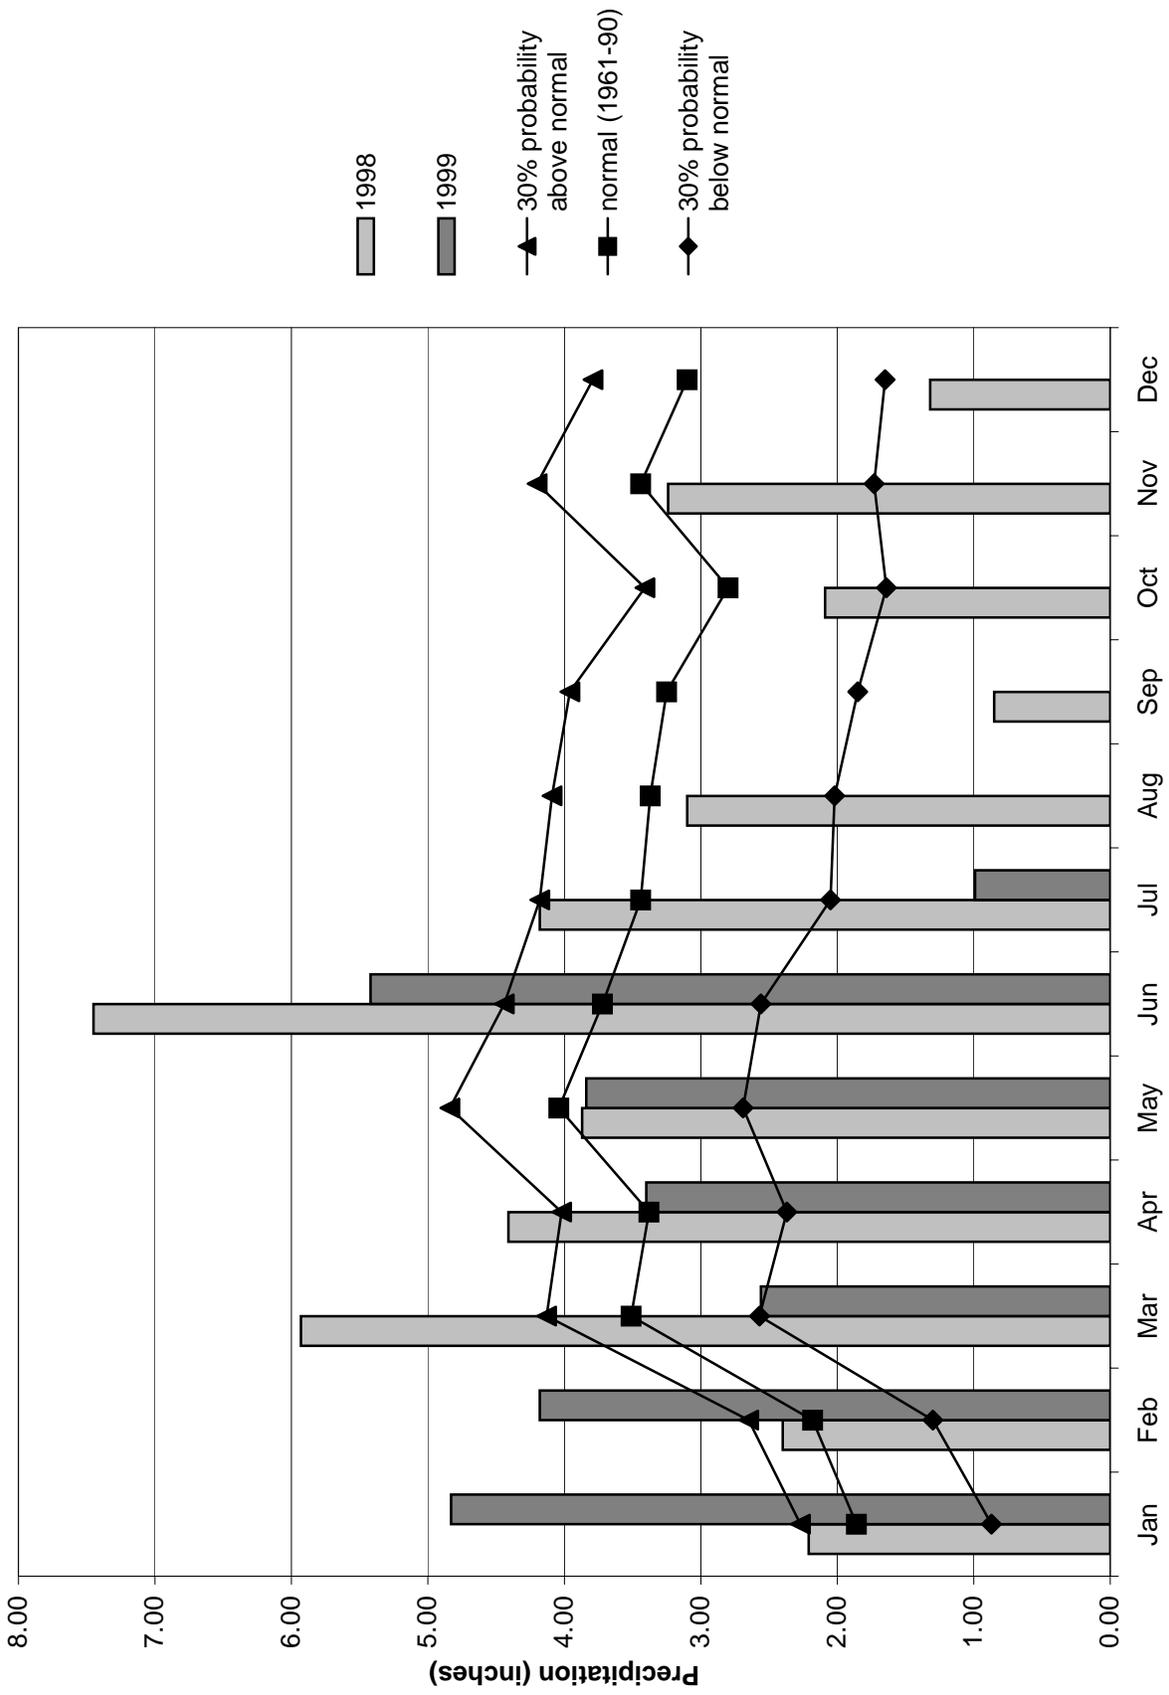
** 30% chance precipitation amounts will be less than or equal to the value shown

*** through 7/31/99 (August data not available)
