Photographing Historic Structures: Guidelines and Photo Logs

Prepared by the Illinois Department of Transportation Bureau of Design and Development Cultural Resources Unit

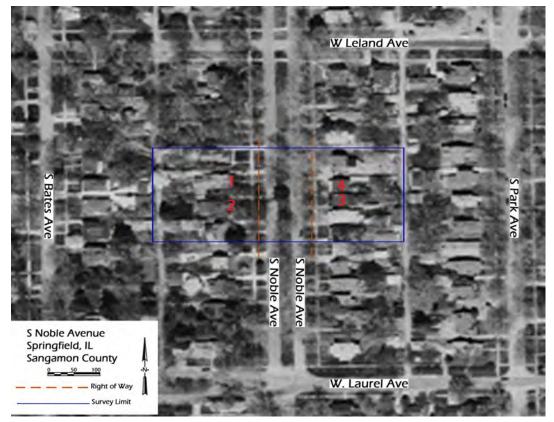
Map of the project area including required information

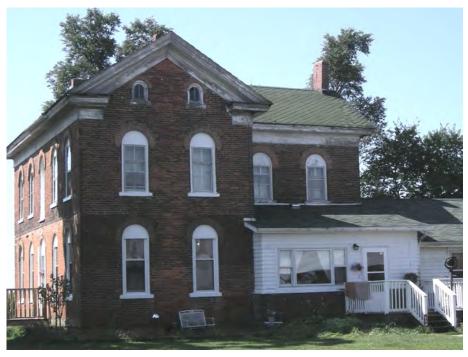
The top photo is of a vernacular "composite" house with some Greek Revival elements. The primary style characteristics of this house include the wide band of trim with turned cornices in the gable.

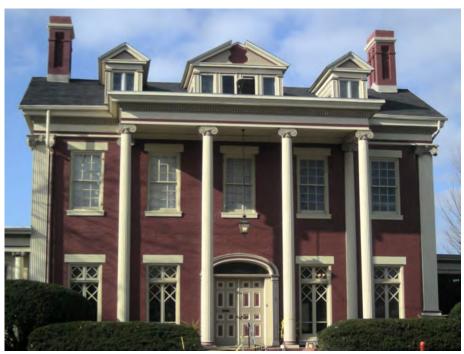
The bottom photo is of a house that exemplifies the Neoclassical style. Note the wide band of trim below the roofline and the accentuated pilasters at the corners. This house also shows a full-height porch supported by classical columns.

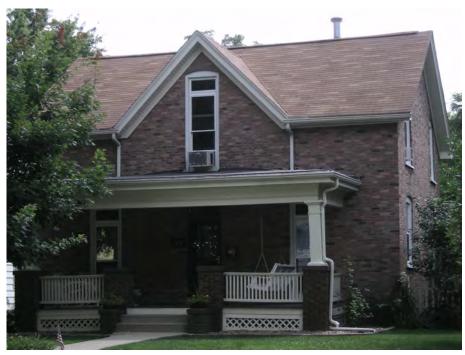
The top photo shows an example of a vernacular Gothic Revival house. Note the steeply pitched side-gabled roof with a central cross gable. The center window is tall, narrow, and extends into the cross gable. The porch is a later addition built in the early 20th century.

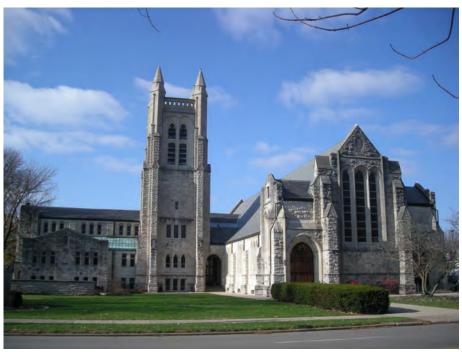
The bottom photo is of a Gothic Revival church. It is reminiscent of the Gothic churches in Europe, where the style originated. The building has the characteristic pointed Gothic windows, rusticated stone, and the tower has parapets.

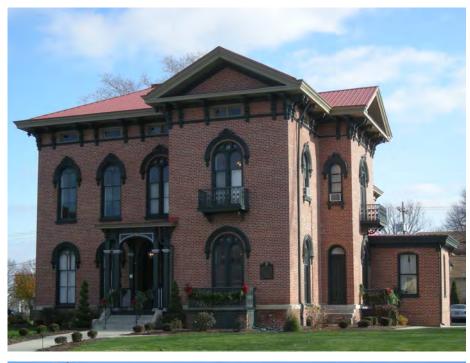
The top photo shows a two-story Italianate house. The pitch of the roof is low with widely overhanging eaves supported by large brackets. The windows are tall, narrow, and rounded at the top. Inverted U-shaped hoods decorate the tops of the windows.

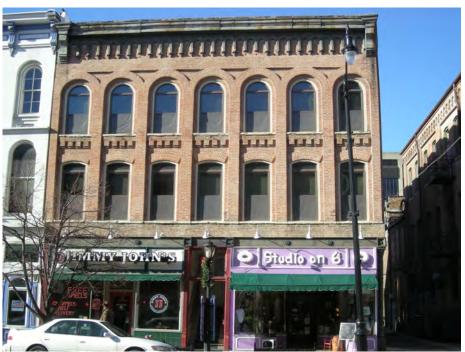
The bottom photo is of a Italianate commercial building. The building has a flat roof with an emphasized cornice. Mock brackets made by protruding bricks are under the cornice. The windows are tall and narrow with curved tops. The second story windows have brick hoods over them.

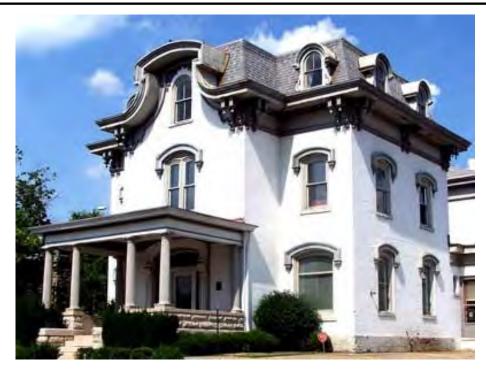
The top photo shows a three-story Second Empire house. The mansard roof has widely overhanging eaves above decorative brackets. The windows have rounded tops covered by decorative hoods. Dormers are present on the steep lower slope of the roof.

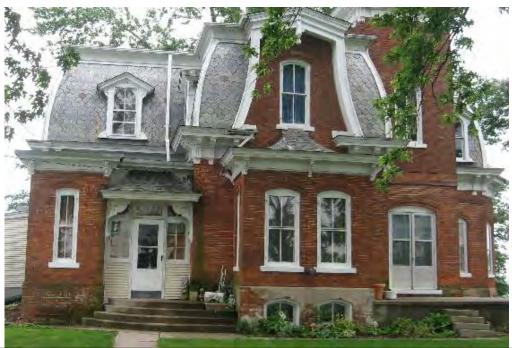
The bottom photo is of a Second Empire house where the main focal point of the building is the patterned mansard roof. Heavy molded cornices bind the top and bottom of the lower slope of the roof. Decorative brackets are beneath the overhanging eaves. The windows are tall, narrow, and have curved tops. Subtle hoods created in the brick pattern cover the windows.

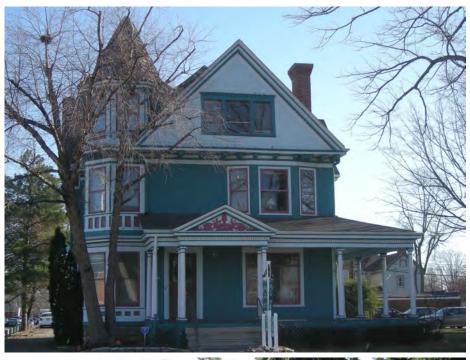
The top photo shows a Queen Anne house that illustrates many of the features of the style. It has a steeply pitched roof with a front facing gable. Flat wall surfaces are minimized by a number of elements: bay windows, the tower with patterned trim, and decorative shingles in the gables. A one-story porch spreads across the front of the house and wraps around the side wall.

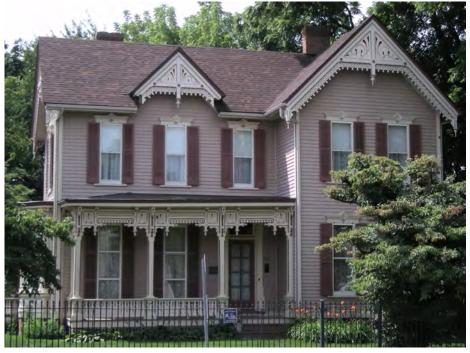
The bottom photo is of a house with Queen Anne detailing. The decorative woodwork in the gables and the porch illustrate the Queen Anne influence on this building. Other influences, such as Italianate (the windows) are also evident.

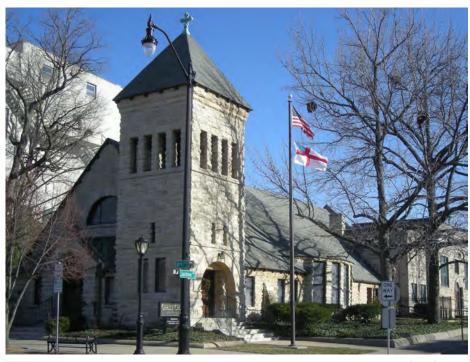
The top photo shows a church that displays several Richardsonian Romanesque characteristics. The walls are comprised of rough-cut or "rusticated" squared stone. The entrance and the window above the entrance have rounded tops. The façade is asymmetrical with a tower.

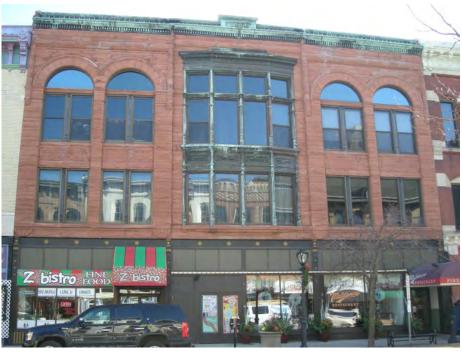
The bottom photo is of a Richardsonian Romanesque commercial building. The façade is rusticated stone. The windows are topped with round arches. Unlike many Richardsonian Romanesque structures the façade on the building is symmetrical and has copper accents.

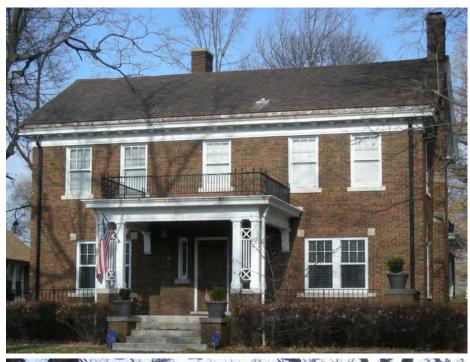
The top photo shows a two-story Colonial Revival house. The front door is accentuated by the front porch. Sidelights flank the door. The windows are symmetrically balanced with the first floor windows in adjacent pairs. The glazing in the windows are in a multi-pane configuration in the top sash.

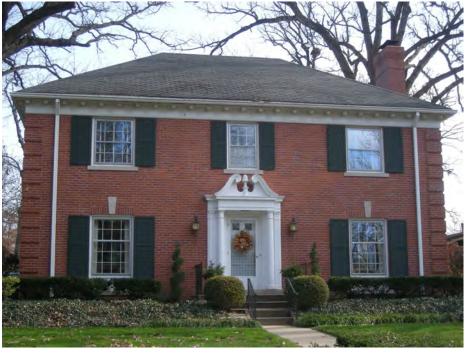
The bottom photo is of a house that is also a two-story Colonial Revival. A pediment supported by pilasters accentuates the front door. The windows are symmetrically placed with multi-pane glazing in both sashes.

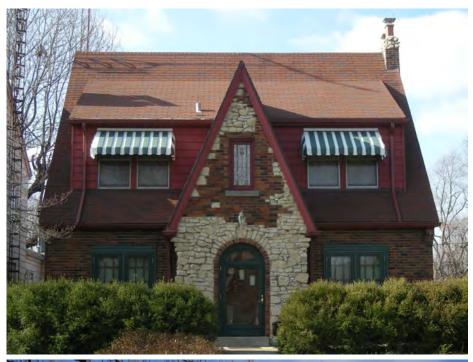
The top photo shows a Tudor Revival house with a steeply pitched side-gabled roof and a front facing steeply pitched gable entrance. The gable and first floor windows are tall and narrow with the first floor windows in groups. The entrance façade has a combination of brick and rusticated stone. The chimney is crowned with a decorative chimney pot.

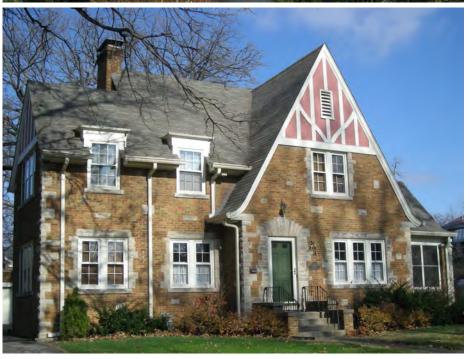
The bottom photo is of another Tudor Revival house showing the characteristic side-gabled roof with a prominent cross gable. Note the decorative half-timbering in the peaks of the gables. The windows are tall, narrow, multi-paned, and grouped. The brick façade has rusticated stone strewn throughout it and on the corners where the walls meet.

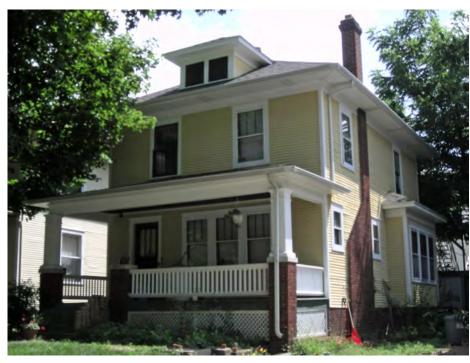
The top photo shows a two-story Foursquare house with a pyramidal roof and overhanging eaves. A dormer projects from the center of the roof above the façade. The house has roughly a square floor plan and a full-width front porch. The porch is supported by columns atop pedestals.

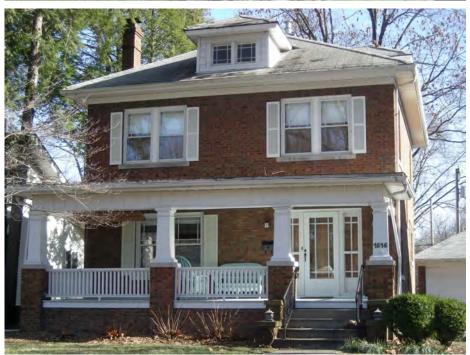
The bottom photo is of a Foursquare house with the characteristic two stories and pyramidal roof. Dormers are present on the front and side roof slopes. The house has a square floor plan with a full-width front porch supported by columns atop pedestals.

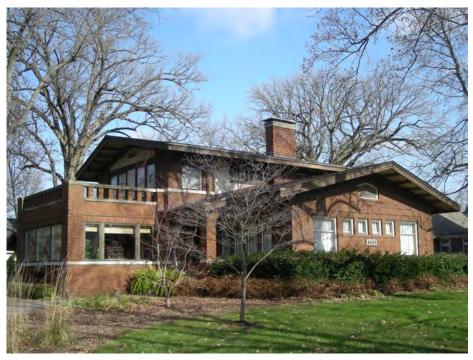
The top photo shows a Prairie style house with low-pitched gable roofs. There are several one-story wings and porches coming off of the main mass of the house. The low pitches of the roof lines and the façade detailing emphasize the horizontal. The enclosed porch is supported by heavy square elements.

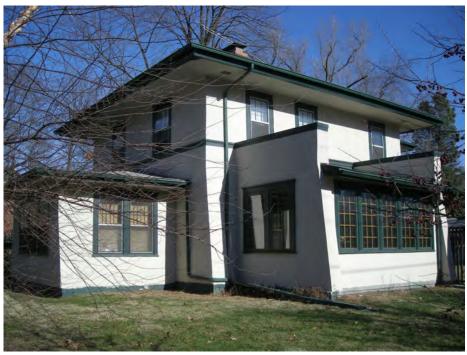
The bottom photo is of a Prairie style house with a deeply overhanging low hipped roof. The mass of the house is two stories with one-story wings. The horizontality is emphasized by the façade details, roof lines, and bands of windows.

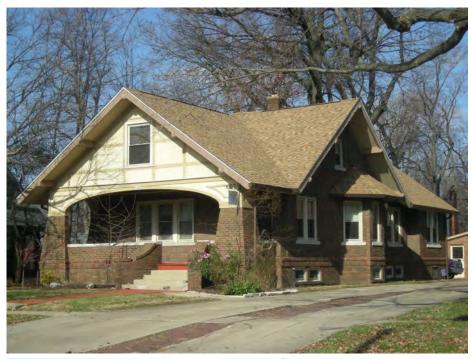
The top photo shows a Craftsman bungalow with a lowpitched roof and eave overhangs. Decorative beams are located under the gables. The house has a full-width porch supported by tapered square columns that do not break at the porch floor level.

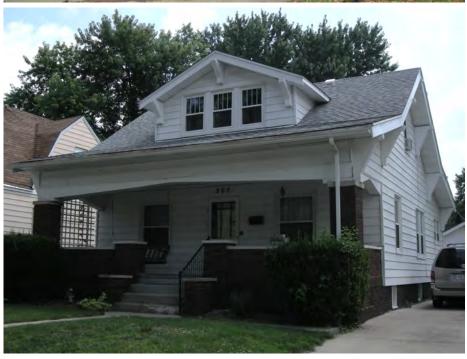
The bottom photo is of a "shed roof" Craftsman bungalow. The house has a side gable with a large front dormer. Simple brackets are located under the overhanging eaves of the gables. A full-width porch is supported by square columns that do not break at the porch level. The shed roof bungalow was very popular and variations of this subtype are common.

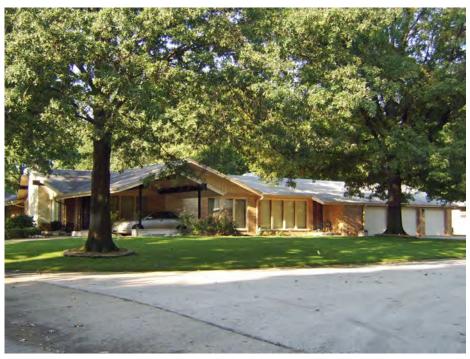
The top photo shows a Ranch house with a low-pitched gable roof. It has moderate overhanging eaves above bands of windows. The carport and changes in wall depth creates an asymmetrical façade. The house is clad in a brick veneer with stone veneer and siding accents. A garage is attached to the house.

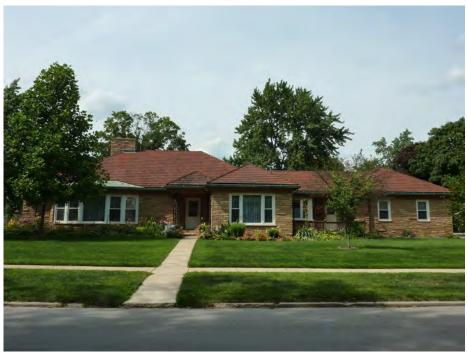
The bottom photo is of a Ranch house with a moderatelypitched hipped roof with wide overhanging eaves. The asymmetrical façade is emphasized by a bay window and changes in the wall depth. Decorative iron elements support the porch roof over the front door.

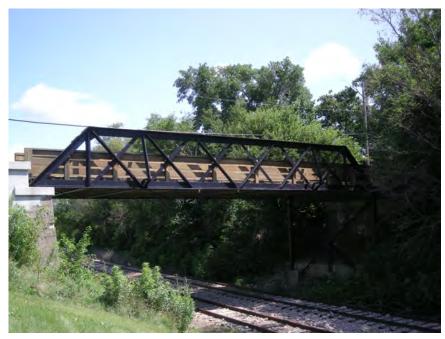
Steel Truss, Quadrangular Warren bridge

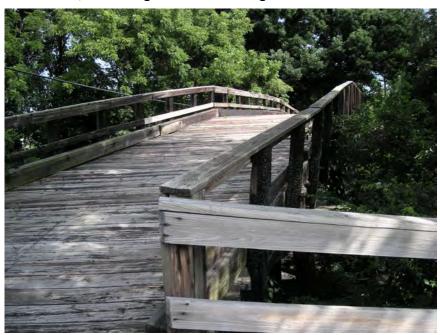
Timber Stringer bridge
