**EXPERIMENTAL EVALUATION OF  
FULL DEPTH  
PRECAST/PRESTRESSED CONCRETE  
BRIDGE DECK PANELS**

**Project IB-H1, FY 98**

Report No. ITRC FR 98-5

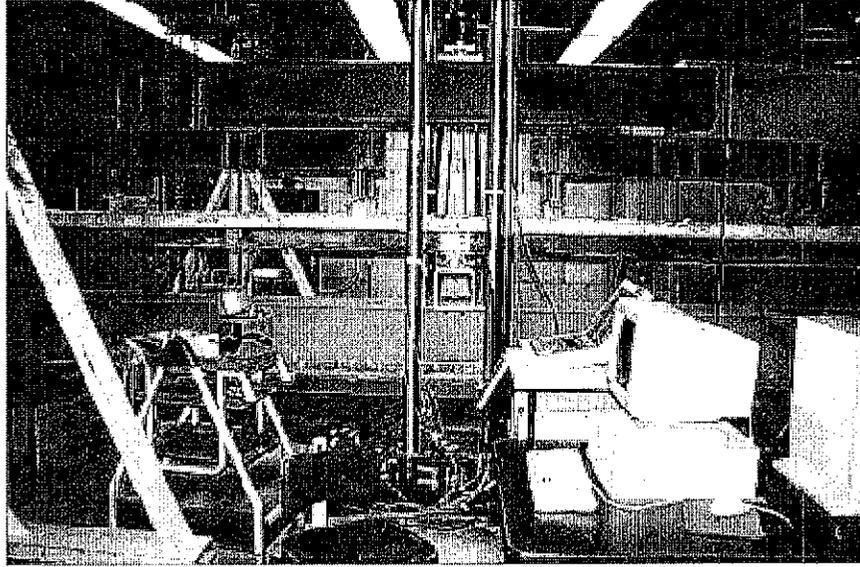
Fig. 2.1 Quarter-scale HS20 truck loading beams

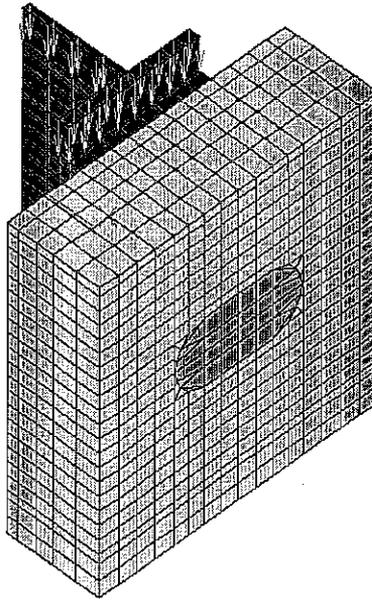
Fig. 3.1 Mesh generation for single pocket configuration

Two configurations of the shear connection test were modeled as shown in Figs. 3.1 and 3.2 using finite element analysis software ALGOR. The mesh generation depicting one pocket and two pockets are shown in these two figures, respectively. Symmetry was used to model these two configurations, where only half of the beam and one panel are modeled. However, appropriate boundary conditions were imposed on the models to simulate exact conditions for the full scale configurations. Figs. 3.1 and 3.2 also depict the applied loading on the beam. This loading was distributed on the top of the beam since it is simulating a plate between the applied loading and beam. Separate models were prepared for the beam, panel, haunch, pockets, studs, and reinforcing steel since the materials used are different for each component.

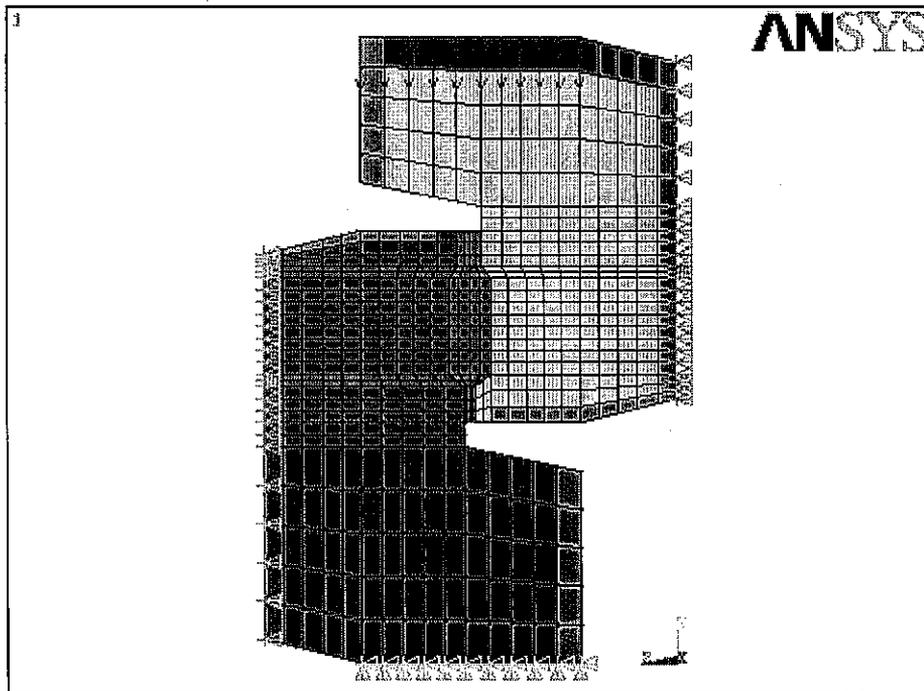
Fig. 3.5 Finite element mesh and boundary conditions

Non-linear finite element analysis was performed for the direct shear test specimen using ANSYS. The main objectives of this analysis was to determine stress distributions and modes of failure for the joint using each of the four types of grouting material, namely, set 45, set 45 hot weather, set grout, and polymer concrete. The exact geometric configuration of the specimen was meshed using SOLID65 elements which are brick elements capable of depicting the nonlinear behavior of concrete and its failure in cracking or crushing. A maximum element size of 1 in. was adopted for the discretization of the model, and a full Newton-Raphson algorithm was employed to trace the solution path. The bottom flange of the specimen was restrained against translational motion and load was applied on the top flange of the specimen as shown in Fig. 3.5. Lateral movement of the two slabs was also restrained to prevent bending.

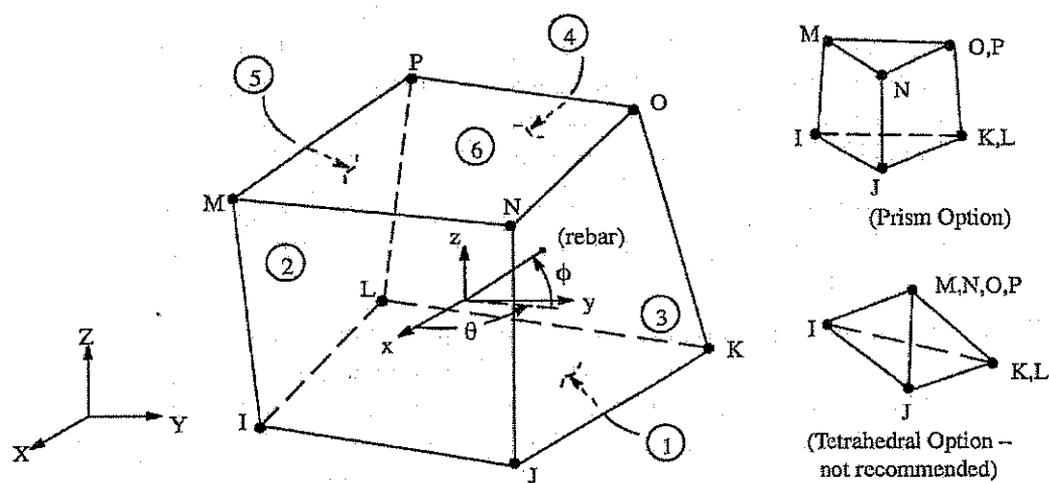
Fig. 3.6 SOLID65 (3-D reinforced concrete solid)

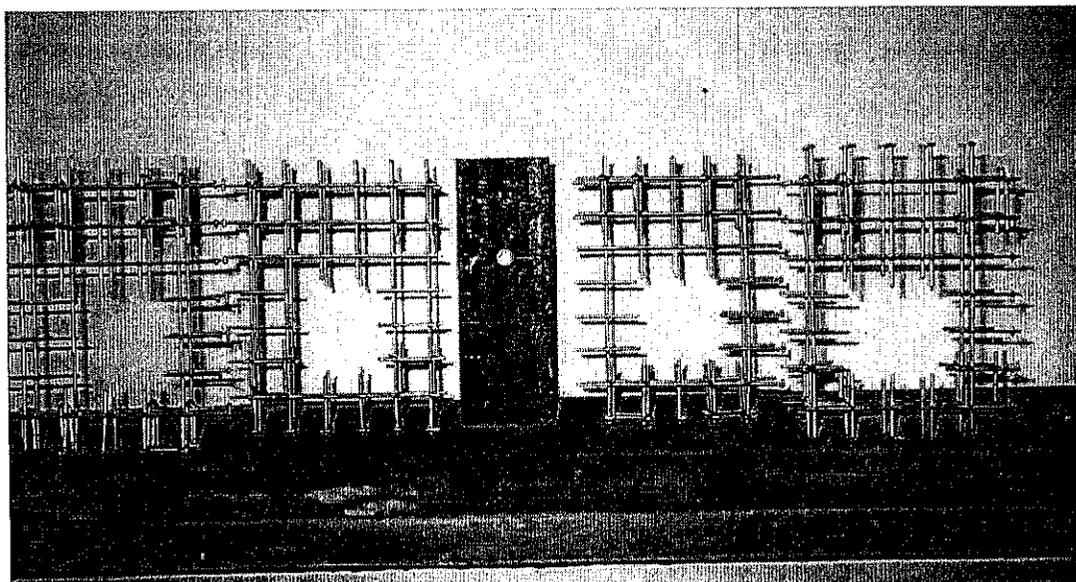
Fig. 4.15 Steel wire mesh, 25 x 25 mm

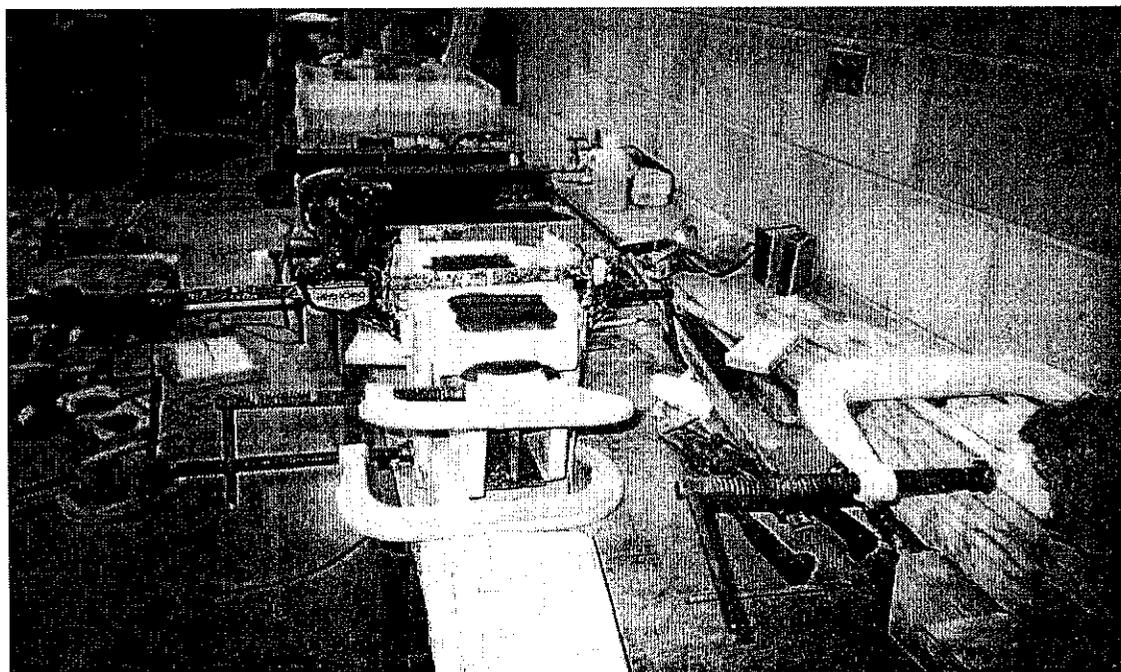
Fig. 4.16 Pocket pouring

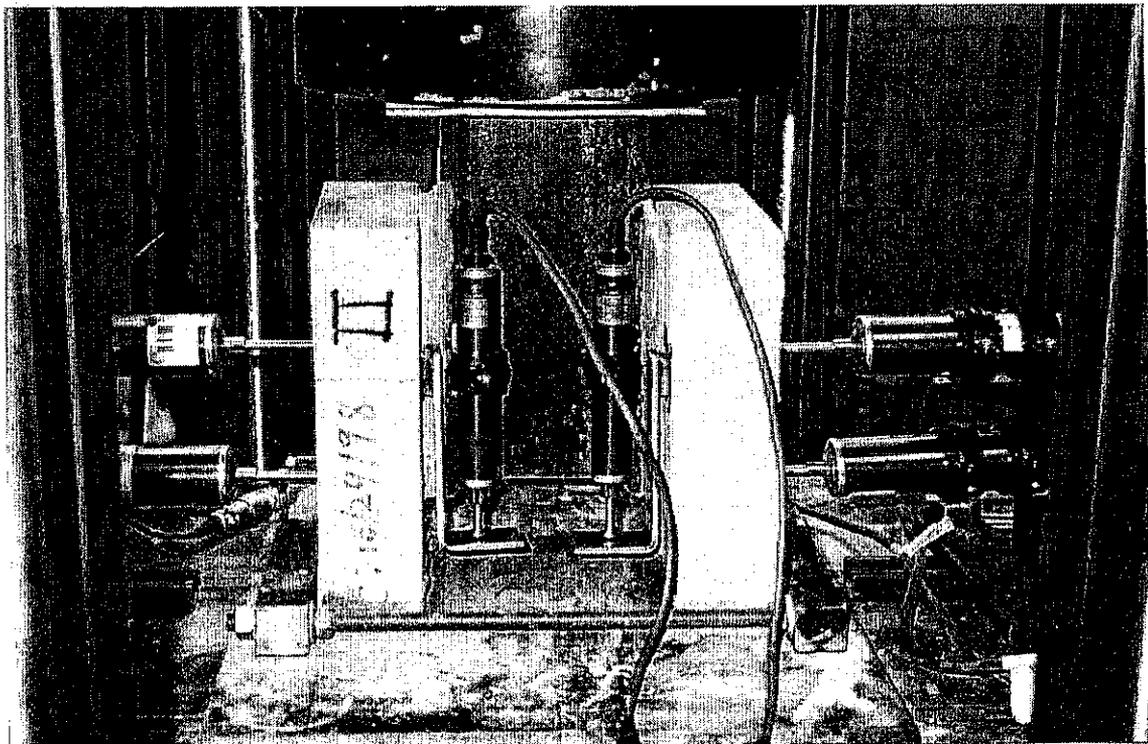
Fig. 4.19 Slip instrumentation for one-pocket specimen

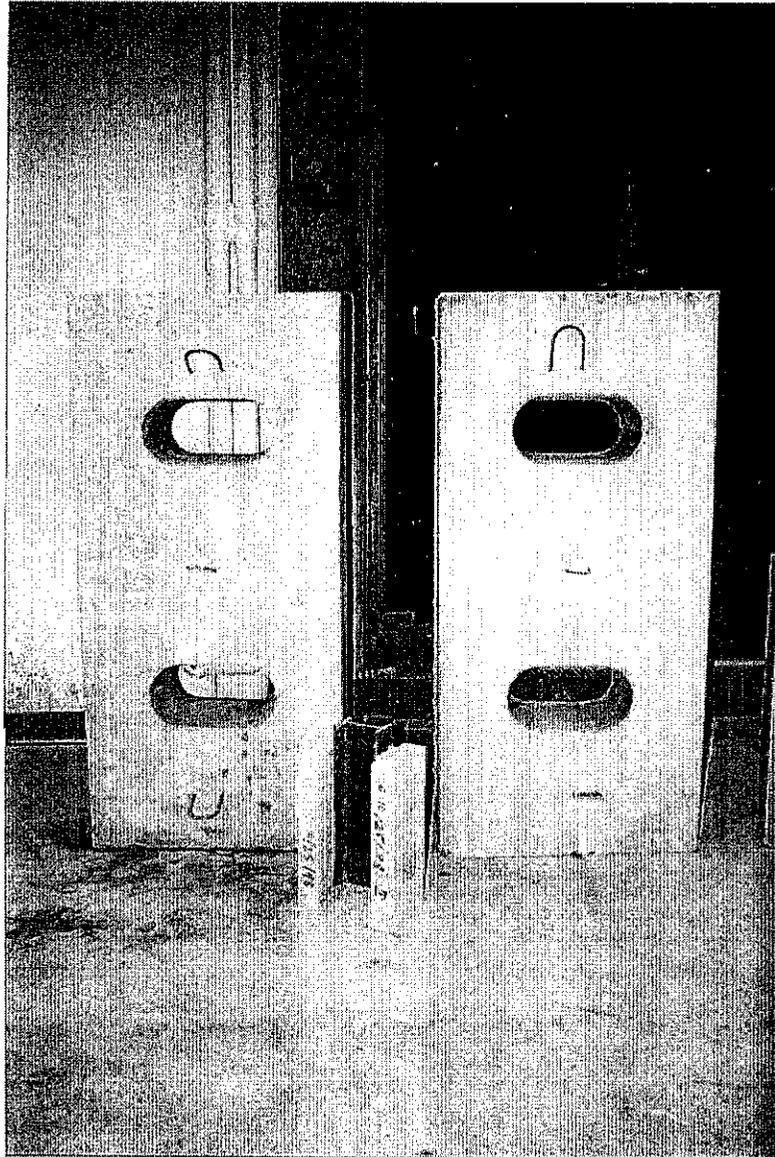
Fig. 4.26 Full-scale panel configuration for two-pocket specimen

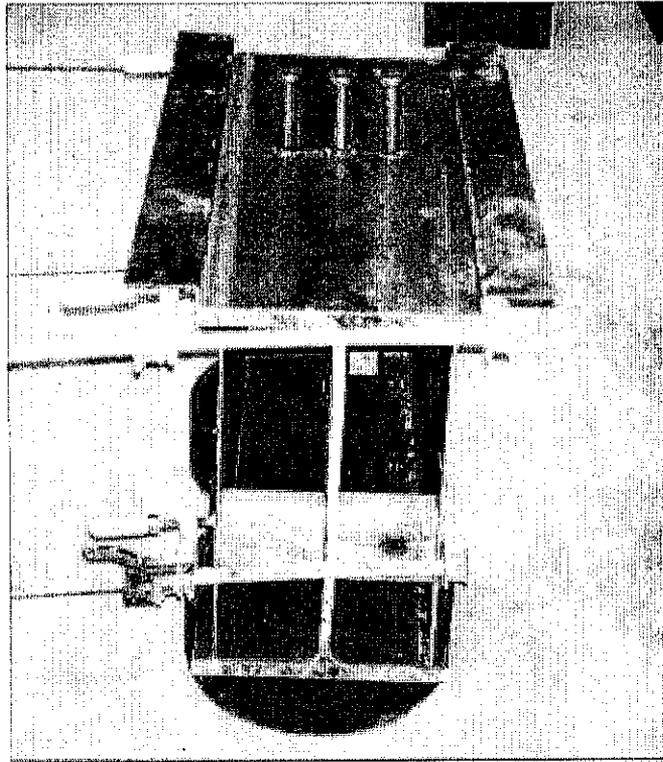
Fig. 4.27 Steel forming used to create haunch

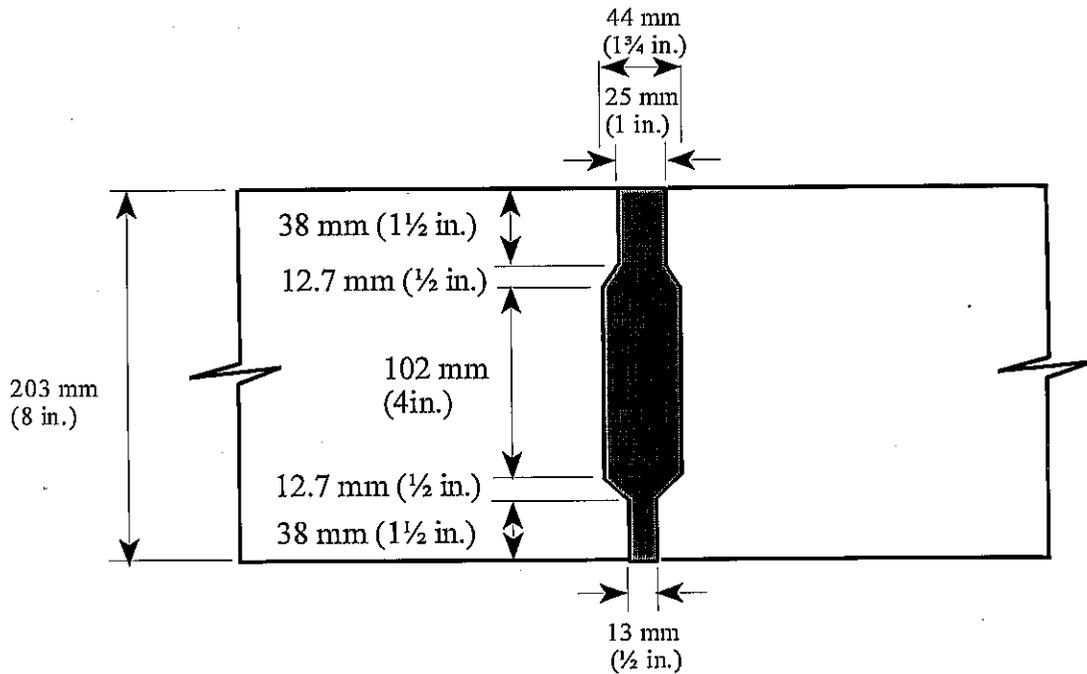
Fig. 4.30 Typical female to female type joint between precast panels

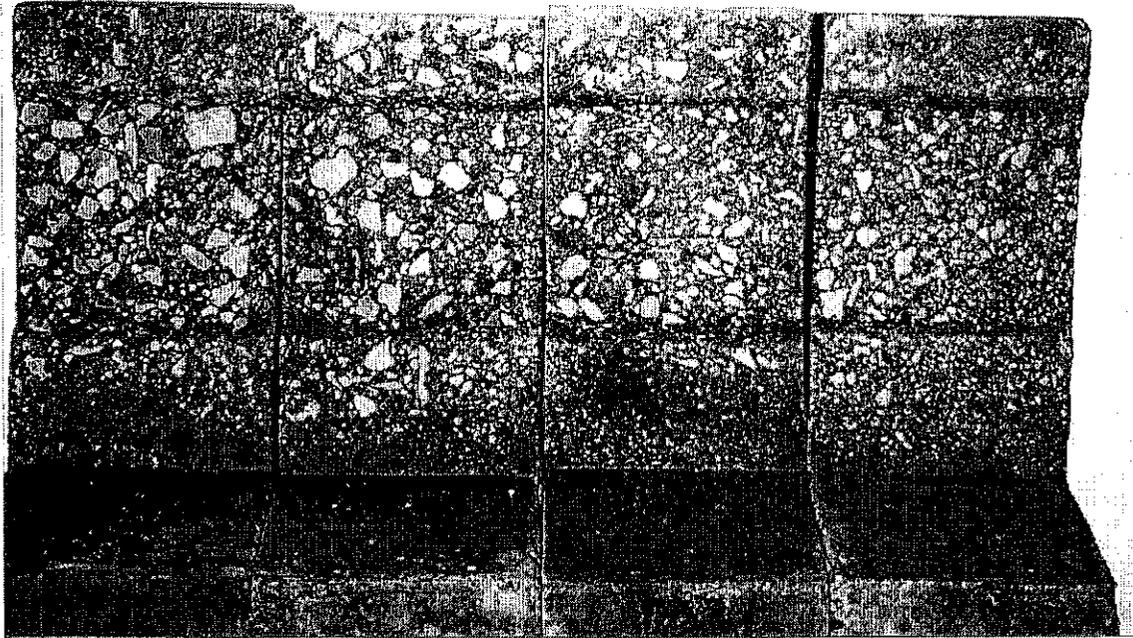
Fig. 4.31 Direct shear test specimen with sandblasted surface

The specimens were designed in order to transfer the load to the joint in such a manner so that the joint experienced only shear forces. The final specimen configuration and test setup is shown on Fig. 4.9(a). The load was applied on a spread area of  $290 \text{ cm}^2$  ( $45 \text{ in.}^2$ ) and the resultant of the load acted exactly at the center. As a result, the load transferred into the joint, forcing the joint to fail in shear. In the shear test, a lead plate was placed on the top and bottom to secure a uniform distribution of the load. The load rate used was  $0.25 \text{ mm/min}$  ( $0.01 \text{ in./min}$ ).

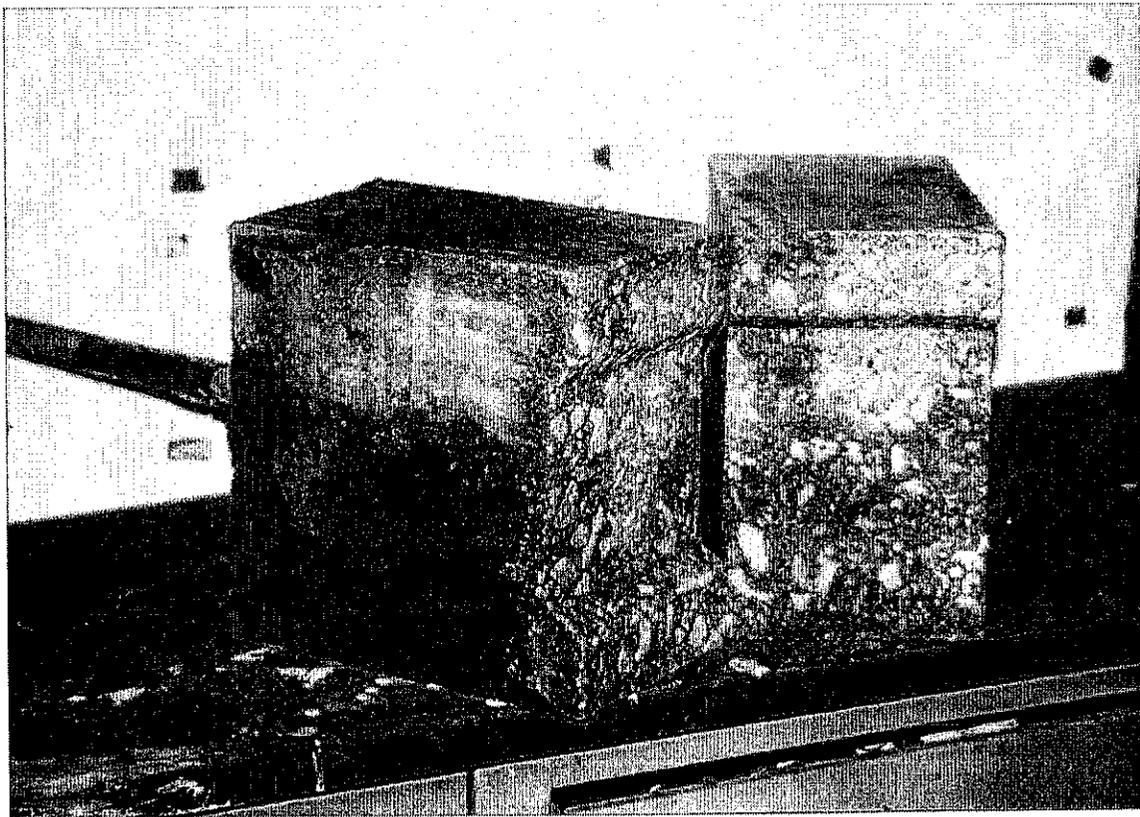
Fig. 4.34 Direct tensile test specimen with sandblasted surface

The tests were performed on three specimens for each type of material. All specimens were moist cured for a period of 28 days and sandblasted prior to jointing as shown in Fig. 4.34. The transverse section of the tensile specimen was  $258 \text{ cm}^2$  (40 in.<sup>2</sup>). A No. 5 steel rebar was cast inside of a block of concrete 203 mm (8 in.) high, providing sufficient area to anchor the load. A cross shape was added, 51 mm (2 in.) from the end (steel rebar No. 5 (102 mm (4 in.) long)). A second specimen was fabricated using No. 4 steel rebar without the cross shape. In the second specimen, a length of 203 mm (8 in.) anchor into a concrete specimen 229 mm (9 in.) high, was satisfactory. The load was transferred to the specimen using the same fixture used in the rebar tensile tests, which consisted of gripping the ends of the rebars to the cross head and applying tension forces as shown in Fig. 4.35. The specimen was tested in a load control mode.

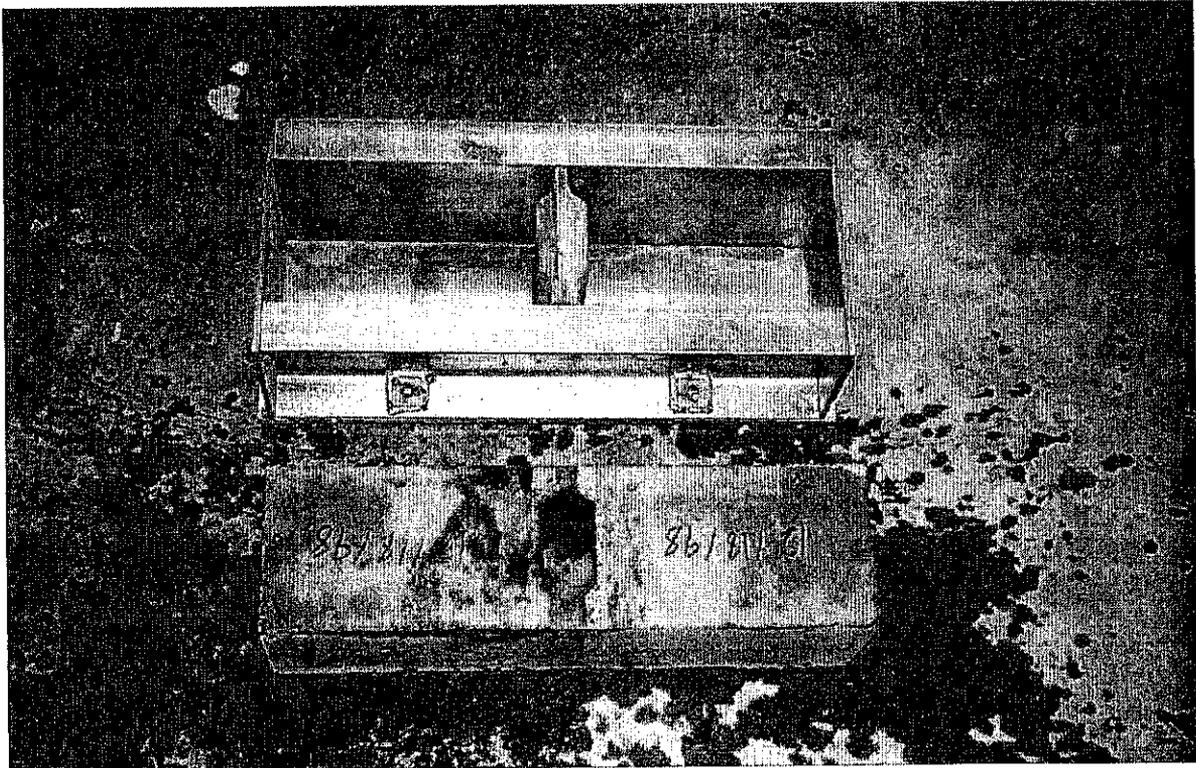
Fig. 4.36 Specimen configuration for flexural testing

The flexure test was conducted using the same fixture used in ordinary flexure tests of three-point bending concrete beams. The concrete specimens were submitted to moisture curing for a period of 28 days prior to jointing. The specimens were sandblasted to provide better bond surface. Specimen configuration is presented in Fig. 4.36, while the test setup is shown in Fig. 4.9 (c).

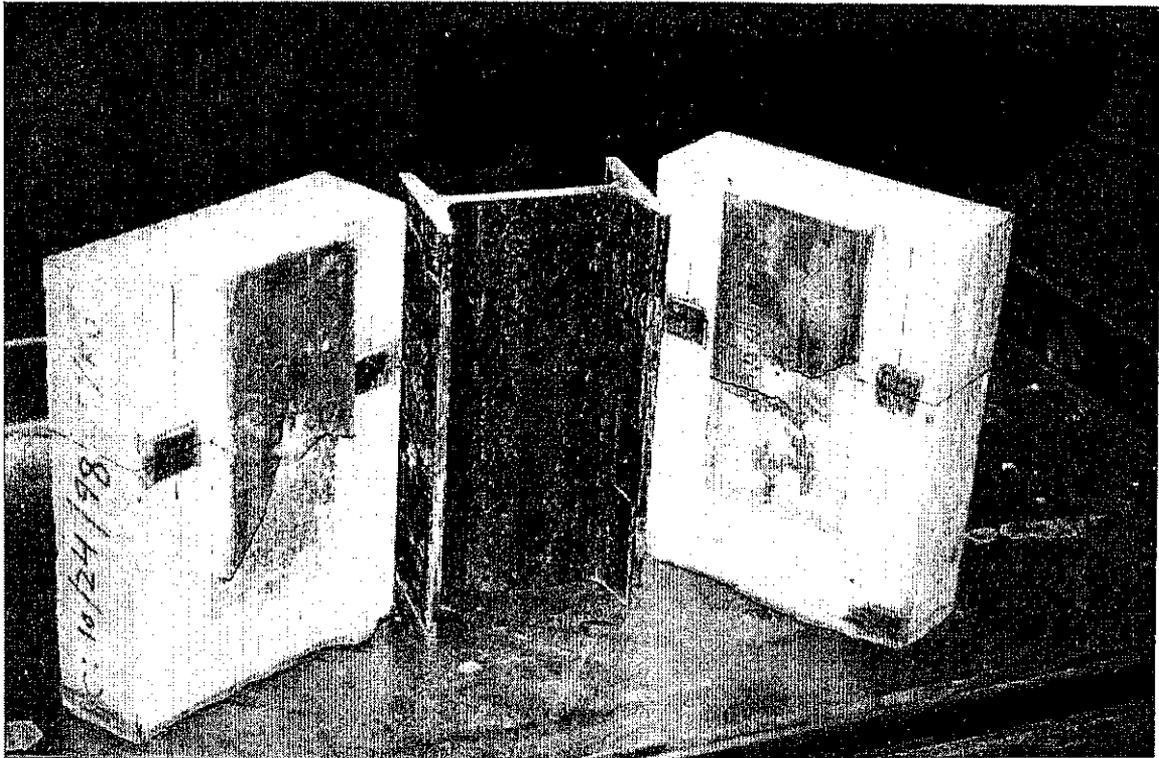
Fig. 5.1 Mode of failure for QS1P1S

In the majority of the specimens, the cracks initiated at the level of the stud, where in principle, the cracks propagated at a 45-degree angle. Stud failures were easy to identify during the test, and overall stud failure occurred after the ultimate load. The mode of failure in all cases occurred at the base of the stud, while all studs failed in shear. The ultimate load was divided by 2 since specimen configuration was symmetric. The test results are shown in Table 5.1. The typical shape of the push-out specimens after failure is shown in Figs. 5.1 and 5.2.

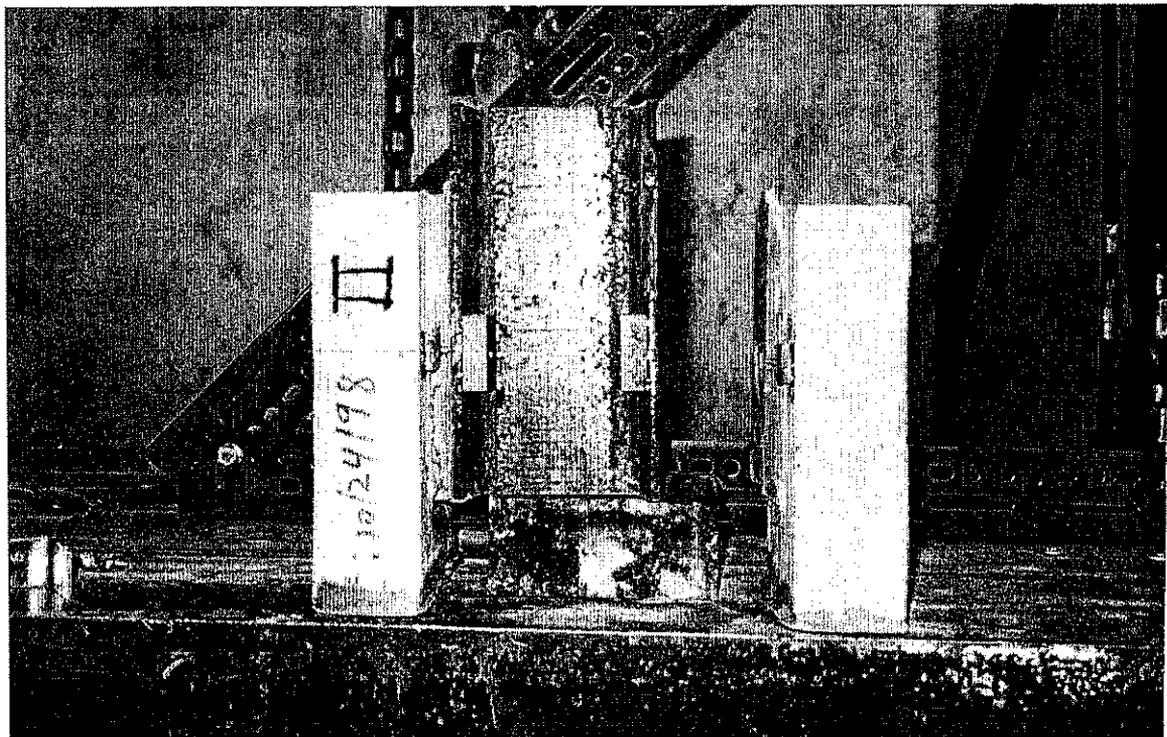
Fig. 5.2 Mode of failure for QS1P2S

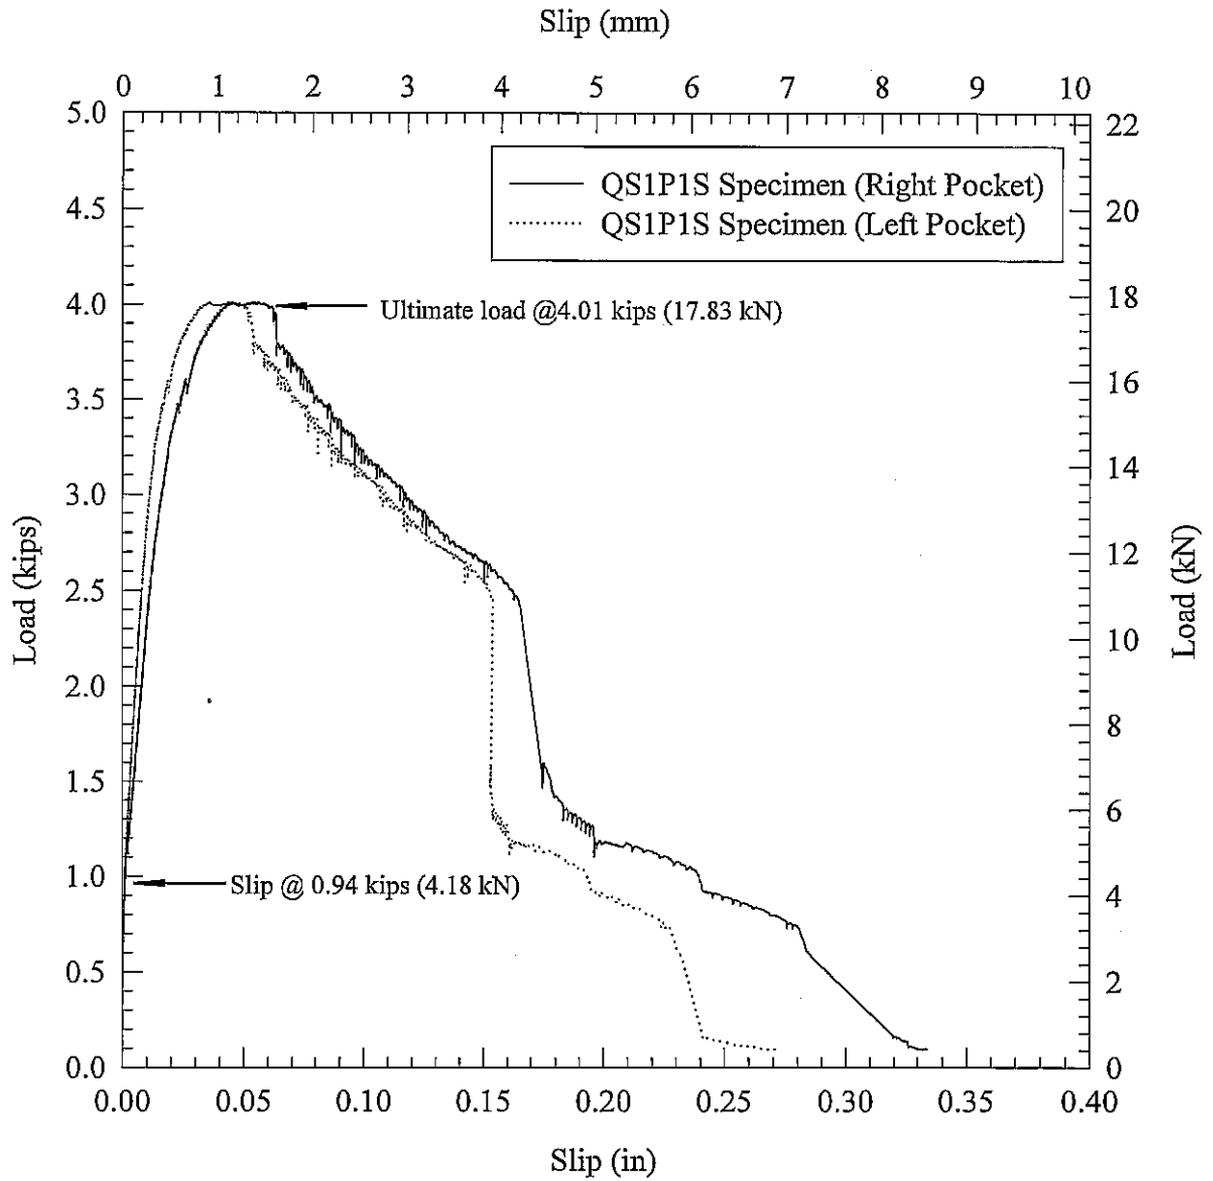
Fig. 5.3 Load-Slip curves for specimen with 1 shear pocket and 1 stud per pocket

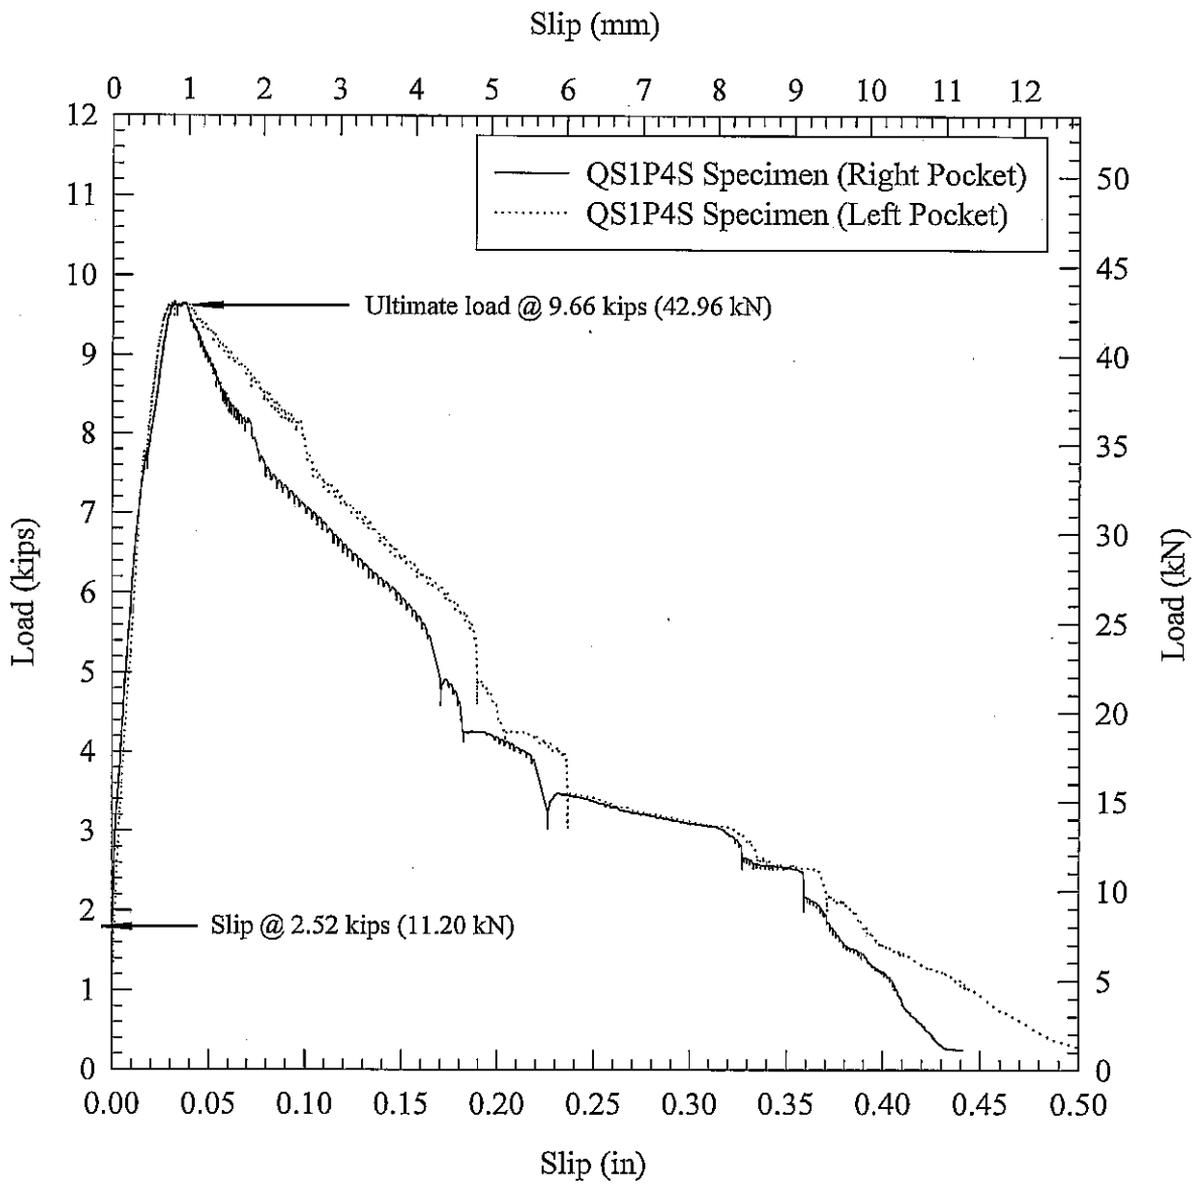
Fig. 5.6 Load-Slip curves for specimen with 1 shear pocket and 4 studs per pocket

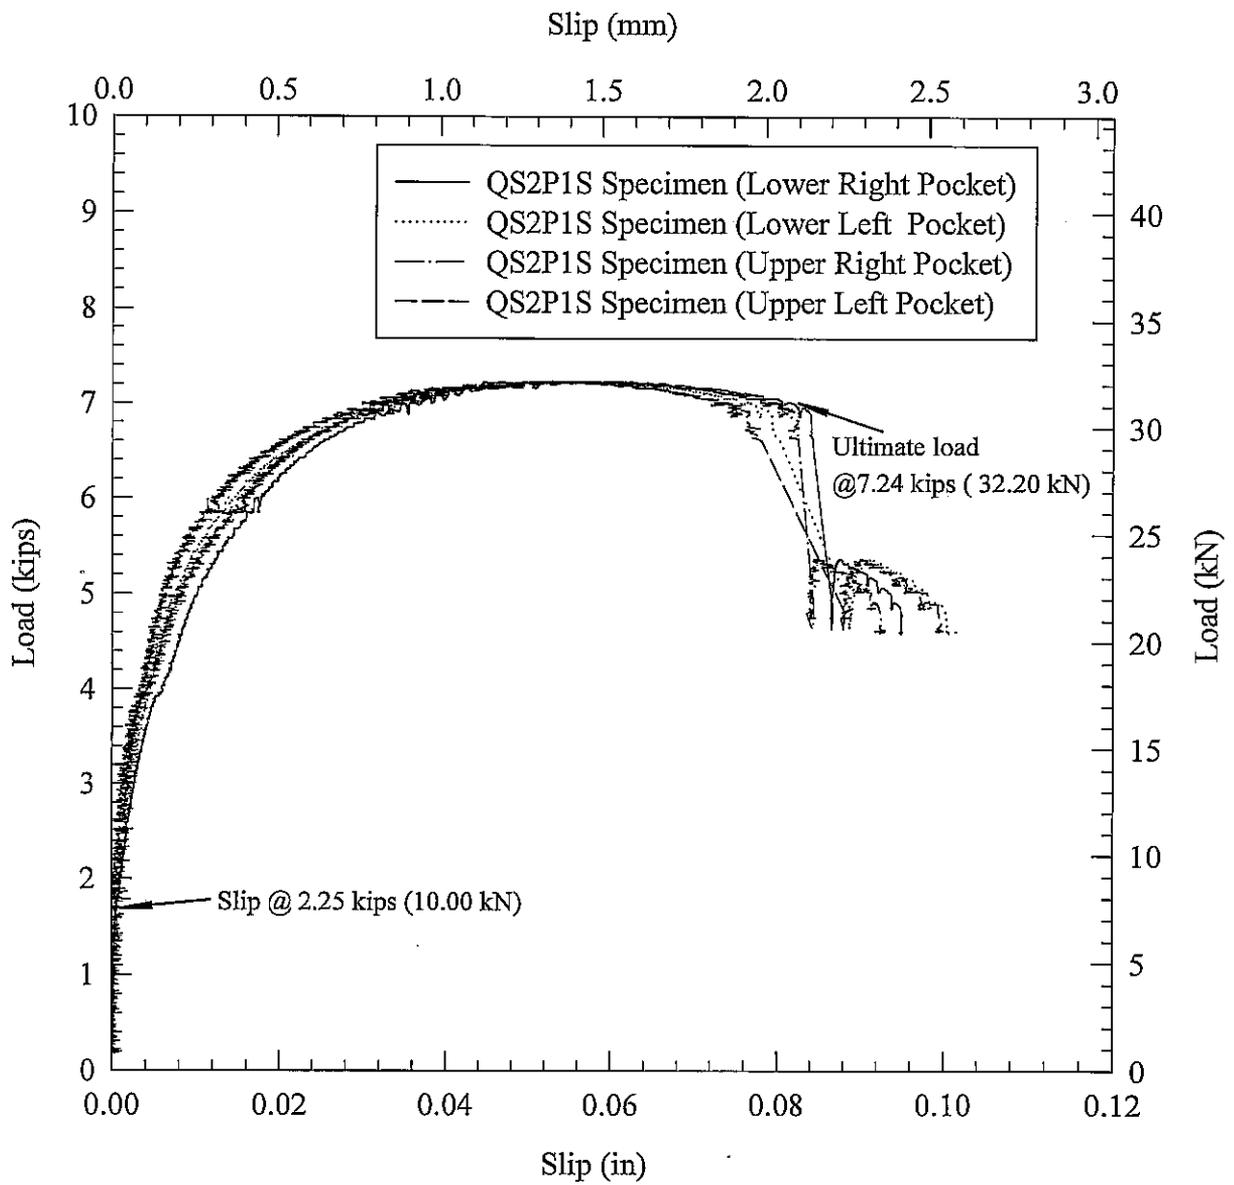
Fig. 5.7 Load-Slip curves for specimen with 2 shear pockets and 1 stud per pocket

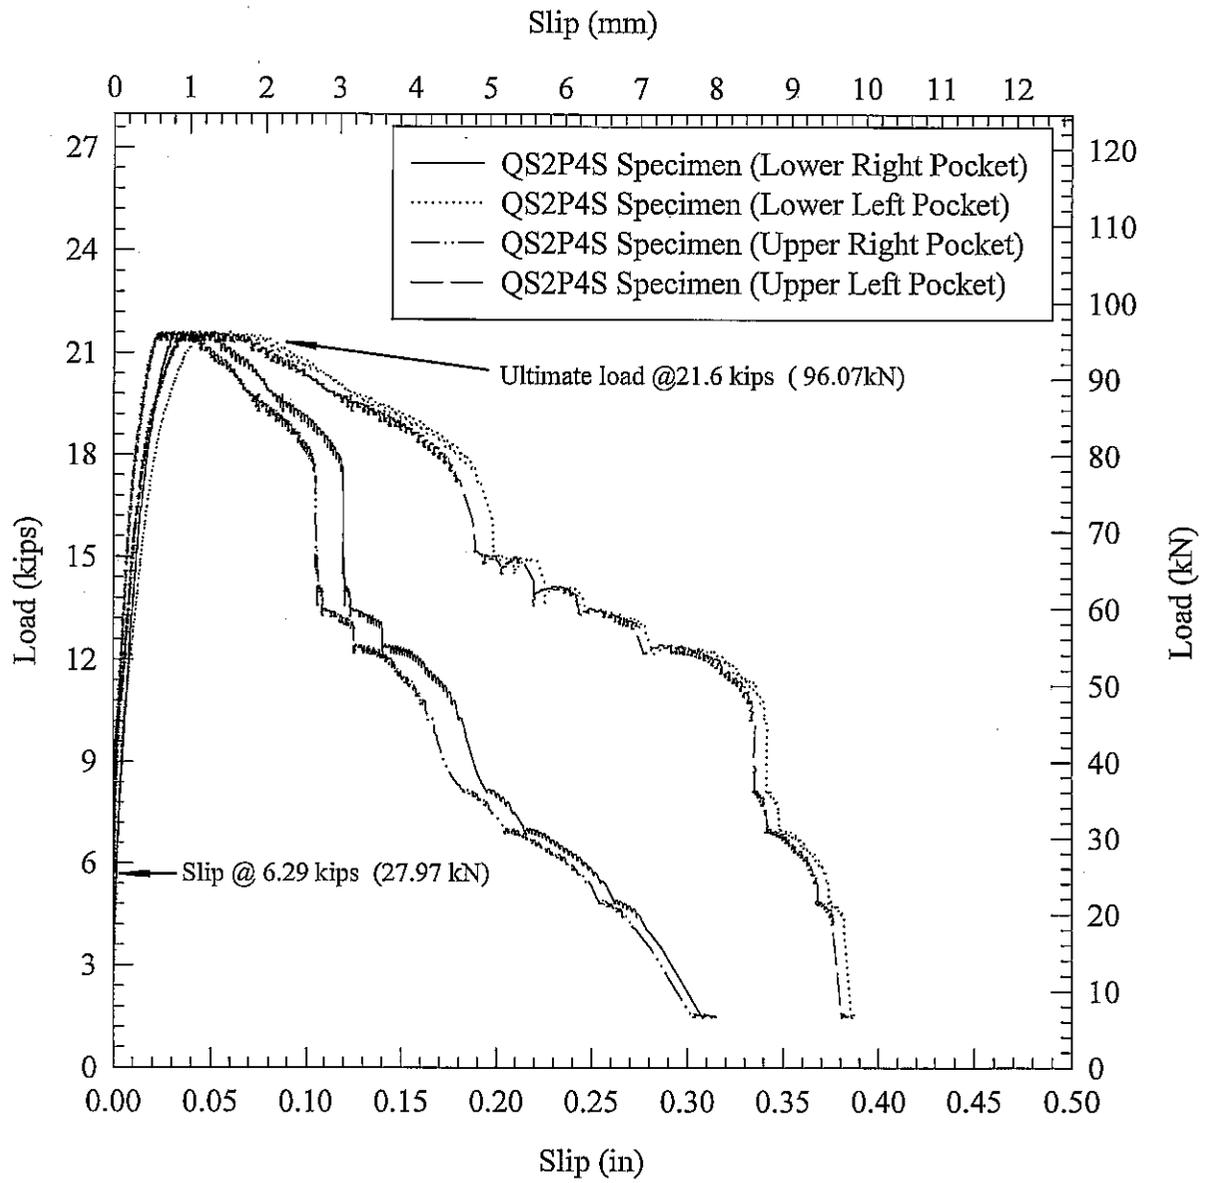
Fig. 5.10 Load-Slip curves for specimen with 2 shear pockets and 4 studs per pocket

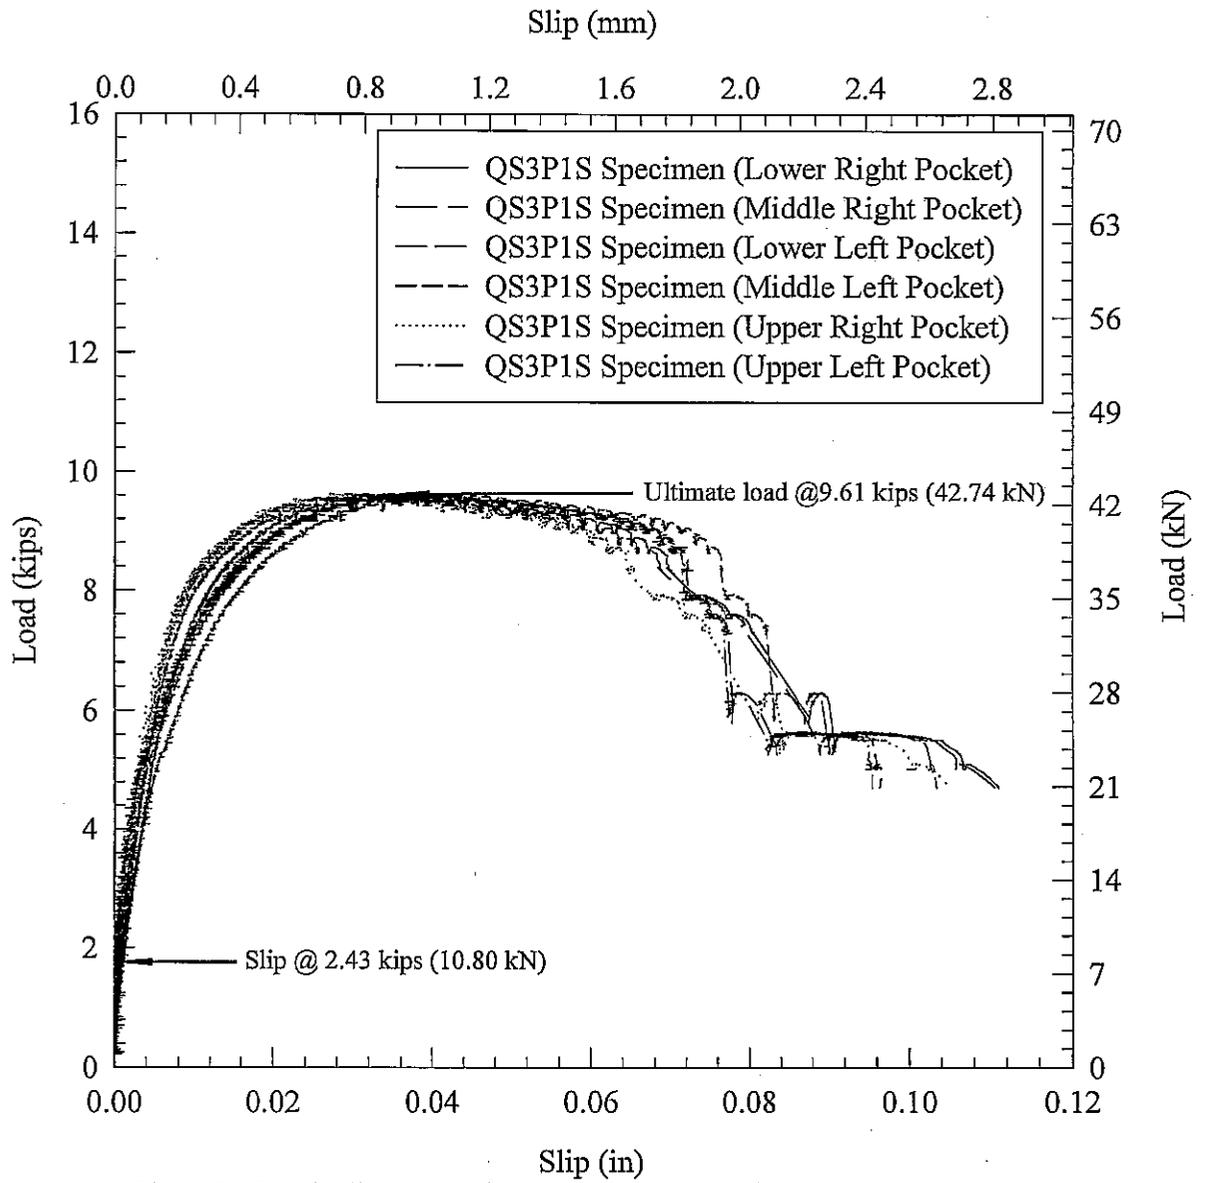
Fig. 5.11 Load-Slip curves for specimen with 3 shear pockets and 1 stud per pocket

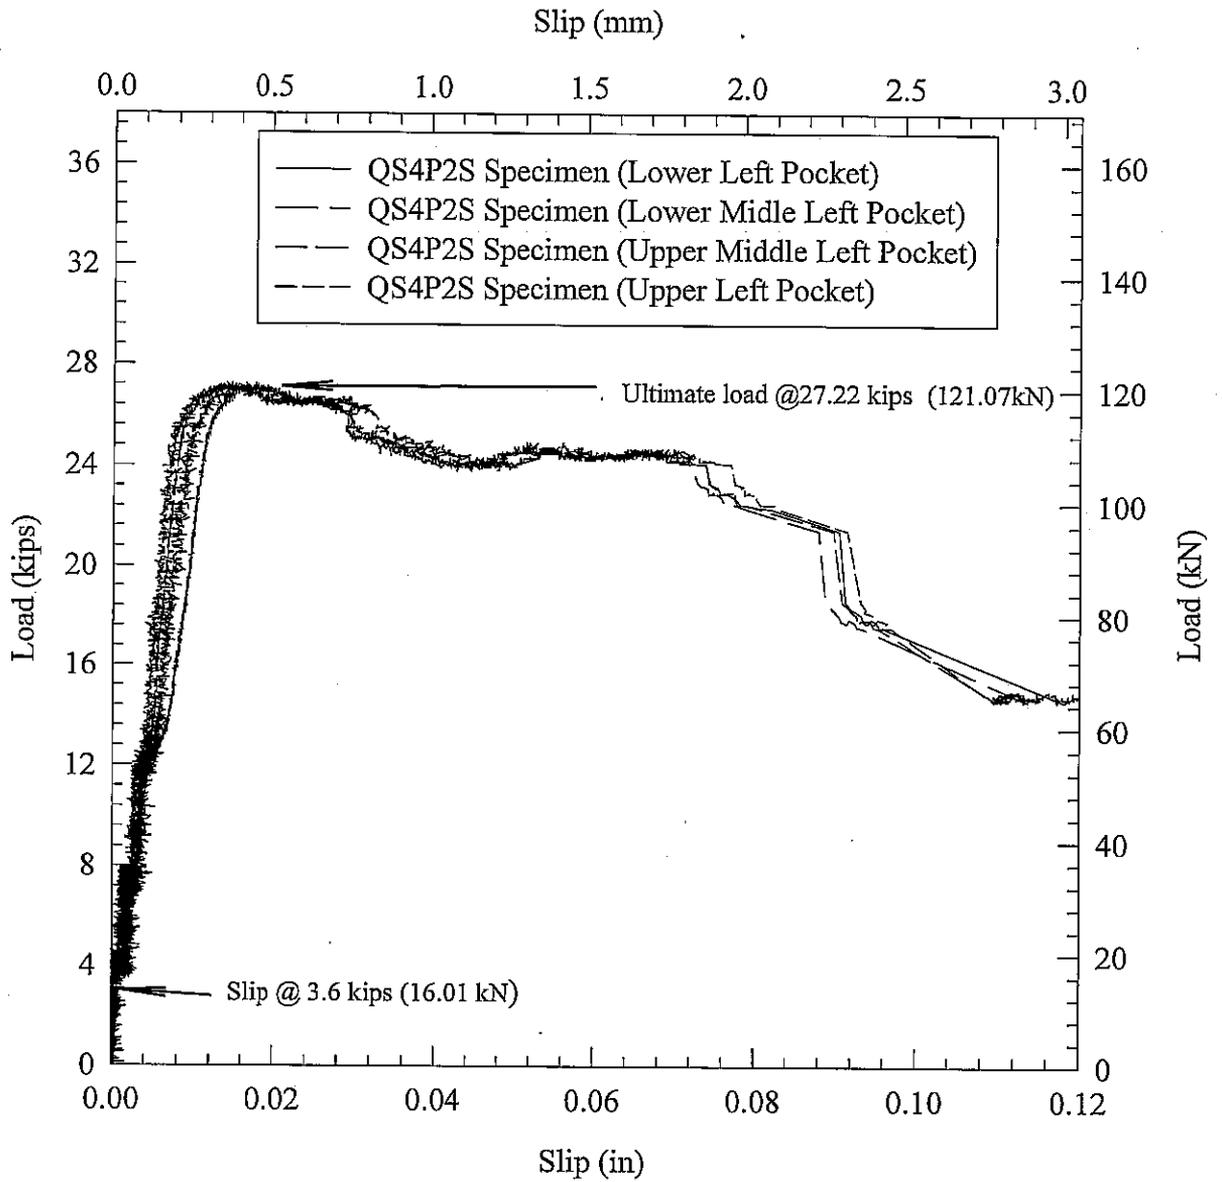
Fig. 5.14 Load Slip curves for specimen with 4 shear pockets and 2 studs per pocket

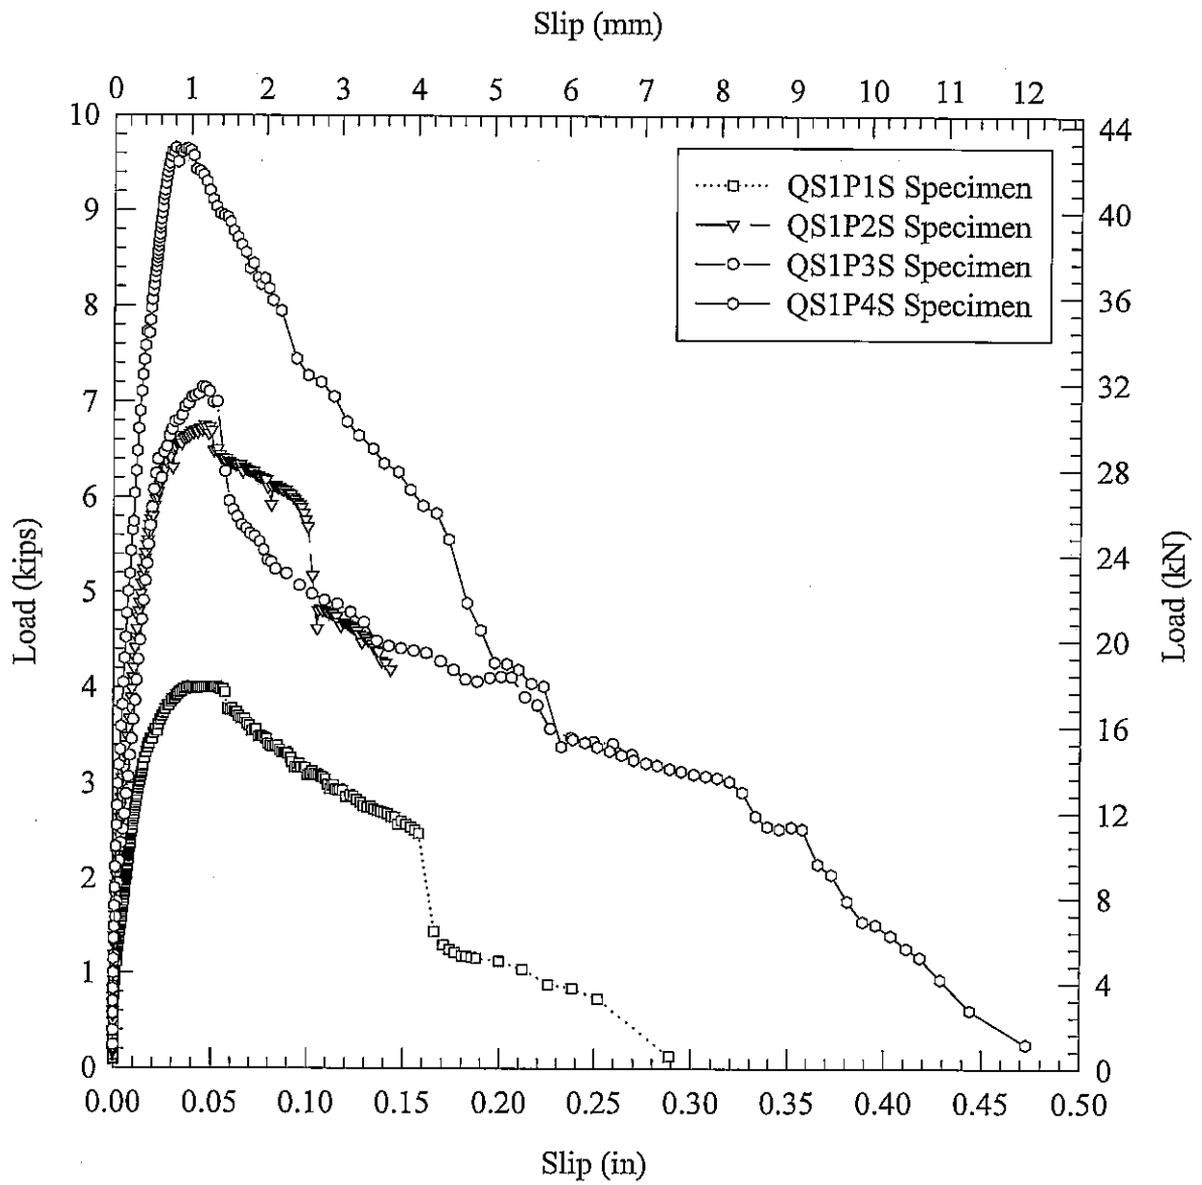
Fig.5.15 Load-Slip curves for specimens with one pocket
