**EXPERIMENTAL EVALUATION OF  
FULL DEPTH  
PRECAST/PRESTRESSED CONCRETE  
BRIDGE DECK PANELS**

**Project IB-H1, FY 98**

Report No. ITRC FR 98-5

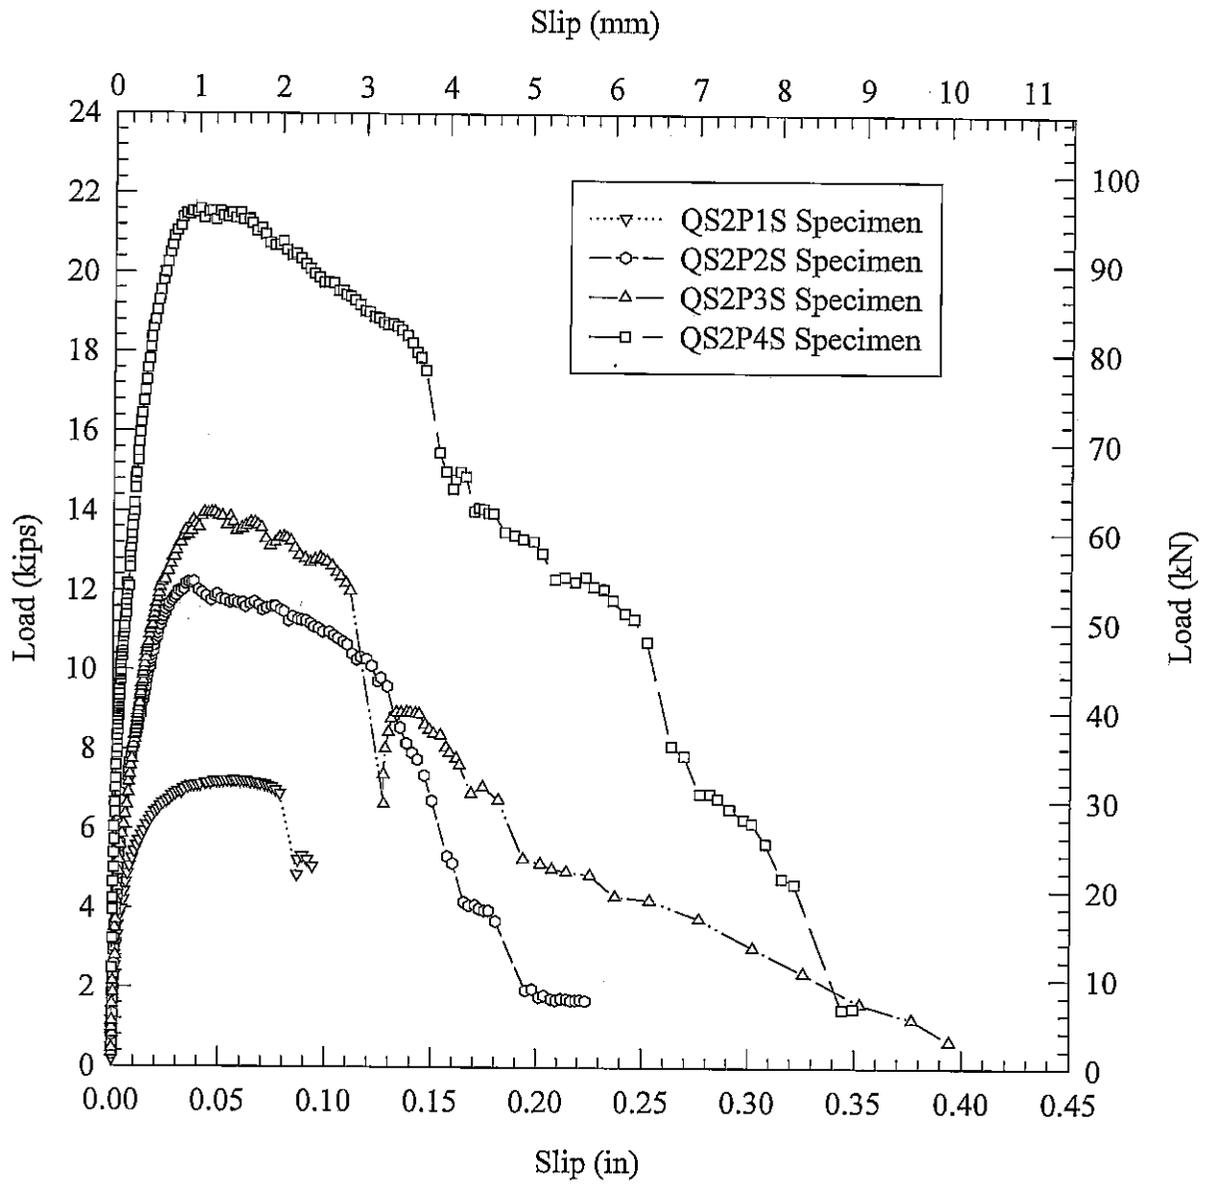
Fig. 5.16 Load-Slip curves for specimens with two pockets

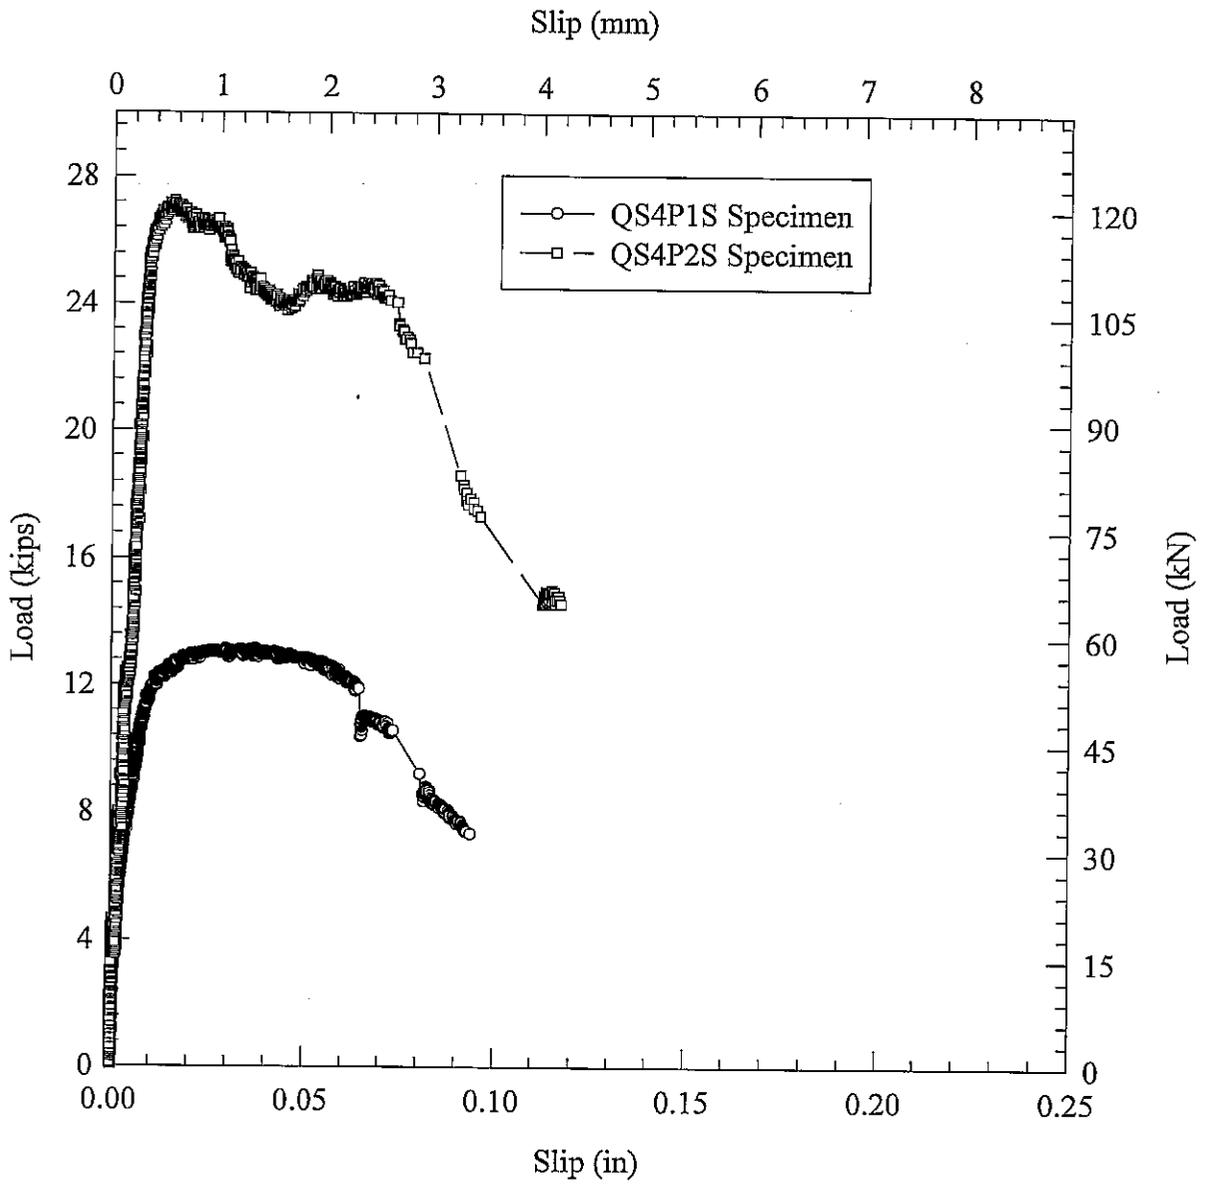
Fig 5.18 Load-Slip curves for specimens with four shear pockets

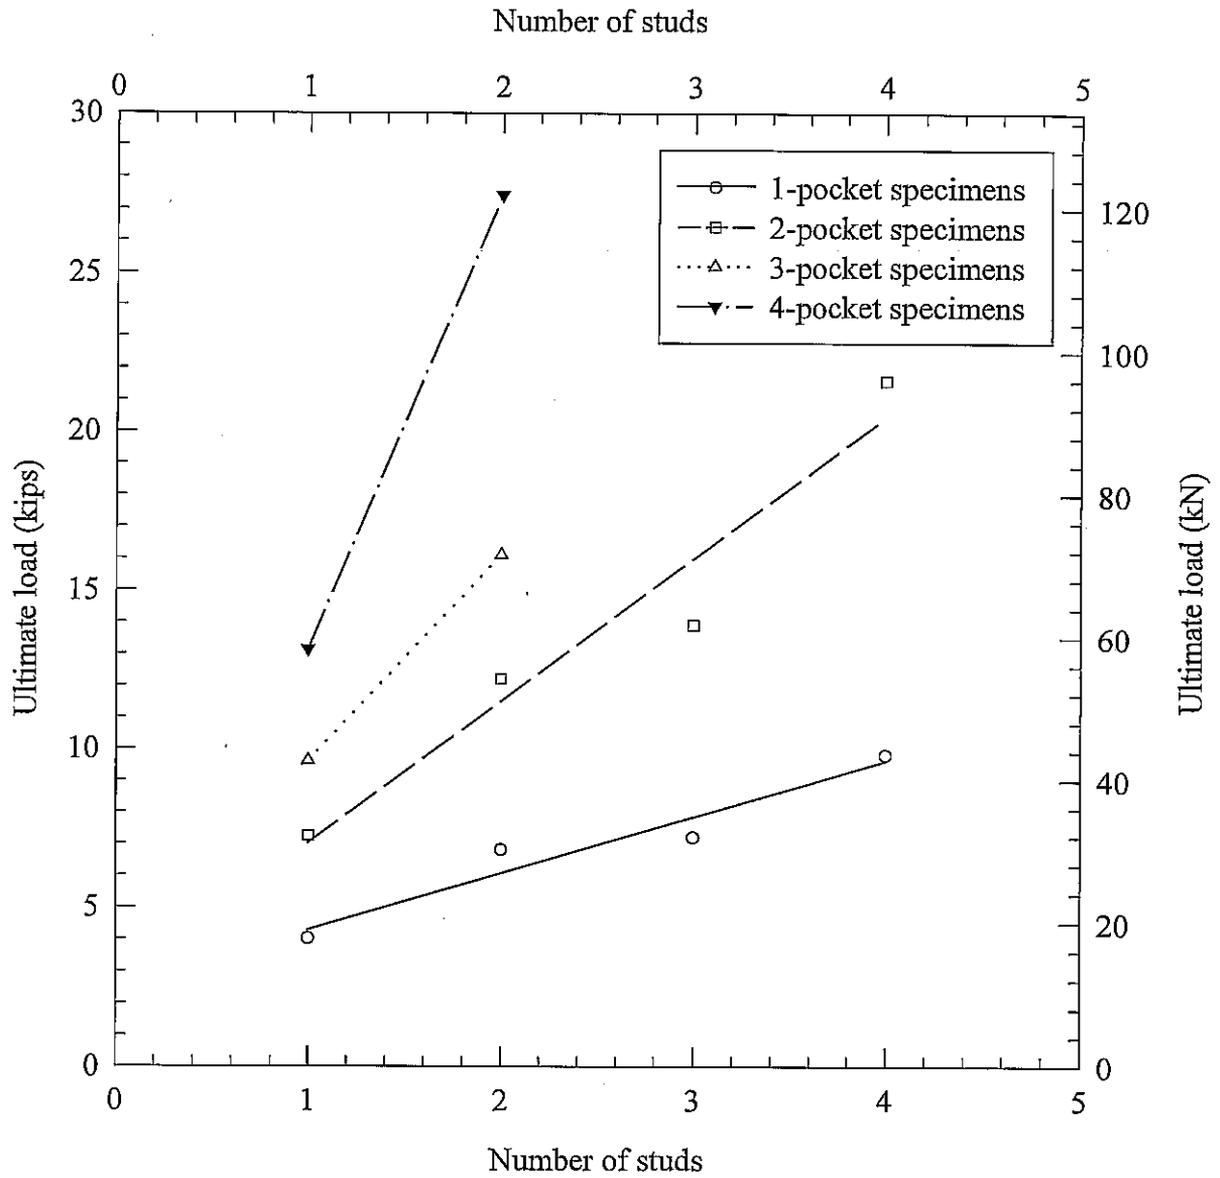
Fig. 5.19 Ultimate load versus number of studs for quarter-scale specimens

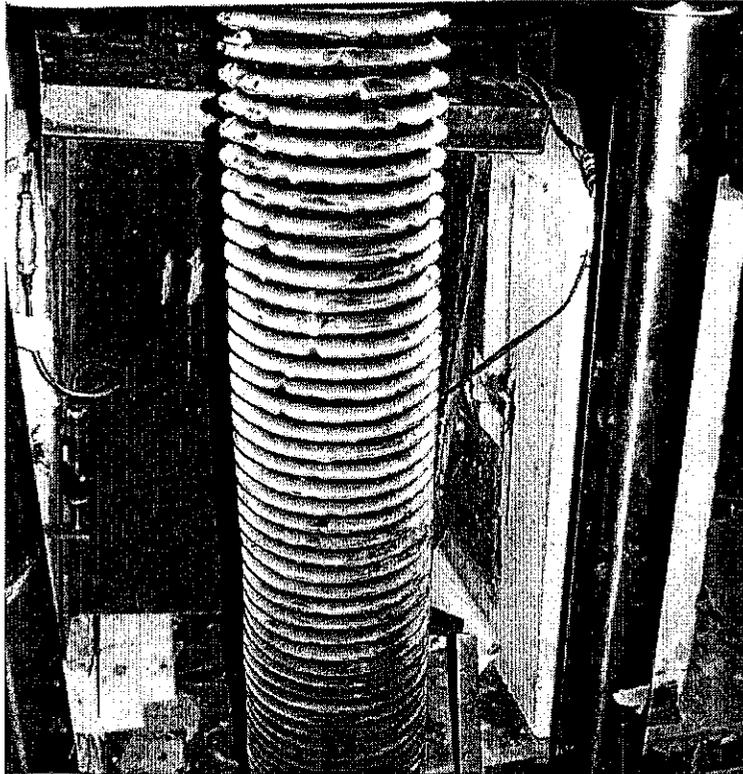
Fig. 5.21 Mode of failure for typical full-scale shear connection specimen

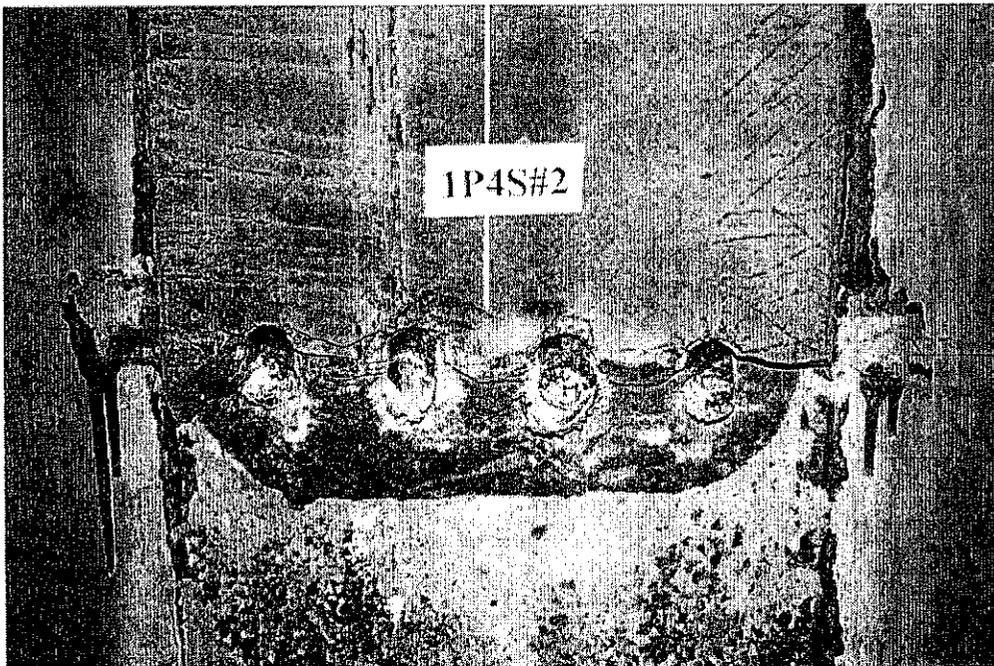
Fig. 5.22 Shearing of studs and the grouting material in typical full-scale specimen

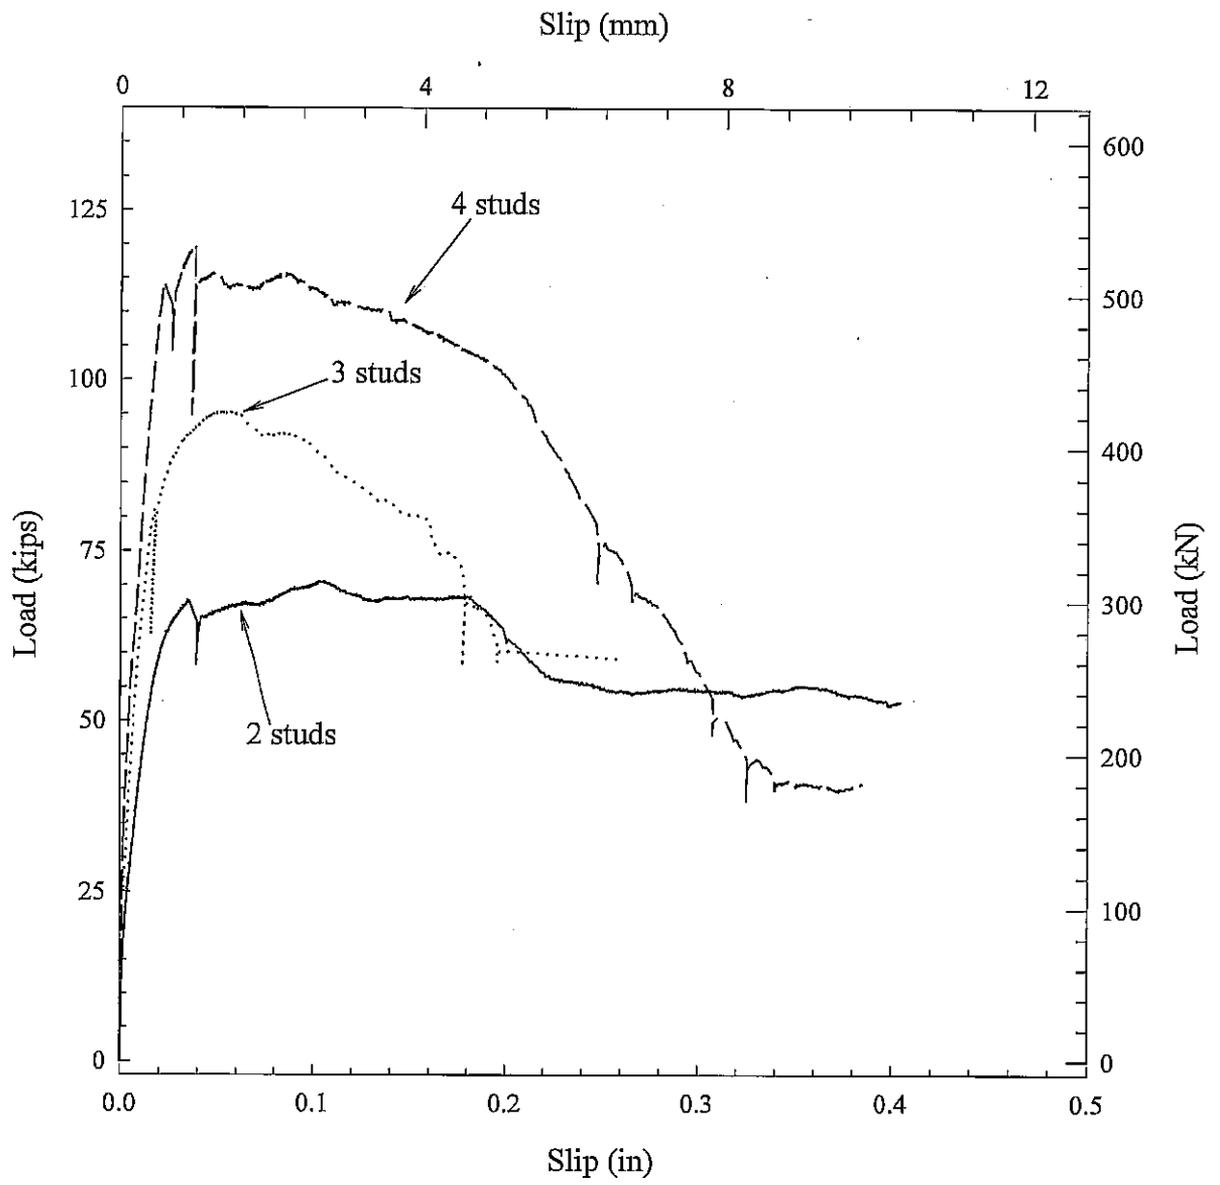
Fig. 5.28 Load-slip behavior for one pocket, various number of studs

Comparison between the different number of studs and load-slip behavior are illustrated in Figs. 5.28 and 5.29 for one and two pockets, respectively. These figures show that there is no direct relationship between the number of studs and load-slip behavior. The ultimate strength increased significantly when the number of studs was increased. Comparison between the number of pockets and load-slip behavior is presented in Figs. 5.30 and 5.31 for 2 and 3 studs, respectively. These figures show a good conformity among specimens with different number of pockets.

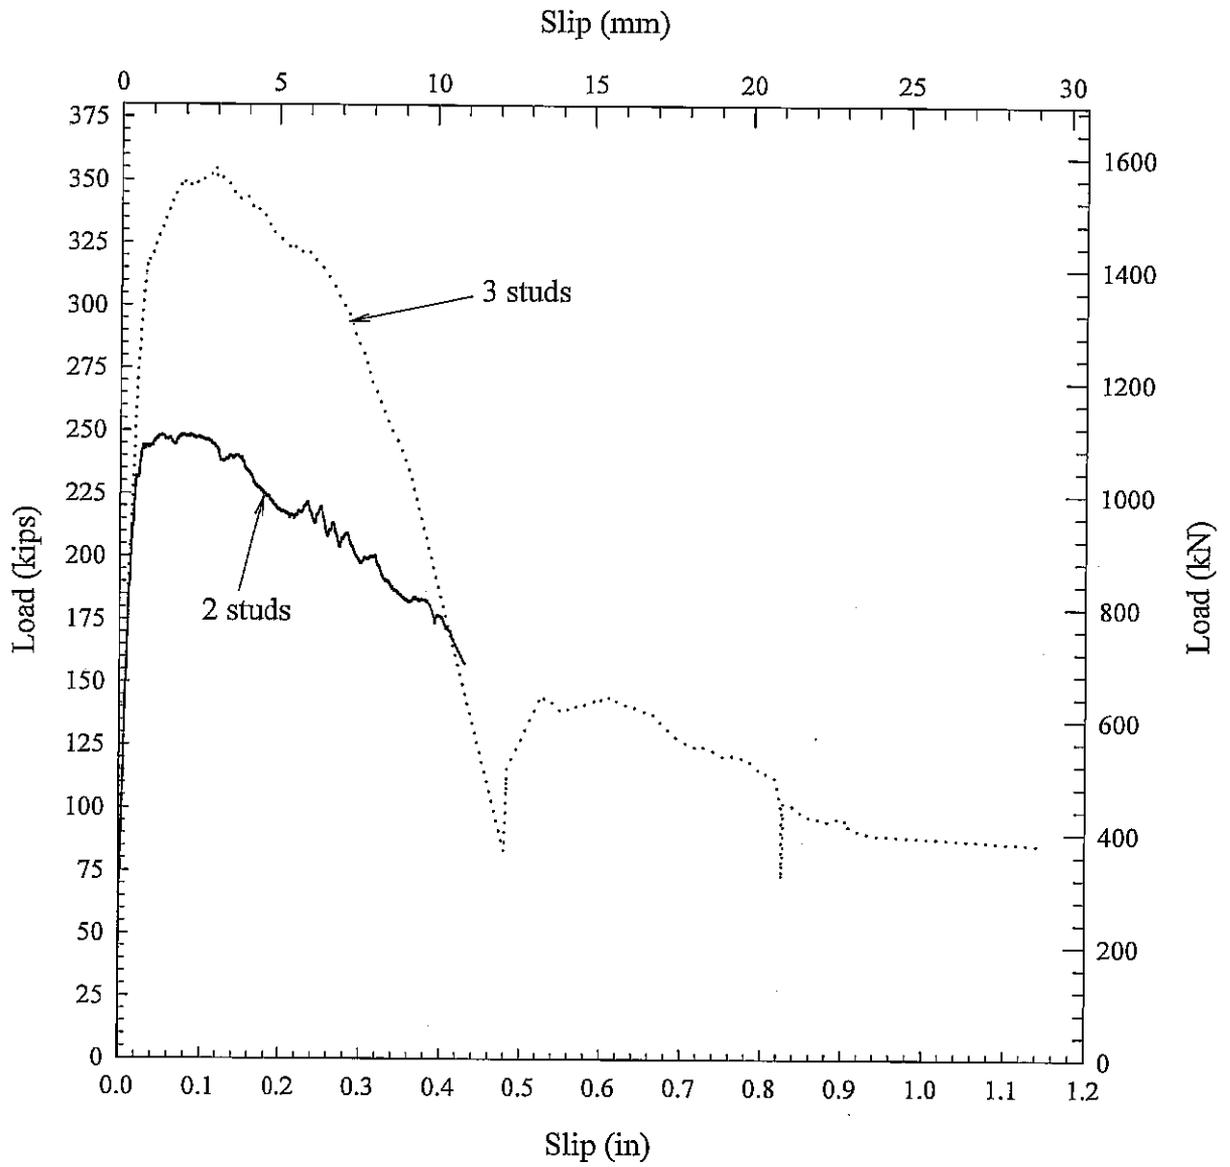
Fig. 5.29 Load-slip behavior for two pockets, various number of studs

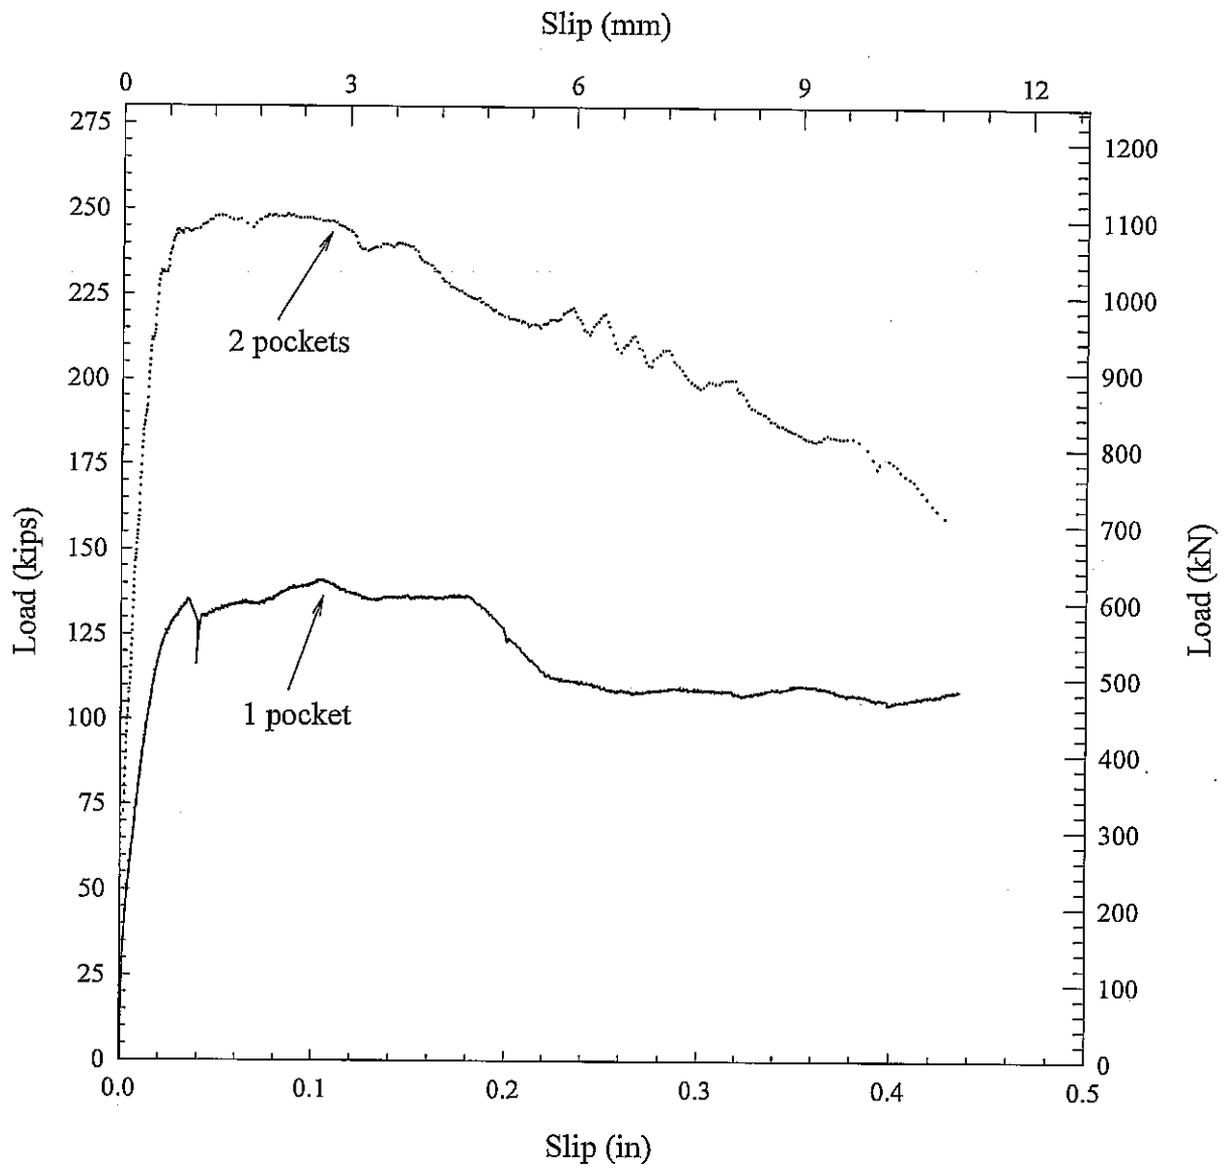
Fig. 5.30 Load-slip behavior for two studs, various number of pockets

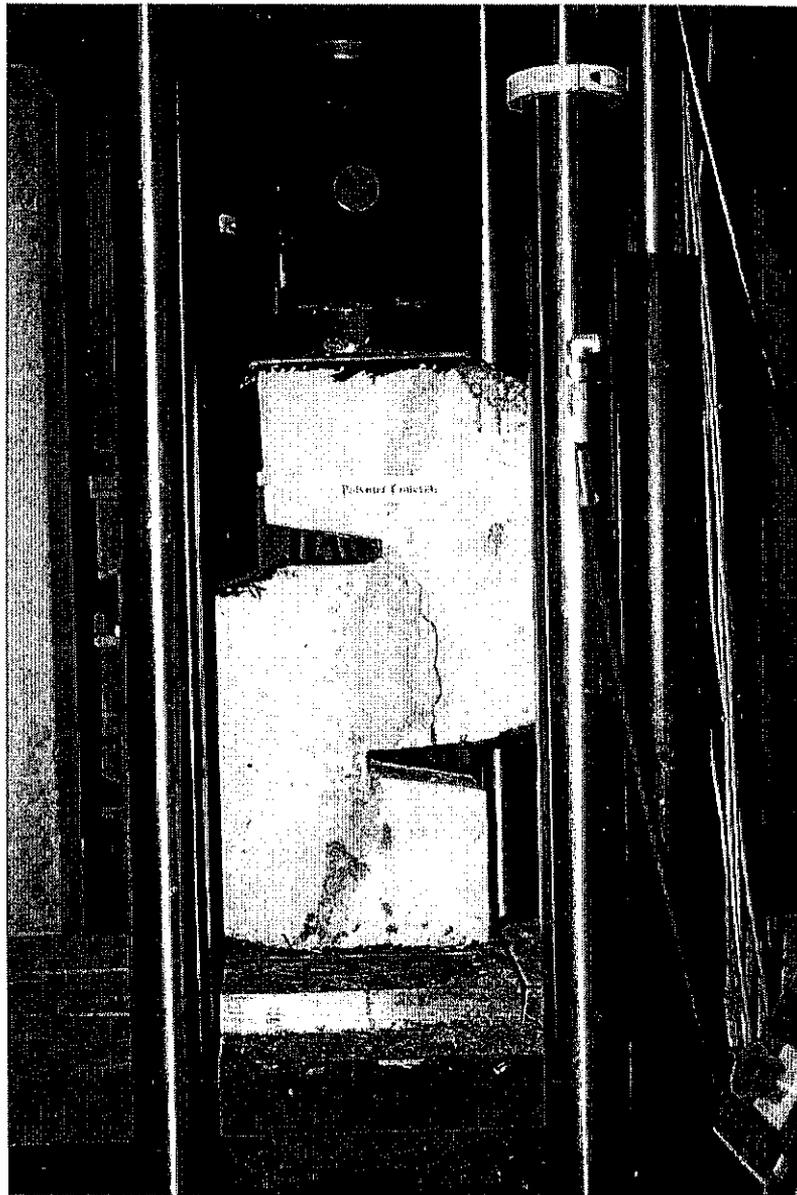
Fig. 5.34 Failure in polymer concrete specimen

apparent cracks were observed at these joint interfaces. Fracture was always encountered away from the joint, i.e., in the concrete (Fig. 5.34). However, the ideal procedure for casting polymer concrete must be adhered to. This proved to be vital in the preliminary casting of the material.

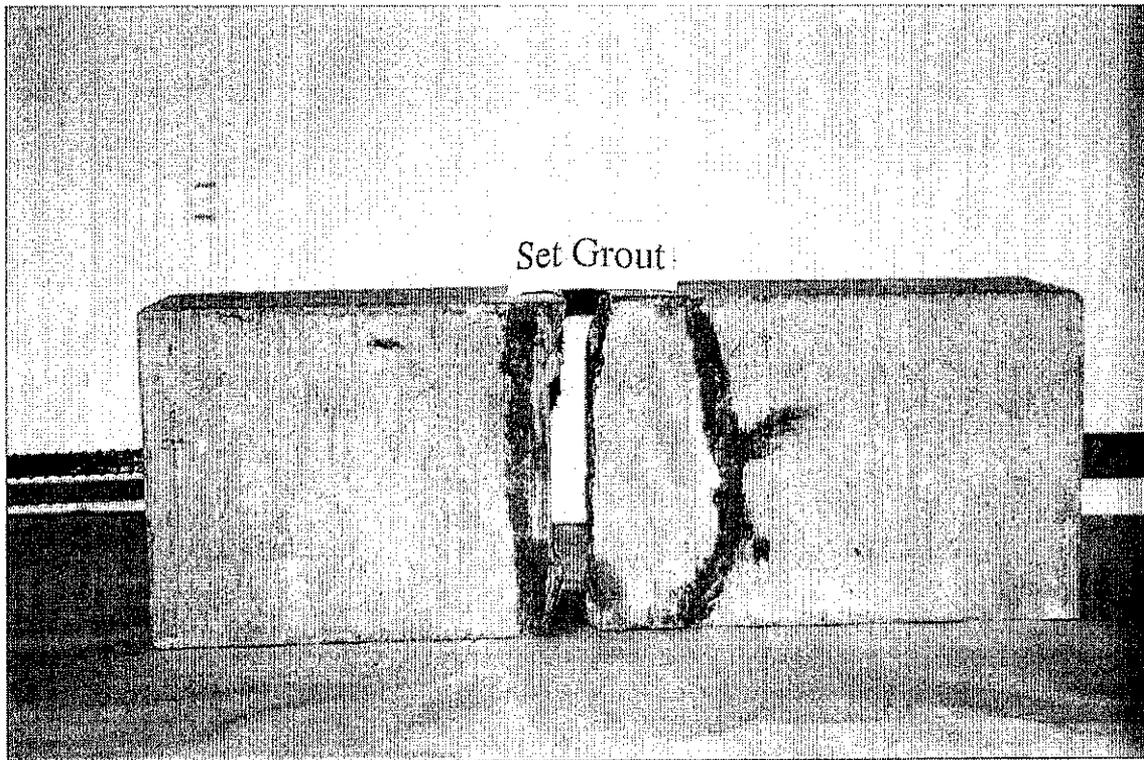
Fig. 5.35 Failure mode in set grout direct tension specimen

The polymer concrete once again proved to be superior to the other materials as shown in Table 5.7. The tensile strengths were higher than those for set 45 and set grout materials. Failure was away from the joint, i.e., in the concrete slab units. The mode of failure for set grout, set 45, and polymer concrete specimens are shown in Figs. 5.35-5.37, respectively.

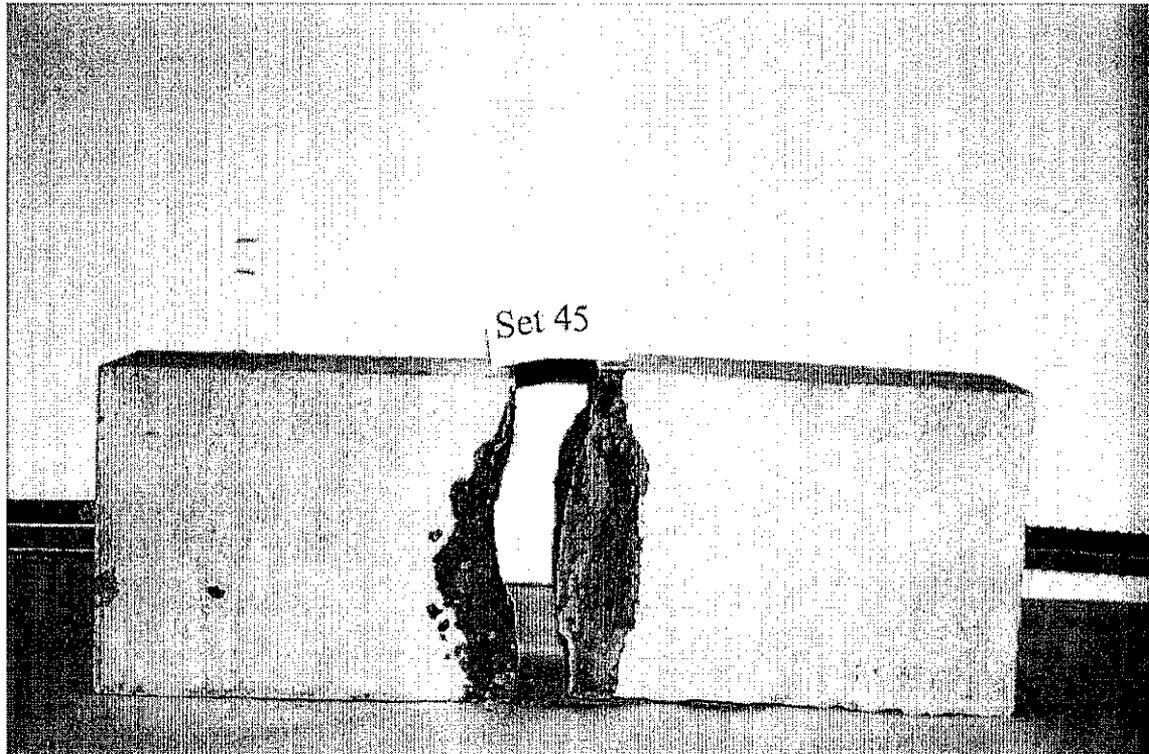
Fig. 5.36 Failure mode in set 45 direct tension specimen

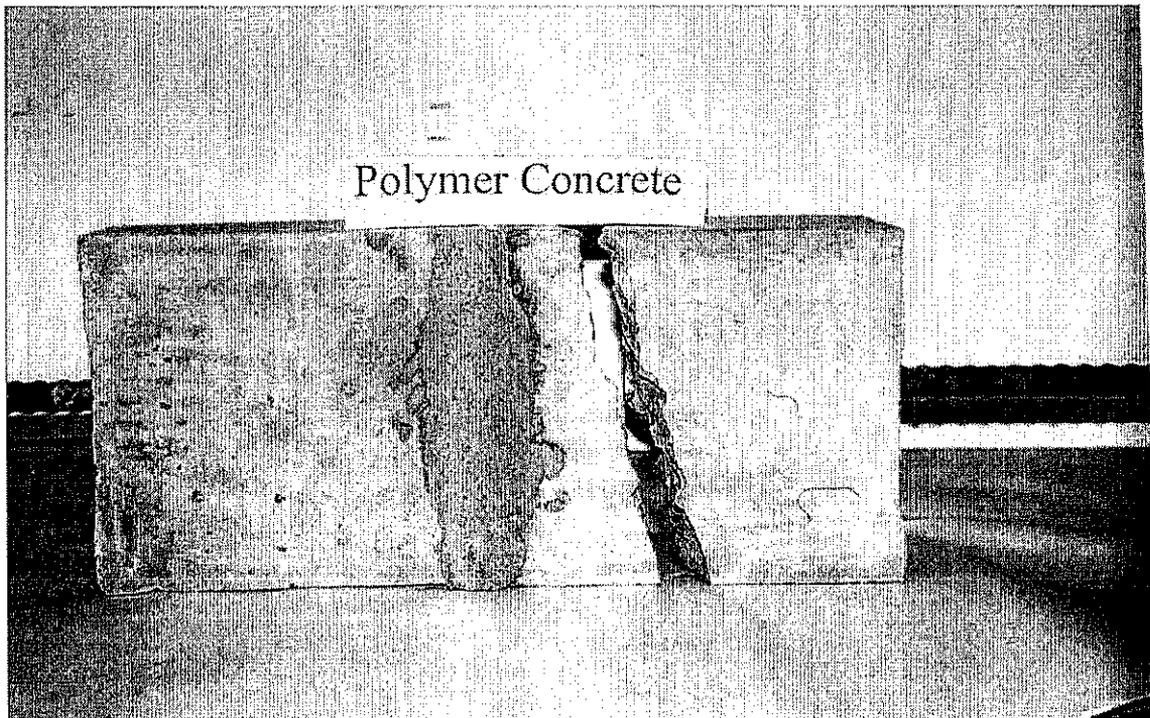
Fig. 5.37 Failure mode in polymer concrete direct tension specimen

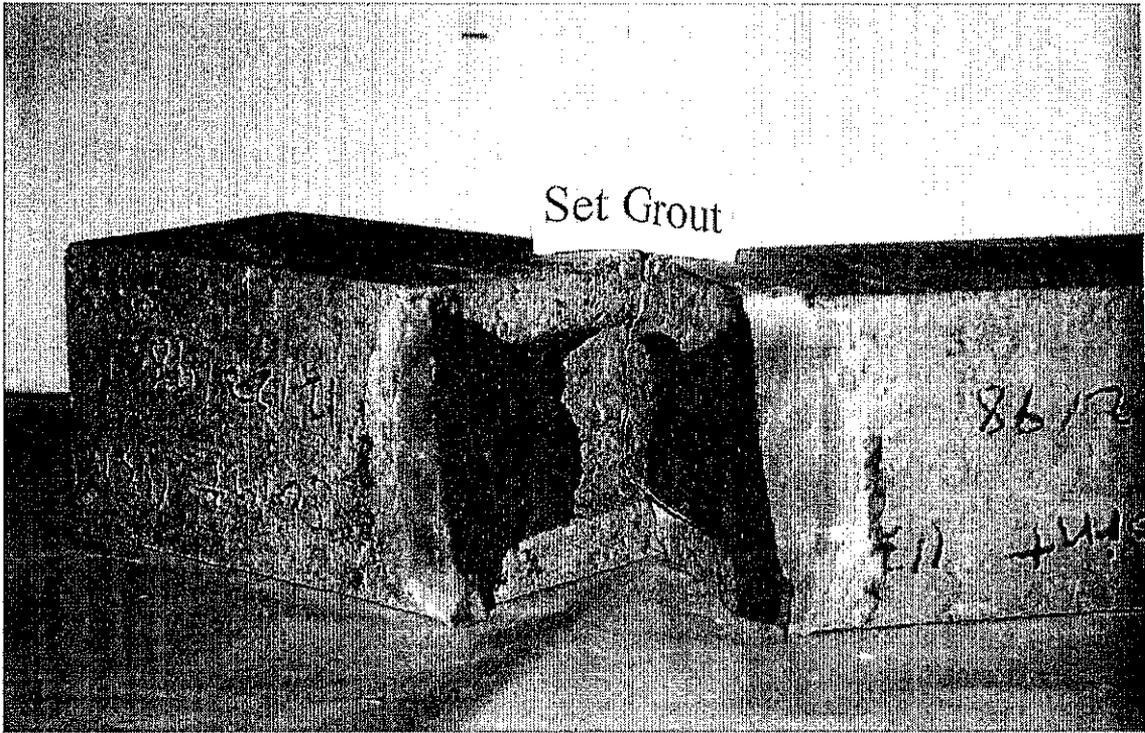
Fig. 5.38 Failure mode in set grout flexural specimen

The same trend was observed for the three materials tested under flexural testing. A dryer surface was more appropriate for specimens cast with set 45. Set grout specimens performed better when the joint surface was saturated. Observed flexural strength results are reported in Table 5.8. It can be seen that the flexural strength of polymer concrete joints was 2.8, 1.5 and 1.2 times the shear strength of joints with set 45, set 45 HW and set grout, respectively. Bond was superior in the polymer concrete specimens, followed by the set grout specimens, and finally the set 45 specimens. The modes of failure for the three materials followed the same trend as previously encountered in the direct shear and direct tension tests. Failure occurred at the joint juncture with some apparent loss of concrete for the set 45 specimens. On the other hand, failure occurred at the joint interface for the set grout specimens, however, more concrete adhered to the grout material at fracture. Once again, failure for the polymer concrete specimens was away from the joint, i.e., in the concrete material. Figs. 5.38-5.40 show the modes of failure for the set grout, set 45, and polymer concrete specimens, respectively.

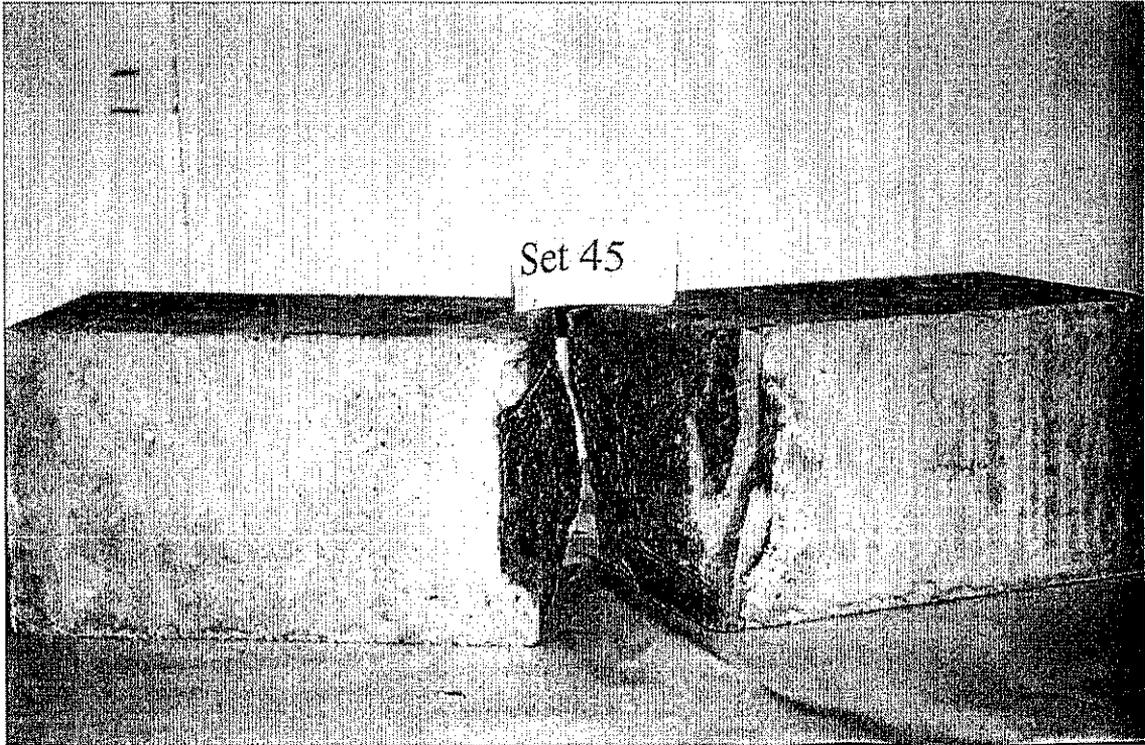
Fig. 5.39 Failure mode in set 45 flexural specimen

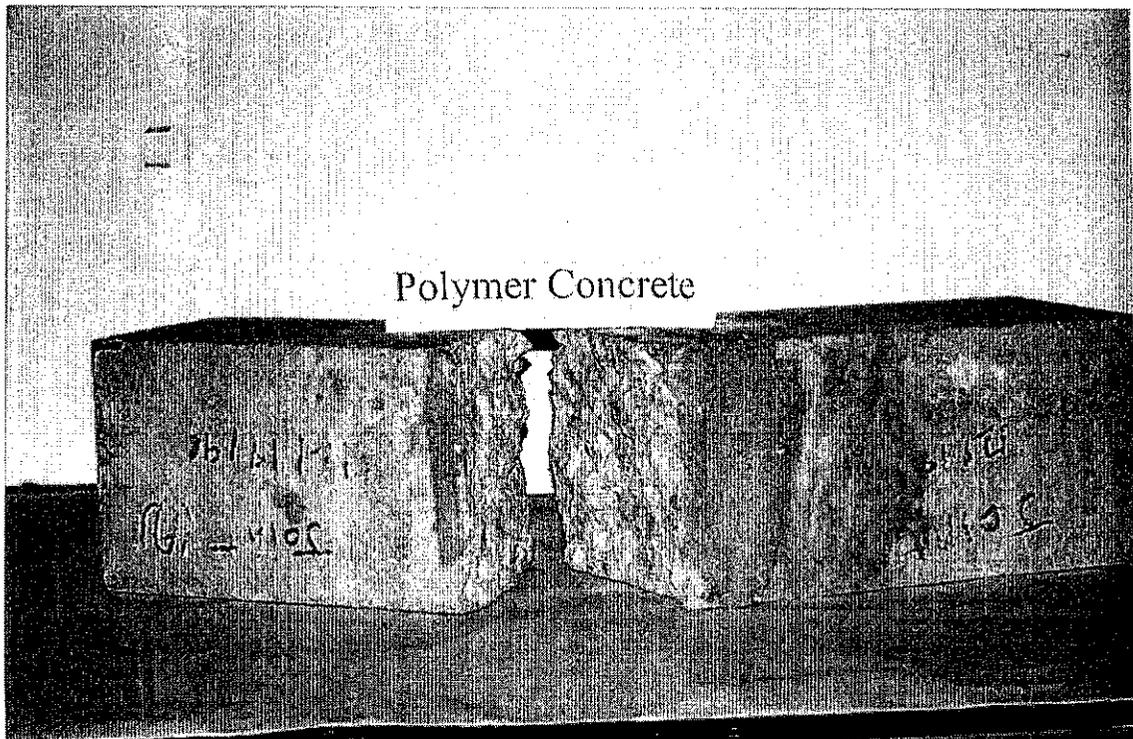
Fig. 5.40 Failure mode in polymer concrete flexural specimen

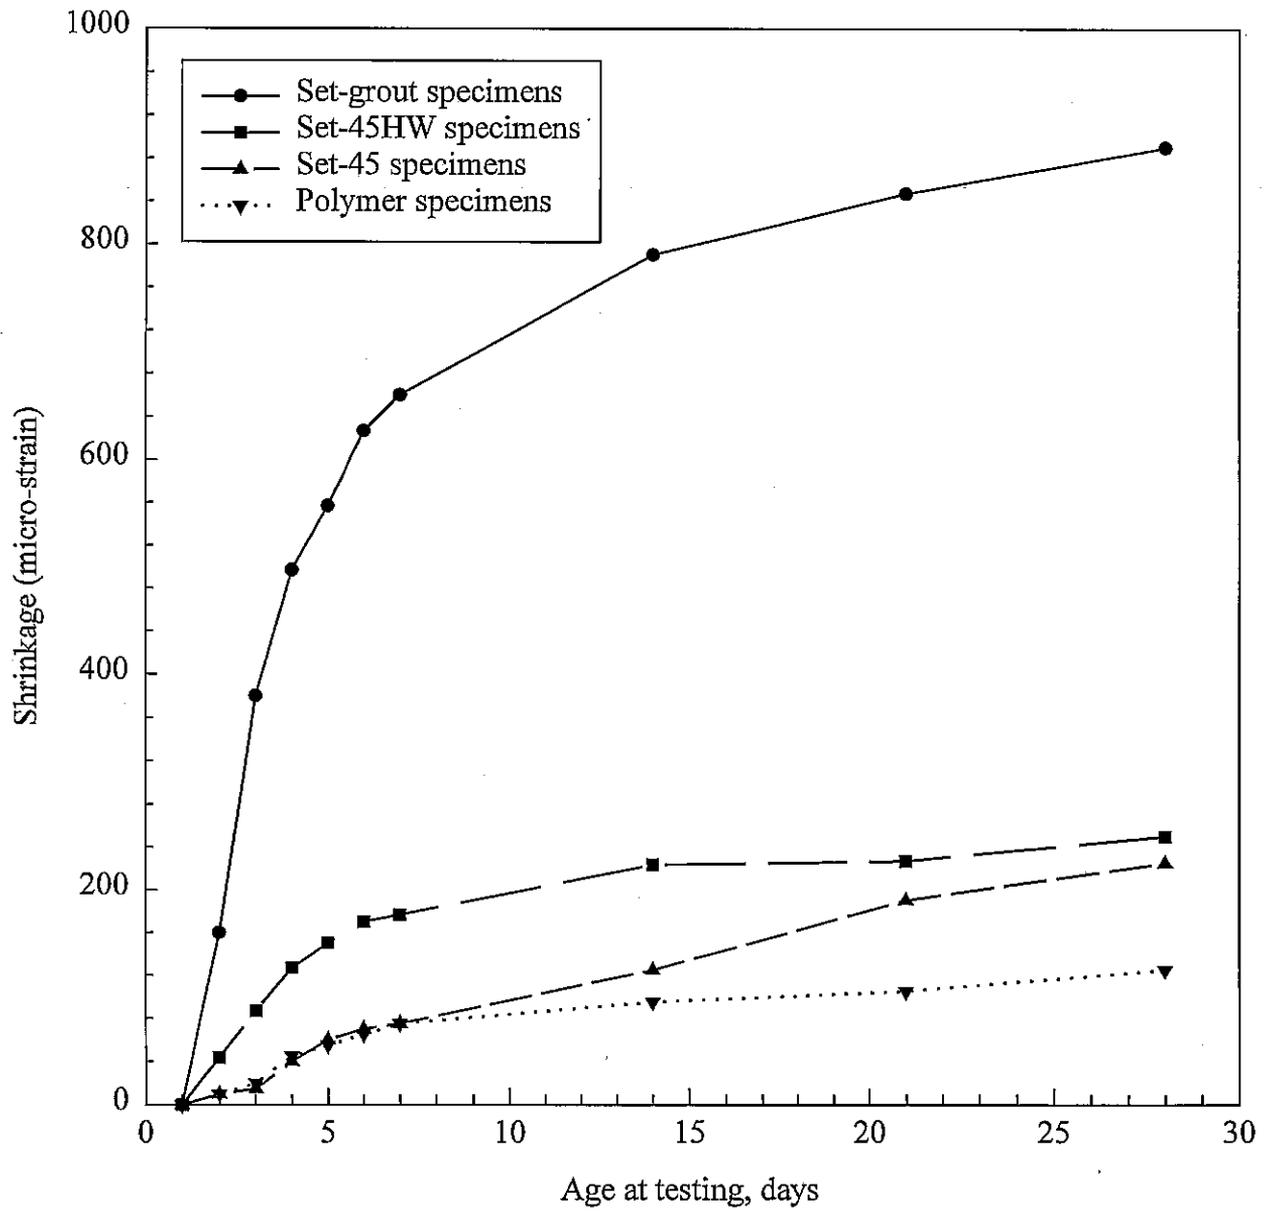
Fig. 5.41. Shrinkage test results of joint materials

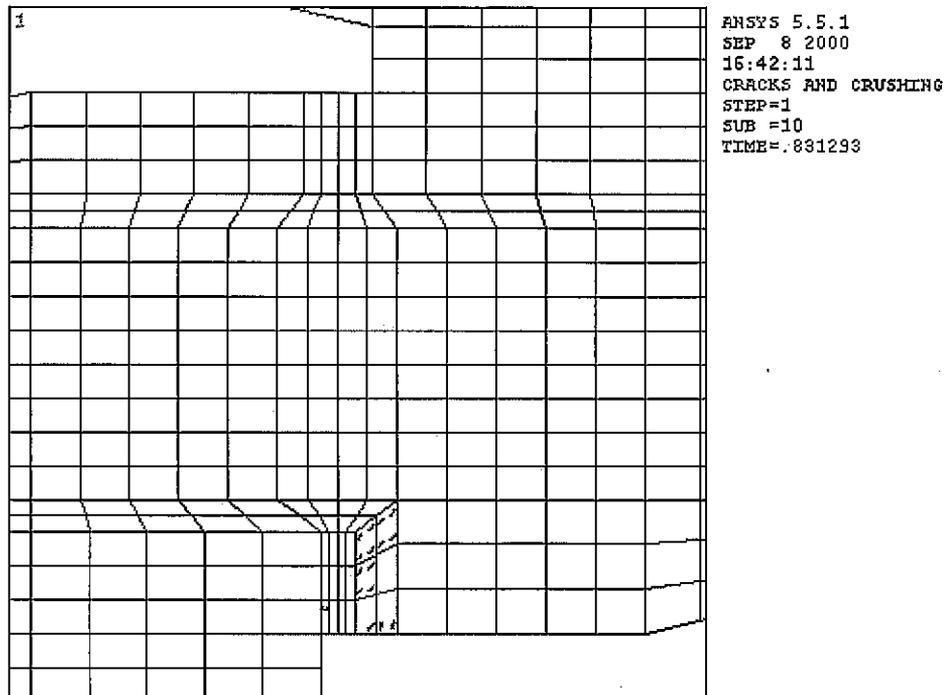
Fig. 5.42 Crack pattern in polymer concrete model

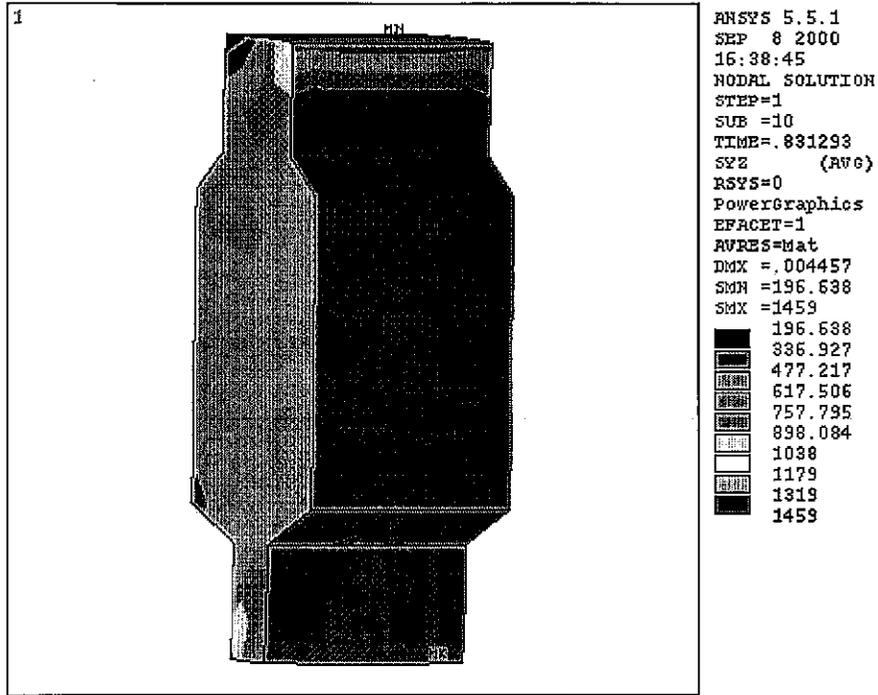
Fig. 5.43 Shear stress distribution in polymer concrete

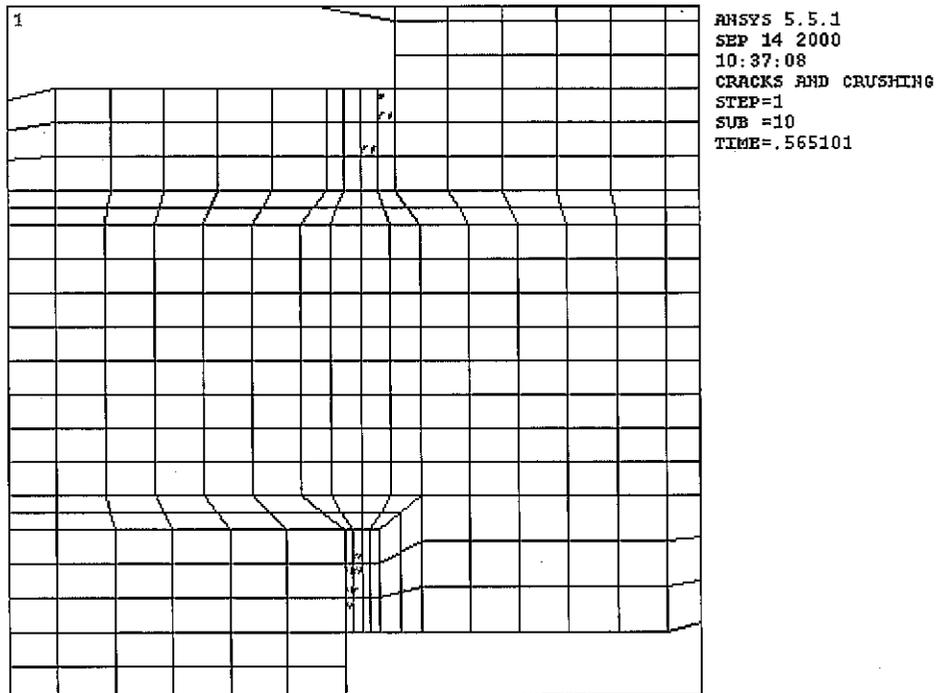
Fig. 5.44 Crack pattern in set grout model

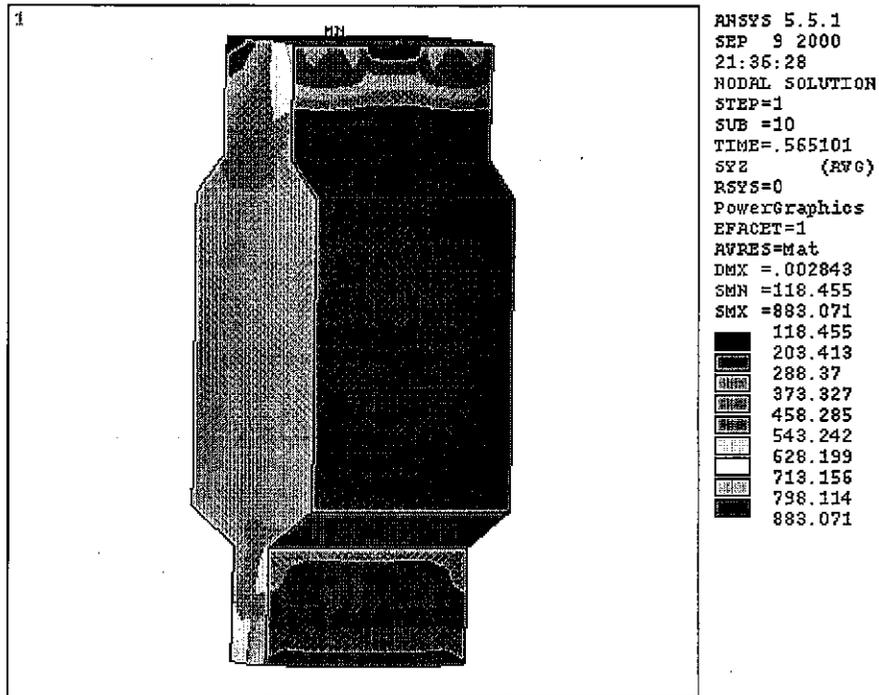
Fig. 5.45 Shear stress distribution in set grout

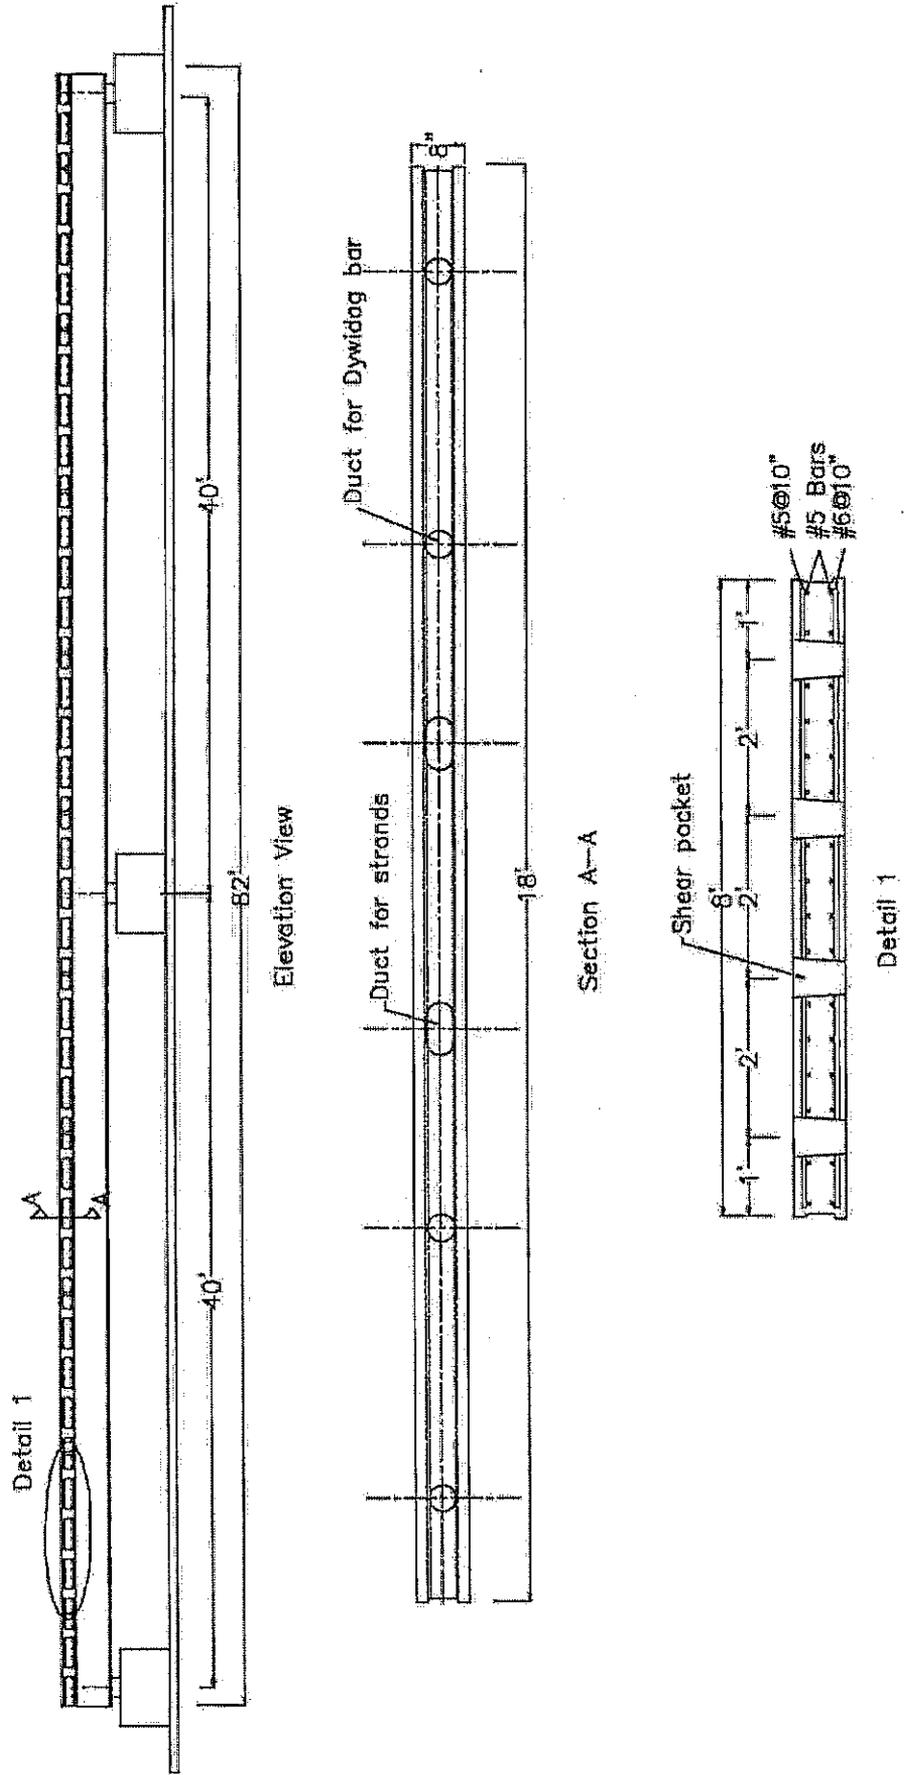
Fig. 6.1 Plan and cross section of the prototype bridge
