**EXPERIMENTAL EVALUATION OF  
FULL DEPTH  
PRECAST/PRESTRESSED CONCRETE  
BRIDGE DECK PANELS**

**Project IB-H1, FY 98**

Report No. ITRC FR 98-5

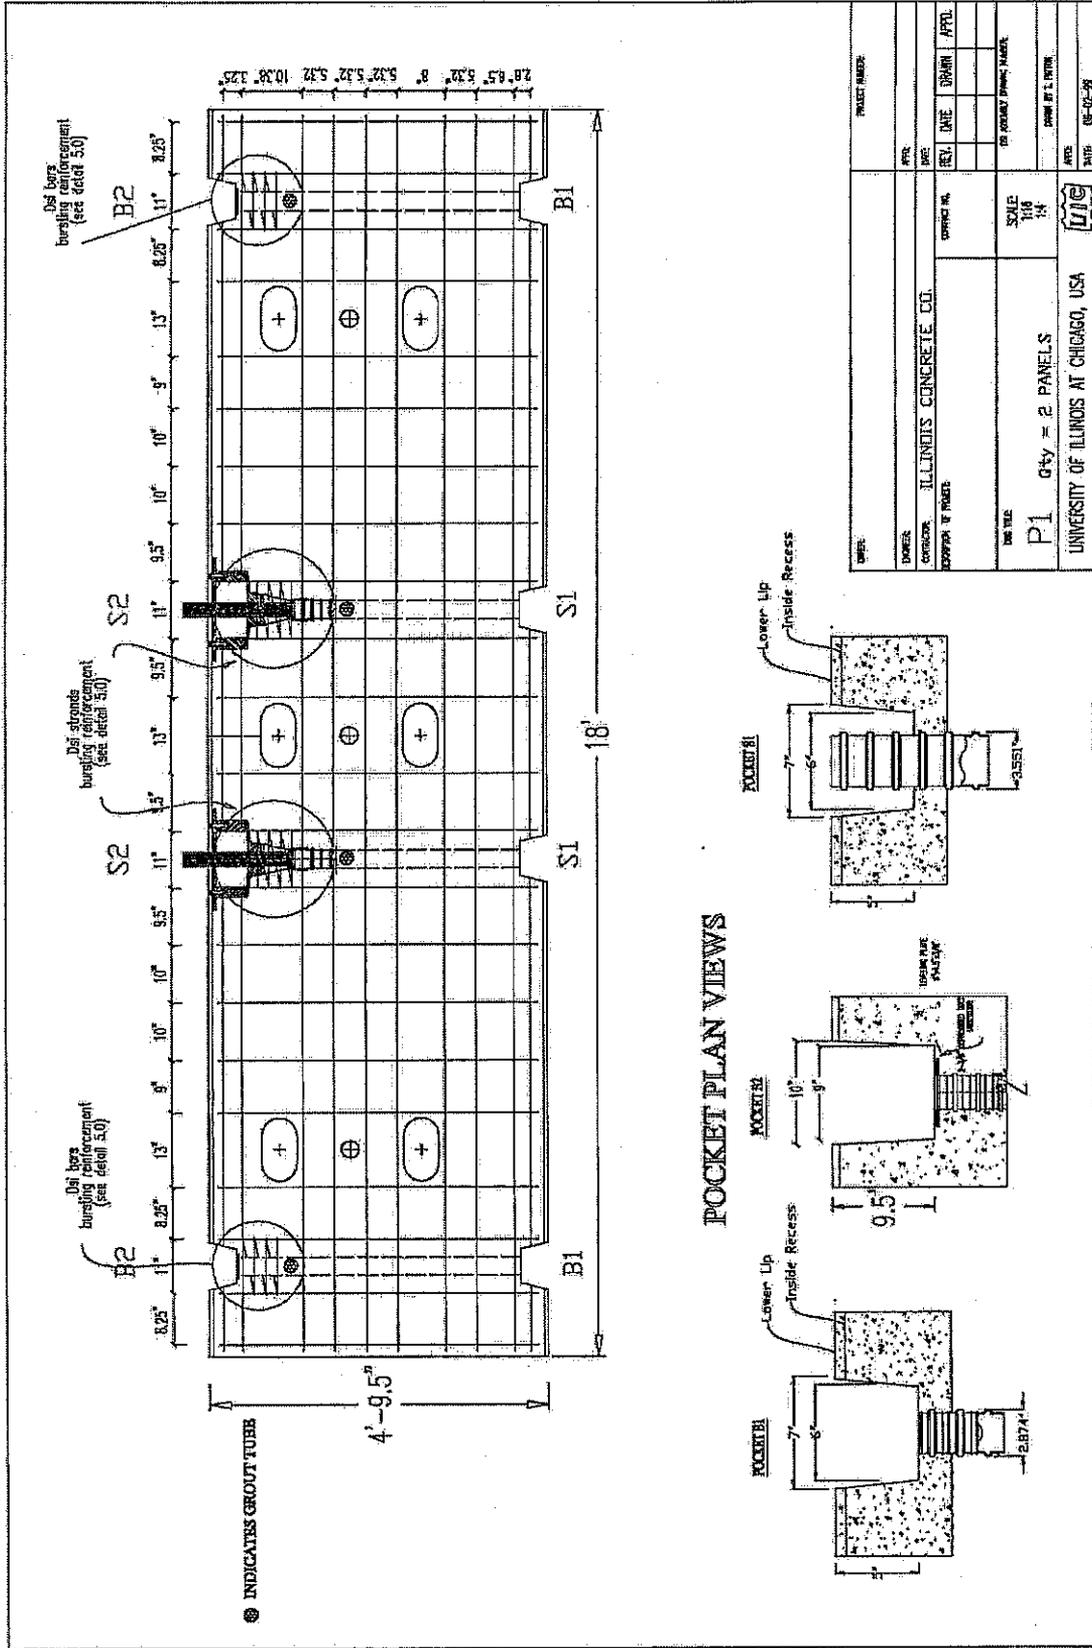
Fig. 6.3 Typical layout of steel reinforcement in full-scale panel

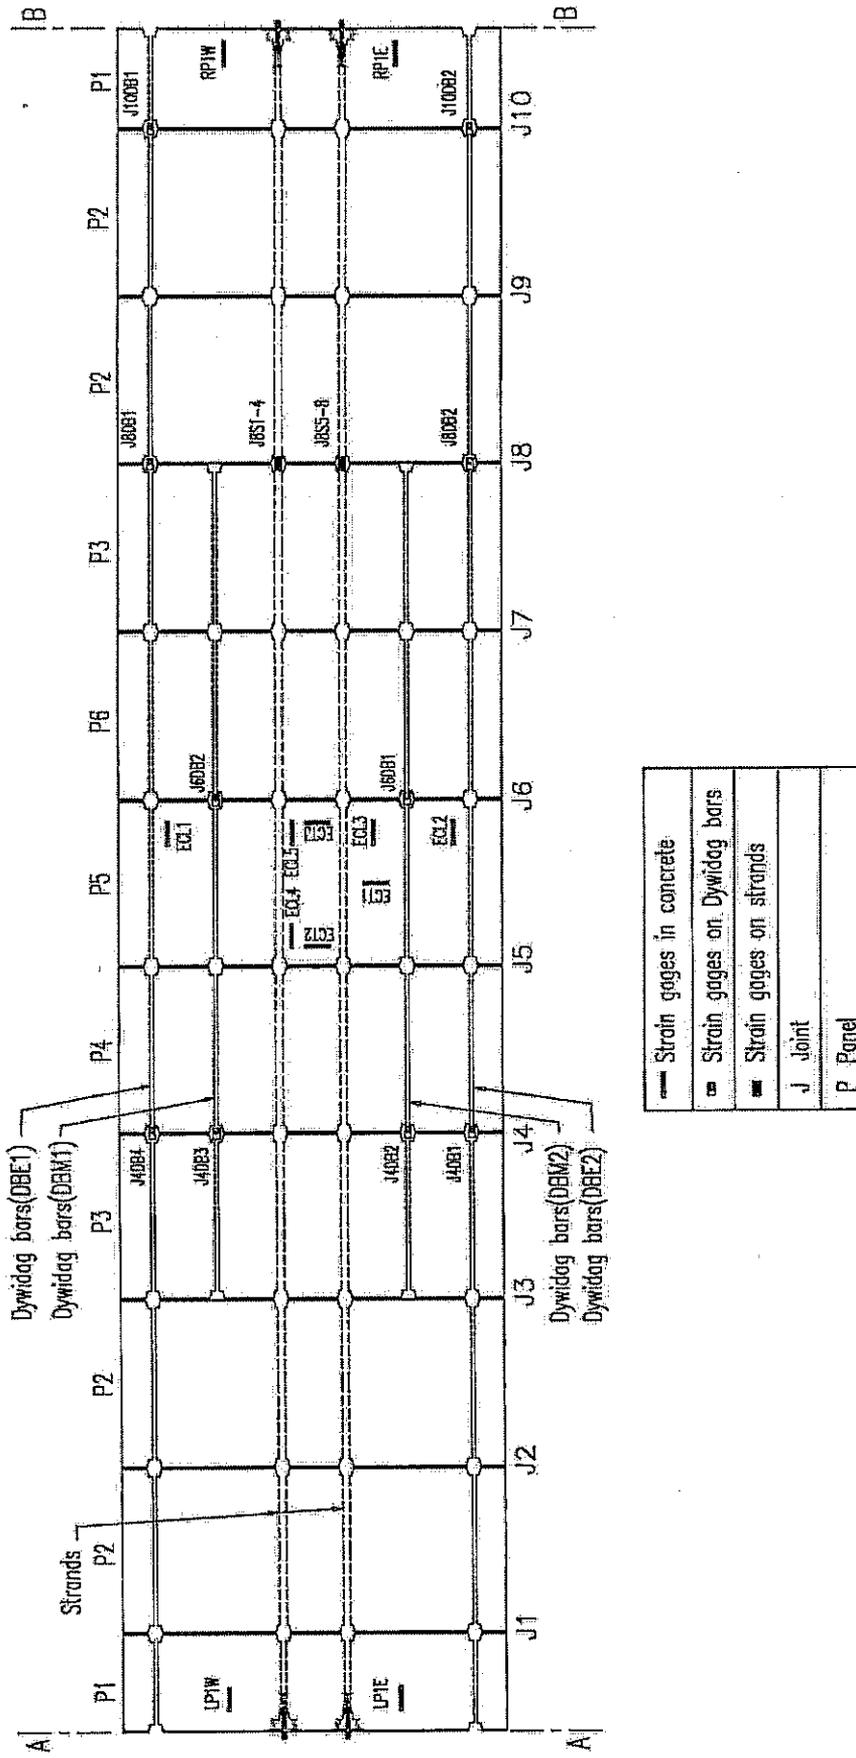
Fig. 6.25 Strain gages mounted on prestressing steel and placed inside concrete deck

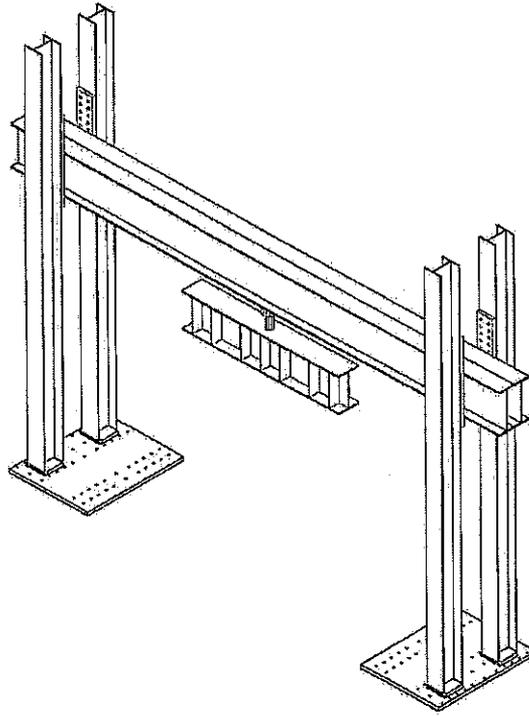
Fig. 6.45 Beam-column connection of loading frame

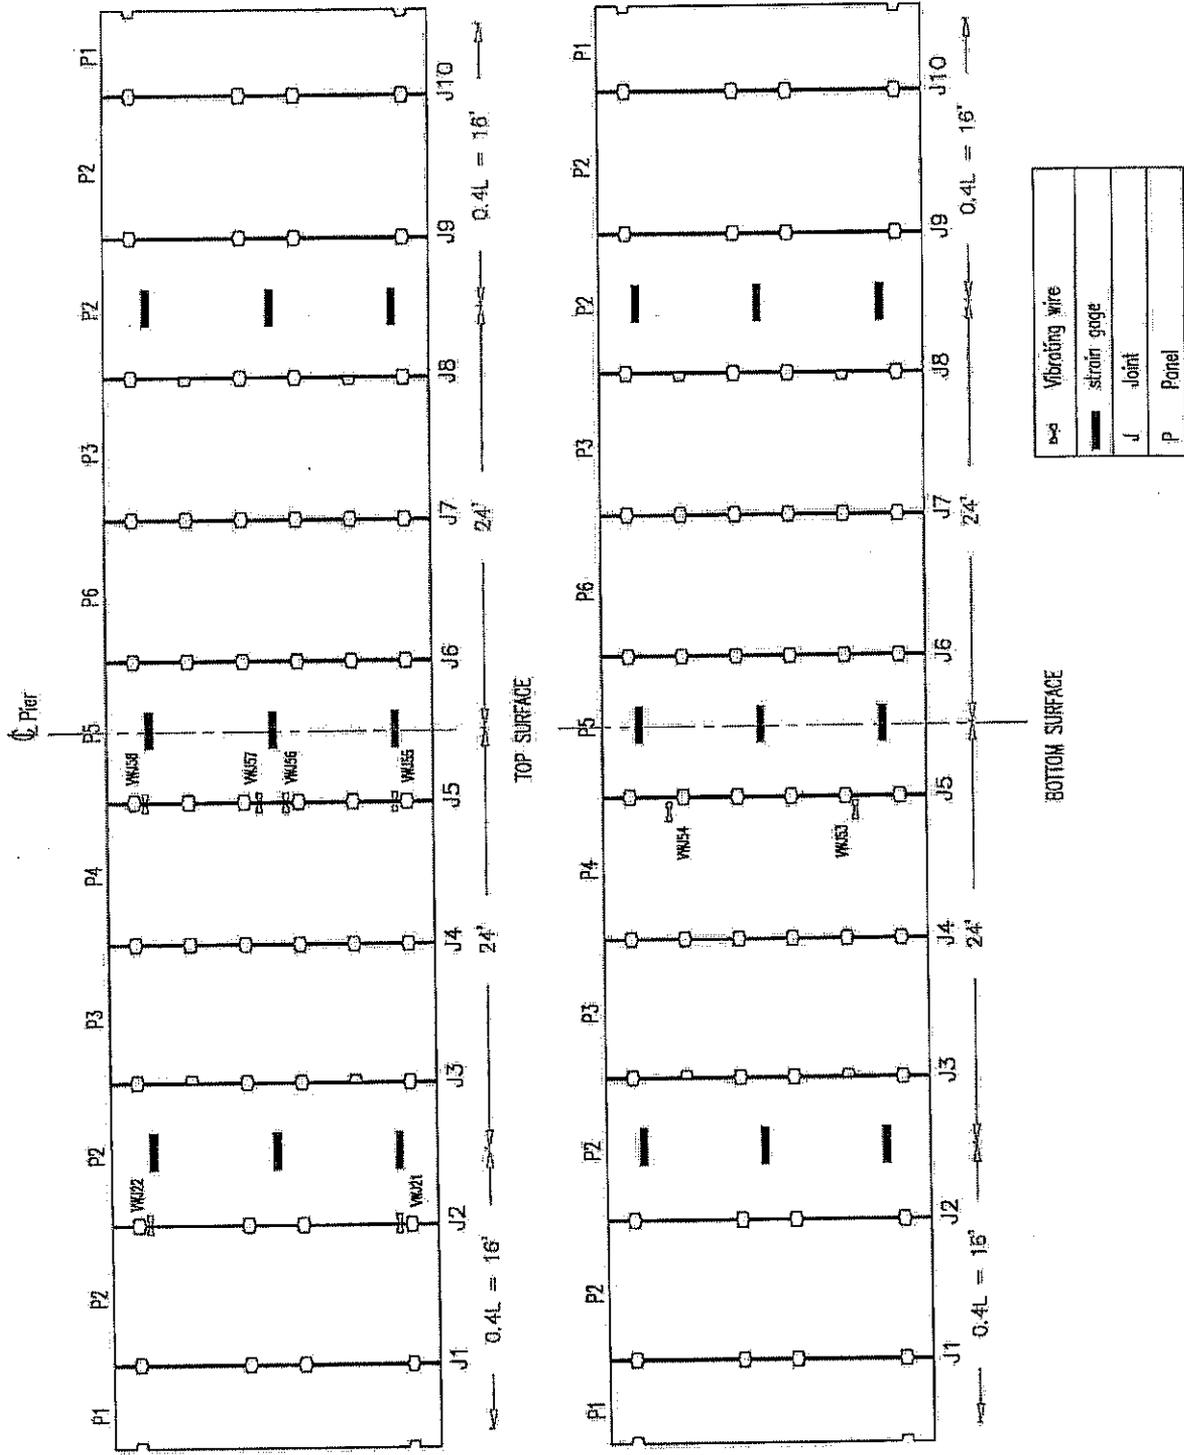
Fig. 6.52 Layout of electrical resistance strain gages and vibrating wire strain gages on concrete bridge deck

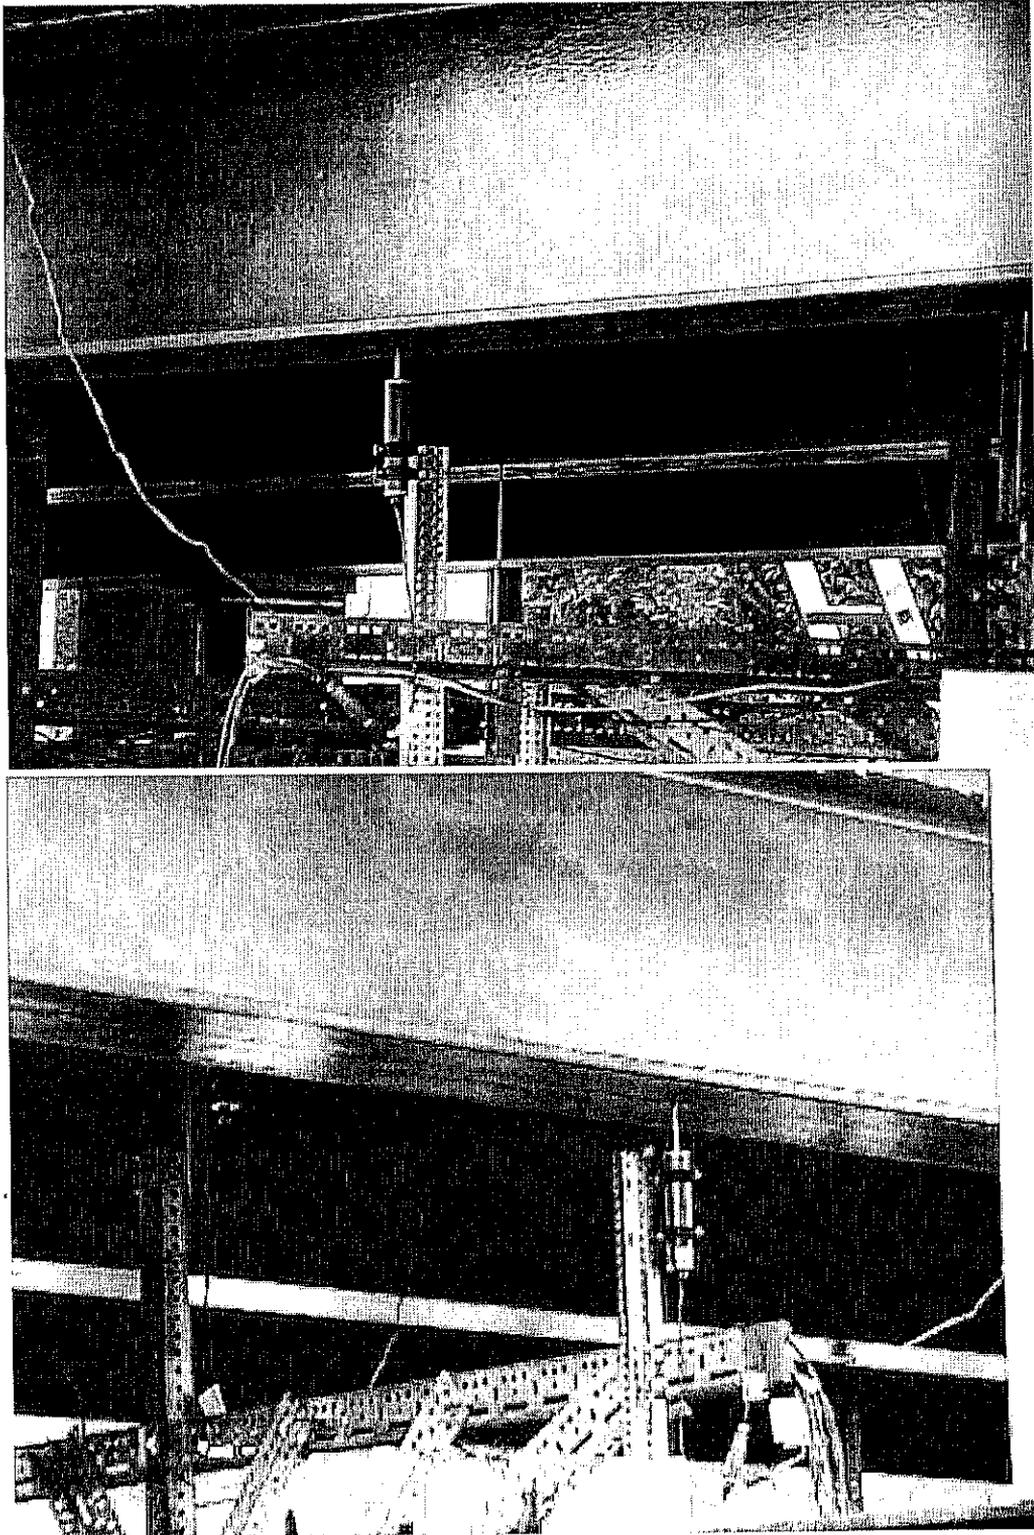
Fig. 6.54 LVDT used to measure the deflection of steel beams and deck

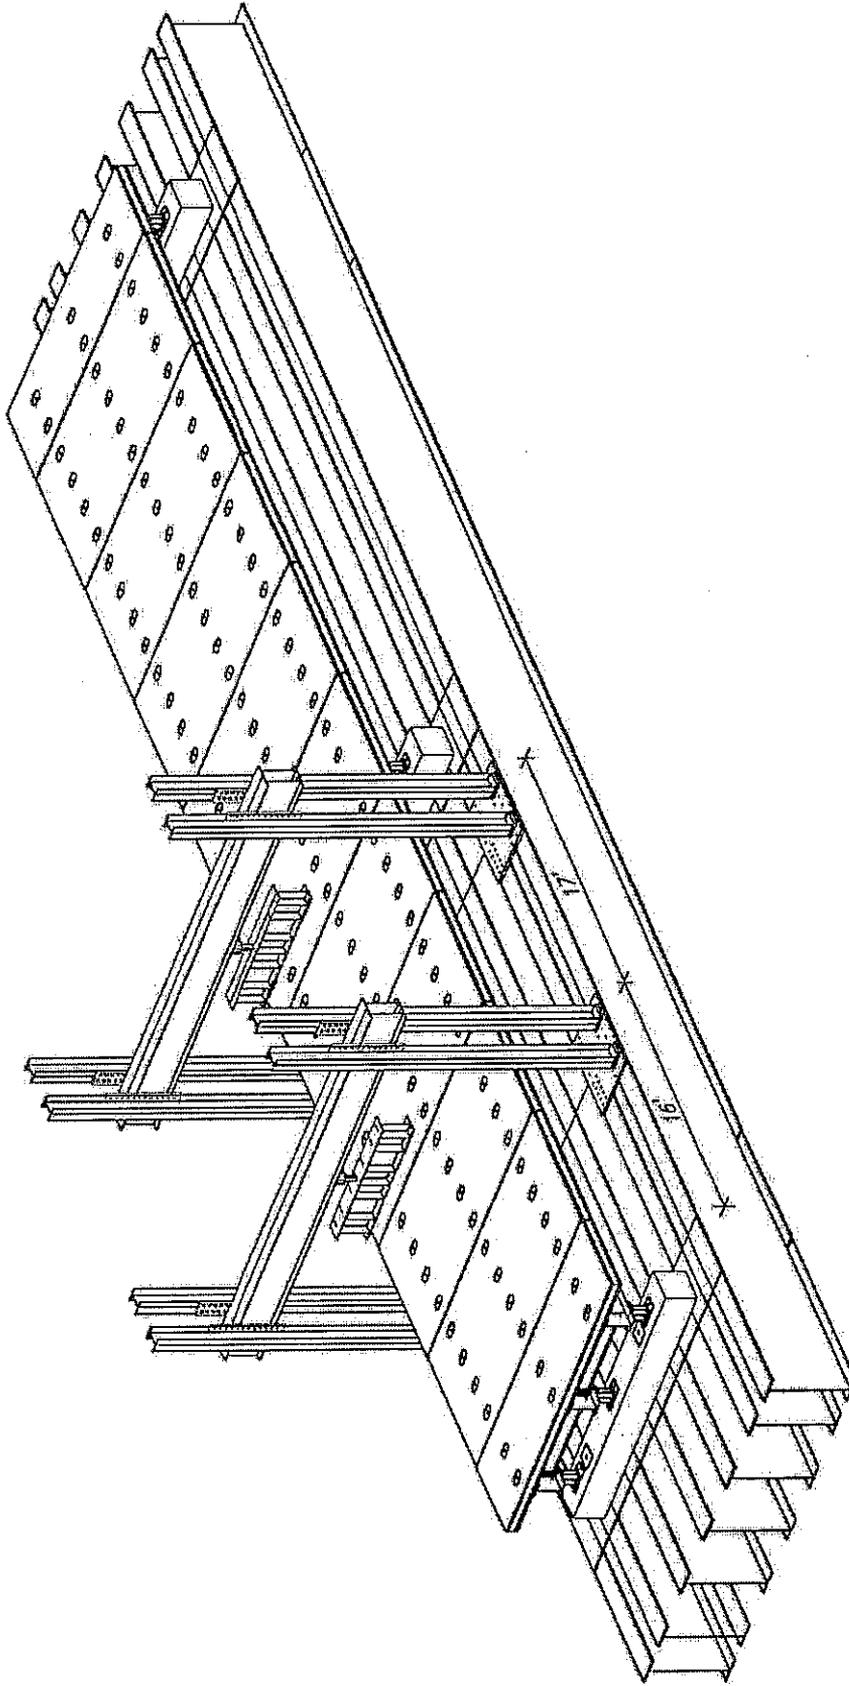
Fig. 6.59 Overall view of the loading arrangement for maximum positive moment

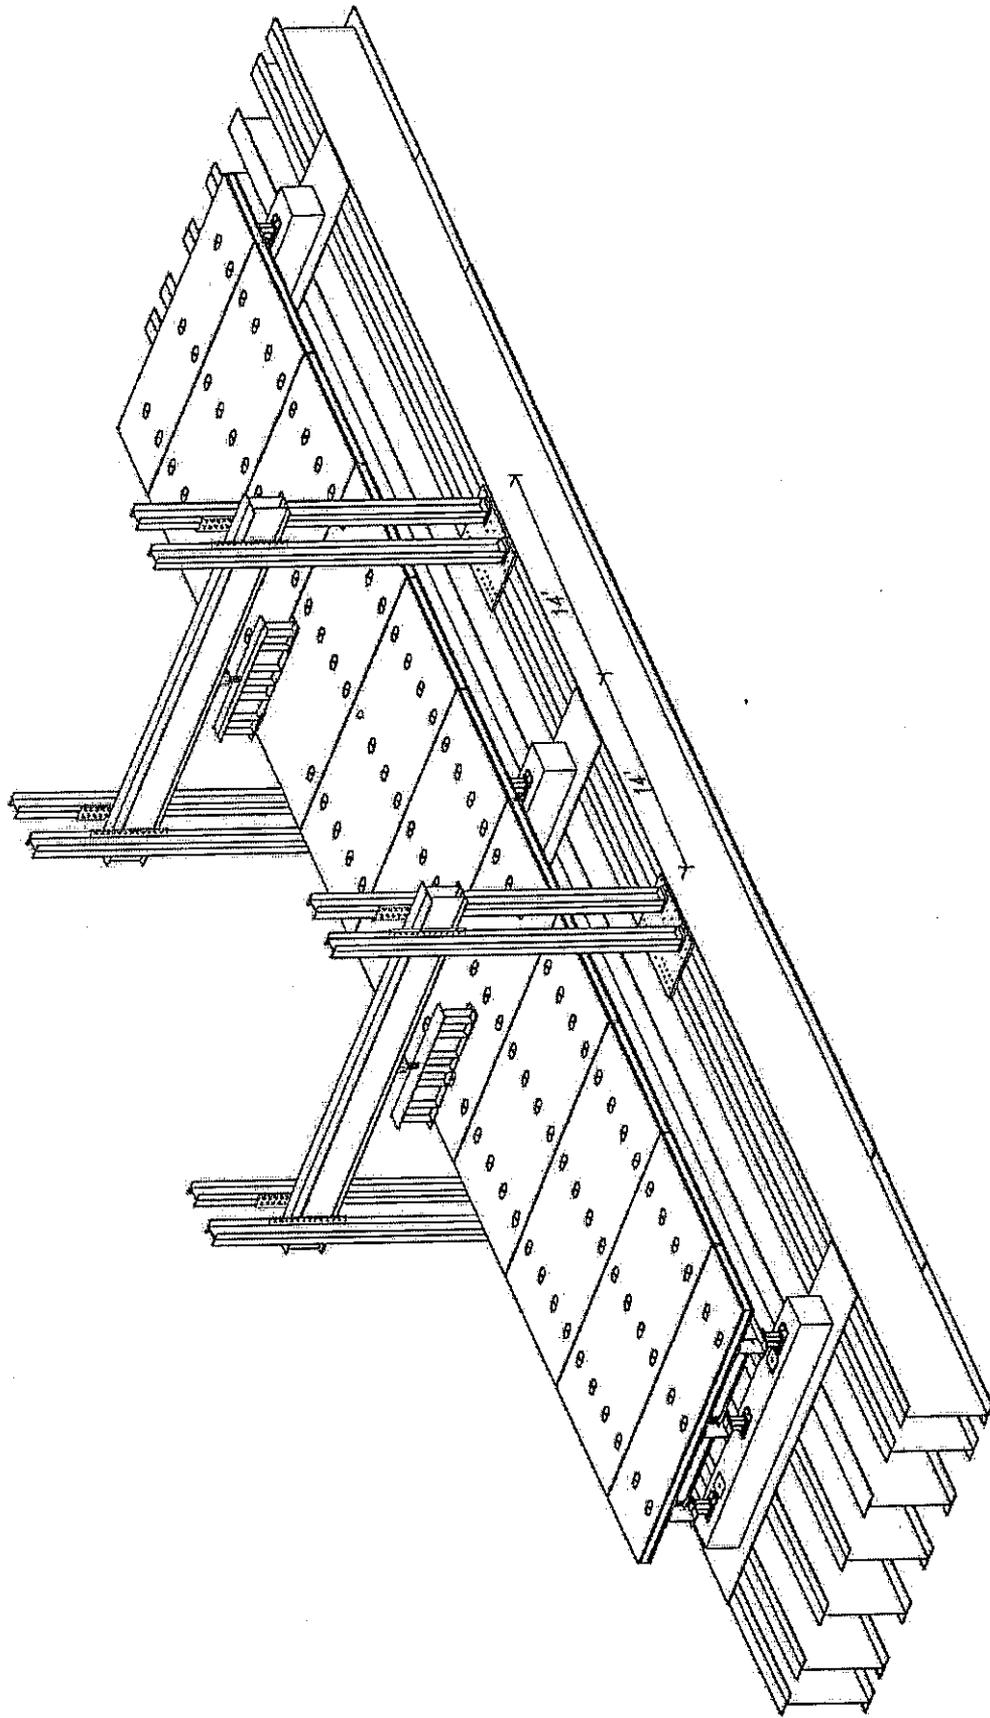
Fig. 6.60 Overall view of the loading arrangement for maximum negative moment

The ultimate load test was carried out in order to investigate adequacy of the precast deck to girder connections under ultimate load conditions and to observe the post-cracking behavior and modes of failure. The behavior of the transverse joint was investigated in terms of the effect of post-tensioning on the performance of the joint. The first case was to load the structure to failure under positive bending using the loading pattern shown in Fig. 6.59. Loads were then applied in a pattern approximating design negative moment envelopes using the loading zones of Fig. 6.60.

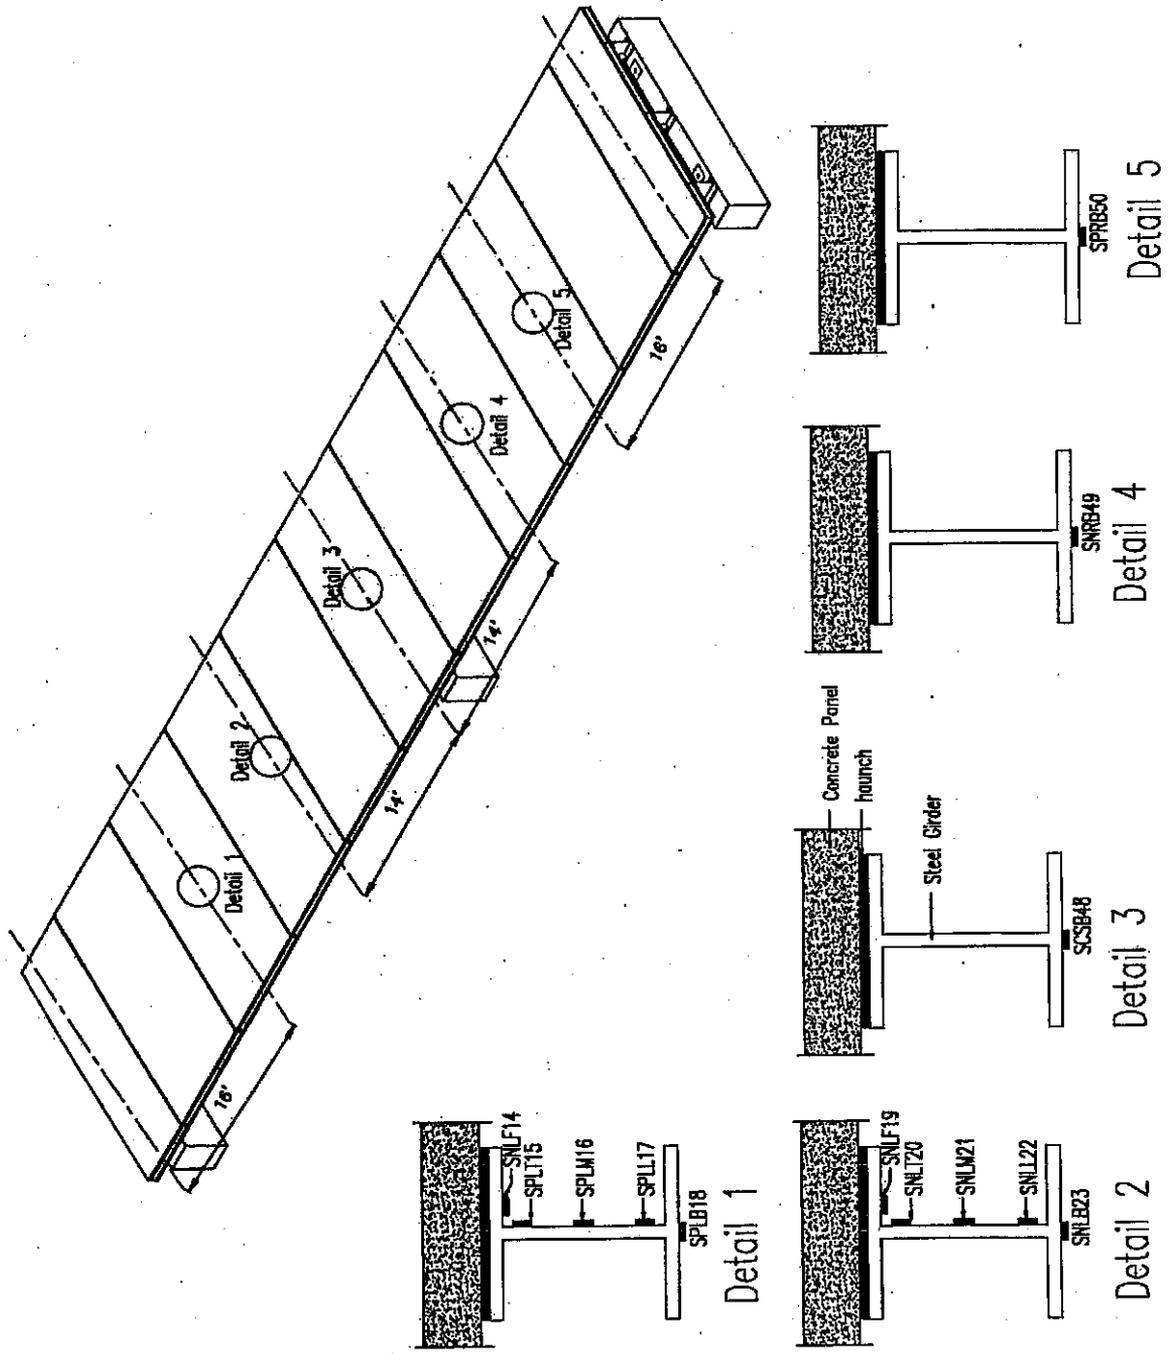
Fig. 7.2 Location of steel strain gages

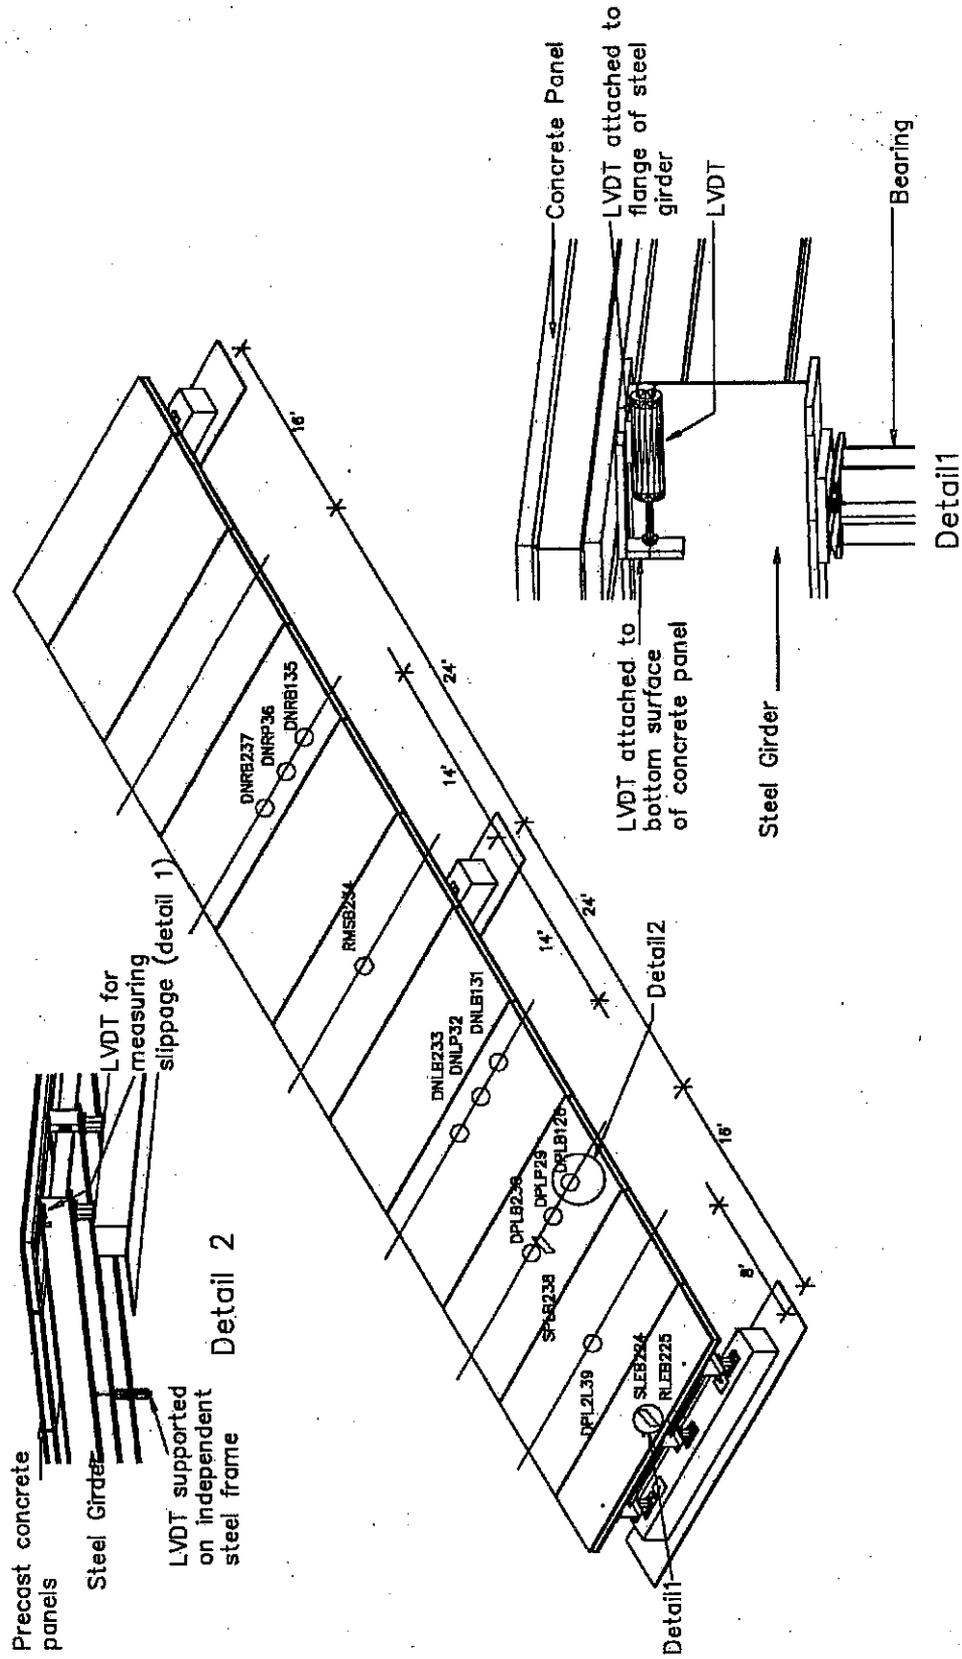
Fig. 7.3 Location of LVDTs for deflection and slippage measurement

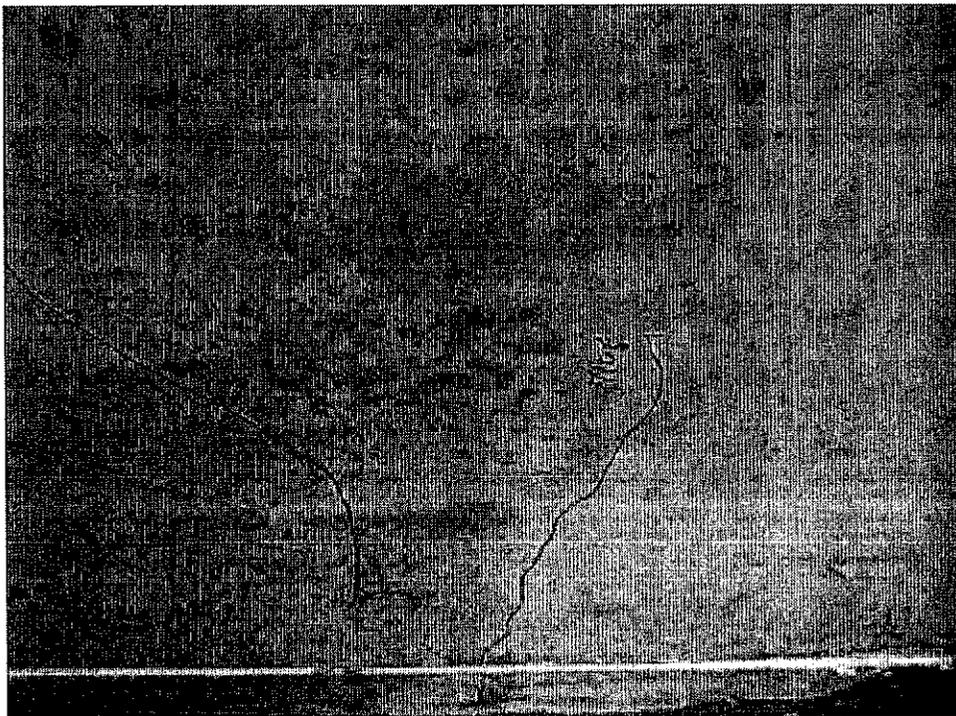
Fig. 7.15 Cracks underneath deck during positive overloading

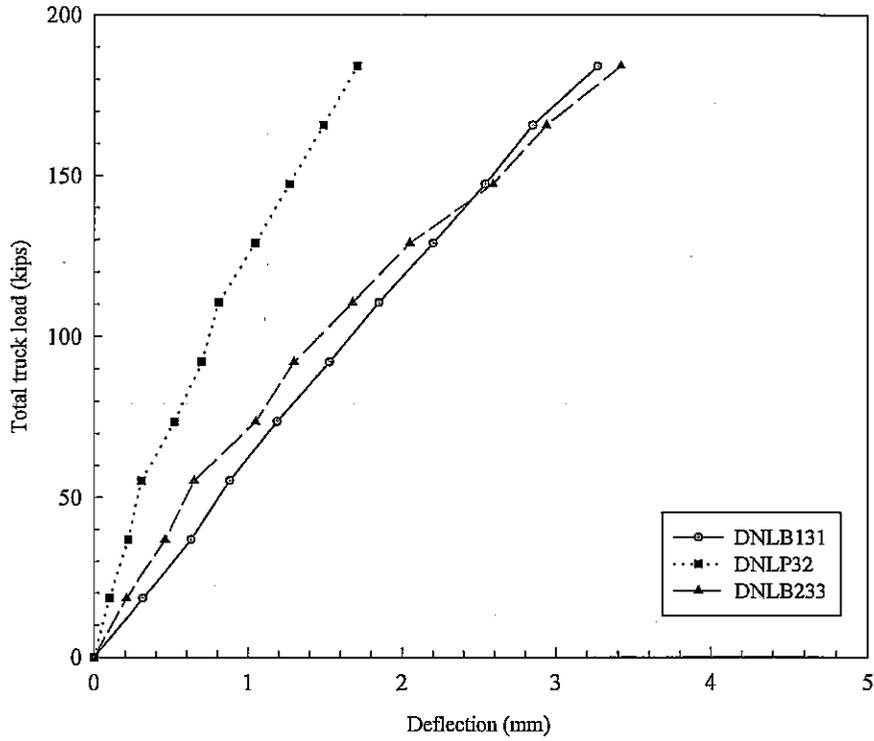
Fig. 7.16 Load-deflection response at 14 ft from middle support for negative overloading

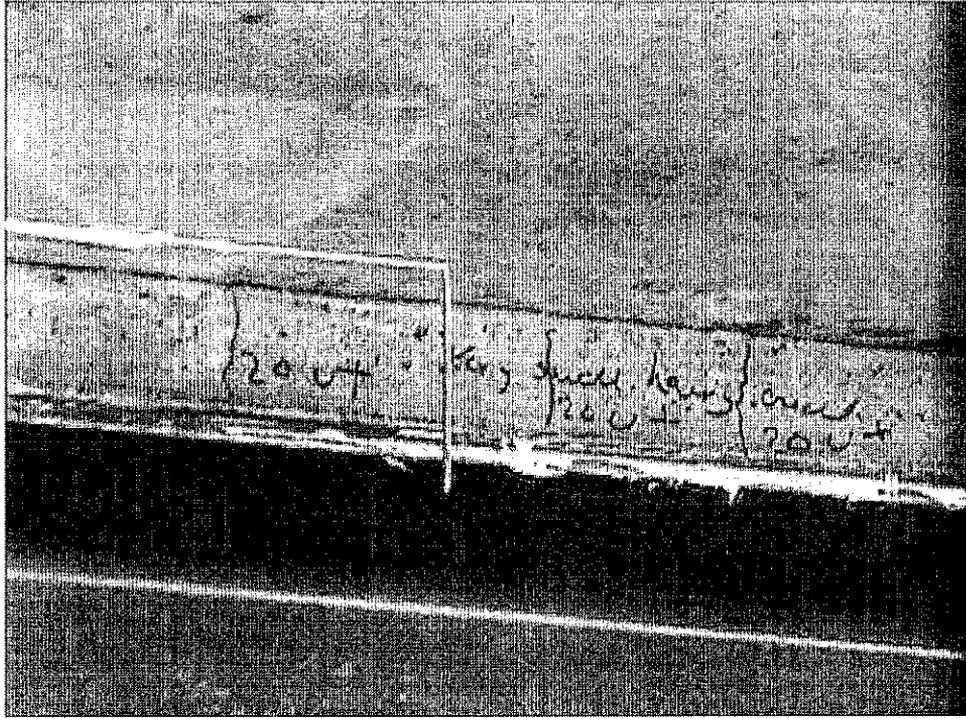
Fig. 7.24 Close-up view of hairline cracking at haunch at 386 kips load for positive bending

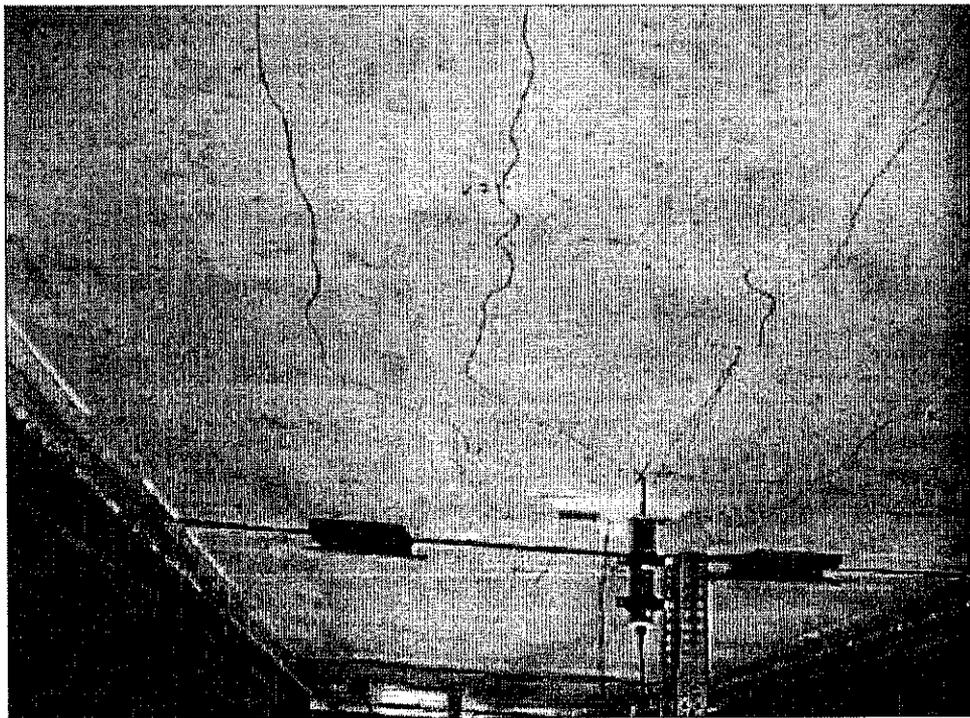
Fig. 7.25 Cracking of bottom deck at ultimate positive loading

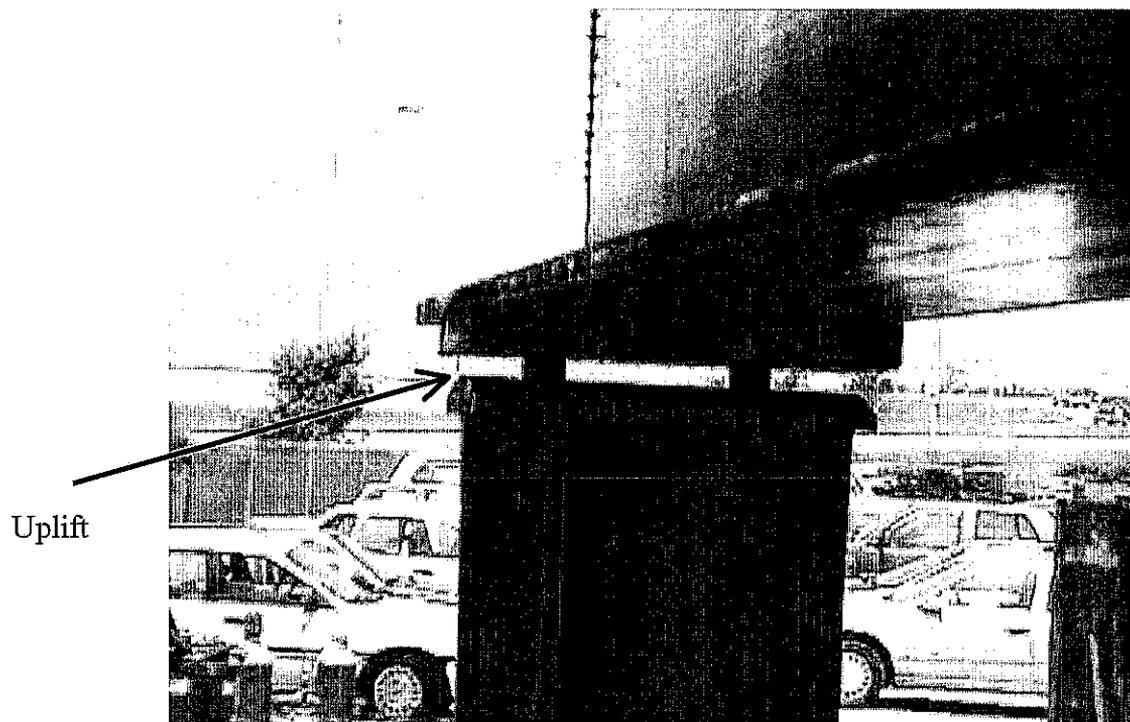
Fig. 7.26 Uplift of steel beam due to positive bending of other span

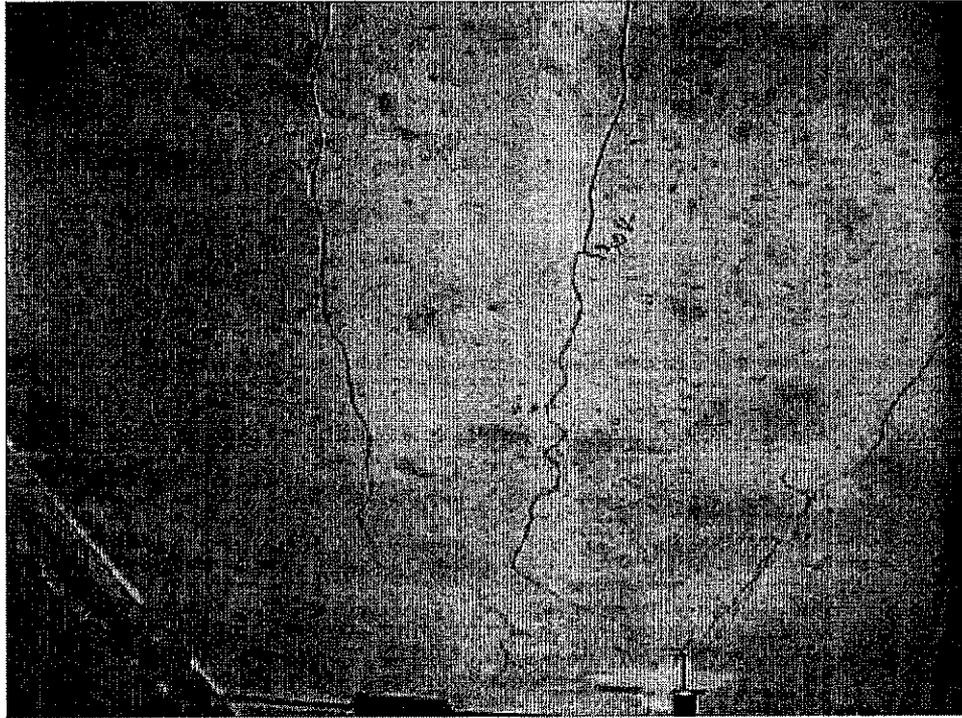
Fig. 7.34 Cracks at bottom of deck at 14 ft from central support at load of 552 kips during negative bending

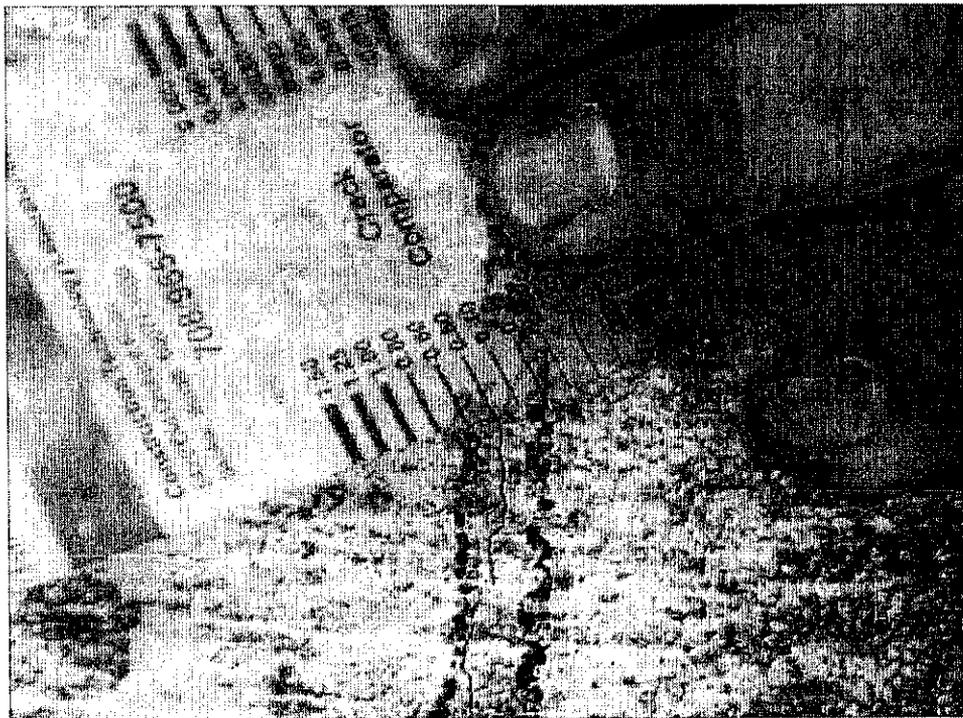
Fig. 7.35 Measuring of crack width after ultimate negative loading

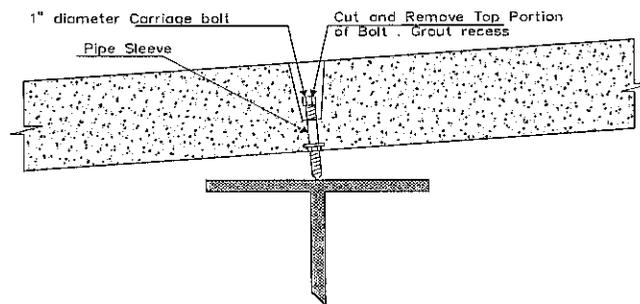
Fig. 8.2 Leveling Device
