State of Illinois  
DEPARTMENT OF TRANSPORTATION  
Division of Highways  
Bureau of Research and Development

INTERIM REPORT  
ON THE PERFORMANCE OF THE  
LAKE COUNTY INVERTED FLEXIBLE PAVEMENT

March, 1972

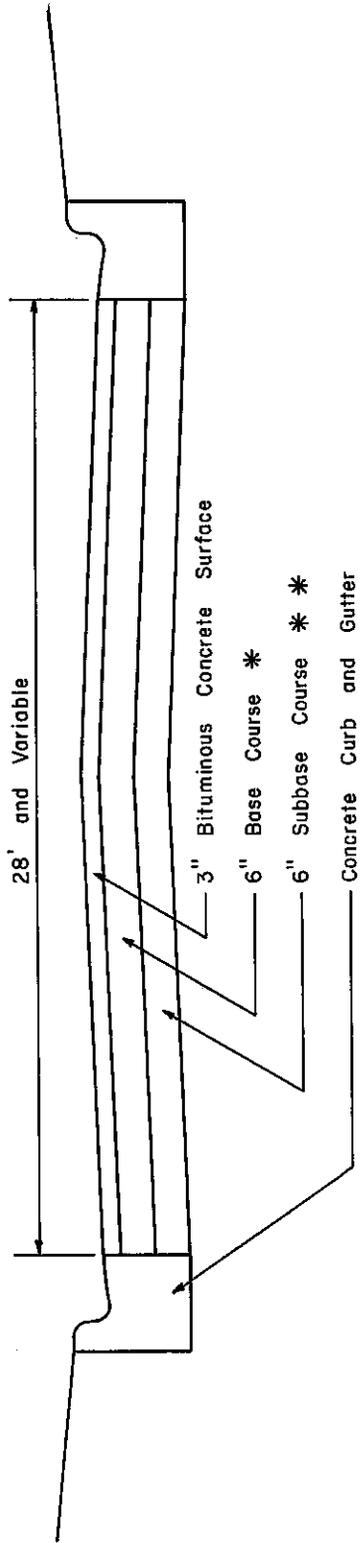
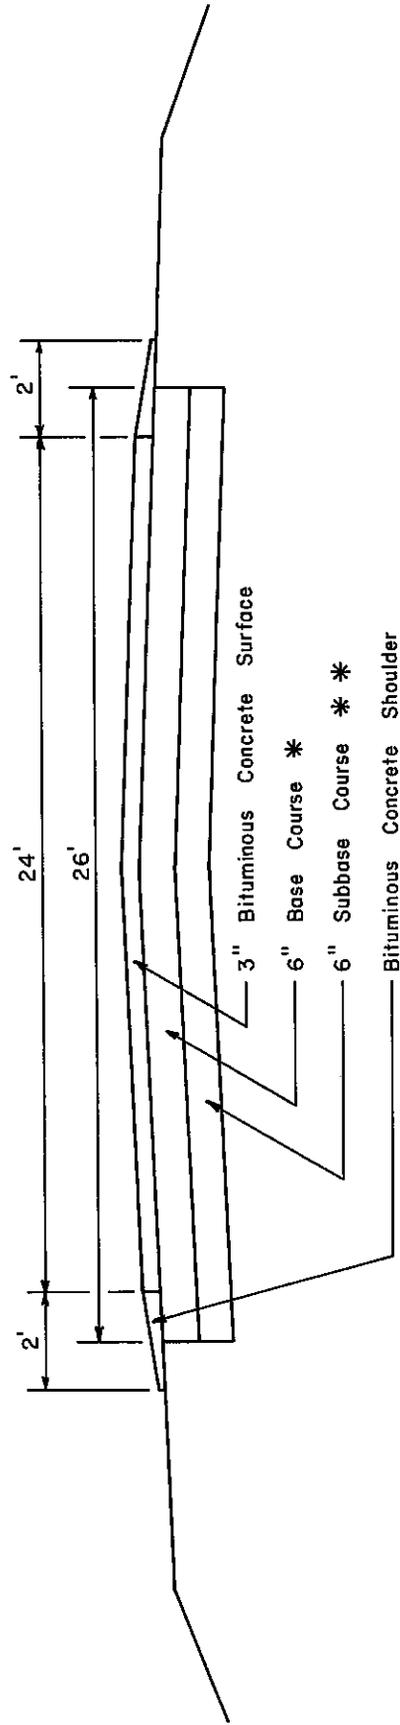
FIGURE 2. TYPICAL CROSS SECTIONS

TYPICAL URBAN SECTION

TYPICAL RURAL SECTION

<u>INVERTED DESIGN</u>	<u>CONVENTIONAL DESIGN</u>
* BASE	Crushed Gravel	Lime Flyash Stabilized Aggregate
** SUBBASE	Lime Flyash Stabilized Aggregate	Crushed Gravel

Mundelein, Illinois (Figure 1). Since the test site included both rural and urban areas, the experiment was designed to have four test sections with an inverted and a conventional pavement design in both the rural and urban portions. Typical cross sections of these designs are shown in Figure 2.

Subgrade soils throughout the test site consist predominately of A-7-6 (12-19) brown clays. Design analyses, using the Illinois design procedure for flexible pavement, indicated that a conventional pavement design of three inches of bituminous concrete surfacing (Illinois Class I), six inches of lime fly ash stabilized aggregate base (minimum compressive strength of 750 psi after a seven day moist cure at 130<sup>0</sup> F.) and six inches of crushed gravel subbase should be adequate for a twenty-year design life. For the inverted pavement design, the positions of the base and subbase materials were reversed. This allowed a direct comparison of the performance of the two designs.

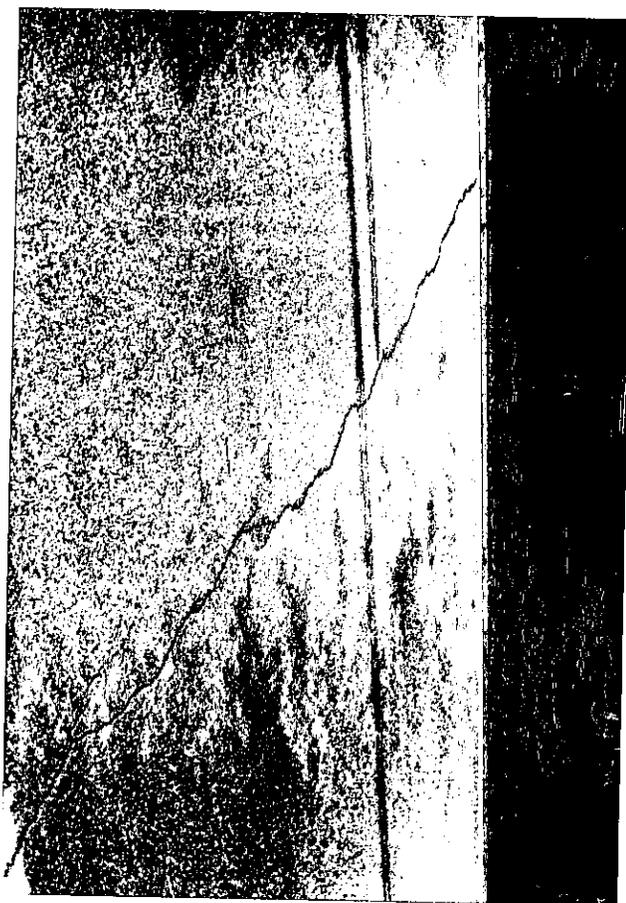
However, while fewer in number, the transverse cracks in the inverted pavement appear to be potentially more troublesome. Multiple cracking adjacent to transverse cracks has developed in most of the rural (67 percent of the cracks) and some of the urban (9 percent of the cracks) inverted pavement. A typical example is shown in Photo 1. Similar developments have not been viewed in the conventional pavements. A typical transverse crack in the conventional pavement is shown in Photo 2.

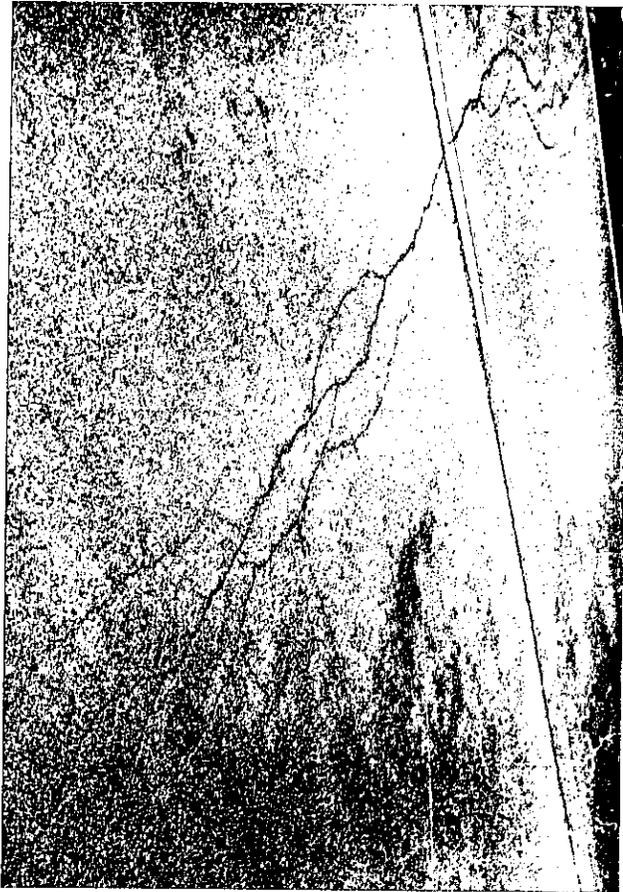
No significant difference between designs has been observed in the quantity of longitudinal cracking (Figure 4). However, here again the inverted pavement seems to offer the more potentially troublesome cracking. Multiple cracking is again in evidence, a minor amount of which has developed into alligator cracking. The longitudinal cracks in the conventional pavement have remained sharp and distinct. Typical examples of longitudinal cracks in the two designs are shown in Photos 3 and 4.
