State of Illinois
DEPARTMENT OF PUBLIC WORKS AND BUILDINGS
Division of Highways
Bureau of Research and Development

SOME TESTS OF STUDDED TIRES IN ILLINOIS

John E. Burke
Engineer of Research and Development

Preliminary Draft

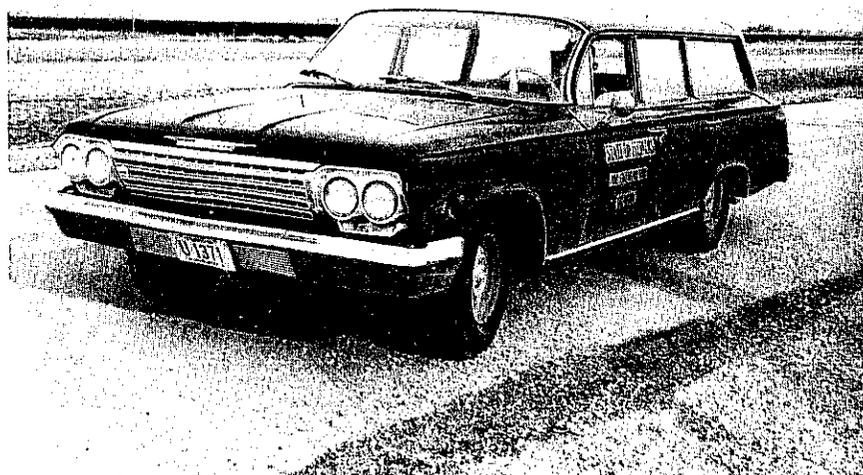
Figure 4. Studded tires by Goodyear were placed on all four wheels of a 1962 model Chevrolet station wagon.

108 tungsten carbide studs per tire, also arranged in two rows along each edge of the tread. The studs on these tires protruded on the average about 3/32" above the surface of the tread. The Goodyear tires were mounted on all four wheels of a 1962 Chevrolet station wagon (figure 4).
