Bituminous Overlay Policy

A Performance Evaluation

Physical Research Report No. 116
February 1995

Illinois Department of Transportation
Bureau of Materials and Physical Research

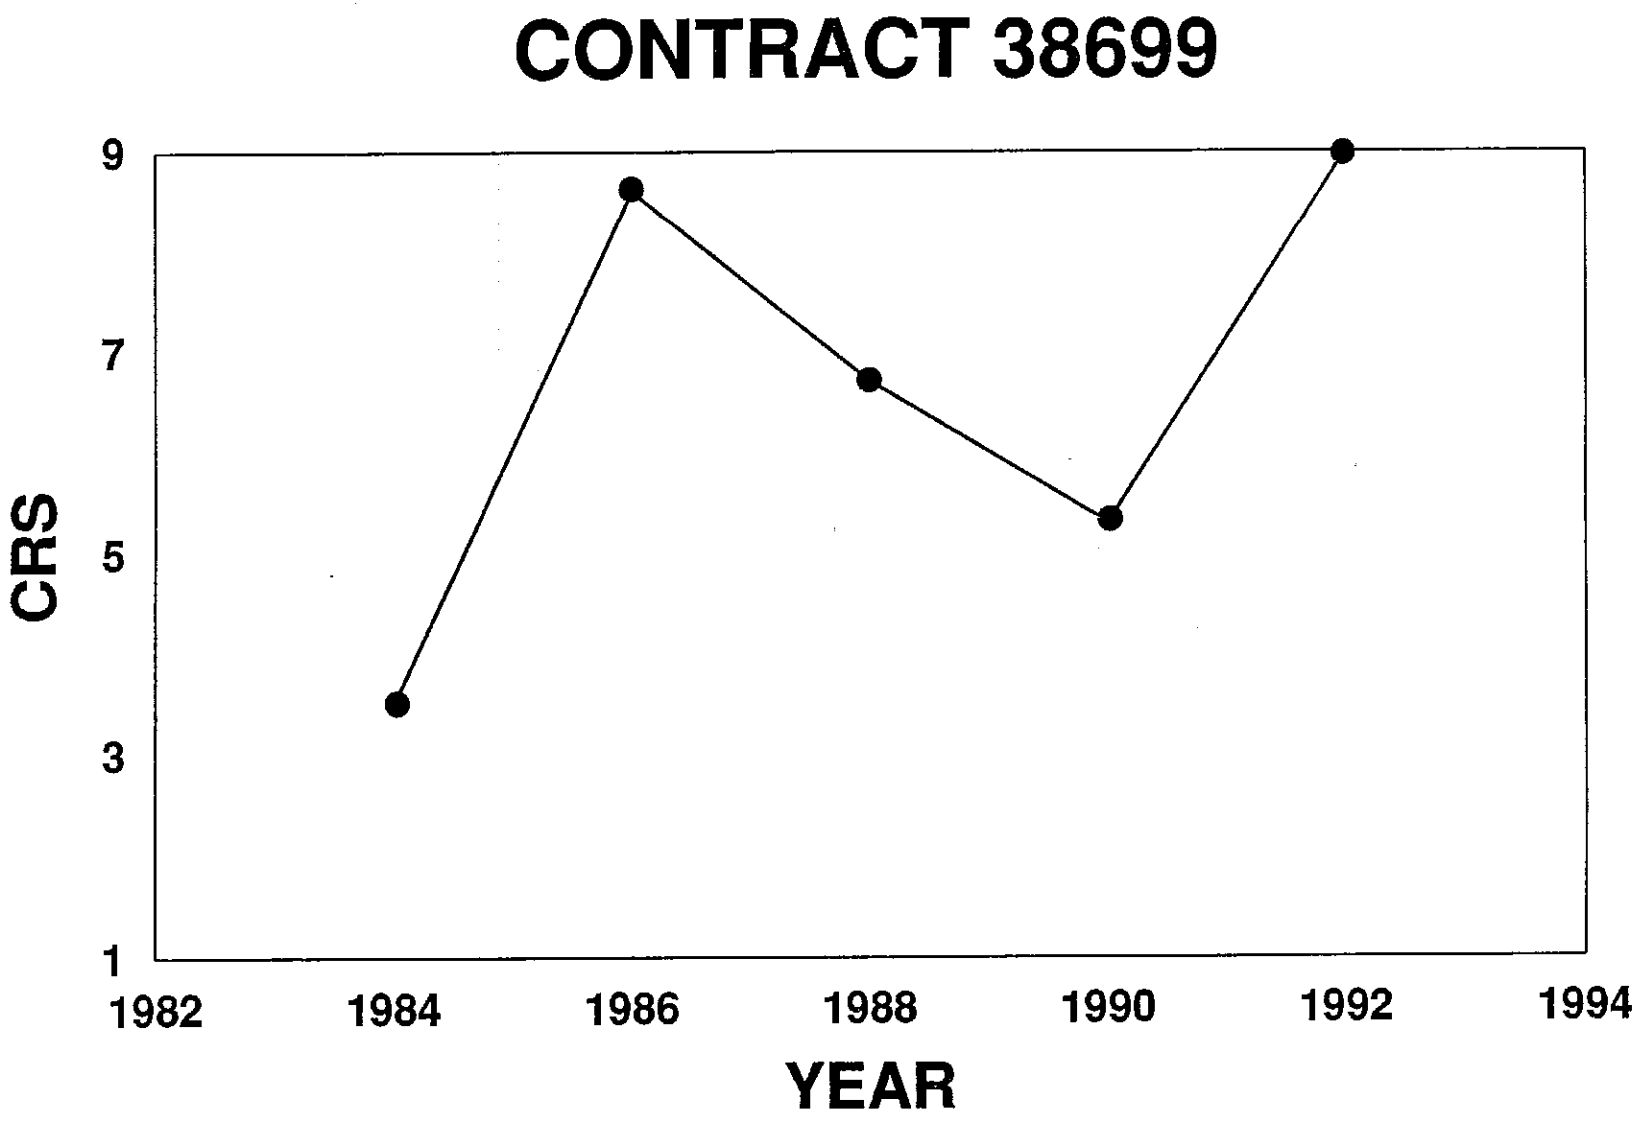
Figure 2: CRS History for Contract 38699

In 1991, after 6 years in service, a visual survey showed transverse cracking, centerline cracking, widening cracking, and block cracking. Most of the cracks were fairly open. None of the cracks were sealed. Deflection testing with the FWD showed poor subgrade support in general and approximately 8 areas where future patching and/or additional overlay thickness might be warranted. Figure 2 provides the CRS history of the project. This section was overlaid in 1992 at a CRS of 5.3. The 9.0 1992 CRS in Figure 2 reflects the condition rating after the overlay was placed.

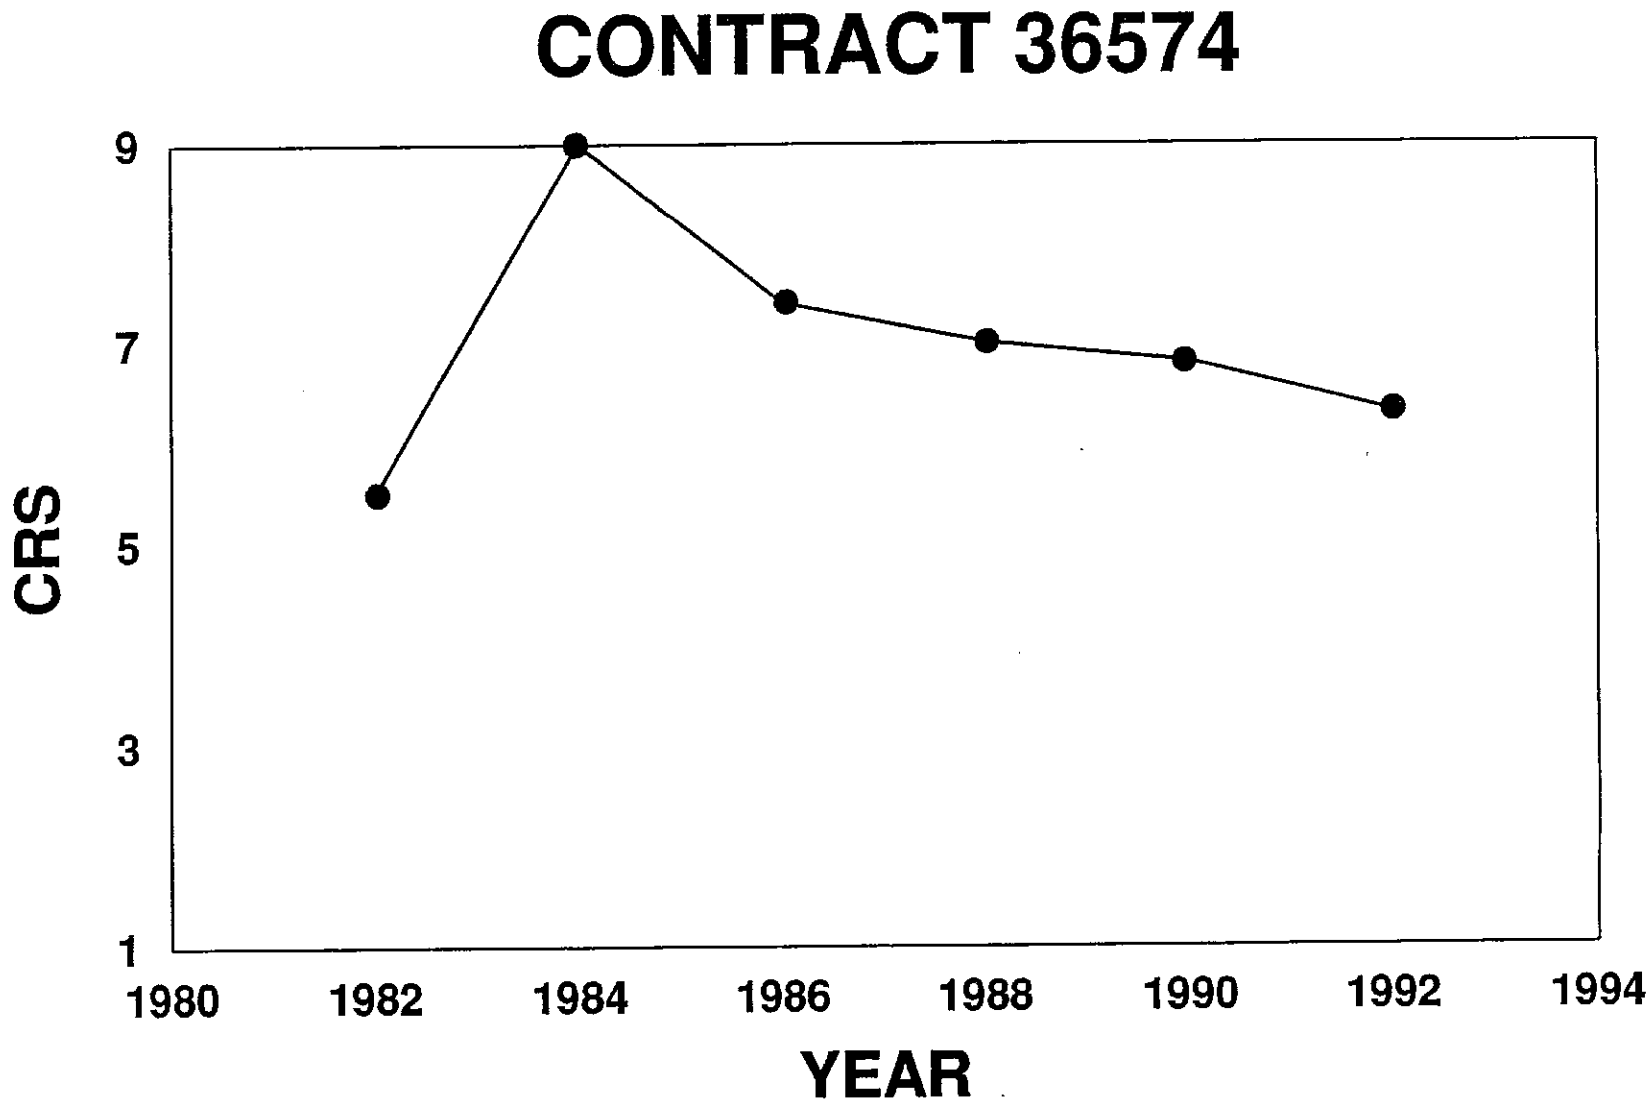
Figure 3: CRS History for Contract 36574

A visual survey was made of both sections in 1991. In Section 1, transverse, longitudinal, and centerline cracking was apparent. This cracking was inconsistent throughout the section. Belt cracking, a series of parallel and interconnecting cracks, was beginning to form. Alligator cracking, a sign of base failure, was noted infrequently. Approximately 80 yards of patching was needed based on the visual survey; deflection testing confirmed the need for isolated patching.

In Section 2, some transverse and longitudinal cracking was observed. In some areas, the centerline joint was beginning to deteriorate. Deflections were slightly higher in Section 2 than in Section 1, but the subgrade support was much higher (E_{Ri}, modulus of subgrade reaction, was 10.7 ksi in Section 2 as compared to 4.1 ksi in Section 1), reflecting the beneficial effect of the granular material. Deflection data had a lower coefficient of variability in Section 2 than in Section 1 (12.3 percent versus 38.1 percent).

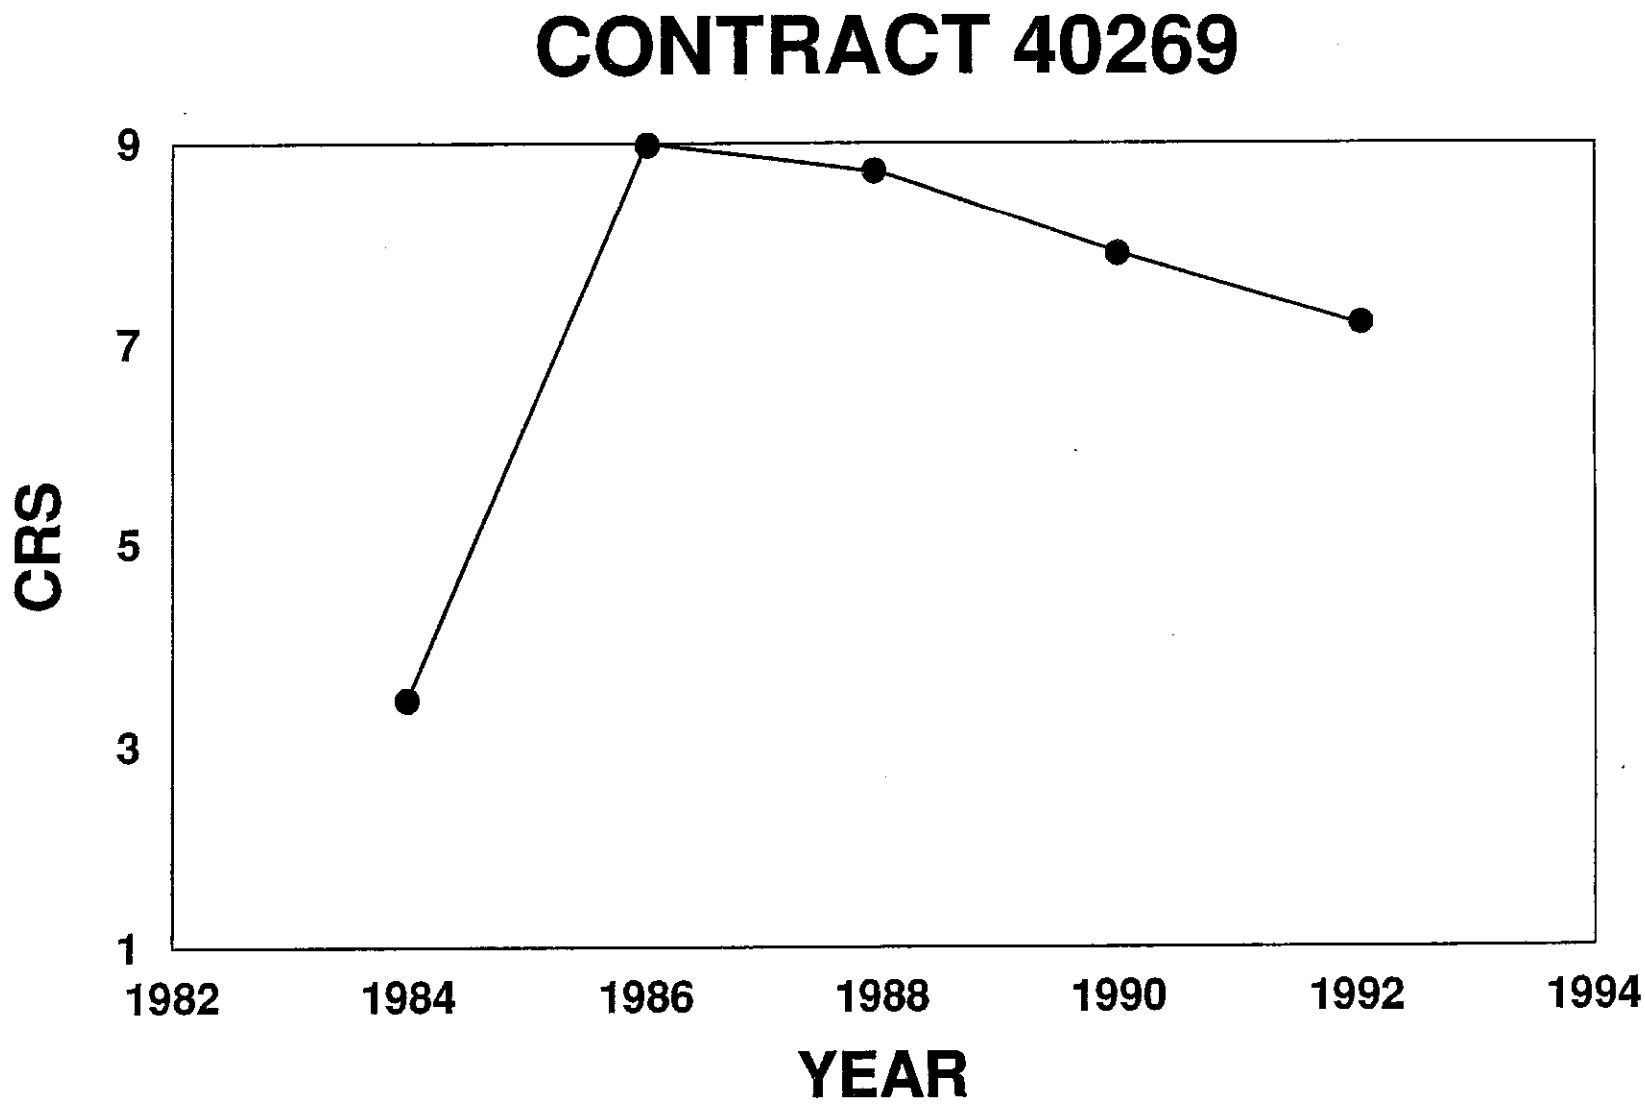
Figure 8: CRS History for Contract 40269

After 5 years in service, the 1991 visual survey showed that the centerline joint had opened up over the length of the job. Some widening cracking and random longitudinal cracking was found. The majority of the transverse cracks that reflected through the overlay had been sealed with a hot-poured joint sealer by Maintenance forces. Deflection testing showed the need for 1 to 2 patches per mile. Subgrade support averaged only 2.0 ksi for the section, surprising since this county is known for sandy subgrades capable of providing good support. The 1992 CRS was 7.2. Figure 8 shows the CRS history of contract 40269. This section is not scheduled for rehabilitation between FY 1995 and FY 1999.

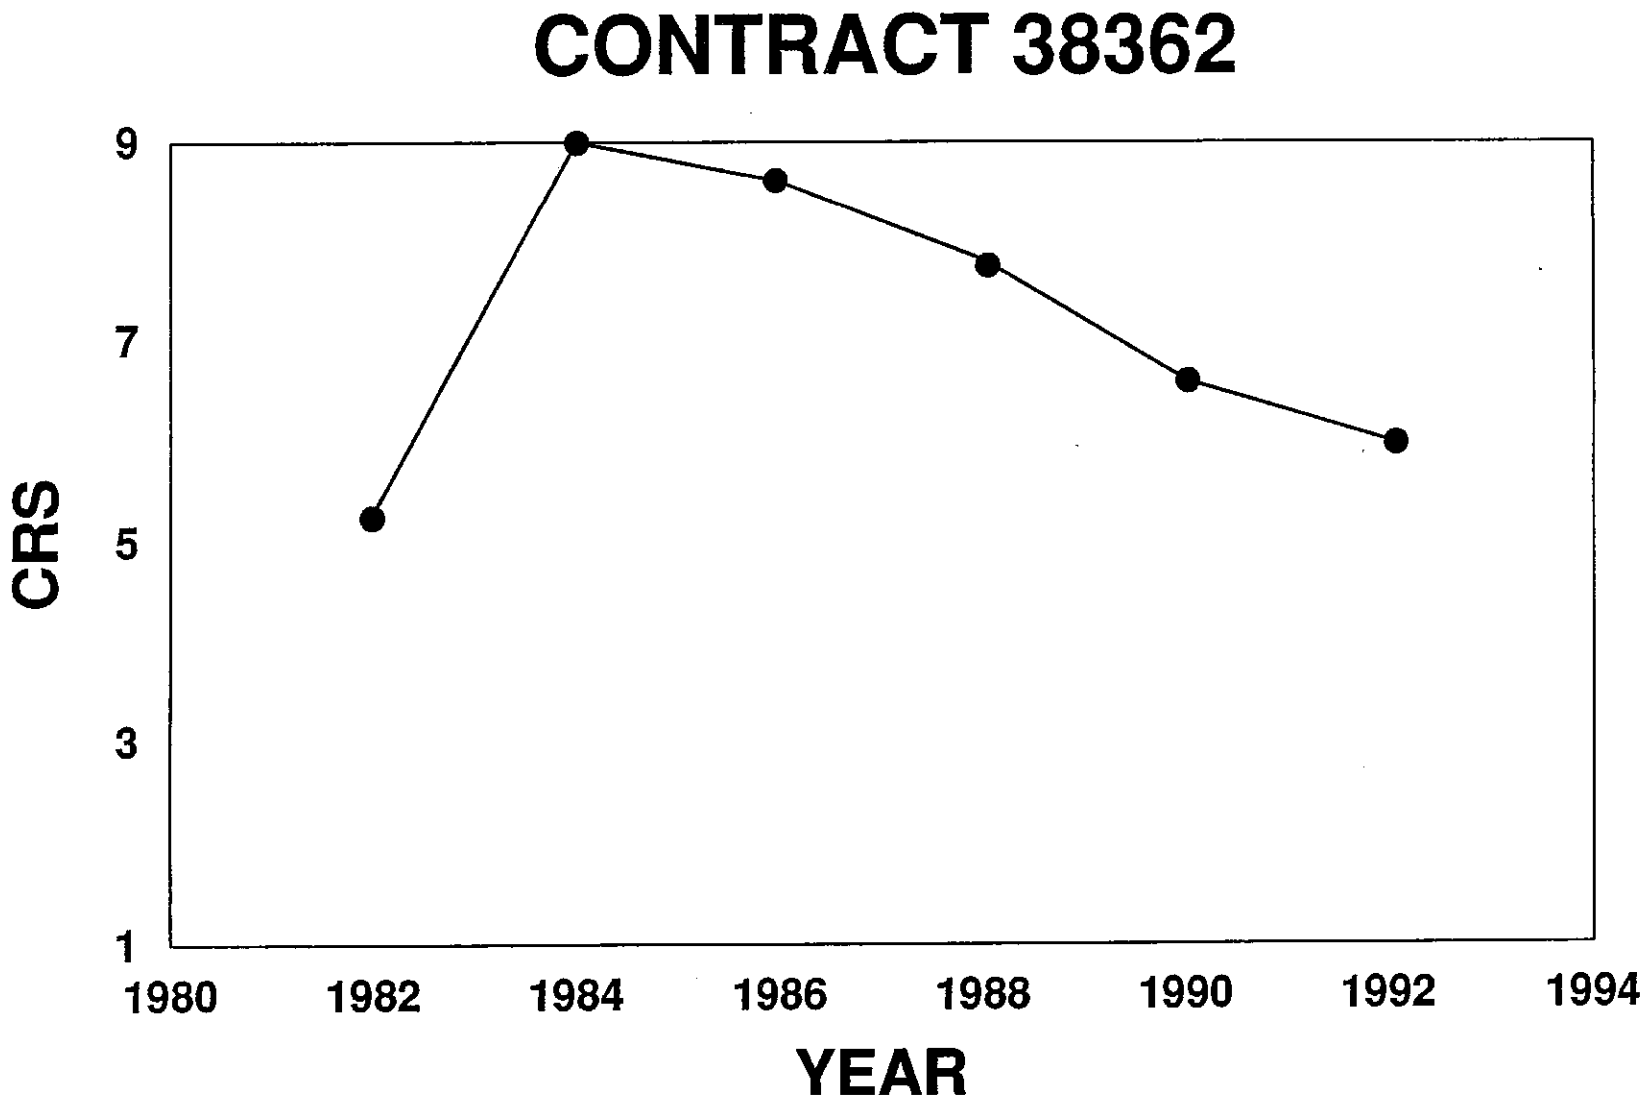
Figure 10: CRS History for Contract 38362

A visual survey was conducted in 1991. After 7 years in service, the policy first overlay showed transverse cracks with developed belt cracking, and centerline and center of lane cracking. Block cracking had also started to develop. Temporary patches had been placed with cold patch, and reflected patches were beginning to heave through the overlay. These same distresses were apparent in the policy second overlay, except to a much smaller degree. A few areas in need of patching were identified through deflection testing. A higher average deflection was found in the policy second overlay than in the policy first overlay (13.2 mils versus 5.1 mils). Figure 10 details the CRS history for this project. The 1992 CRS was 6.0. This section is not scheduled for rehabilitation in the FY 1995 to FY 1999 program.

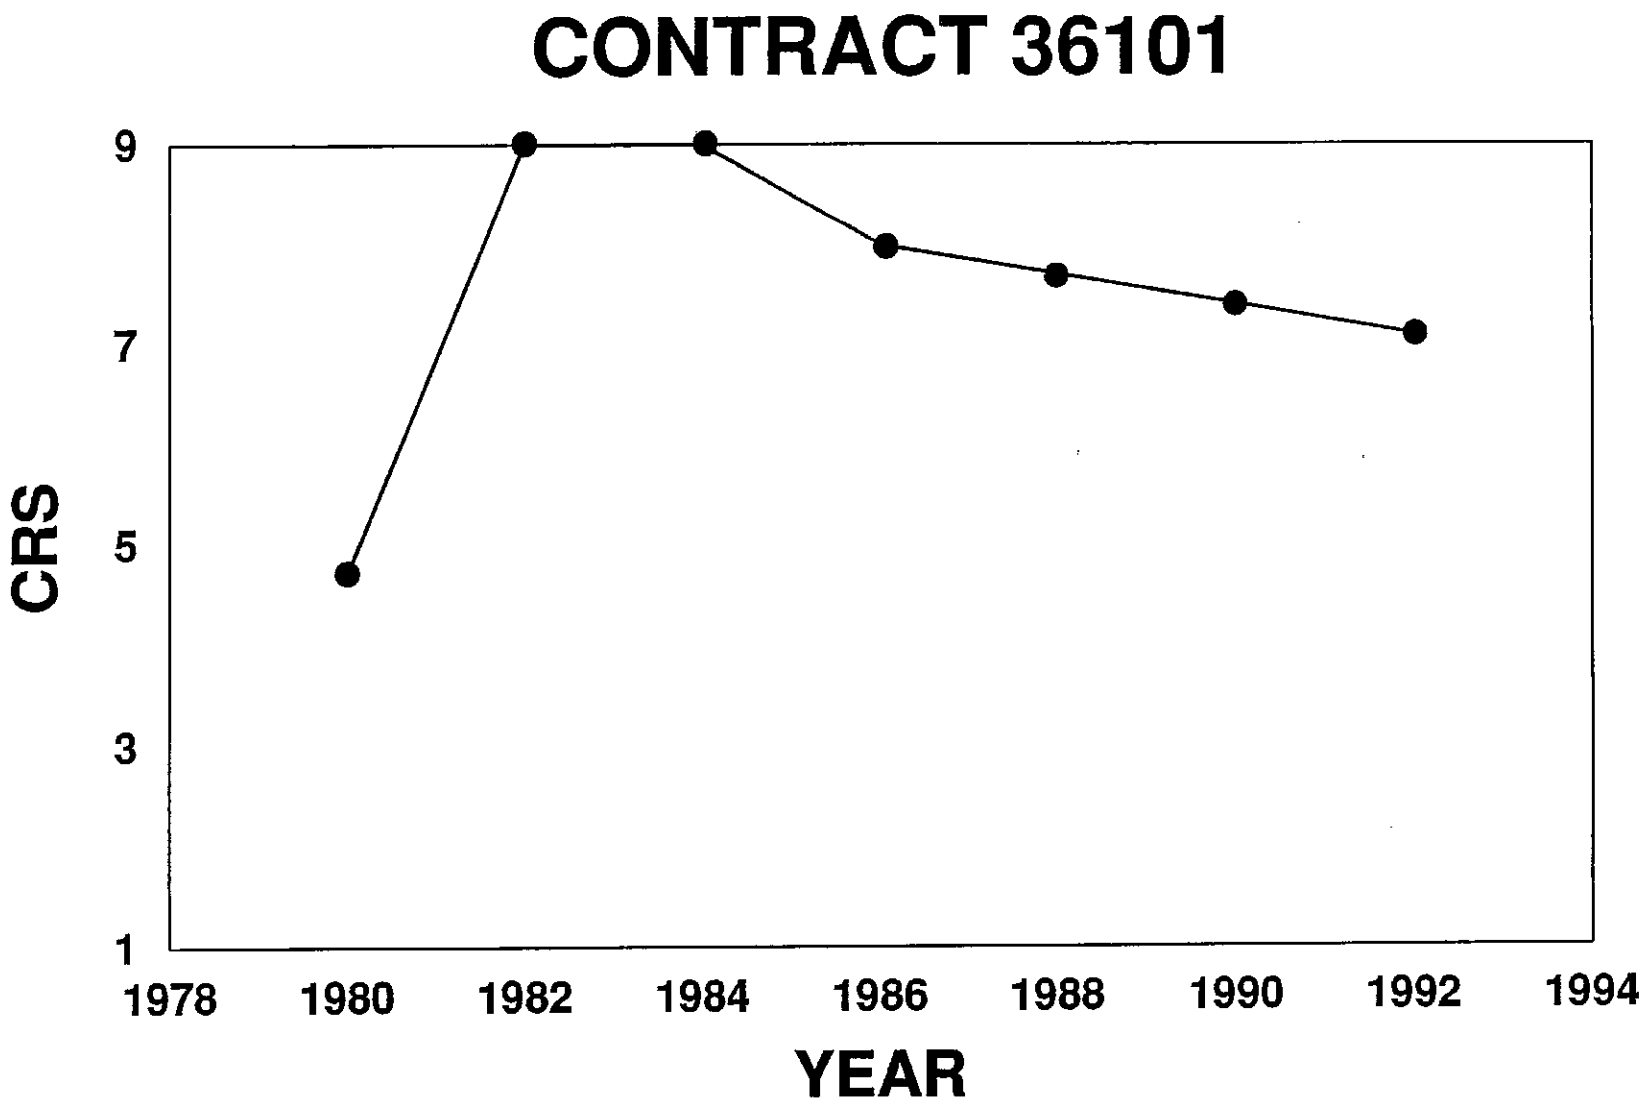
Figure 11: CRS History for Contract 36101

After 8 years in service, the 1991 visual survey showed transverse cracking with associated belt cracking as well as overlaid patch reflection cracking. Some random longitudinal cracking was also found. Deflection testing indicated only 2 areas in need of patching. In general, deflections were low and subgrade support was high. The CRS history for Contract 36101 is shown in Figure 11. The 1992 RS was 7.1, and as a result, this project is not scheduled for rehabilitation between FY 1995 and FY 1999.
