**INFRASTRUCTURE CONDITIONS  
ASSESSMENT**

**AMERICA'S CENTRAL PORT**

**MADISON, VENICE, AND  
GRANITE CITY, ILLINOIS**

December 30, 2021

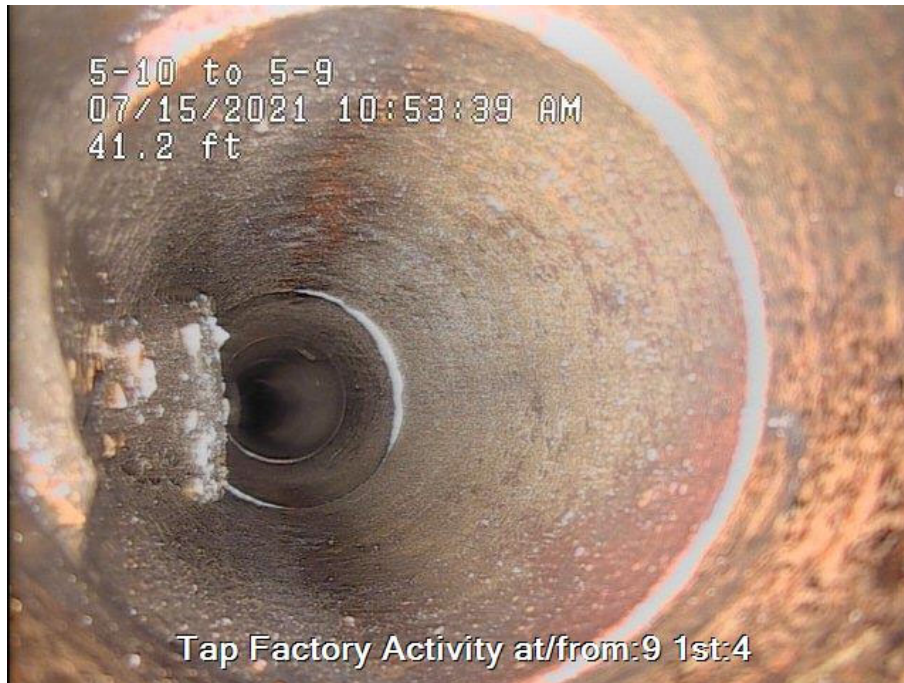
**Example: Factory Tap - Intruding on Pipe Area**

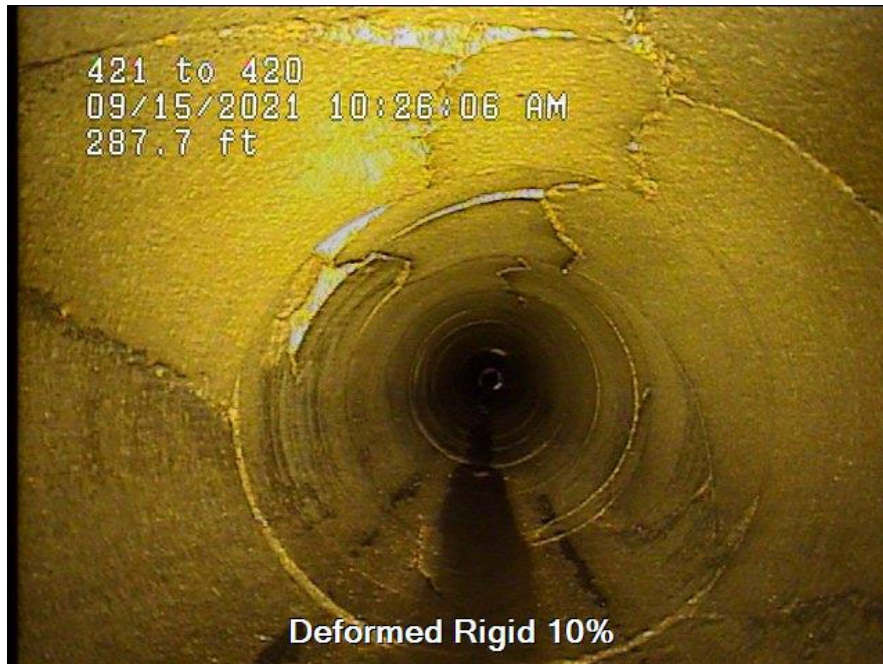
**Example: Deformed Pipe (Rigid)**

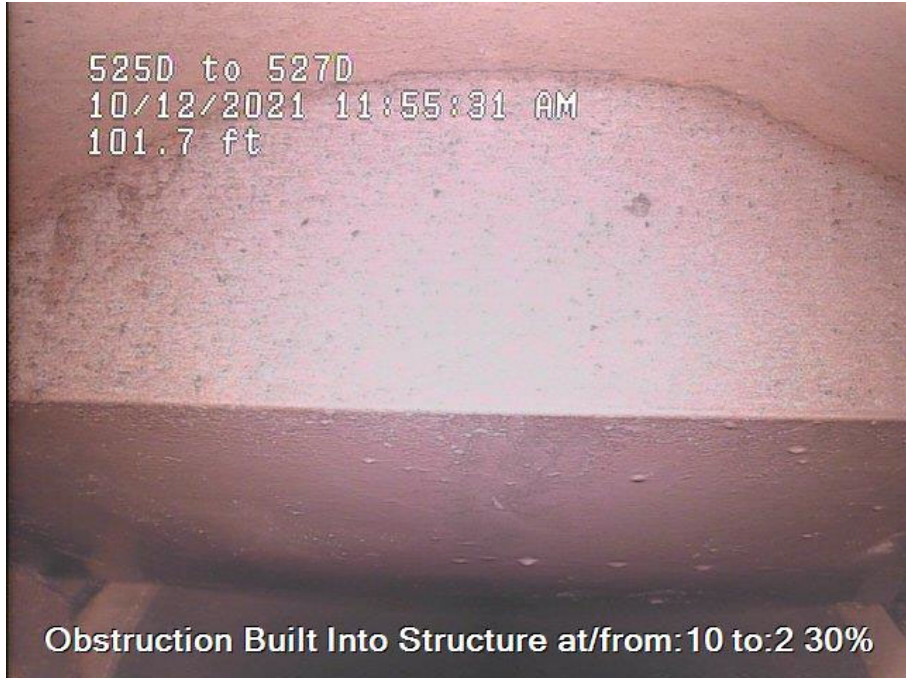
**Example: Obstruction Built into Structure**

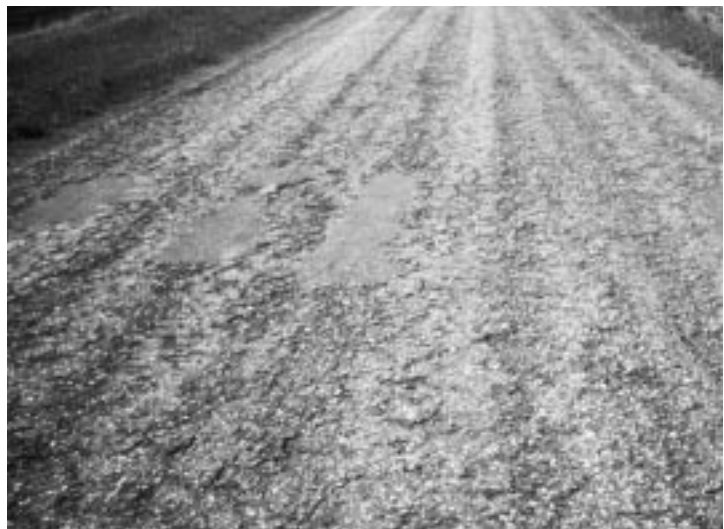
◀ Severe raveling and loss of surface material.

Raveling is progressive loss of pavement material from the surface downward, caused by: stripping of the bituminous film from the aggregate, asphalt hardening due to aging, poor compaction especially in cold weather construction, or insufficient asphalt content. Slight to moderate raveling has loss of fines. Severe raveling has loss of coarse aggregate. Raveling in the wheelpaths can be accelerated by traffic. Protect pavement surfaces from the environment with a sealcoat or a thin overlay if additional strength is required.

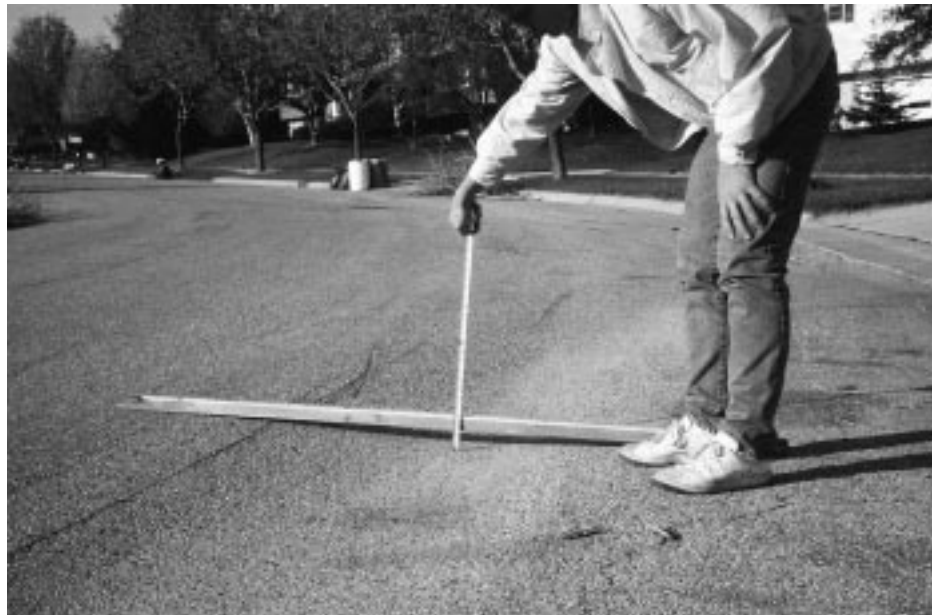
► Severe settling from utility trench.

Other pavement distortions may be caused by settling, frost heave, etc. Patching may provide temporary repair. Permanent correction usually involves removal of unsuitable subgrade material and reconstruction.

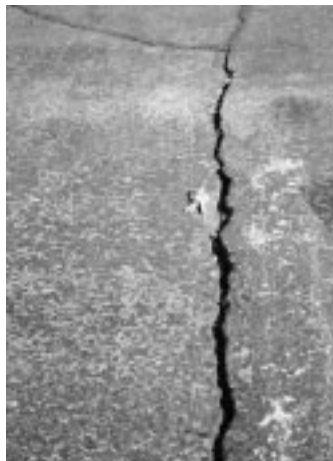
▲ Open crack – 1/2" or more in width.

Prevent water intrusion and damage by sealing cracks which are more than 1/4" wide.

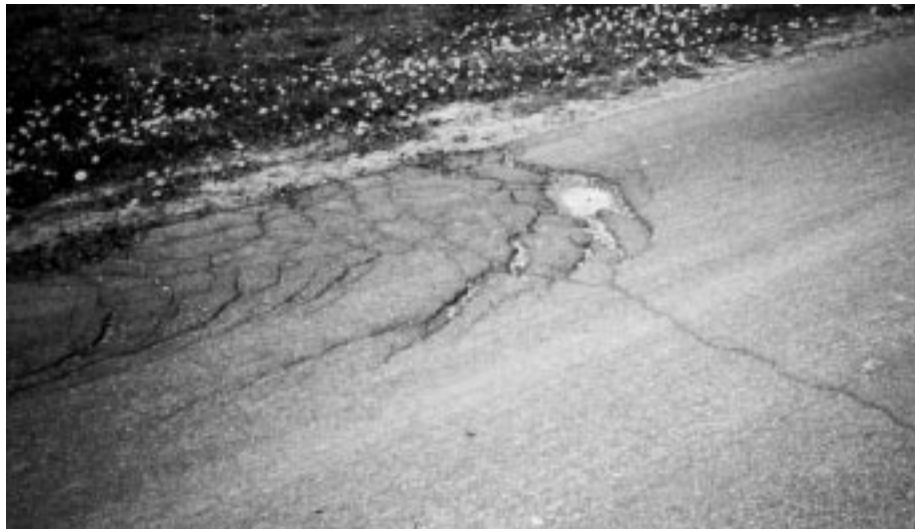
Crescent or rounded cracks in the direction of traffic, caused by slippage between an overlay and an underlying pavement. Slippage is most likely to occur at intersections where traffic is stopping and starting. Repair by removing the top surface and resurfacing using a tack coat.

►  
**Crescent-shaped cracks characteristic of slippage.**

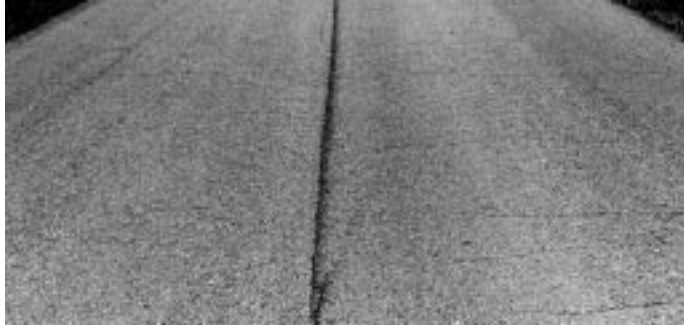
Centerline crack (still tight). ▶

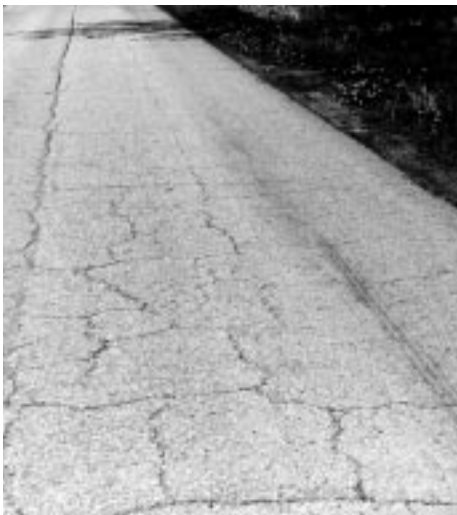
▲ **Extensive block cracking in an irregular pattern.**

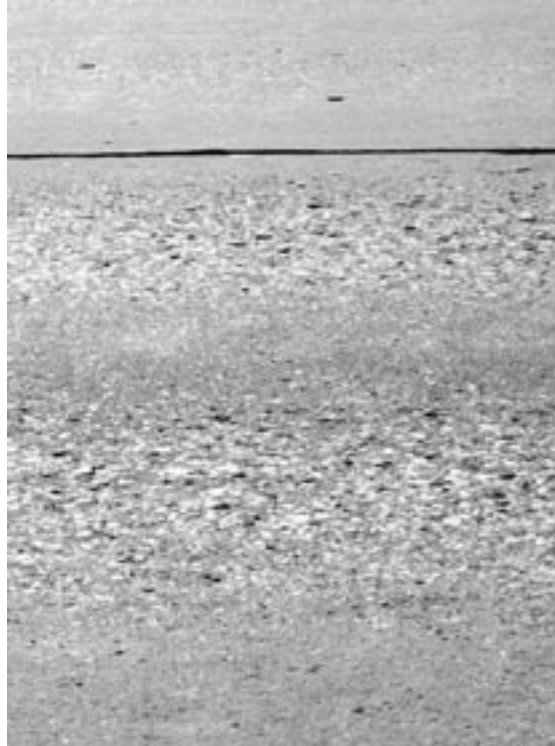
▶ **Surface mortar worn away exposing larger aggregate. Accidents or friction testing may indicate a slippery surface in need of improved texture.**

A worn or polished surface may appear from traffic wearing off the surface mortar and skid resistant texture. Extensive wear may cause slight ruts where water can collect and cause hydroplaning. Sometimes traffic may polish aggregates smooth, causing the surface to be slippery. An asphalt overlay or grinding of the concrete surface can restore skid resistance and remove ruts.

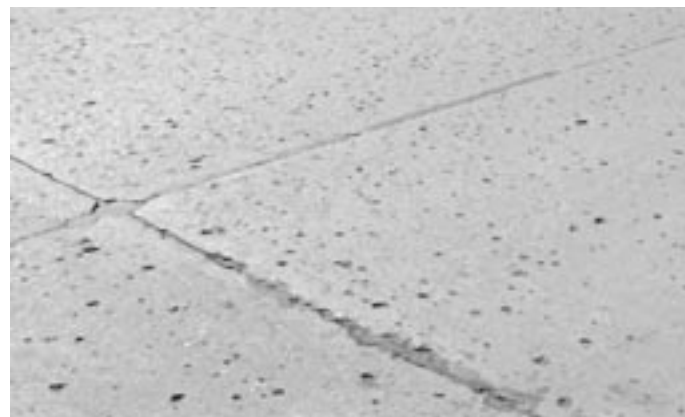
◀ **Extensive pop-outs of large aggregate from surface. Pop-outs alone have not affected pavement serviceability.**

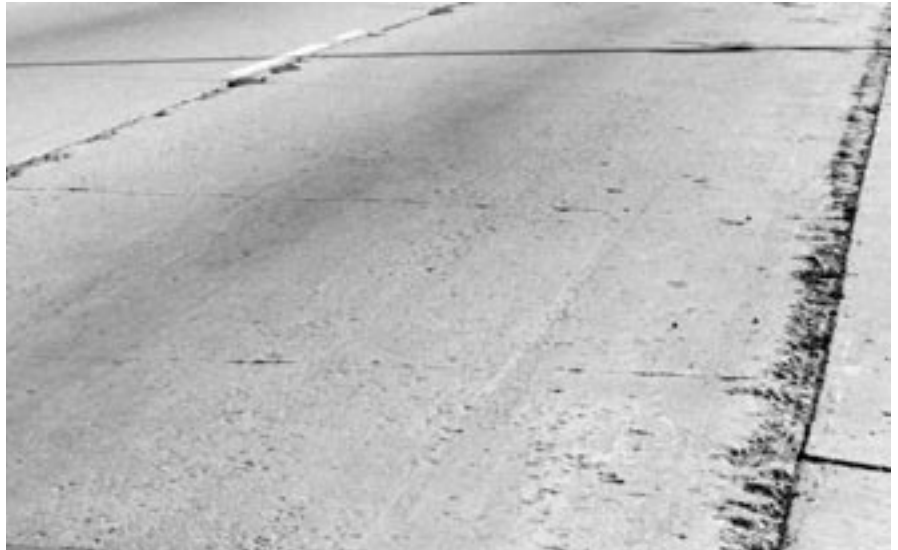
▶  
Spalling along  
longitudinal  
joints.

Repair will depend on the cause. Small spalled areas are often patched. Spalling at joints may require full depth joint repair.

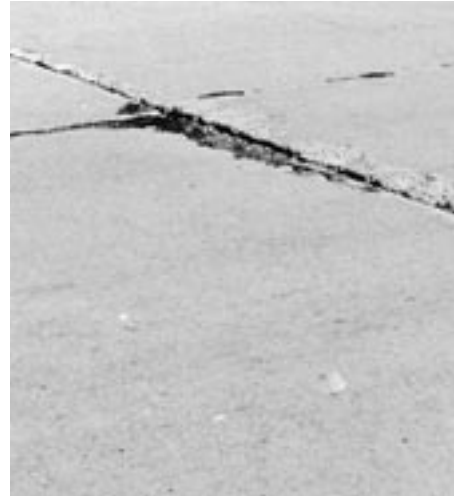
▼ **Transverse joint has slight faulting and spalling.**

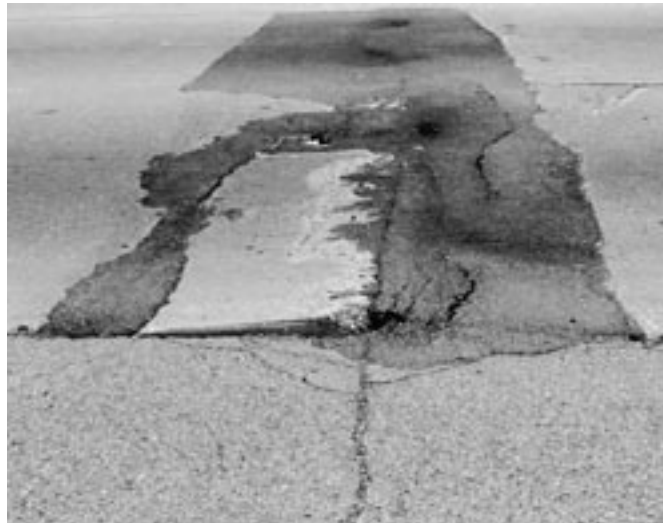
◀ Internal pressure has partially raised slab at the joint. Complete replacement is required.

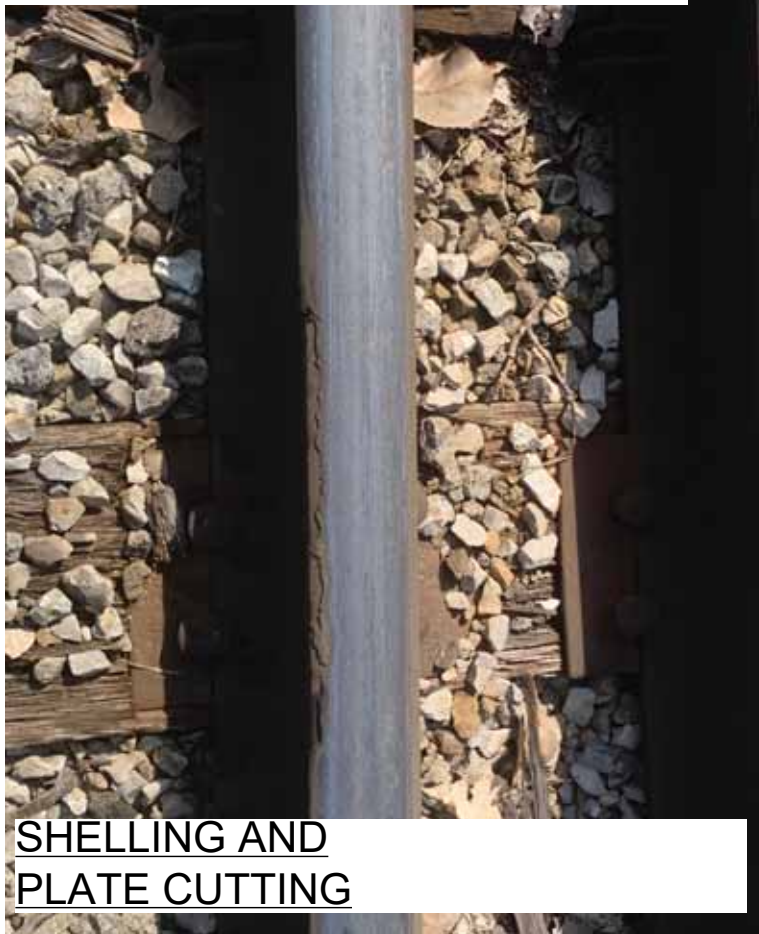
SHELLING AND PLATE CUTTING

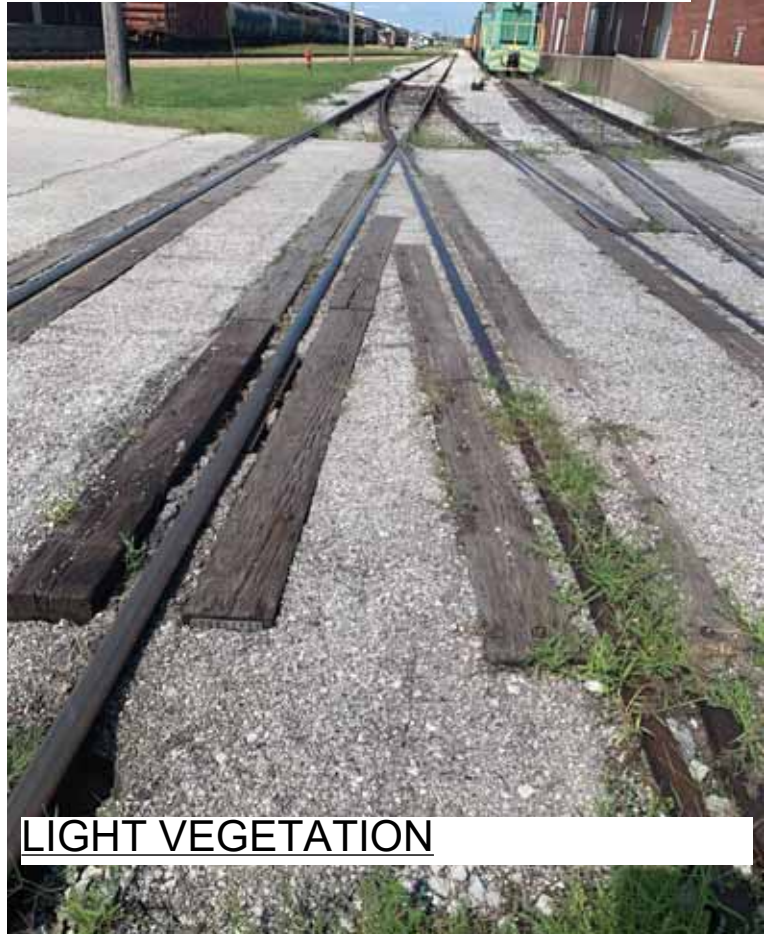
LIGHT VEGETATION

- b. Vegetation should be managed with an application of weed spray or other environmentally approved method on an annual basis or as site conditions require extending at a minimum of twelve (12) feet from centerline of track.

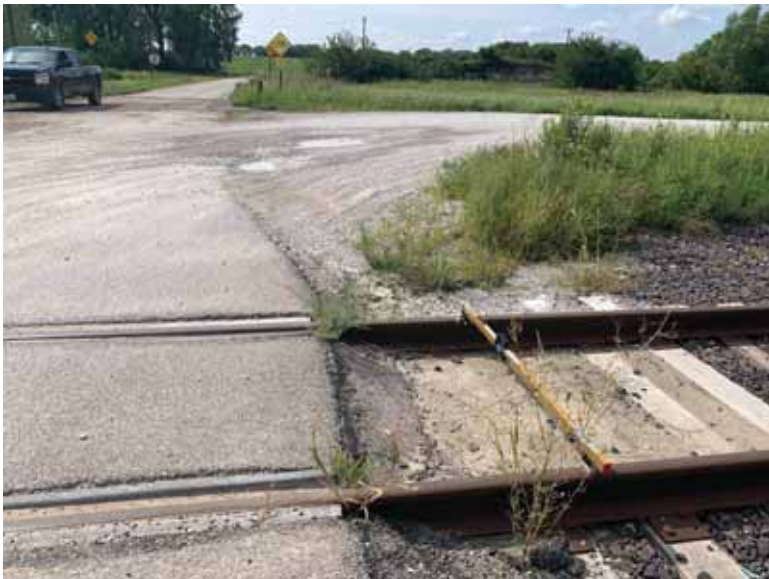
FOULED TRACK BALLAST AND LACK OF POSITIVE DRAINAGE

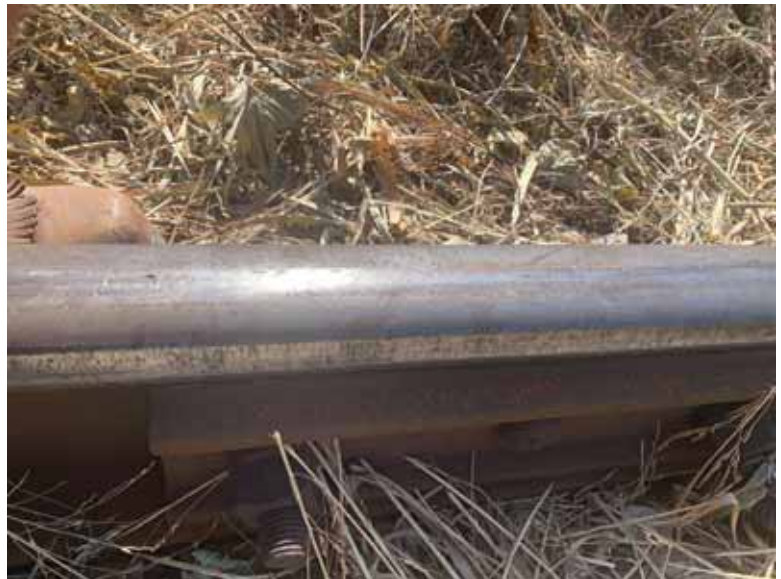
EXCESSIVE WEAR ON GAUGE SIDE OF RAIL

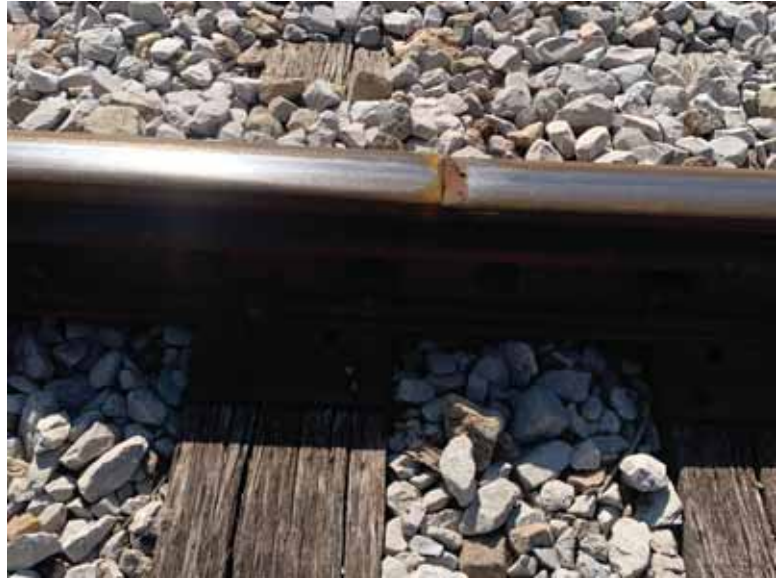
RAIL END BATTER (CHIPPED)

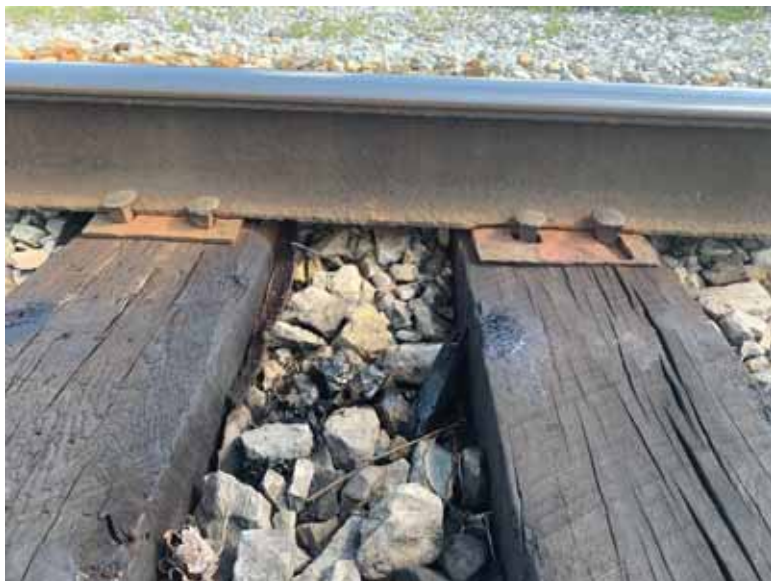
WEB AND BASE CORROSION OF SINGLE SHOULDER TIE PLATES

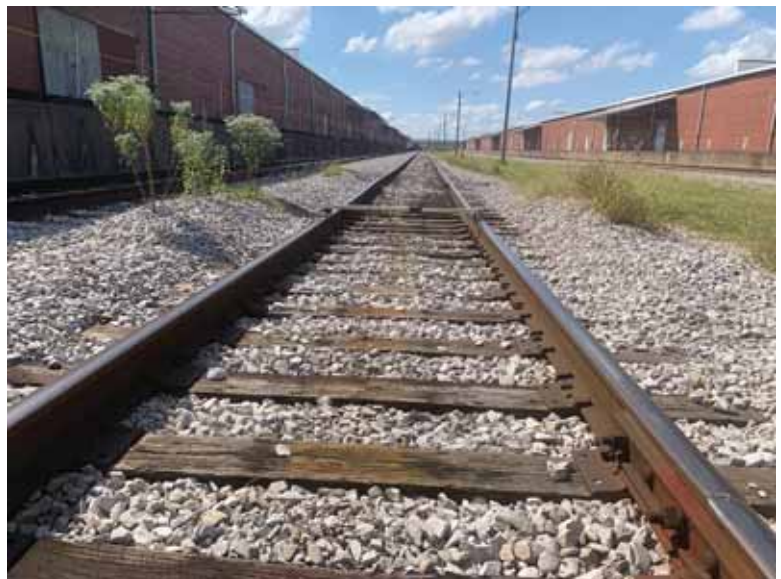
PROFILE DIP FROM SUBGRADE INSTABILITY HEAVING TRACK BALLAST SHOULDERS

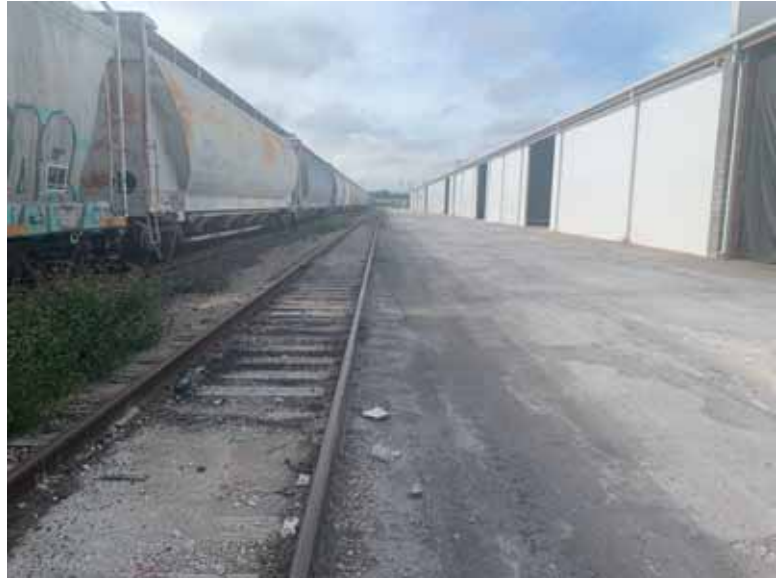
FOULED TRACK BALLAST FROM LACK OF ADEQUATE DRAINAGE

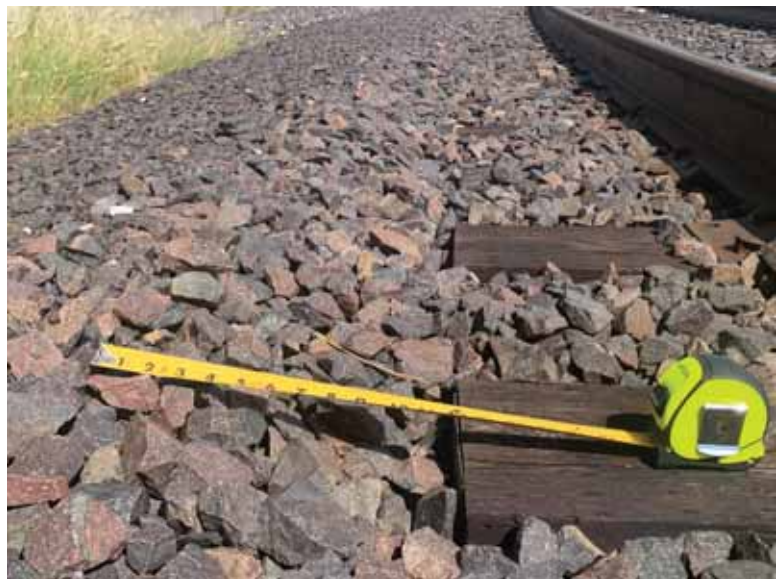
LATERAL TRACK MOVEMENT HEAVING BALLAST SHOULDERS

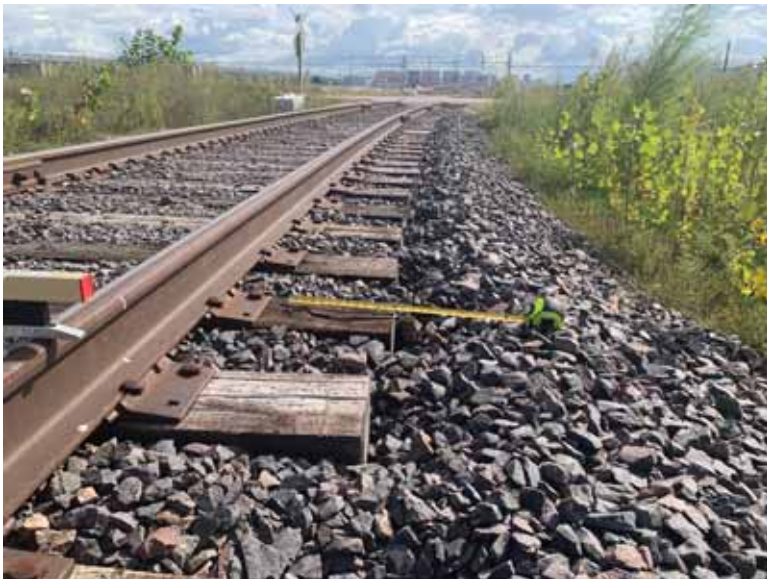
LATERAL MOVEMENT WITH BALLAST GAP AT TIE ENDS

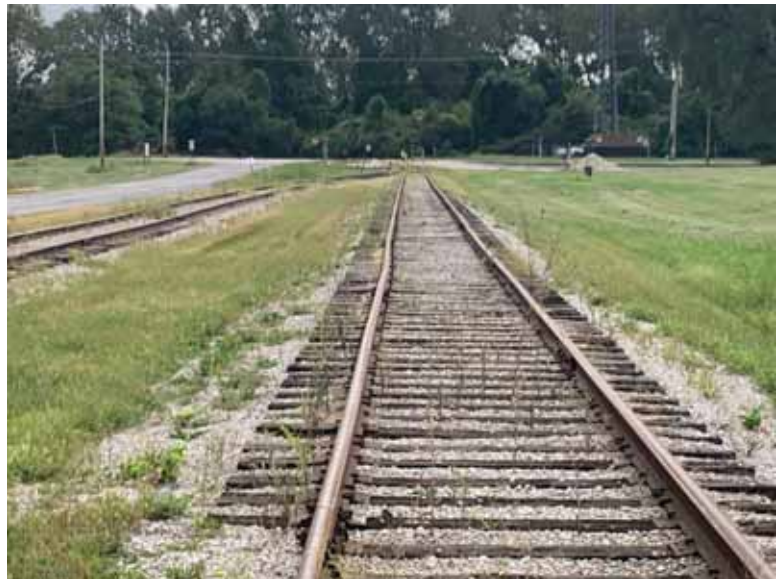
TRACK MISALIGNMENT WITH SHALLOW TIE CRIBS

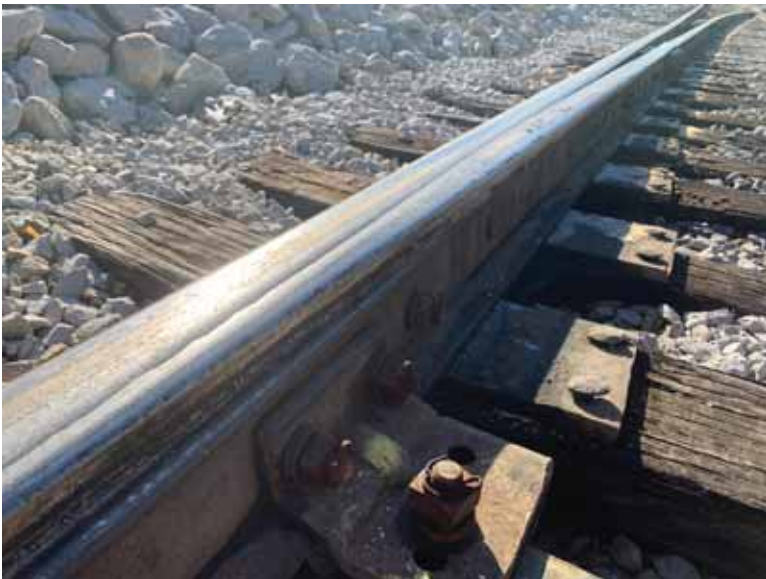
ABRASIVE SWITCH POINT WEAR WITH LIPPING ONTO STOCK RAIL

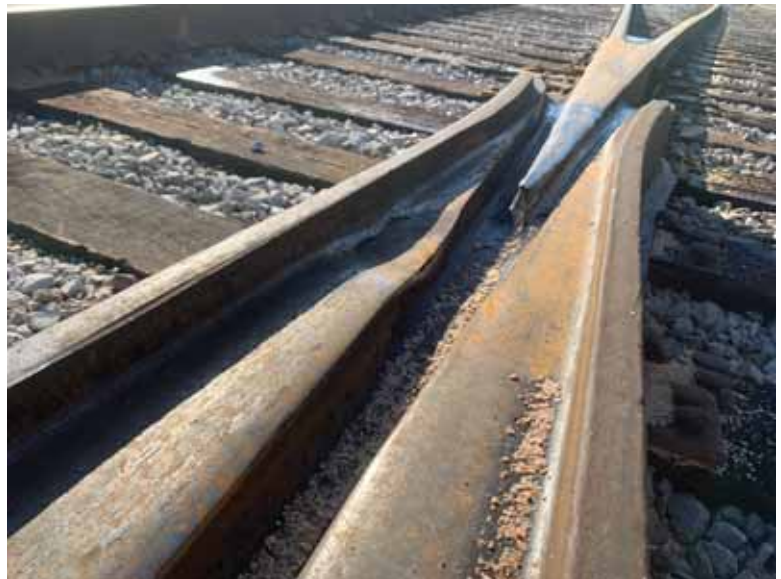
DEFORMED FROG WITH CRUSHED HEAD ALONG WING RAIL
