Design, Construction, and Analysis of CRCP Patching Techniques

Physical Research Report No. 124

March 1998

Illinois Department of Transportation
Bureau of Materials and Physical Research

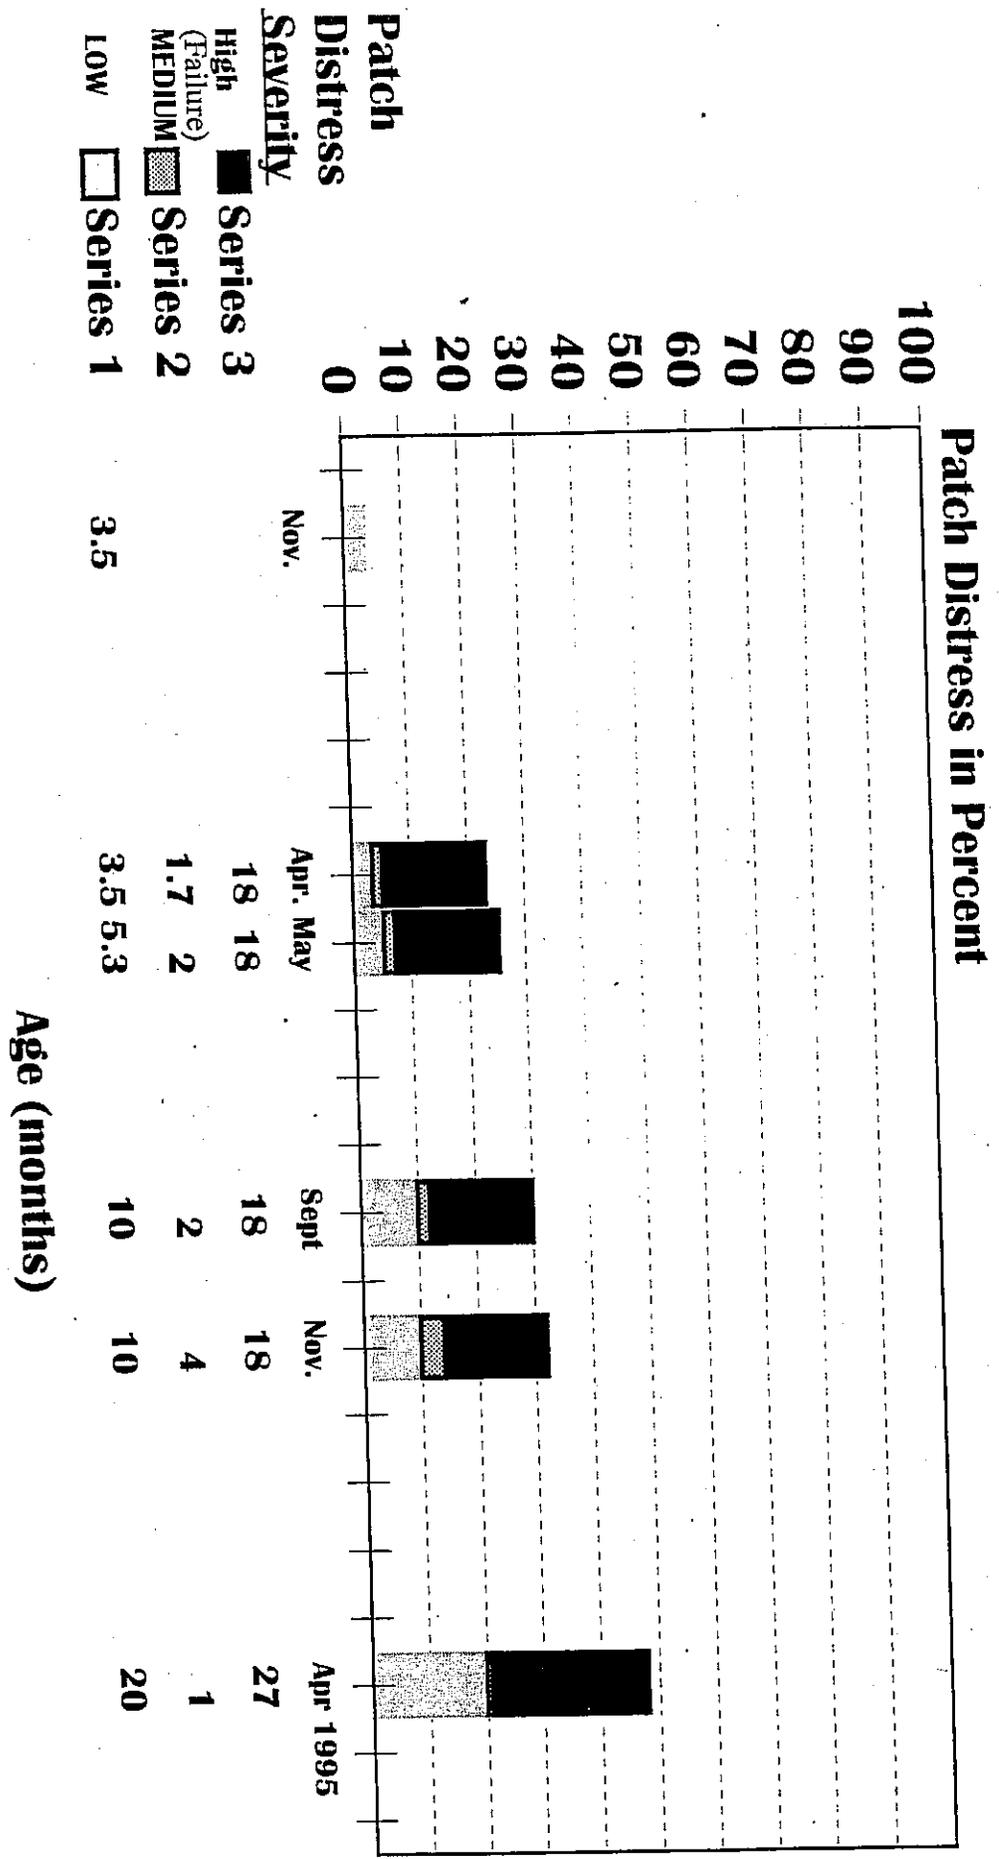
Figure 3. Conventional Class 'A' Patch Design

distress ranged from medium and high severity transverse cracking to pumping of fines and faulting, followed by patch failure. Seventeen percent of the conventional patches failed within 1 month, as shown in Figure 3. Many of these failures were severe in nature. It was evident that patch cracking resulted at existing steel junctions 1 month after construction when mechanical bar couplers were used instead of the lap-splice method. The data also showed a consistent deterioration rate with similar distress stages from patch to patch. However, the conventional Class A patch has a fair or moderate reliability if constructed according to standard policies and procedures.

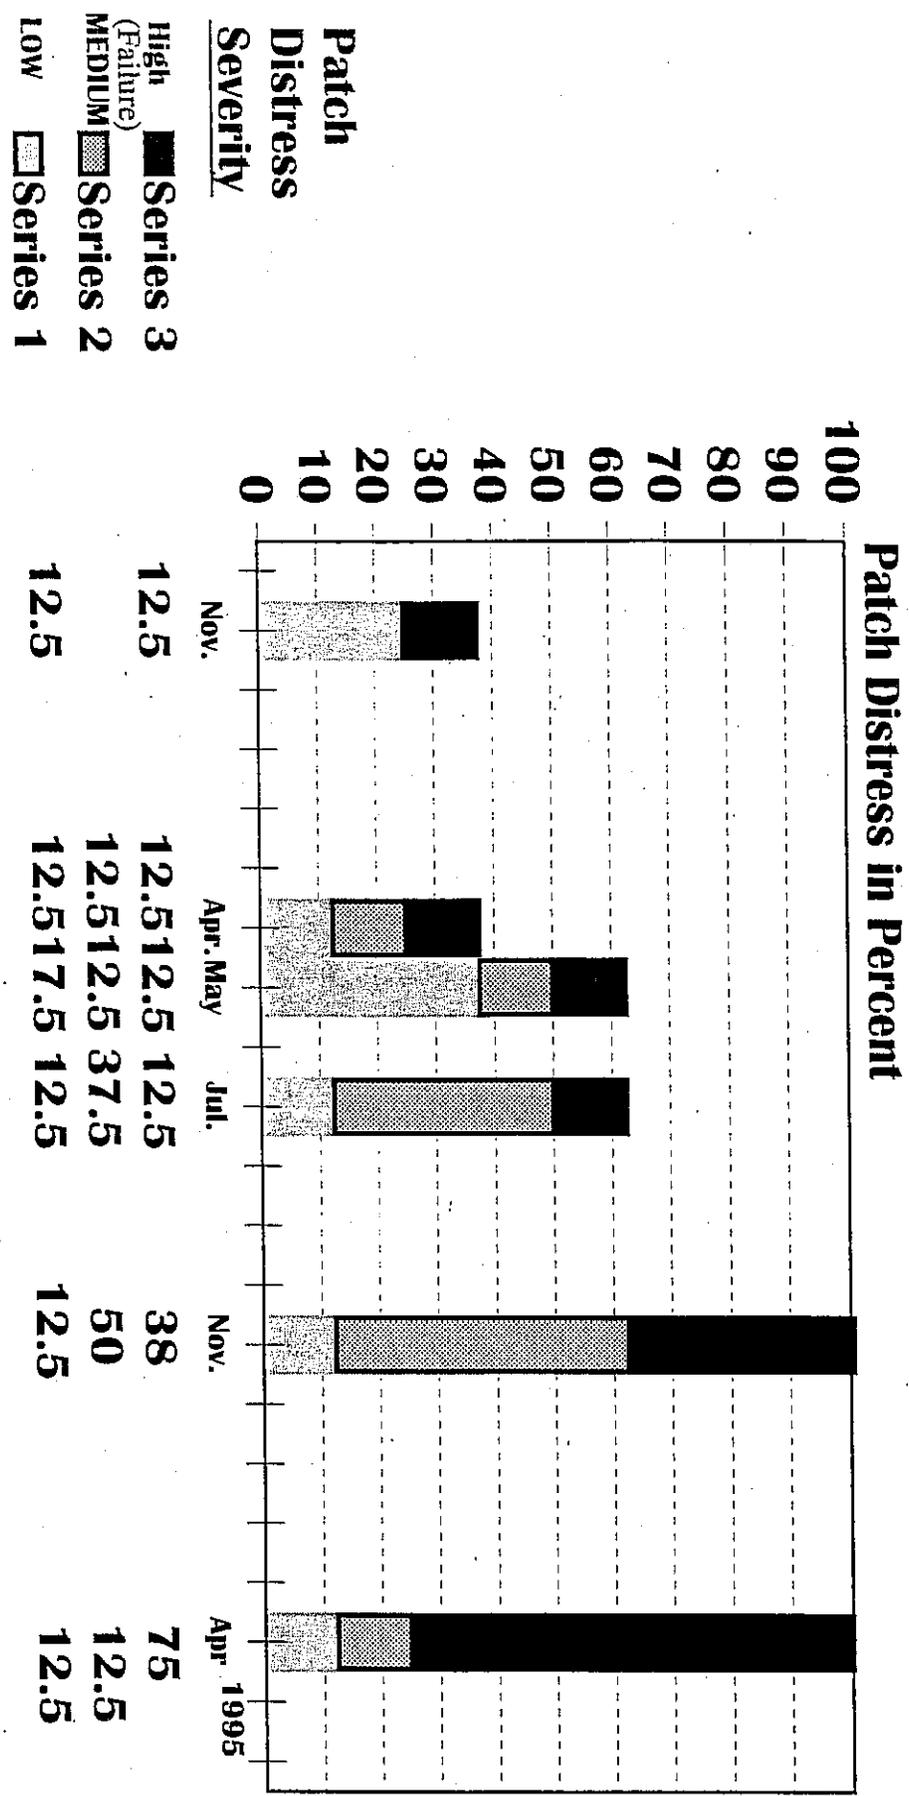
Figure 5. High-Early Strength Patch Design

Survey data analysis indicates an 80% patch failure rate after 2 years, as shown in Figure 5. Serious transverse cracks and spalling occurred at a higher rate than the standard concrete mixture. The surface of the concrete at Site 4 in Sangamon County appeared cracked or crazed (many fine cracks) soon after curing. The crack pattern produced pieces of concrete that eventually worked loose from the surface. It was noted that the recommended calcium chloride dose was exceeded. This may explain the surface crazing in the repair. Caution is needed in maintaining a maximum of 2% by weight of cement, and no more than 1% when the ambient temperature is above 80° F. This is to avoid a flash set and excessive heat of hydration. Further concerns on the use of calcium chloride include the corrosive properties imparted to the reinforcing bars. For further information, refer to the "Manual of Concrete Proportioning and Testing" issued January 1, 1988 (Reference 2).

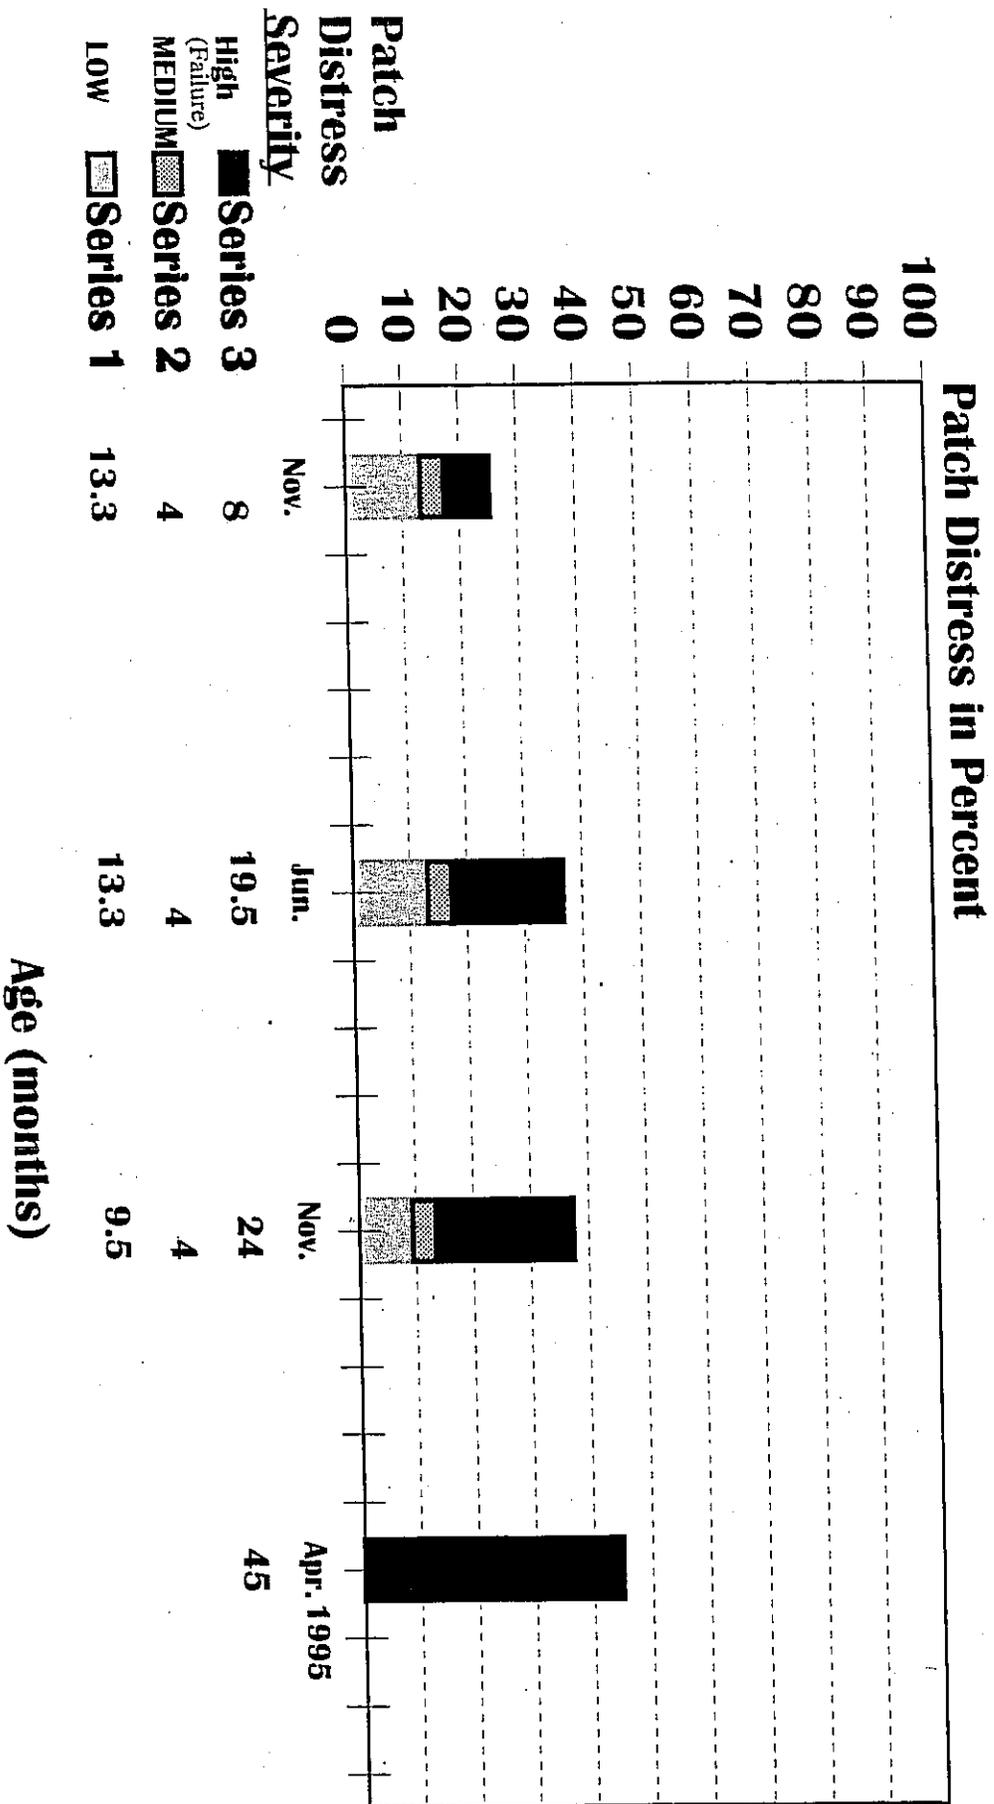
Figure 6. Drilled-Tied Patch Design

pavement removal. Between Site 2 in Macoupin County, Site 3 in Montgomery County, and Site 5 in Douglas County, 75 drilled-tied patches were constructed and studied. Survey data analysis indicates that 45% of the patches failed in the two-year study period (see Figure 6).

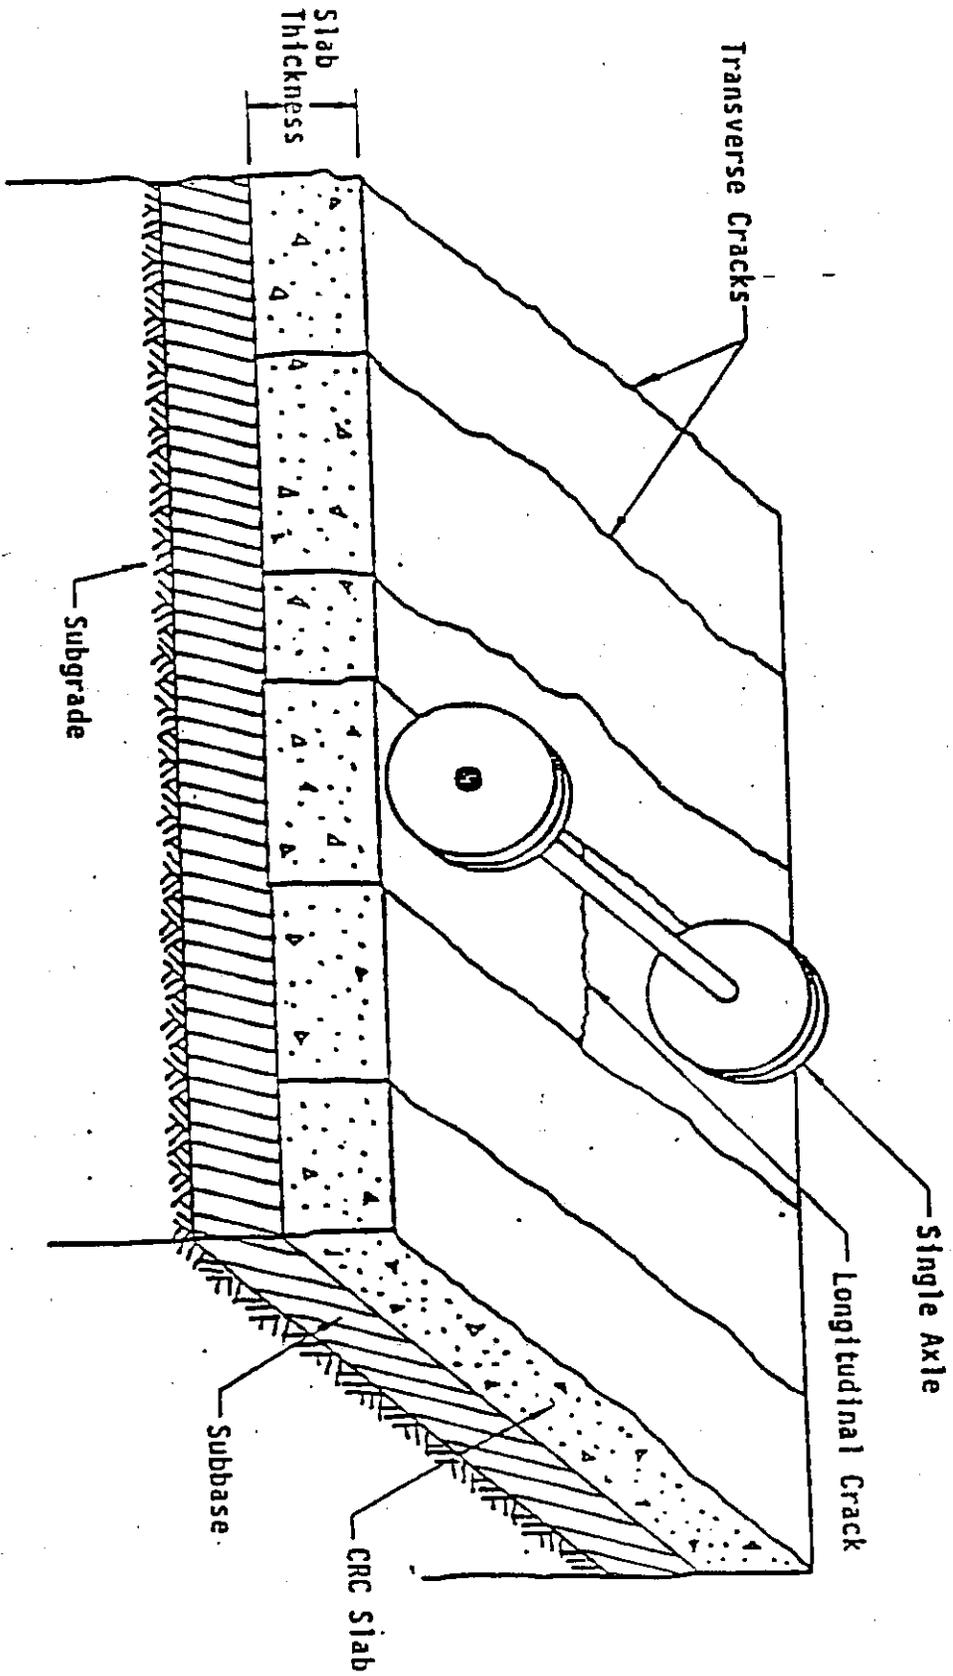
Figure 8. Formation of Longitudinal Crack Between Two Transverse Cracks - Intermediate State of Edge Punchout

The development of longitudinal cracking has long been associated with the formation of "punch out" distress, along with poor subgrade support and short transverse crack spacing. Figure 8 illustrates the location of maximum bending stress CRCP experiences in the transverse direction. Stress concentration is the primary factor leading to a longitudinal crack approximately 760 mm (30 inches) from the pavement edge, as witnessed by the performance monitoring during this study.

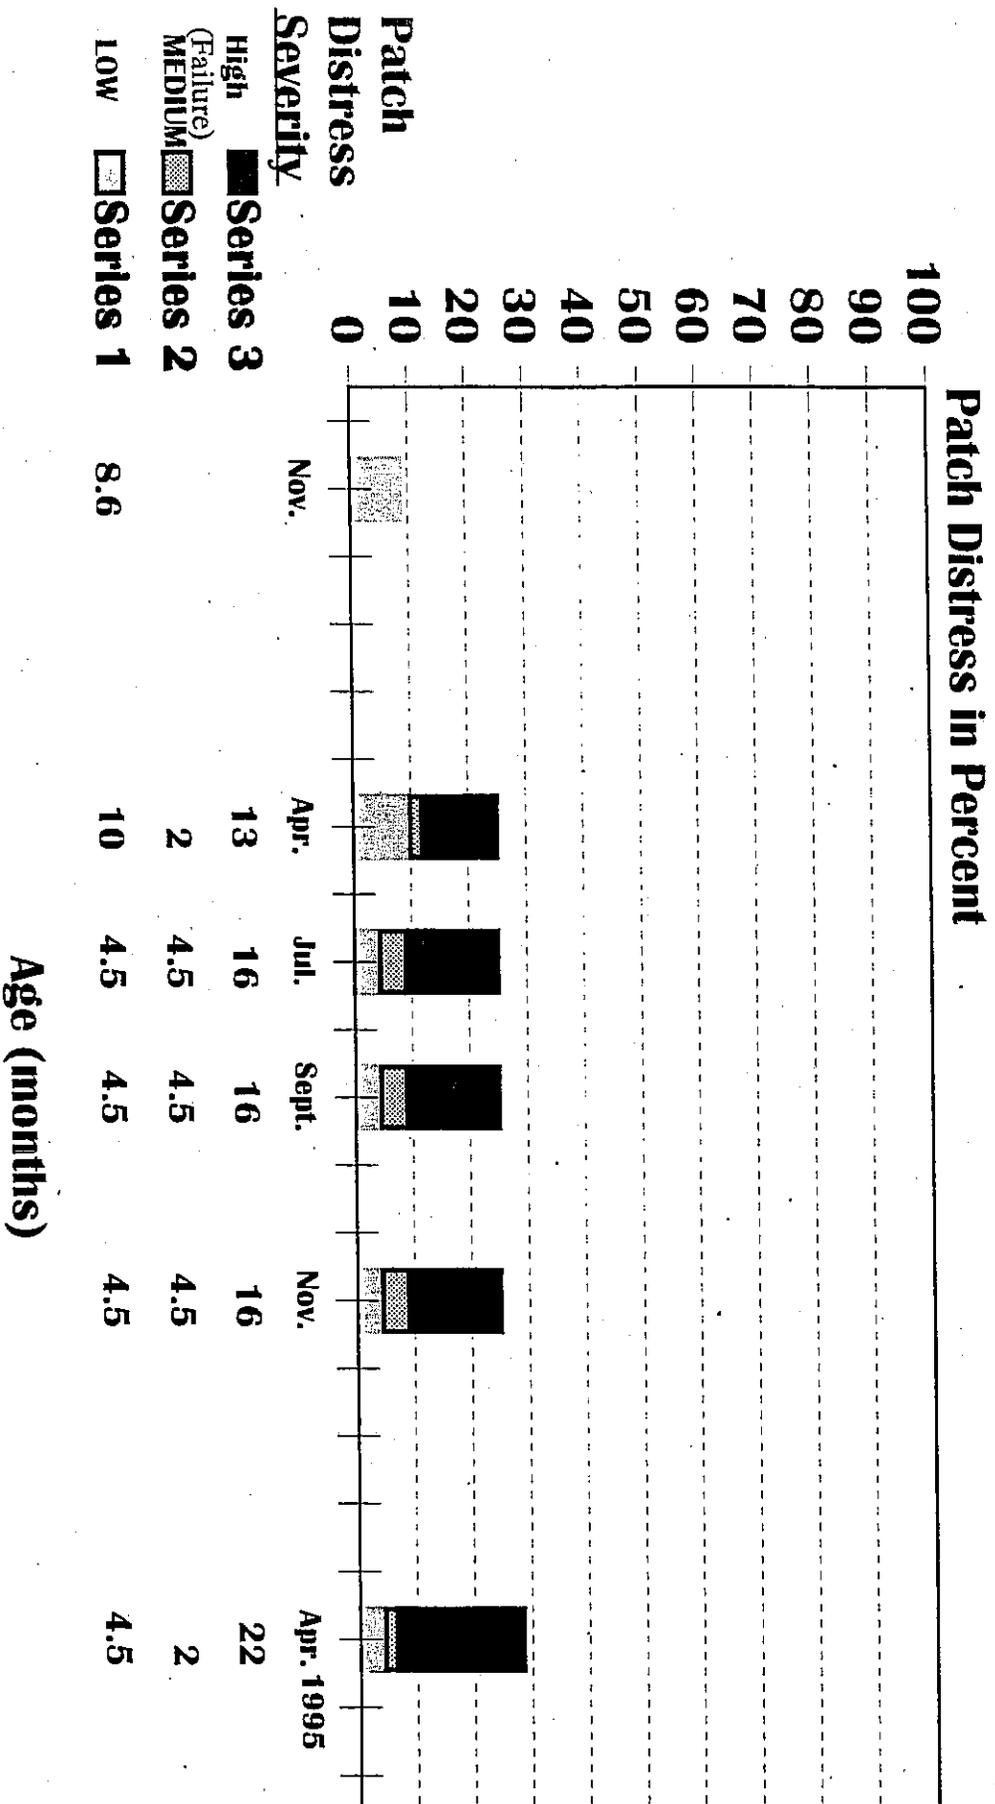
Figure 9. Steel Fiber Modified Concrete Patch Design

patches showed minimal distress at 2 months. Patches at Site 4 in Sangamon County contained only 44.5 Kg/cu. meter (75 lb/cu. yd) of steel fibers. These patches showed no improvement in performance over the conventional Class A patches. Patches of 7-inch CRCP at Site 5 in Douglas County contained 118.7 kg/cu. meter (200 lb/cu. yd) of steel fibers. These patches showed only marginal improvement (20% after 18 months) over the conventional Class A patches (see Figure 9). A reduced pavement thickness may have offset the strength gain of the steel fibers. The failure mode for the steel fiber modified concrete CRCP patch design was the formation of wide longitudinal and transverse cracks followed by punch outs, as depicted in Photo 16.

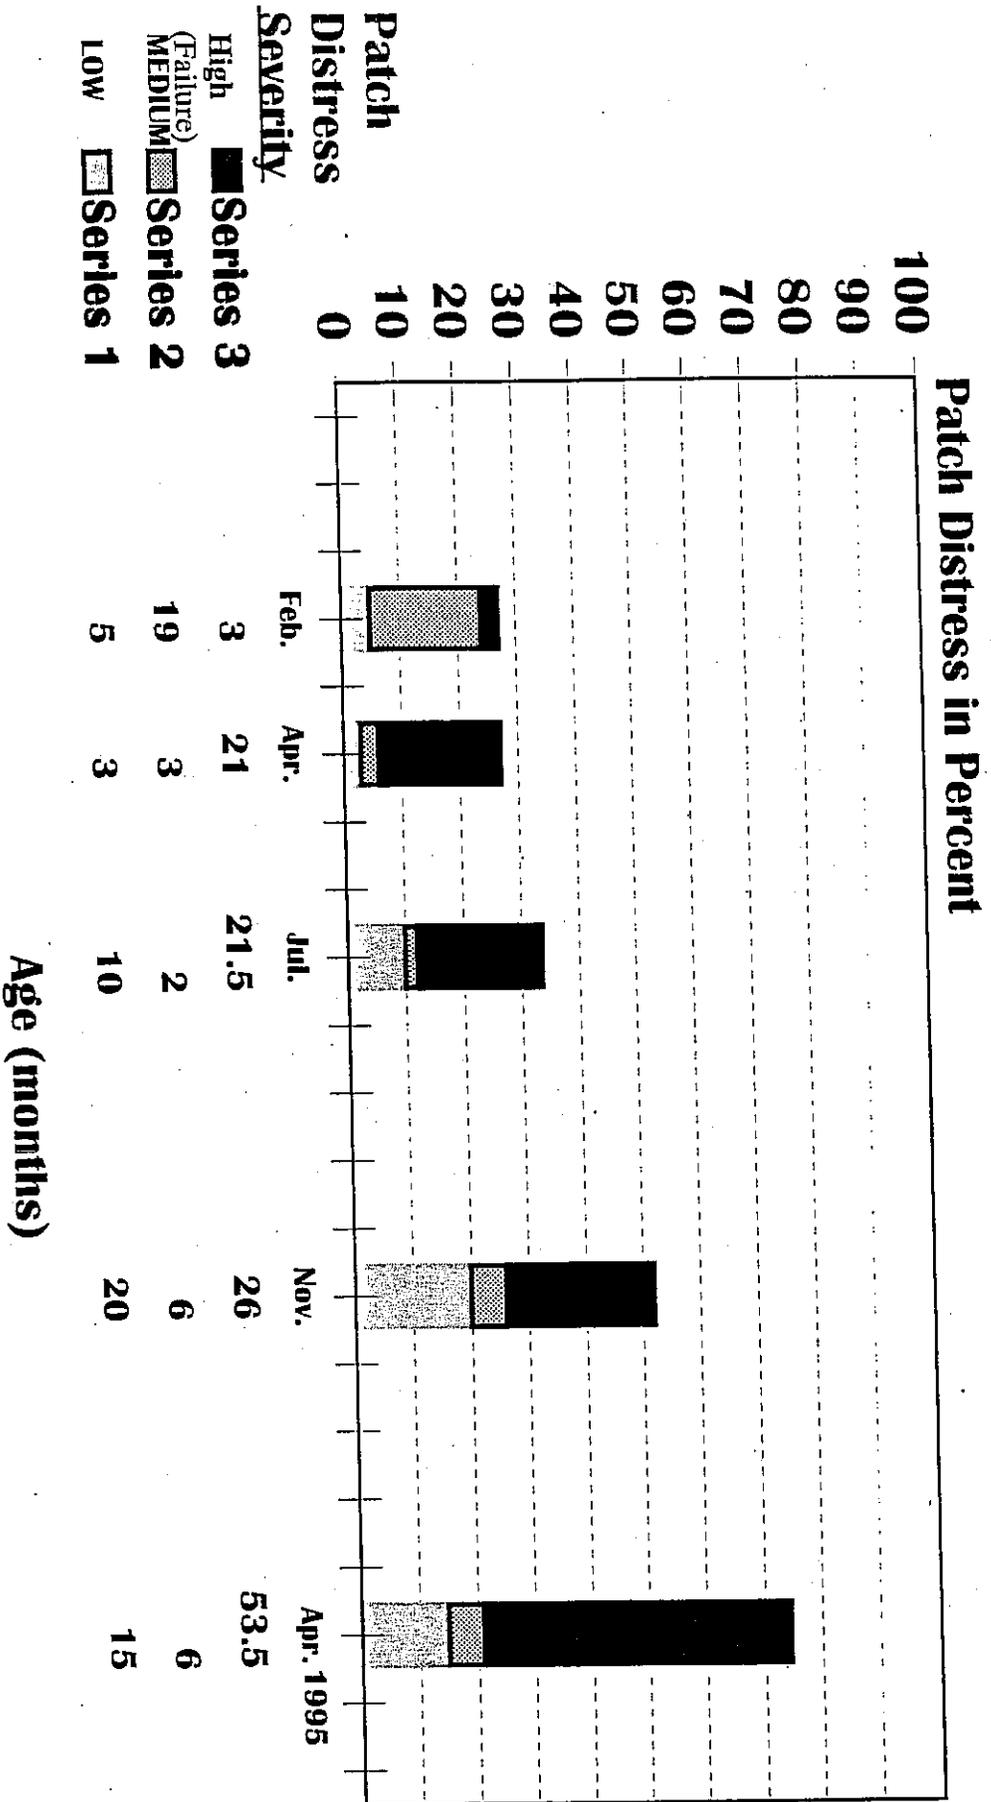
Figure 10. Drainage layer Patch Design

Survey data analysis indicates that over 75% of the patches failed completely in the two-year study period. Patch distresses ranged from spalling and longitudinal cracking to punch outs and pumping of fines. The design exhibited unexpected results with respect to the purpose of drainage. Figure 10 reveals an extremely high rate of patch failures. The fracture pattern of the majority of these patches showed that the excavation of the subbase between the rebar to be lap-spliced resulted in a loss of support between the rebar severed ends (see Photos 19-20). Drainage under the patch caused migration of subgrade fines, which washed through the underdrain network regardless of drain type. The drainage features actually allowed water to remain in the pavement, resulting in weakened subbase/subgrade support as indicated from CBR readings taken after the concrete was removed. It became evident that disturbance of the subbase/subgrade was responsible for the failures.

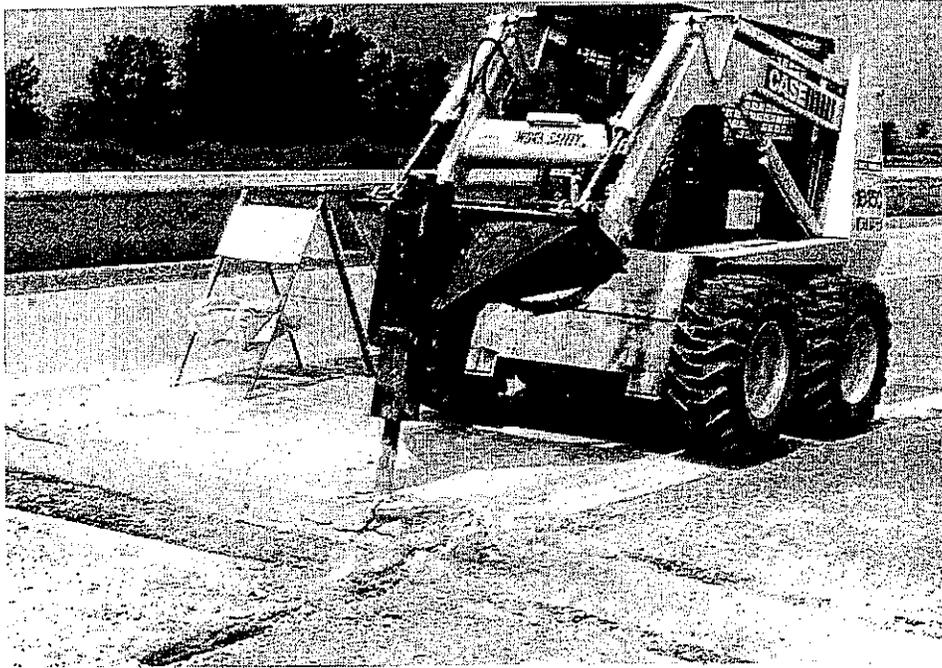
Photo 1. Skid-steer loader using mounted jackhammer to remove concrete.

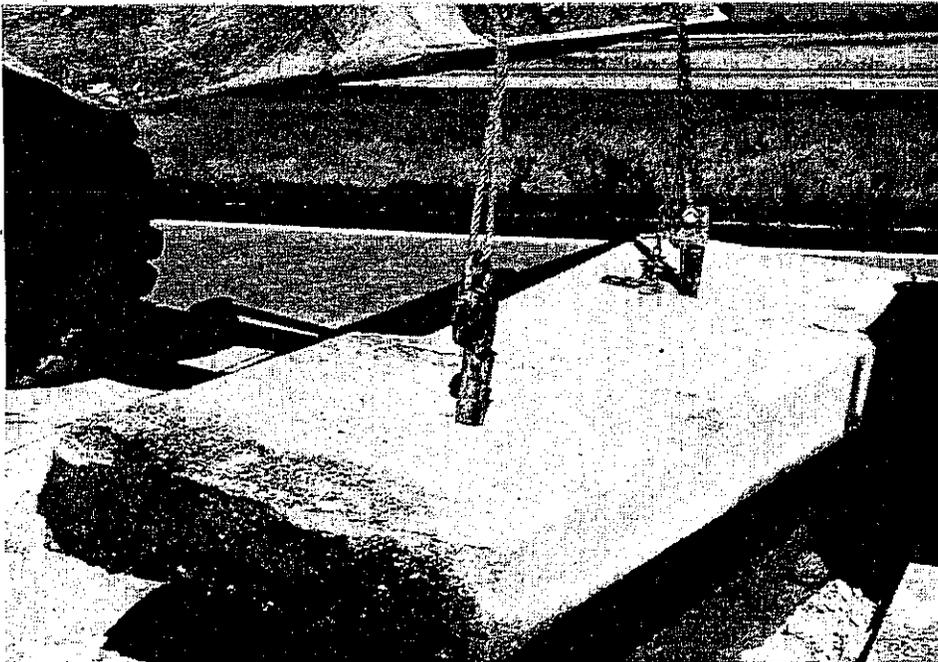
Photo 6. Slab lift-out method by the use of pins.

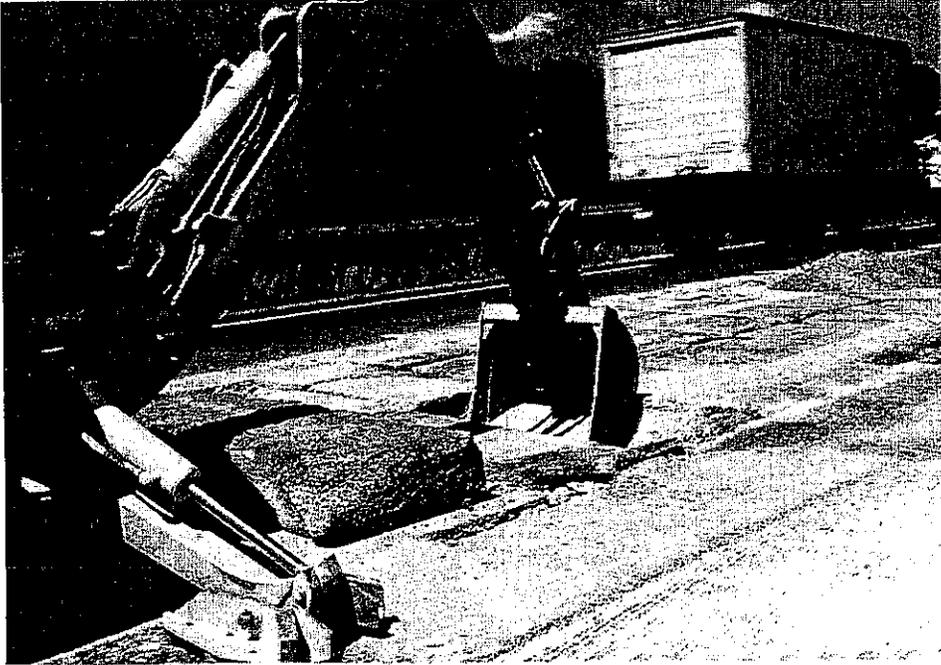
Photo 7. Removal of concrete by backhoe in segments.

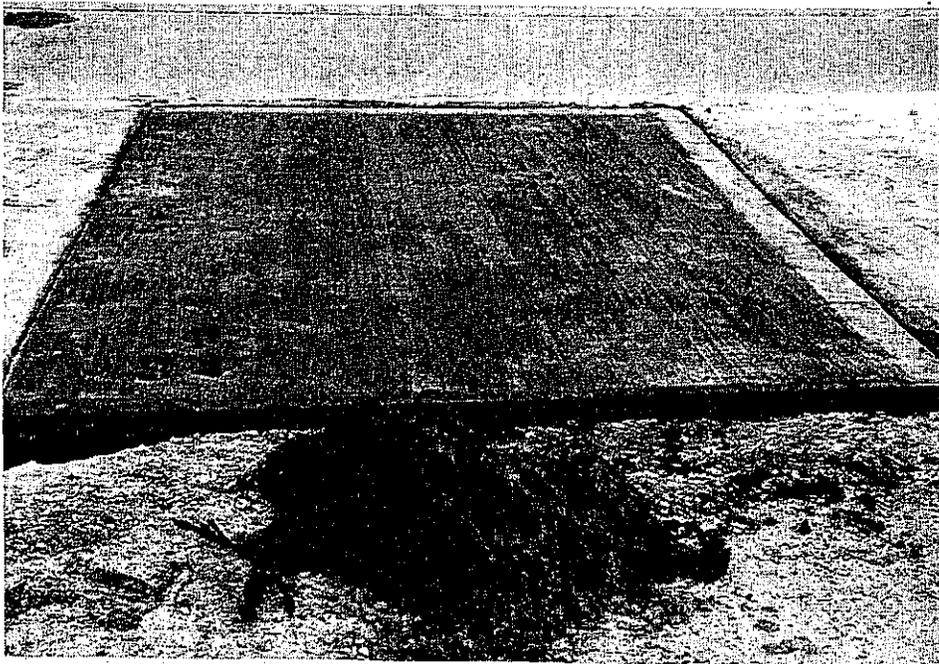
Photo 12. Edging of the patch perimeter to form sealant reservoir.

Patch joints were sealed using ASTM D 3405 hot poured sealant for 90 of the 132 patches. Refer to Special Provision for Joint Sealing Continuously Reinforced Concrete Patches. Photos 12 through 14 illustrate the hot poured sealant procedure. The 90 sealed patches were able to withstand large impact forces resulting from traffic loadings at all sites, but most notably, Site 1 in Logan County. Figure 7 shows a very low percentage of patch failures (4.5% after 18 months). Unlike other experimental CRCP patch designs in this study, the transverse rebar design did not have a high failure rate immediately after construction (see Photo 15).

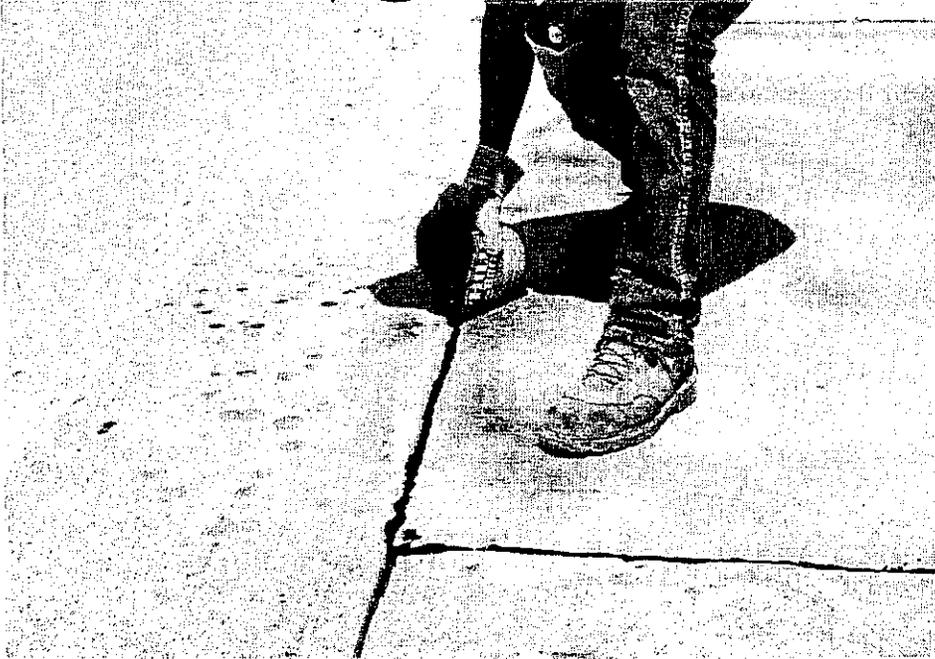
Photo 13. Pouring of joint sealant using ASTM D 3405.

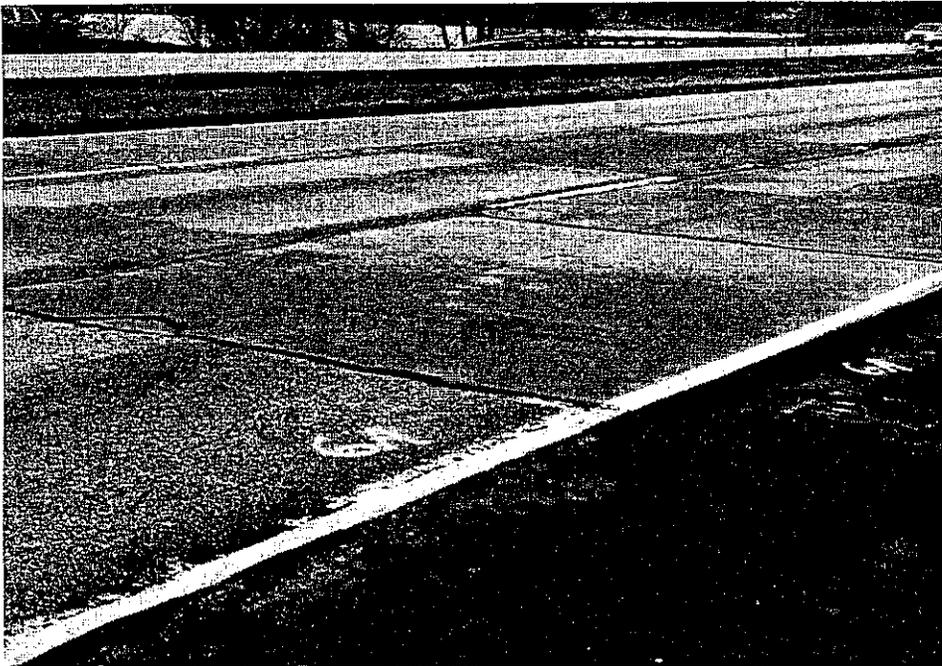
Photo 14. An example of a completed patch with joint sealing.
