# **Investigation of Rack and Pinion**

## **Alignment of the Cass Street**

### **Movable Bridge in Joliet, Illinois**

**Physical Research Report No.129**

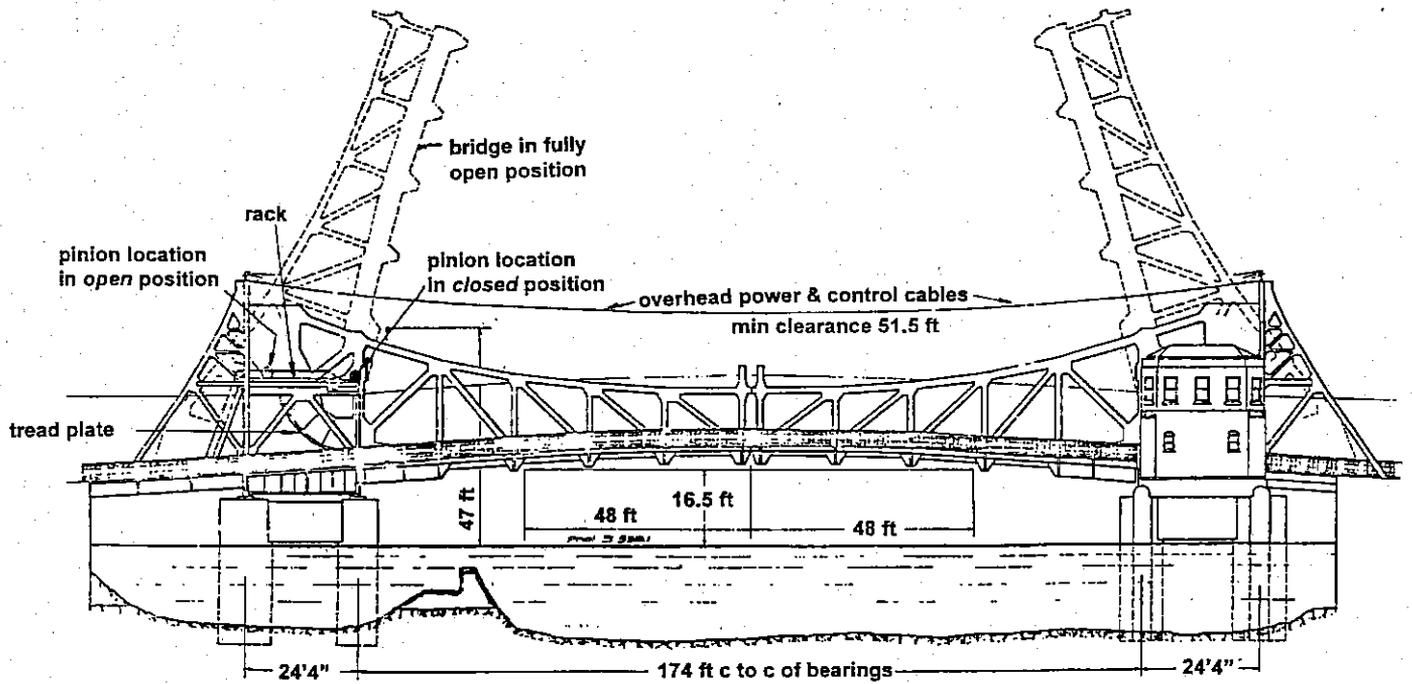
*Figure 1.* Elevation view of the Cass St. Bridge over the DesPlaines River, Joliet, Illinois, showing general lift span dimensions and overall geometry. Locations of the pinion on the fixed rack in the open and closed positions are shown. Adapted from original 1931 plans.

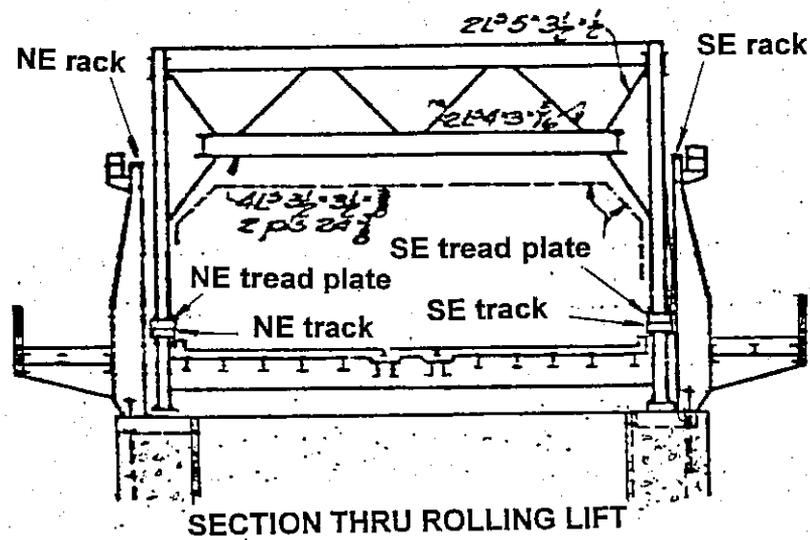
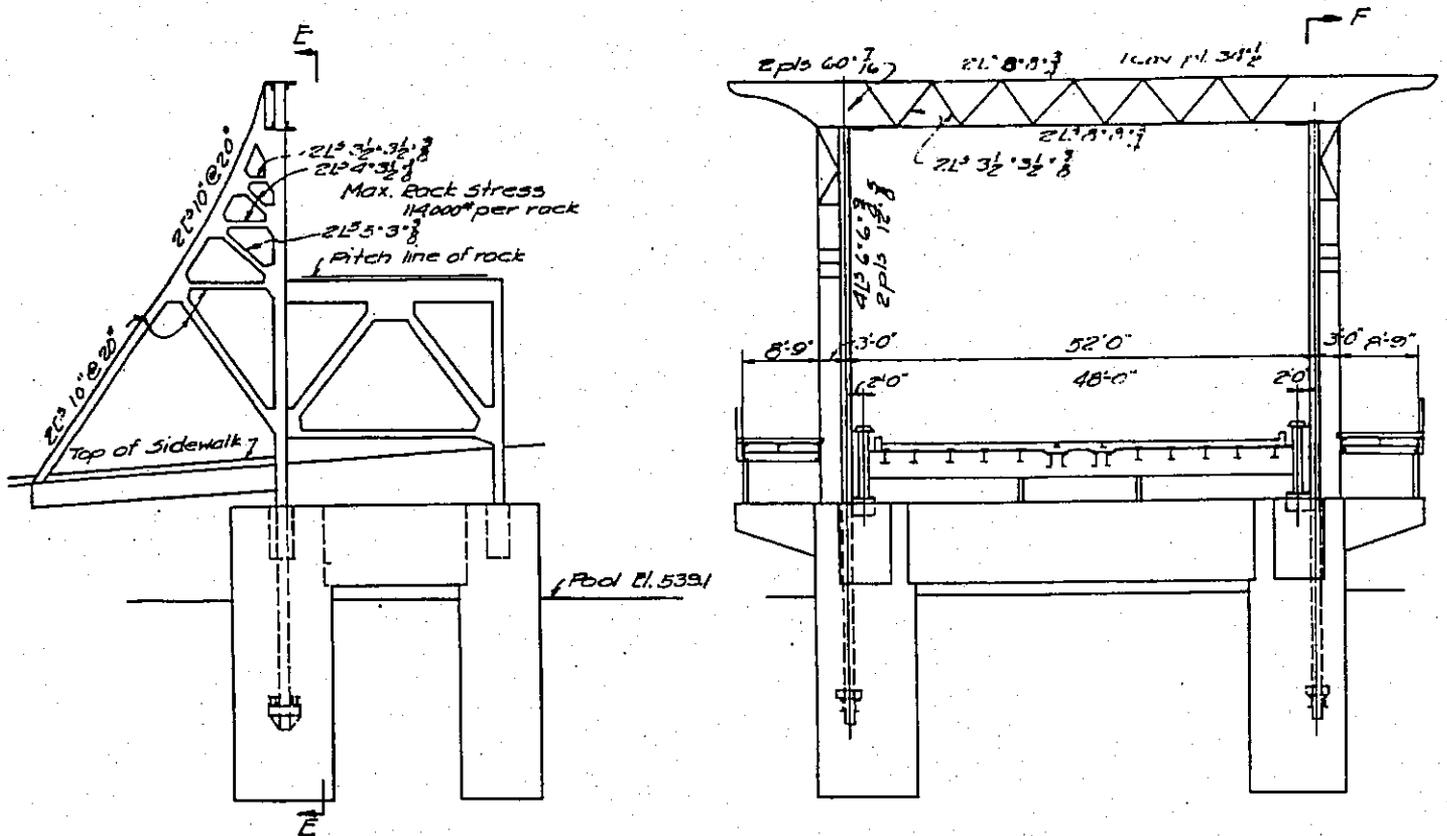
Figure 3. Rack and track supports and anchorages, and respective locations of tread plates, racks and tracks on the abutment end of the Cass St. Bridge. Adapted from 1931 plans.

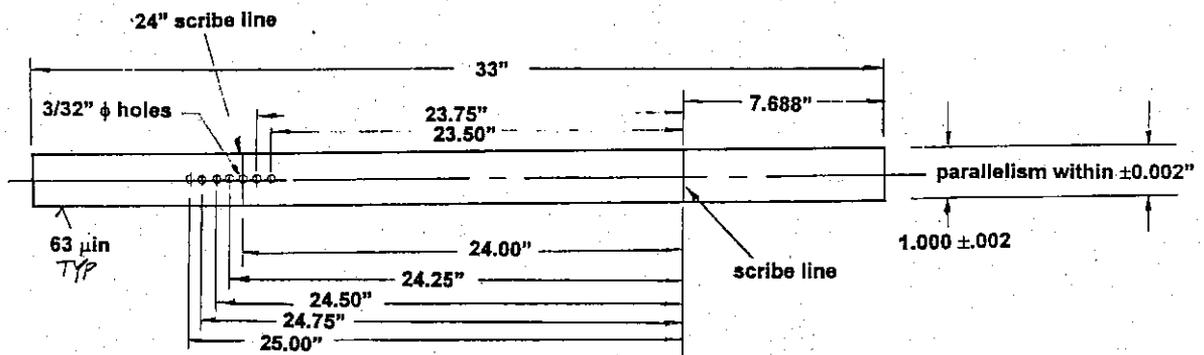
**PLUMB LINE OFFSET BAR**

However, measurements of the 24" offset on the river side of the track proved to be difficult. First, there was no means of attaching the calibrated bar to the rack, since the supporting base plate for the rack terminates flush with the forward rack element. Even after clamping the offset bar to the rack, structural elements on the bascule span interfered with the drop of the plumb line. In addition, traffic must be halted to obtain this measurement. Because the riverside measurement was not made, an extension bar should be fastened to the track to make this measurement in the future.
