FINAL REPORT

EVALUATION OF BRIDGE DECK DELAMINATION INVESTIGATION METHODS

Project IC-H1, 95/96

Report No. ITRC FR 95/96-1

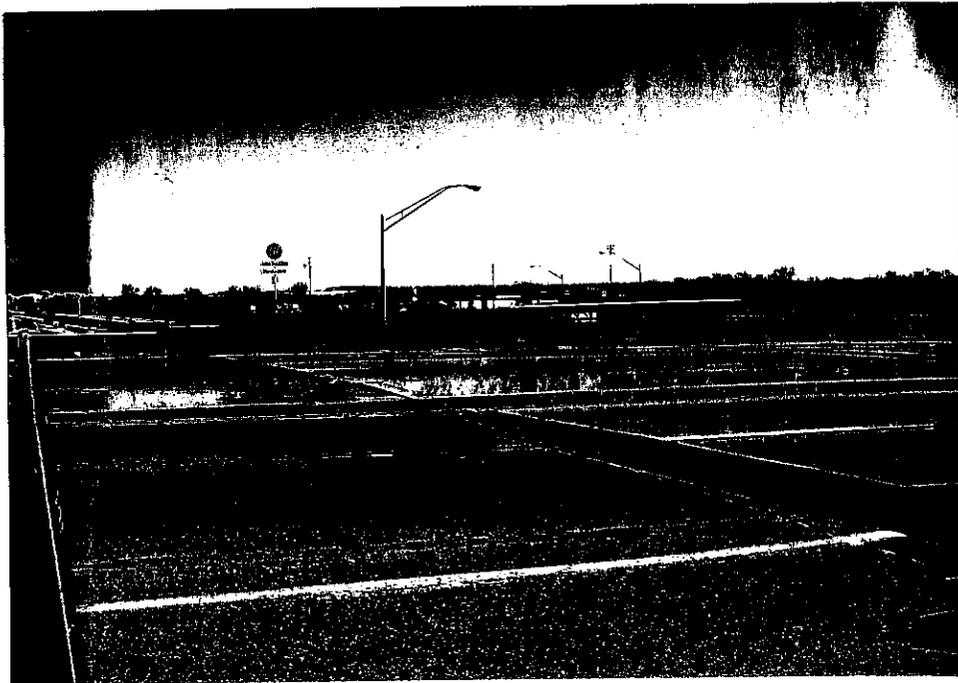
Figure 1.1 Bloomington Structure Number 057-0088 bridge deck showing asphalt patching along abutment joints.

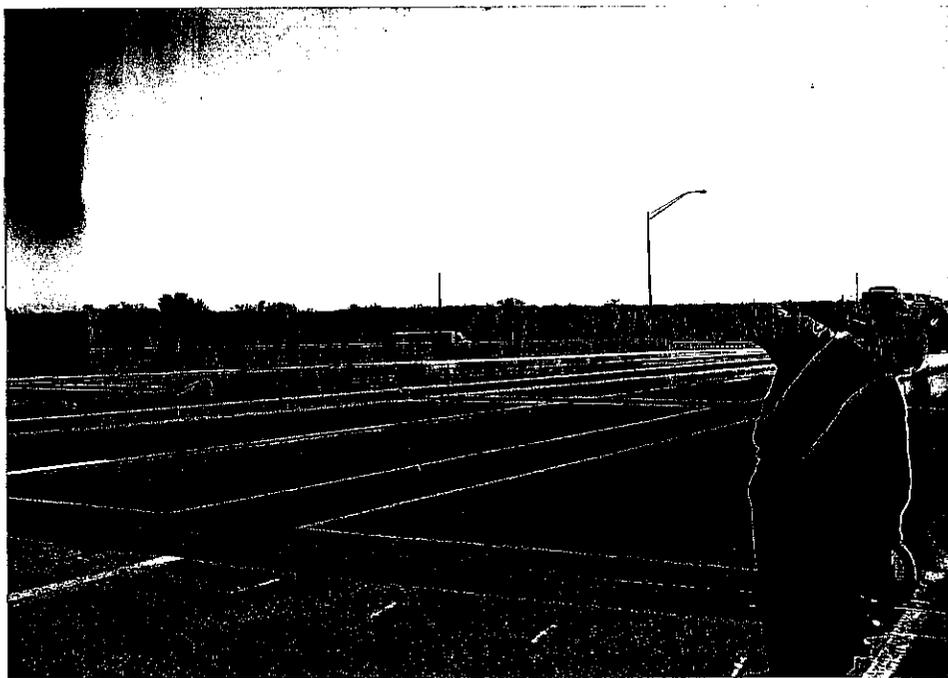
Figure 1.2 Bloomington Structure Number 057-0088 bridge deck showing asphalt patching along longitudinal joints.

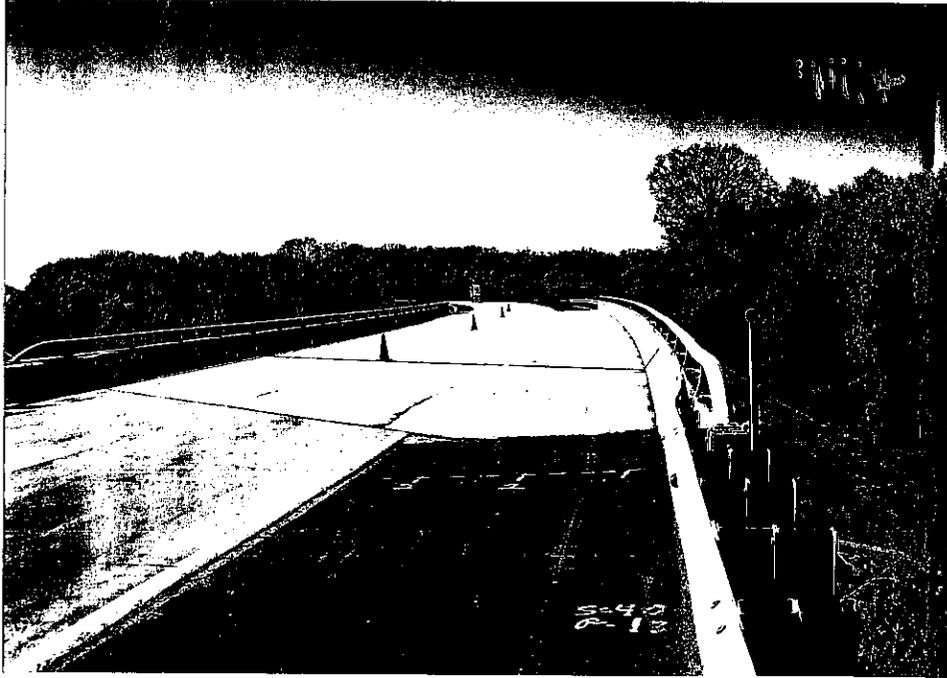
Figure 1.10 Peoria Structure Number 072-0110 looking west prior to removal of overlay.

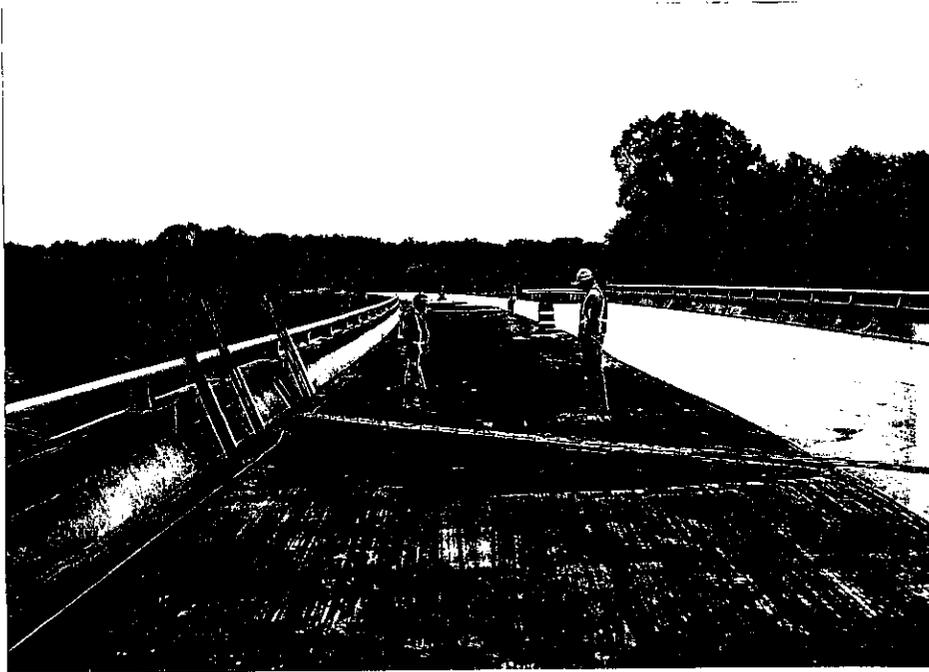
overlay. After removal of the overlay, it was noted that the concrete deck had been milled with gouges up to 1 inch (25.4 mm) deep. Visual underside inspection showed no major deterioration. Pictures of the structure are shown in Figure 1.10 and Figure 1.11.

Figure 1.11 Peoria Structure Number 072-0110 looking west following removal of overlay exposing milling marks in concrete bridge deck.

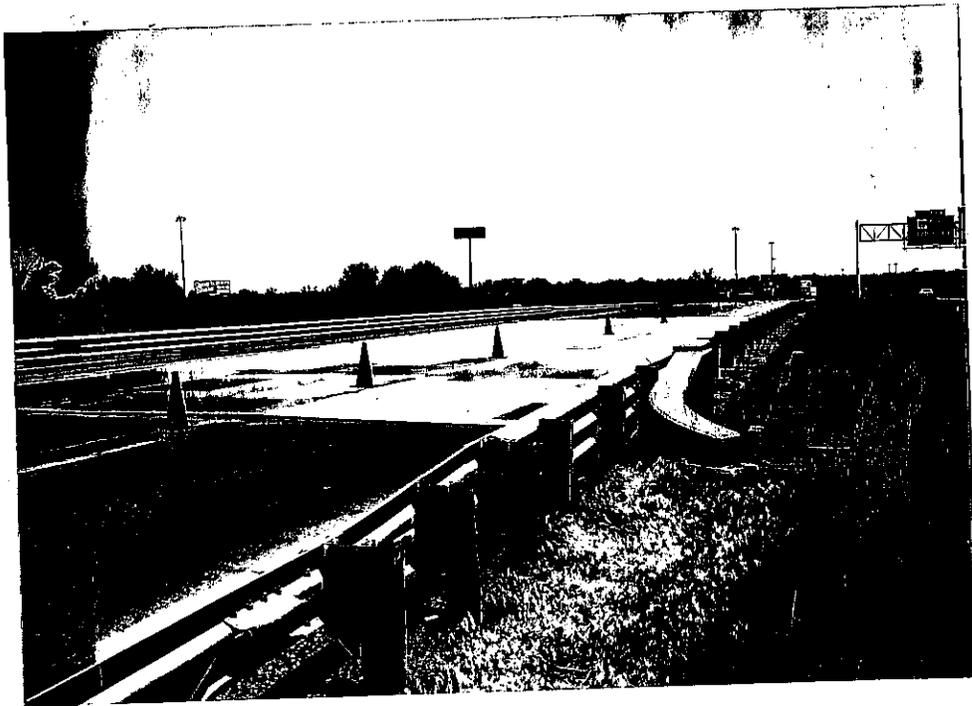
Figure 1.12 Marion Structure Number 100-0005 looking north before removal of overlay showing concrete surface patches.

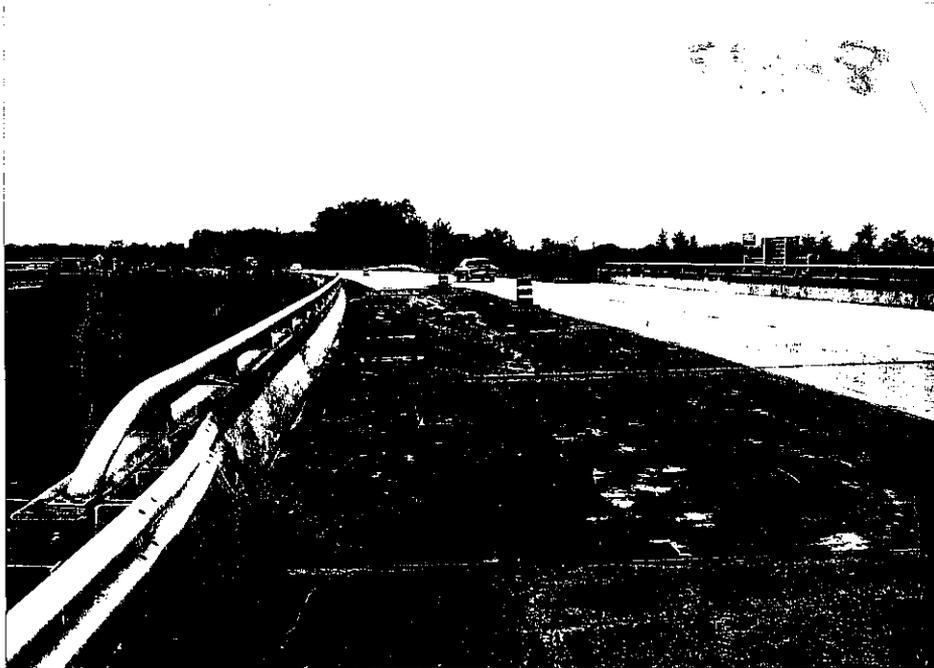
Figure 4.7 Peoria Structure Number 072-0107 after removal of west lane asphalt overlay.

The Peoria Structure Number 072-0107 bridge deck was found to be in fair condition, Figure 4.7. This bridge deck had minor asphalt patching along its longitudinal construction joints and some asphalt patches over previous rehabilitation work. The underside showed no signs of deterioration. There were 46 delaminated areas found by chain dragging, Appendix A, Figure A-5. Table 4.6 and Table 4.7 summarize the results of each test. Section 4.4.1 through Section 4.4.3 detail the results of each nondestructive test.

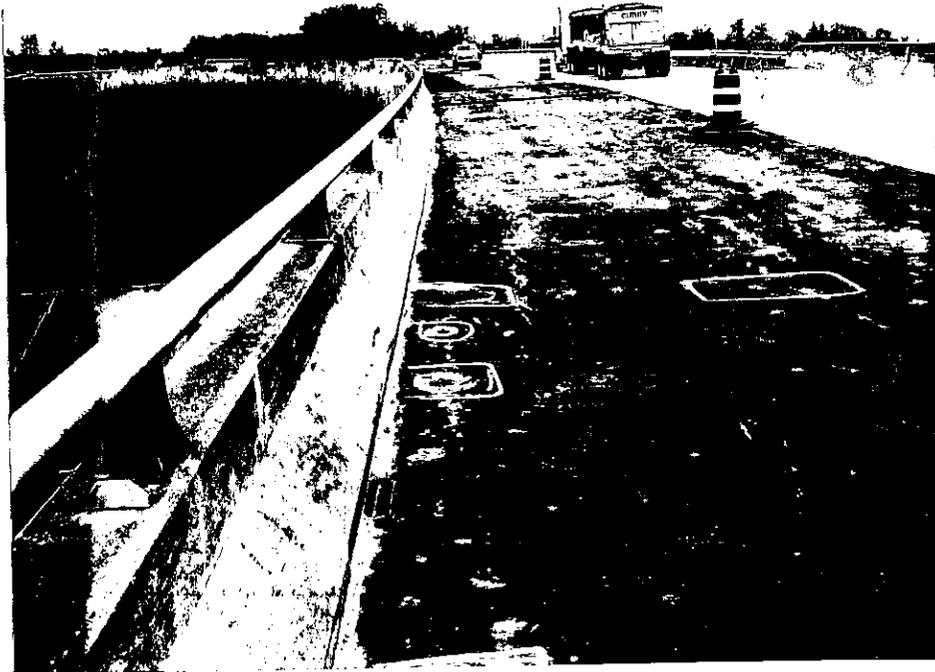
Figure 4.8 Peoria Structure Number 072-0109 after removal of west lane asphalt overlay.

The Peoria Structure Number 072-0109 bridge deck was found to be in good condition, Figure 4.7. This bridge deck had minor asphalt patching along its longitudinal construction joints and a large asphalt patch at its north end. The underside showed no signs of deterioration. There were 15 delaminated areas found by chain dragging, Appendix A, Figure A-7. Six of these areas were minor spalling along the transverse joints in the deck. In addition, the deck had unusual potholes in the surface of the concrete, Figure 4.8 and Figure 4.9. Table 4.10 and Table

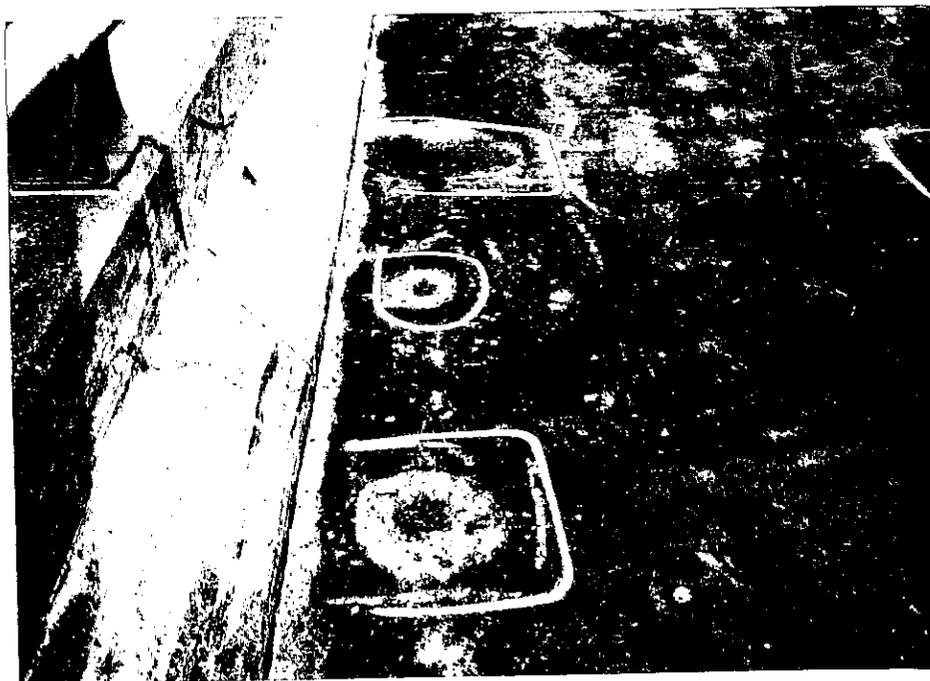
Figure 4.9 Peoria Structure Number 072-0109 potholes in concrete.

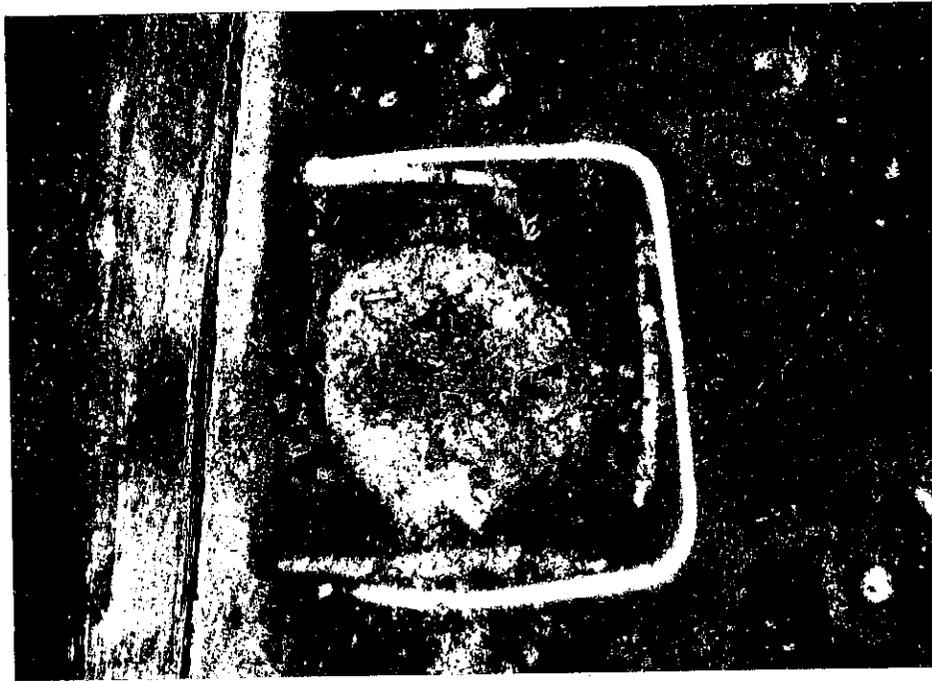
Figure 4.10 Peoria Structure Number 072-0109 close up of pothole in concrete.

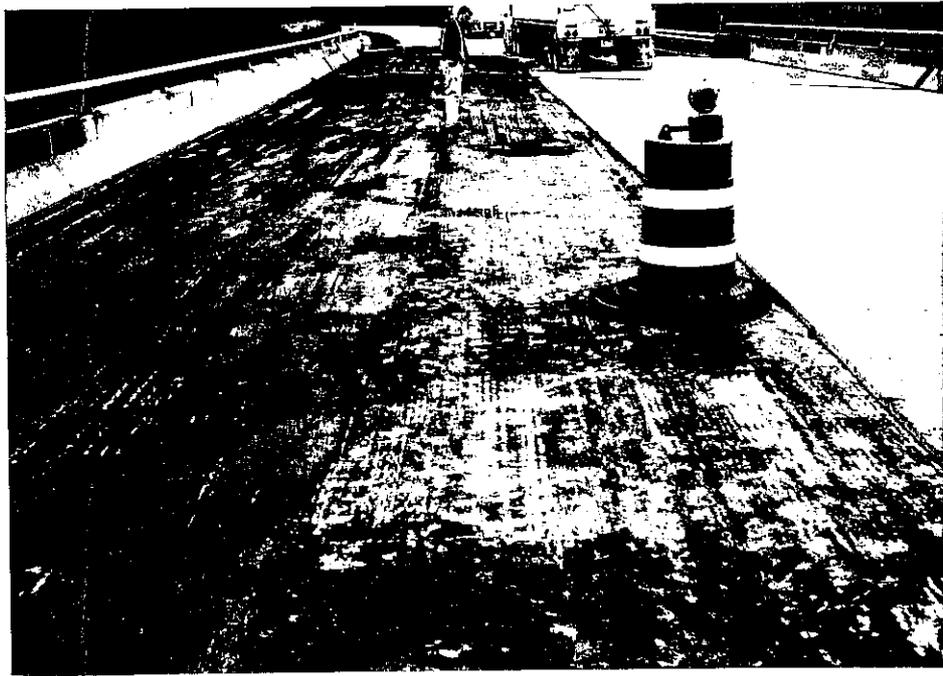
The Peoria Structure Number 072-0110 bridge deck was found to be in fair condition, Figure 4.11. This bridge deck had no areas of asphalt patching. The underside showed no signs of deterioration. Upon removal of the asphalt overlay, milling gouges across most of the surface of the deck were observed, Figure 4.12. Some of the gouges were 1 inch (25.4 mm) deep, Figure 4.13. There were 34 delaminated areas found by chain dragging, Appendix A, Figure A-8. Table 4.12 and Table 4.13 summarizes the results of each test. Section 4.7.1 through Section 4.7.3 detail the results of each nondestructive test.

Figure 4.11 Peoria Structure Number 072-0110 after removal of left lane overlay revealing milling gouges.

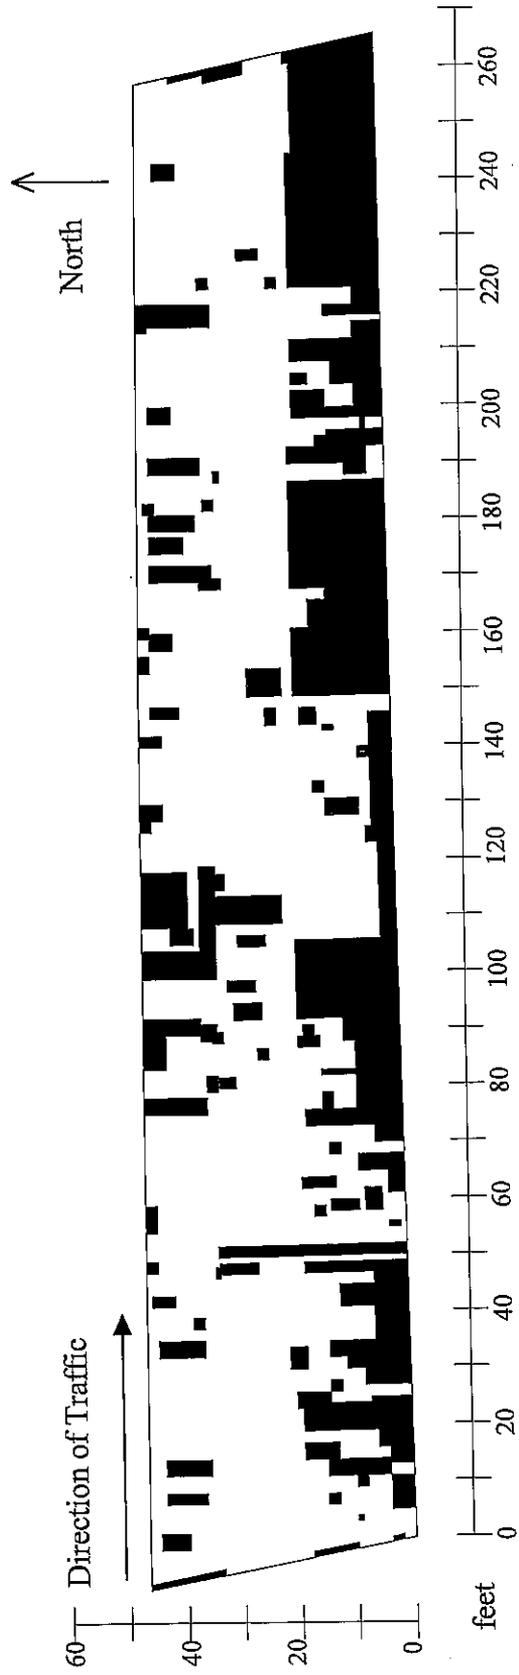
Figure A-1. Bloomington Structure Number 057-0088 eastbound chain drag survey. Dark areas indicate delaminations.

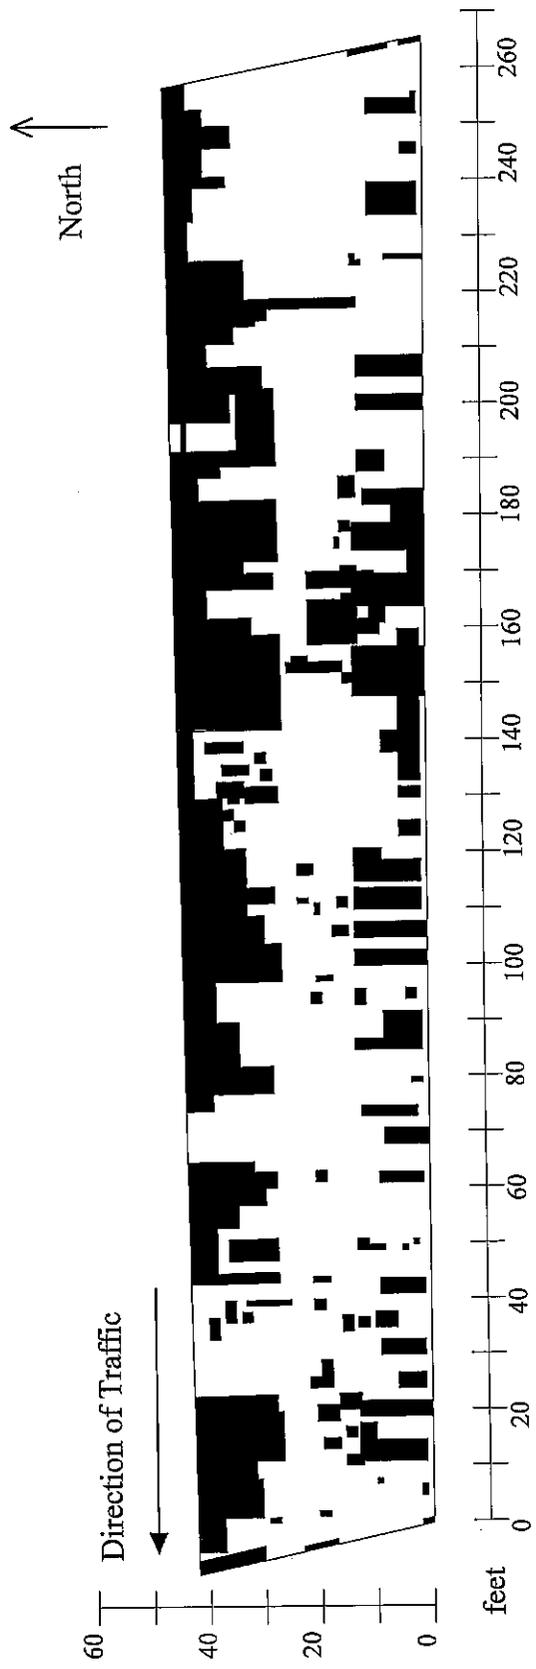
Figure A-2. Bloomington Structure Number 057-0088 westbound chain drag survey. Dark areas indicate delaminations.

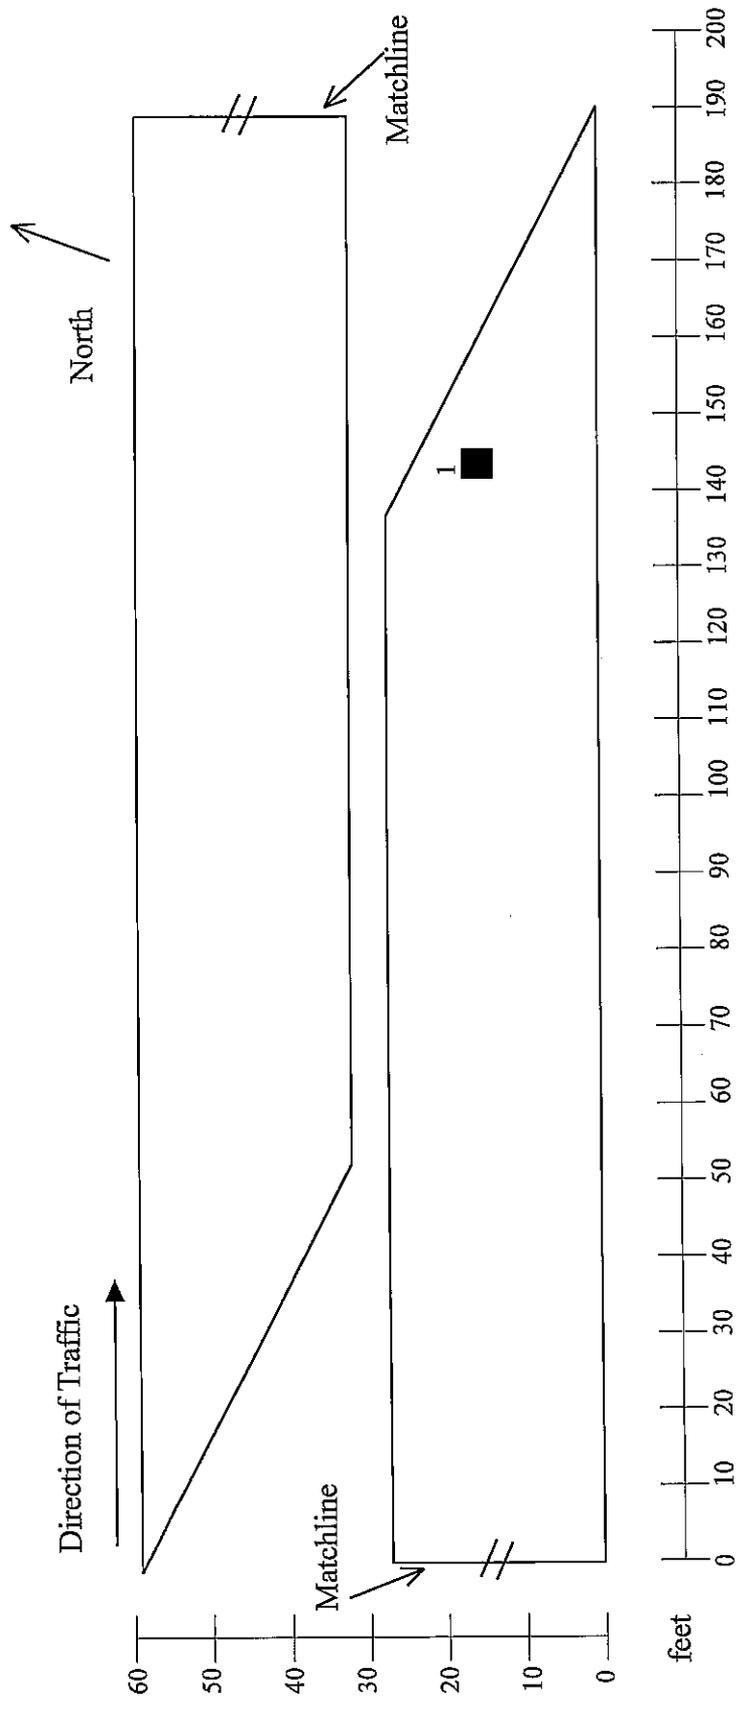
Figure A-3. Peoria Structure Number 090-0118 chain drag survey. Dark areas indicate delaminations.

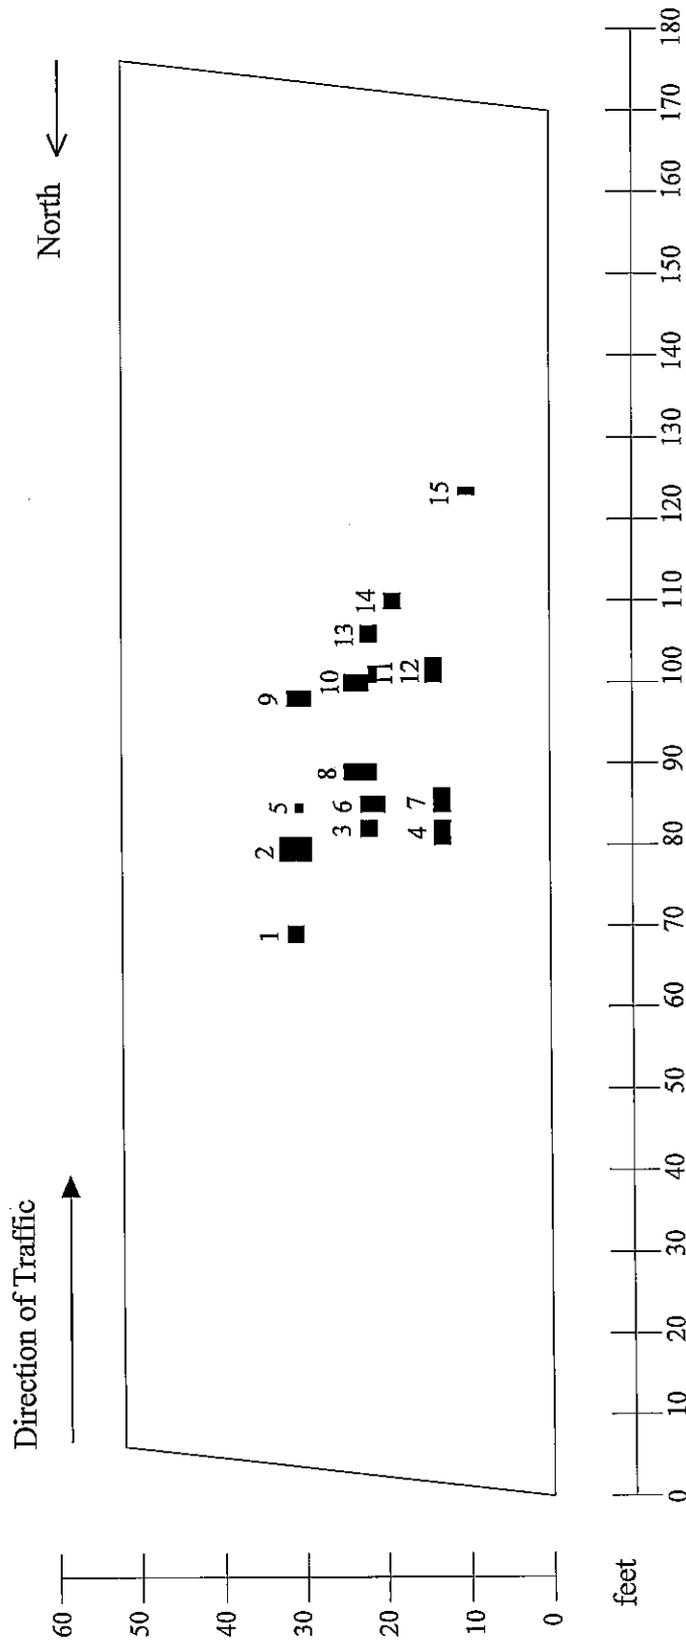
Figure A-4. Peoria Structure Number 072-0106 chain drag survey. Dark areas indicate delaminations.

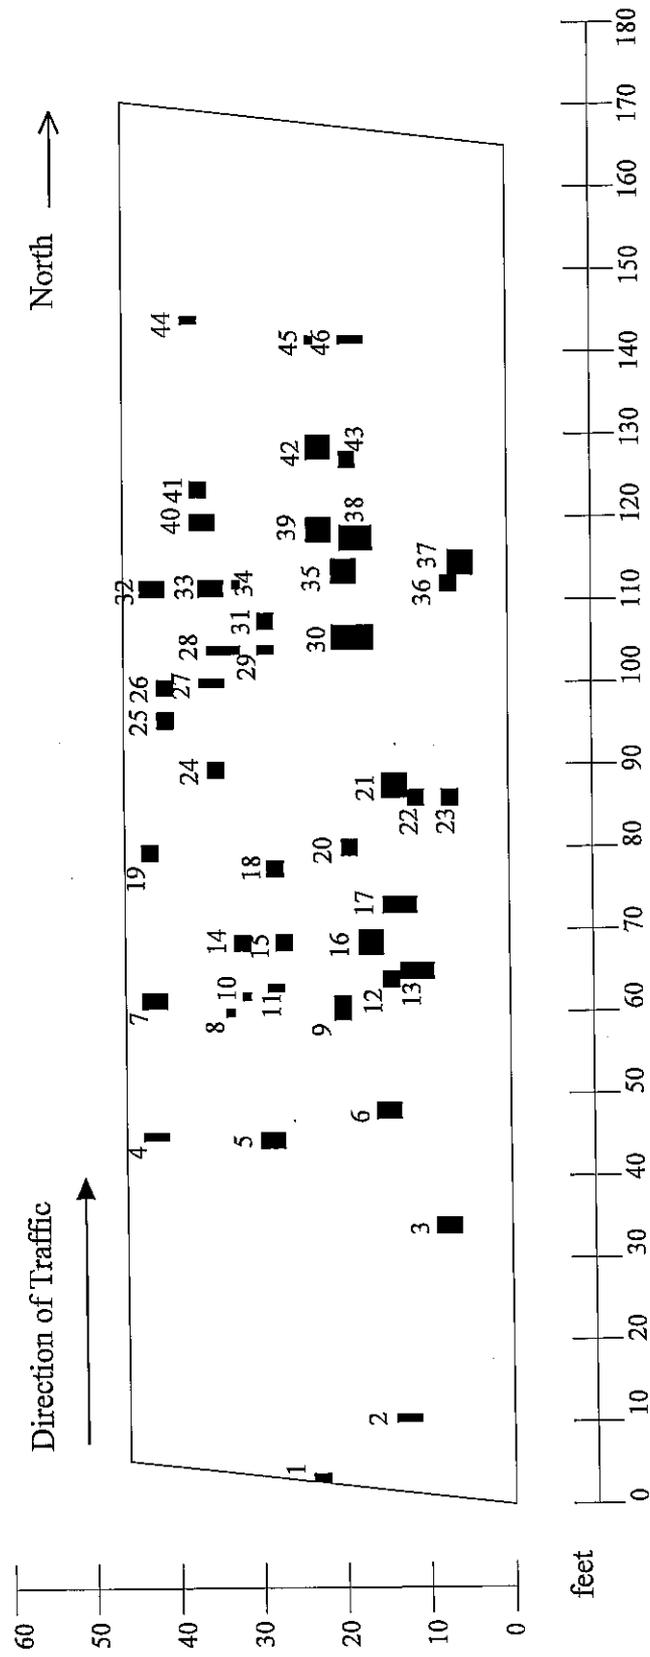
Figure A-5. Peoria Structure Number 072-0107 chain drag survey. Dark areas indicate delaminations.

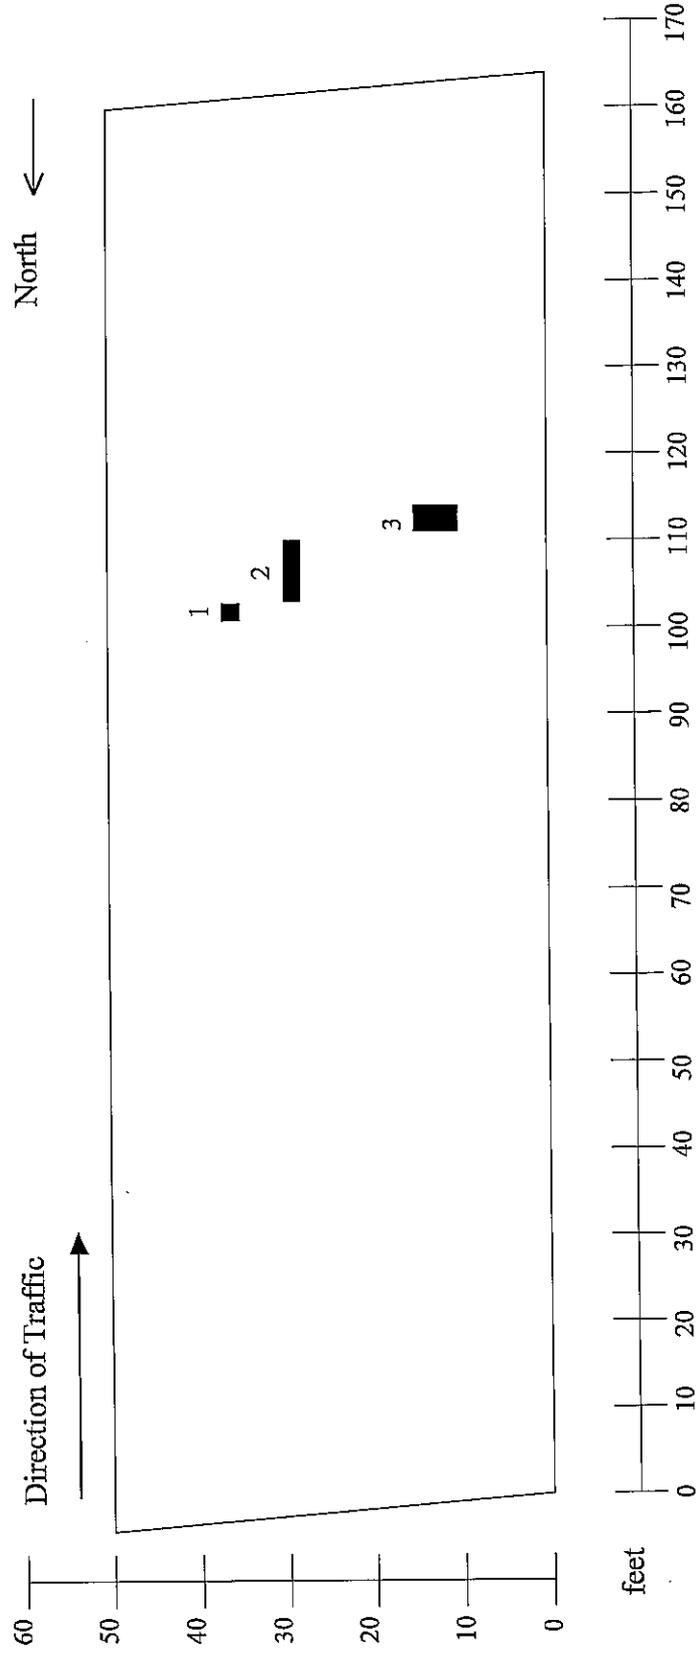
Figure A-6. Peoria Structure Number 072-0108 chain drag survey. Dark areas indicate delaminations.

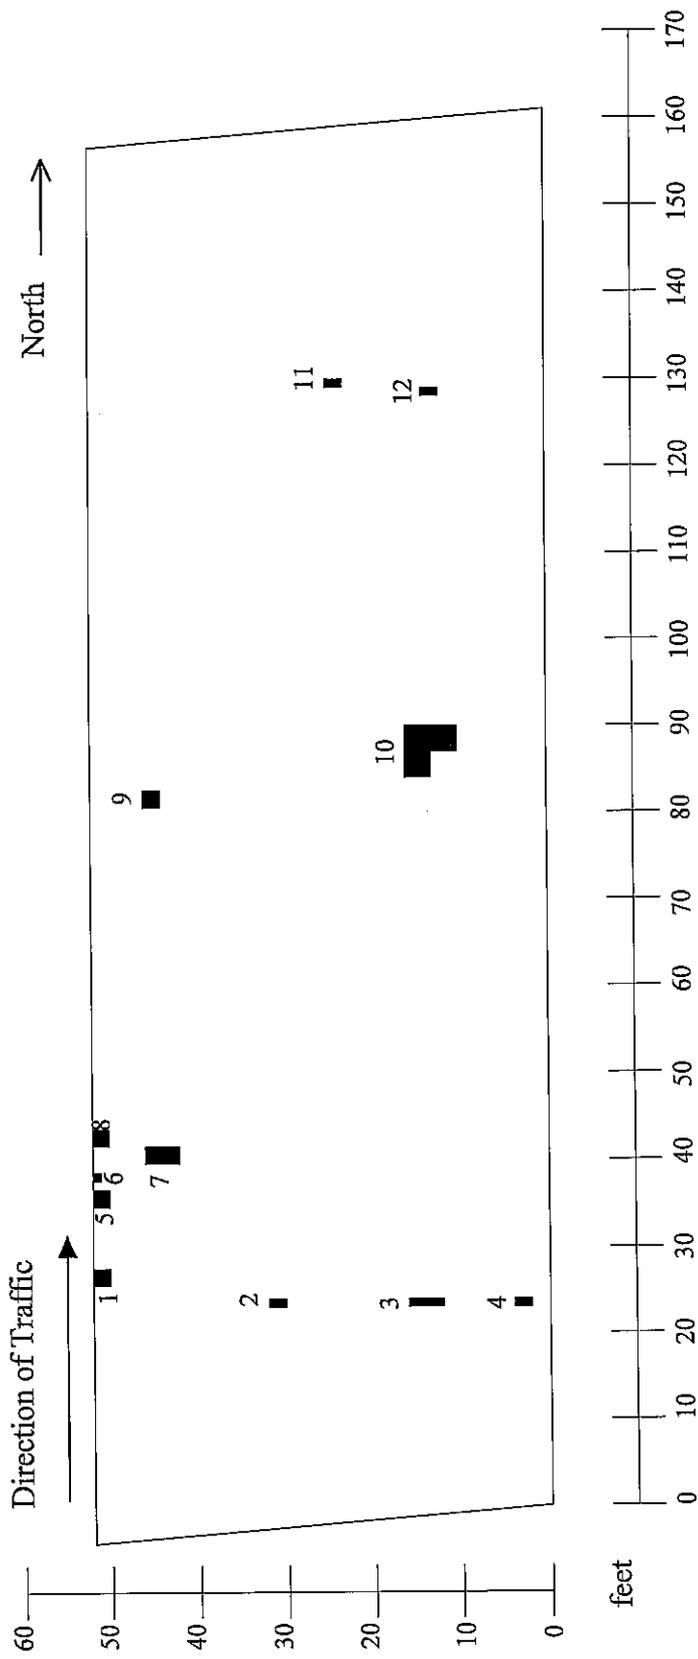
The results of the chain drag survey of the Peoria Structure Number 072-0109 bridge deck can be seen in Appendix A, Figure A-7. The delamination maps show areas that were found to be delaminated by chain dragging after the asphalt overlay was removed. The presence of delaminations was verified during the removal of the damaged concrete. Figure A-7 shows a total of 12 distinct delaminated areas scattered about the deck. Only one delamination, number 10, exceeds 10 ft² (0.93 m²) in areal extent. It should be noted that delamination numbers 2, 3, 4, 11, and 12 are minor spalling along the steel bay joints in the deck. Also, delamination numbers 1, 5, 6, and 8 are unusual potholes found in the concrete surface. These defects exist at the low end of the superstructure. The total area delaminated found by chain dragging and verified during concrete removal is 64 ft² (5.9 m²). Both the locations of the individual delaminated areas

Figure A-7. Peoria Structure Number 072-0109 chain drag survey. Dark areas indicate delaminations.

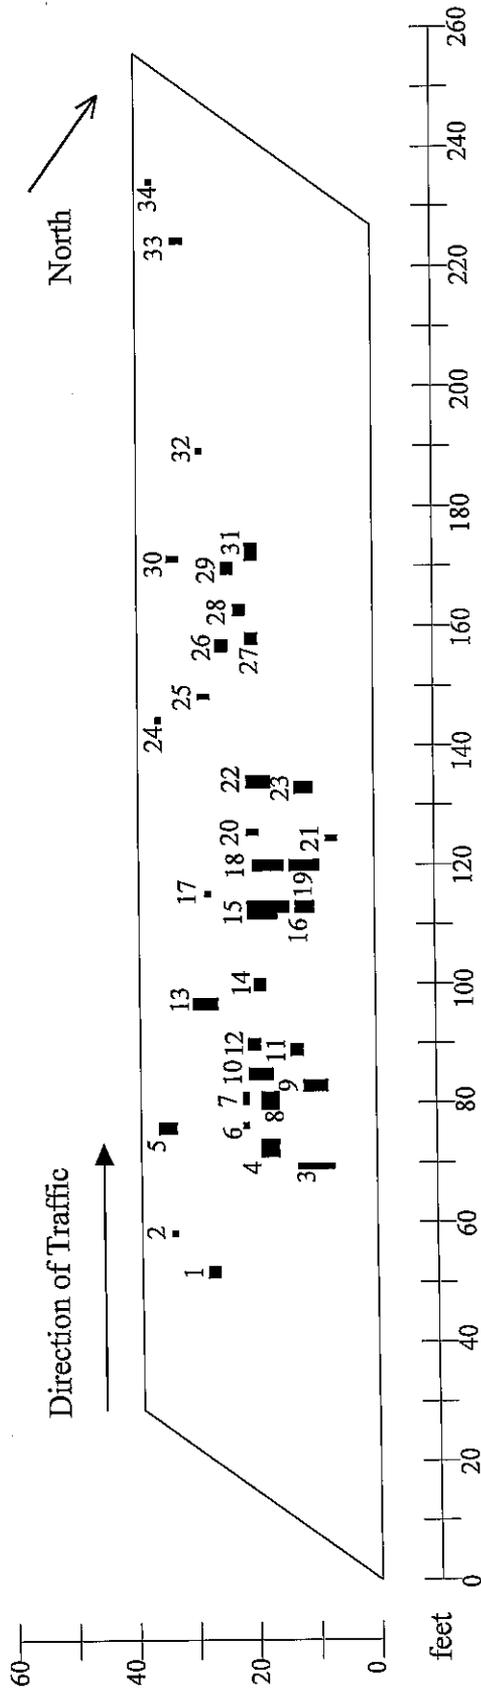
The results of the chain drag survey of the Peoria Structure Number 072-0110 bridge deck can be seen in Appendix A, Figure A-8. The delamination maps show areas that were found to be delaminated by chain dragging after the asphalt overlay was removed. The presence of delaminations was verified during the removal of the damaged concrete. Figure A-8 shows a total of 34 distinct delaminated areas concentrated at the center and south end of the deck, but only one of the delaminations, number 15, exceed 10 ft² (0.93 m²) in areal extent. The total area delaminated found by chain dragging and verified during concrete removal is 169 ft² (15.7 m²). Both the locations of the individual and total delaminated areas are used as a basis of comparison for the other nondestructive testing methods.

Figure A-8. Peoria Structure Number 072-0110 chain drag survey. Dark areas indicate delaminations.

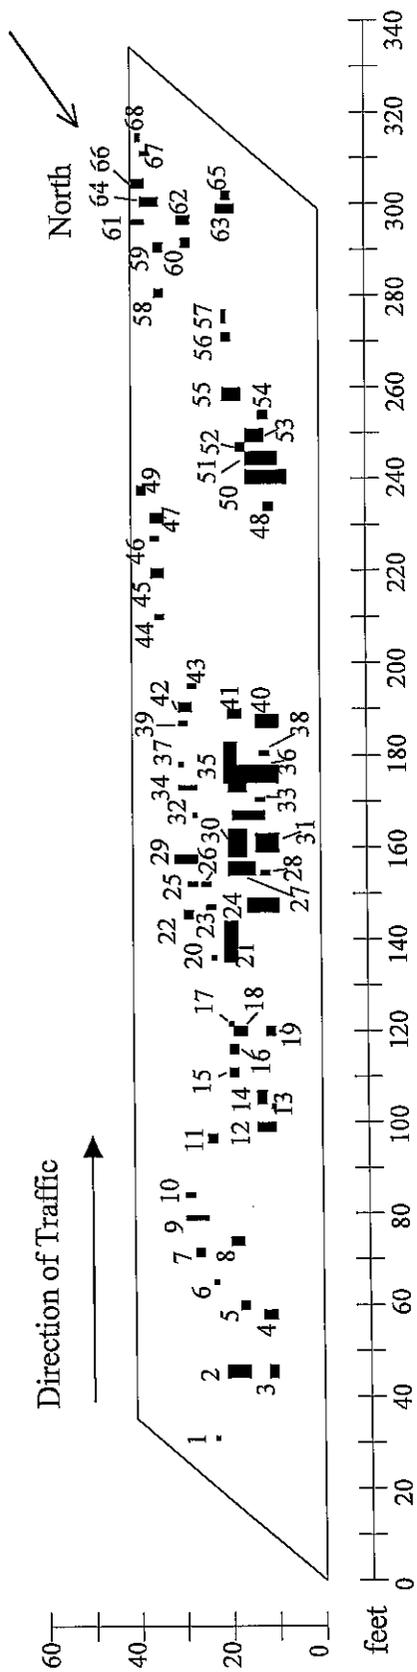
The results of the chain drag survey of the Peoria Structure Number 072-0111 bridge deck can be seen in Appendix A, Figure A-9. The delamination maps show areas that were found to be delaminated by chain dragging after the asphalt overlay was removed. The presence of delaminations was verified during the removal of the damaged concrete. Figure A-9 shows a total of 68 distinct delaminated areas concentrated across the entire deck. Fourteen individual delaminations exceed 10 ft² (0.93 m²) in areal extent. The total area delaminated found by chain

Figure A-9. Peoria Structure Number 072-0111 chain drag survey. Dark areas indicate delaminations.

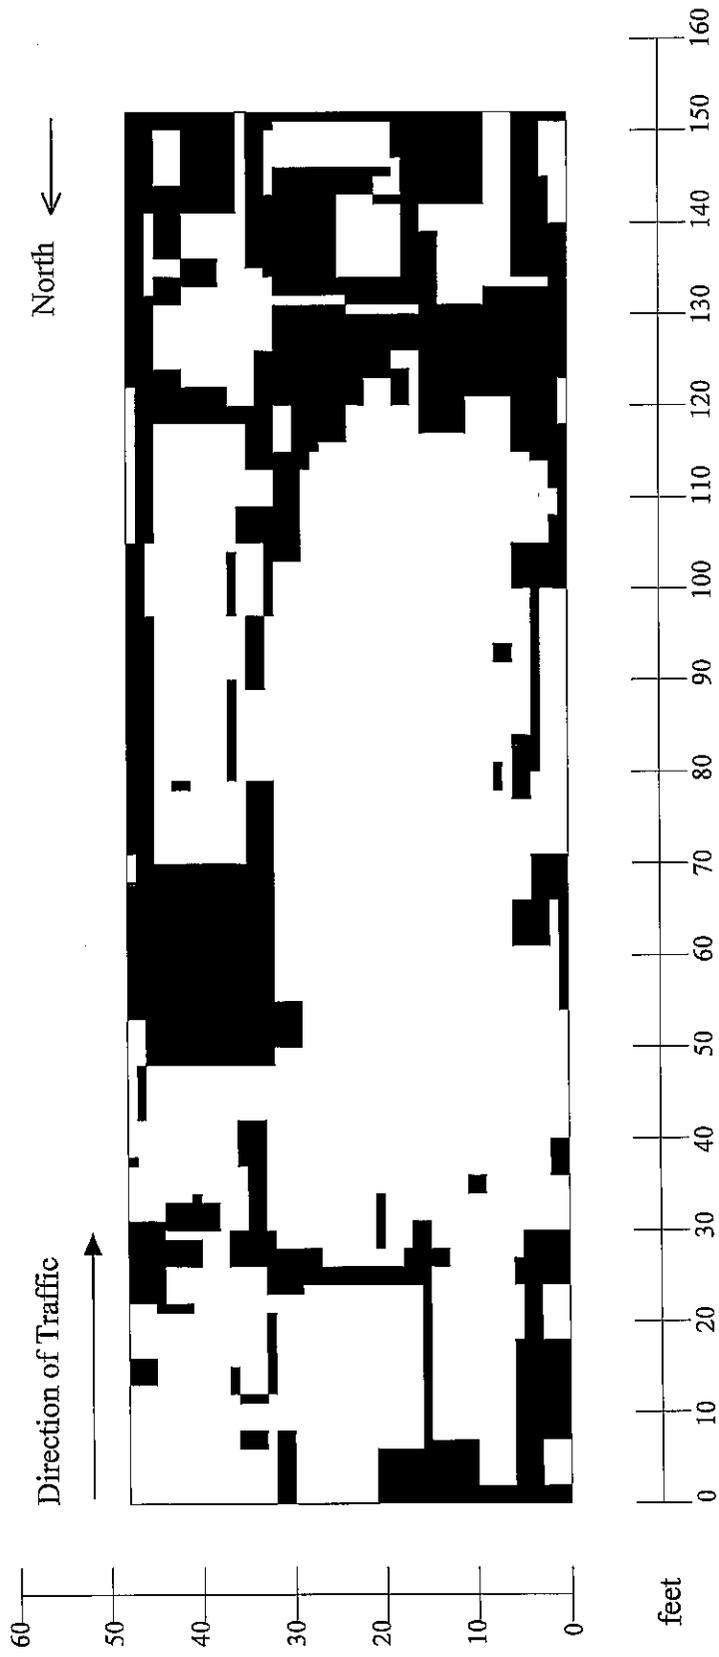
The results of the chain drag survey of the Marion Structure Number 100-0005 bridge deck can be seen in Appendix A, Figure A-10. The delamination map shows areas that were found to be delaminated by chain dragging while the overlay remained on the bridge deck. The presence of delaminations was not able to be verified as the overlay was never removed. Figure A-10 shows extensive areas of delamination. The greatest concentration of delaminated areas were along the east and south edges of the pavement. Because of the extensive nature of the delaminated areas, only the total area delaminated is used for comparing the other nondestructive testing methods as individual delaminations could not be identified. The total area delaminated found by chain dragging is 2984 ft² (277.2 m²).

Figure A-10. Marion Structure Number 100-0005 chain drag survey. Dark areas indicate delaminations.

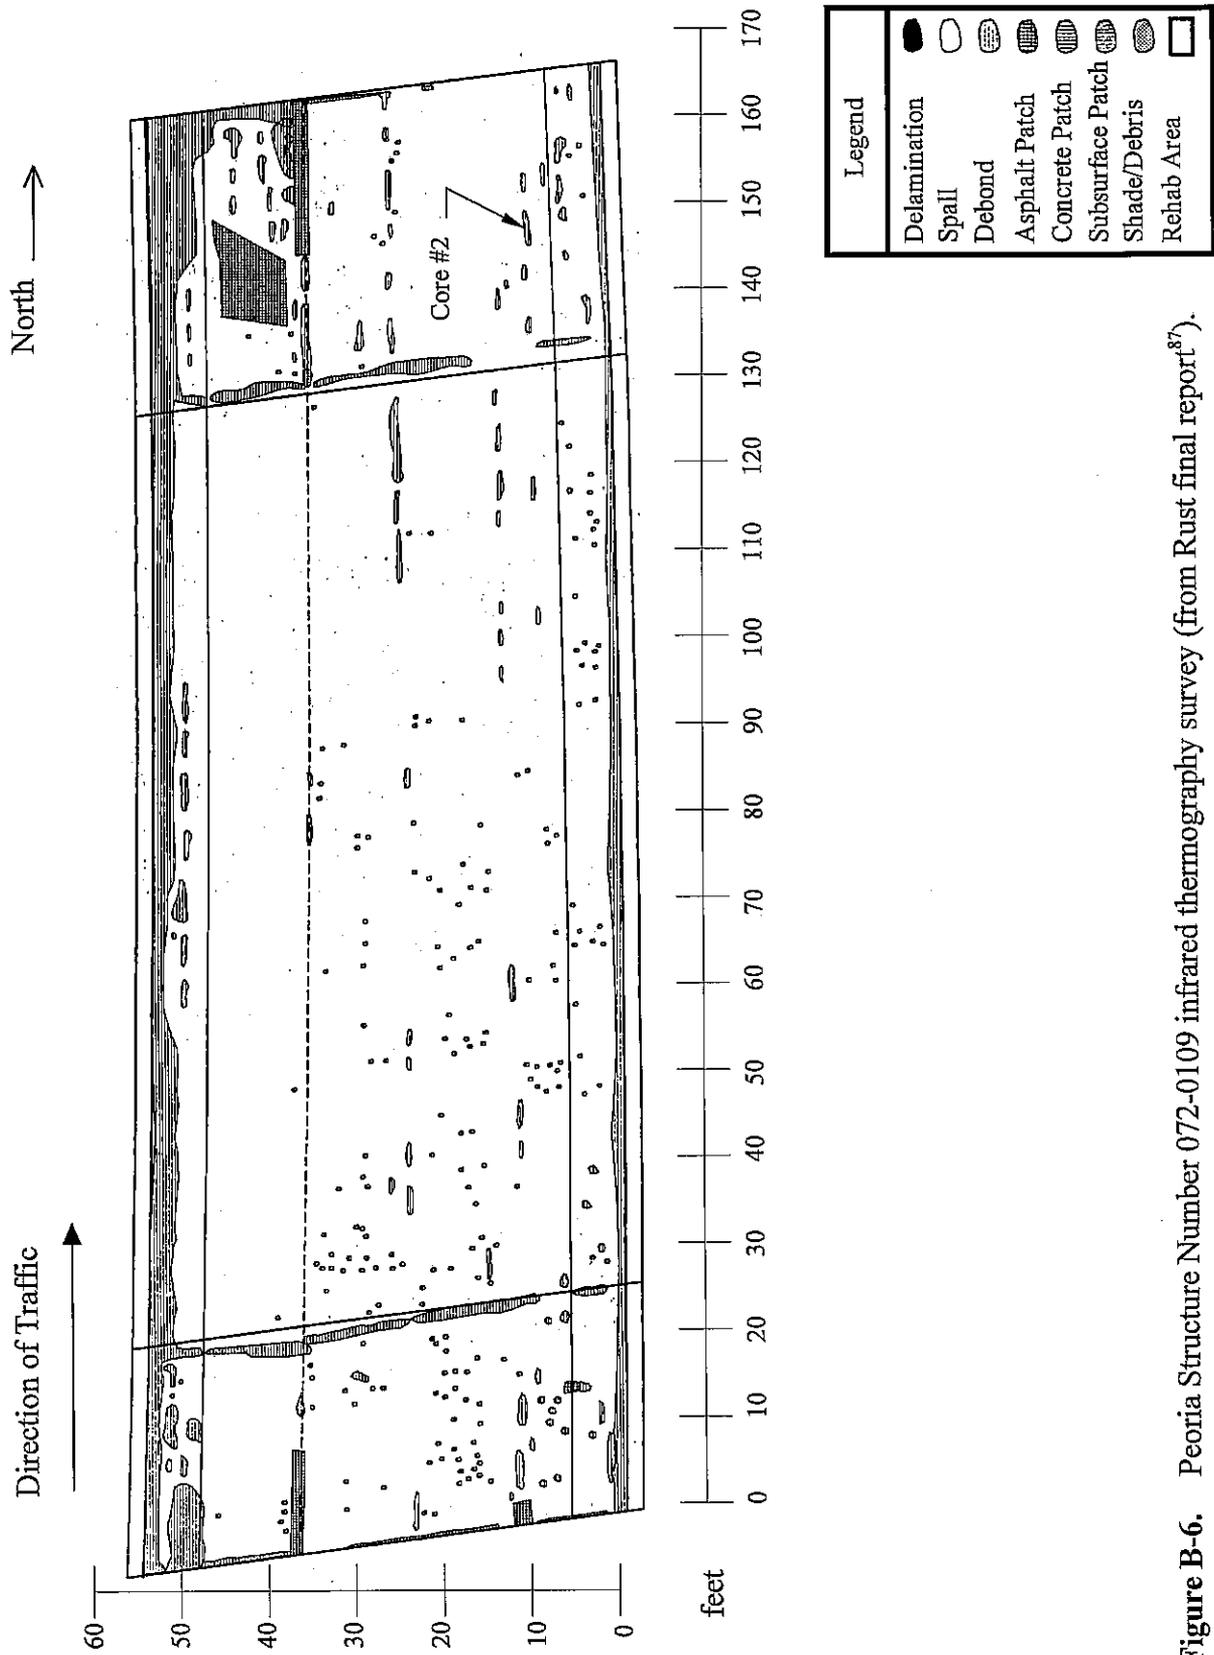
The results of the infrared inspection of the Peoria Structure Number 072-0109 bridge deck can be seen in Appendix B, Figure B-6. The infrared inspection of the bridge deck found 0 of the 12 distinct delaminations found by the chain drag inspection. The total proposed rehabilitation area due to delamination is 0 ft² as compared with 64 ft² (5.9 m²) determined by chain drag. 10.8% of the bridge deck is reported debonded, concentrated along the west edge of the deck. One core (Core #2) was taken at the north end of the bridge. Core #2 was found to be debonded.

Figure B-6. Peoria Structure Number 072-0109 infrared thermography survey (from Rust final report⁸⁷).

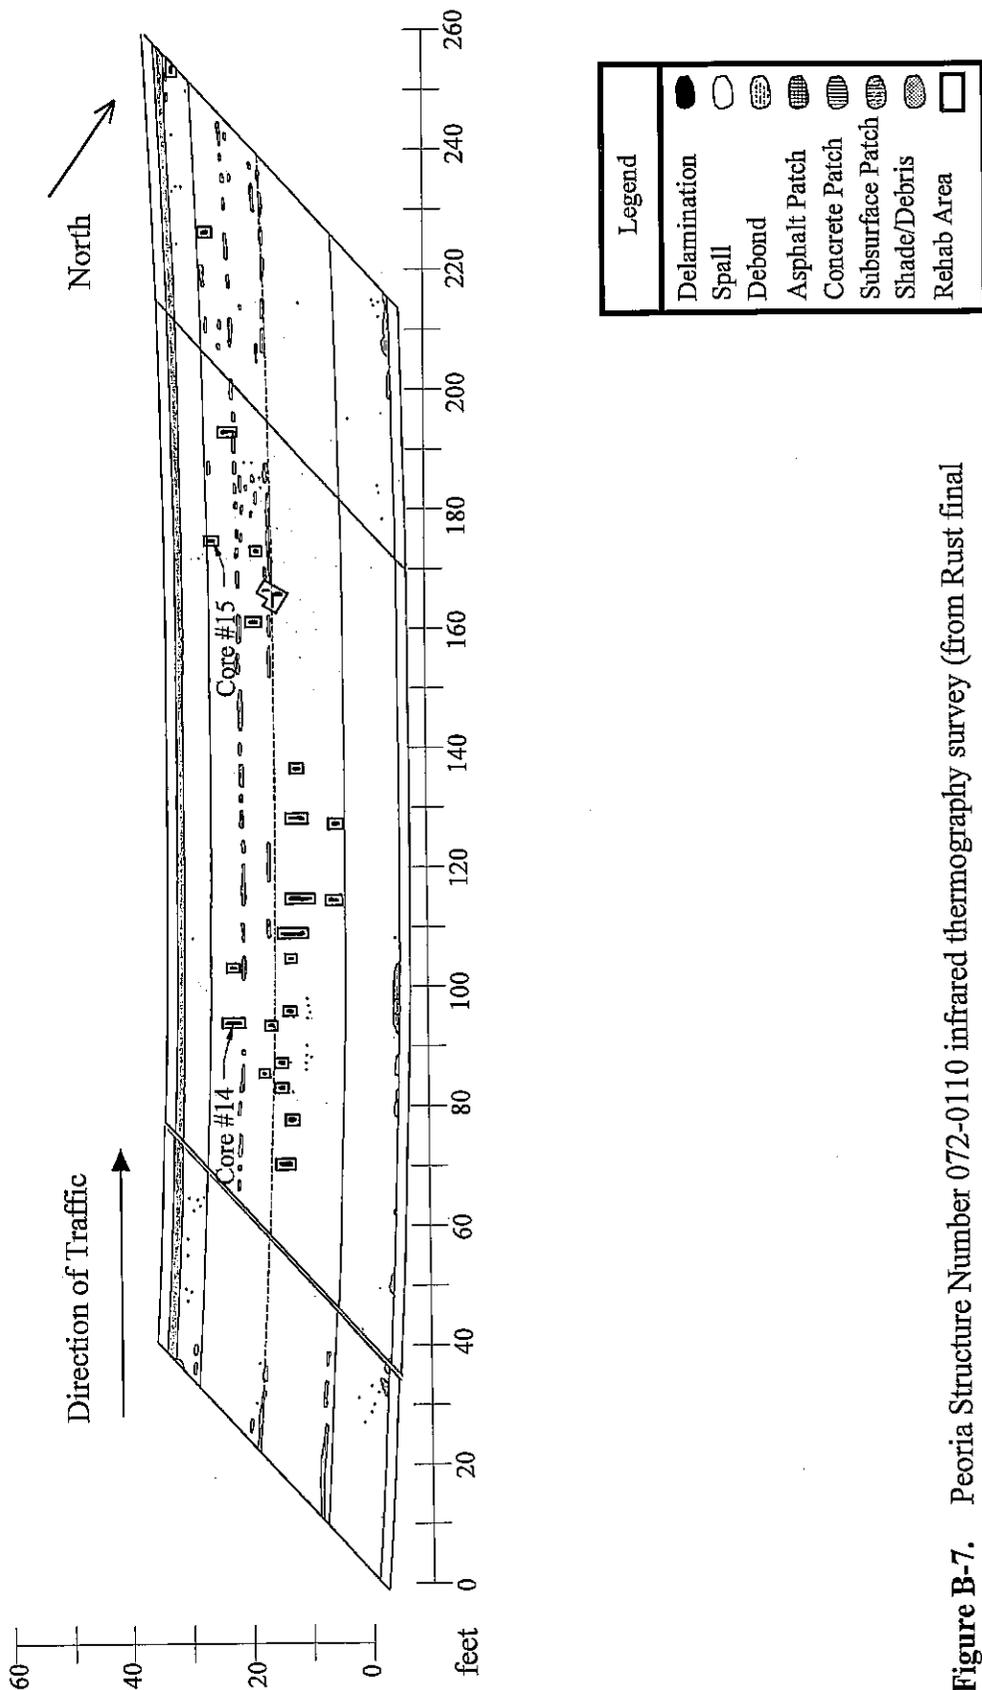
The results of the infrared inspection of the Peoria Structure Number 072-0110 bridge deck can be seen in Appendix B, Figure B-7. The infrared inspection of the bridge deck found 23 of the 34 distinct delaminations found by the chain drag inspection. The total proposed rehabilitation area due to delamination is 127.0 ft² (11.8 m²) as compared with 169 ft² (15.7 m²) determined by chain drag. 2.1% of the bridge deck is reported debonded, concentrated in the right lane of the deck. The western edge of the bridge deck could not be inspected due to shading by the west wall, an area amounting to 3.7% of the total area of the deck. Two cores (Core #14 and Core #15) were taken at the south and north end of the bridge, respectively. Core #14 and Core #15 were found to be delaminated.

Figure B-7. Peoria Structure Number 072-0110 infrared thermography survey (from Rust final report⁸⁷).
