FINAL REPORT

EVALUATION OF BRIDGE DECK DELAMINATION INVESTIGATION METHODS

Project IC-H1, 95/96

Report No. ITRC FR 95/96-1

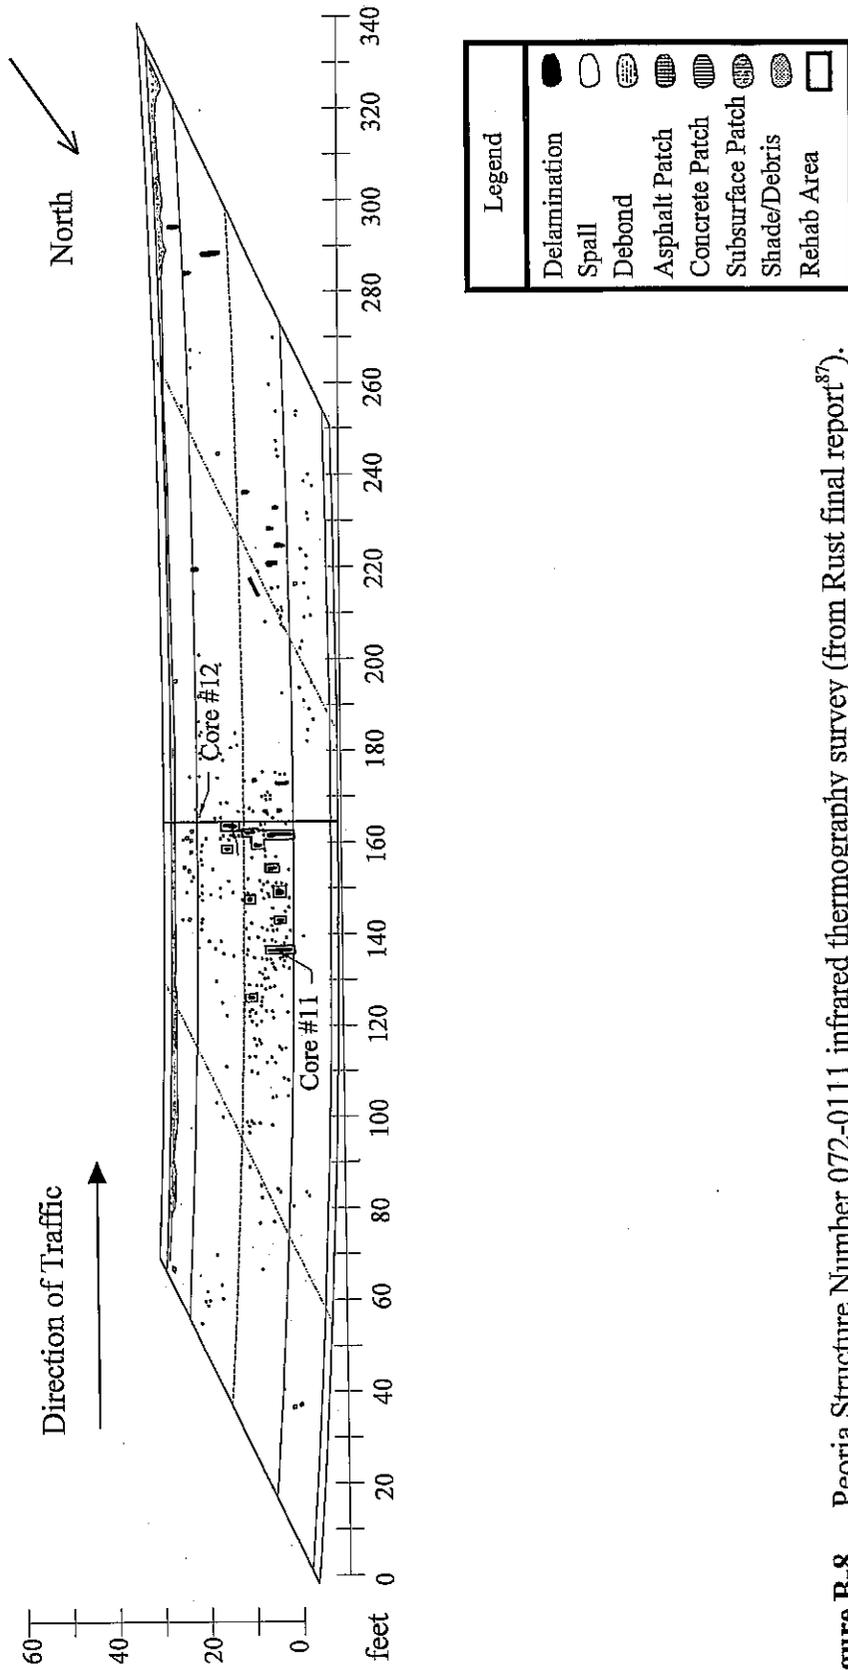
The results of the infrared inspection of the Peoria Structure Number 072-0111 bridge deck can be seen in Appendix B, Figure B-8. The infrared inspection of the bridge deck found 21 of the 68 distinct delaminations found by the chain drag inspection. The total proposed rehabilitation area due to delamination is 415.5 ft² (38.6 m²) as compared with 485 ft² (45.1 m²) determined by chain drag. 3.2% of the bridge deck is reported debonded, concentrated in the east edge of the deck. Three cores (Core #11, Core #12, and Core #13) were taken from the middle of the deck. Core #11 was found to be delaminated. Core #12 was found to be debonded and Core #13 was found to be delaminated.

Figure B-8. Peoria Structure Number 072-0111 infrared thermography survey (from Rust final report⁸⁷).

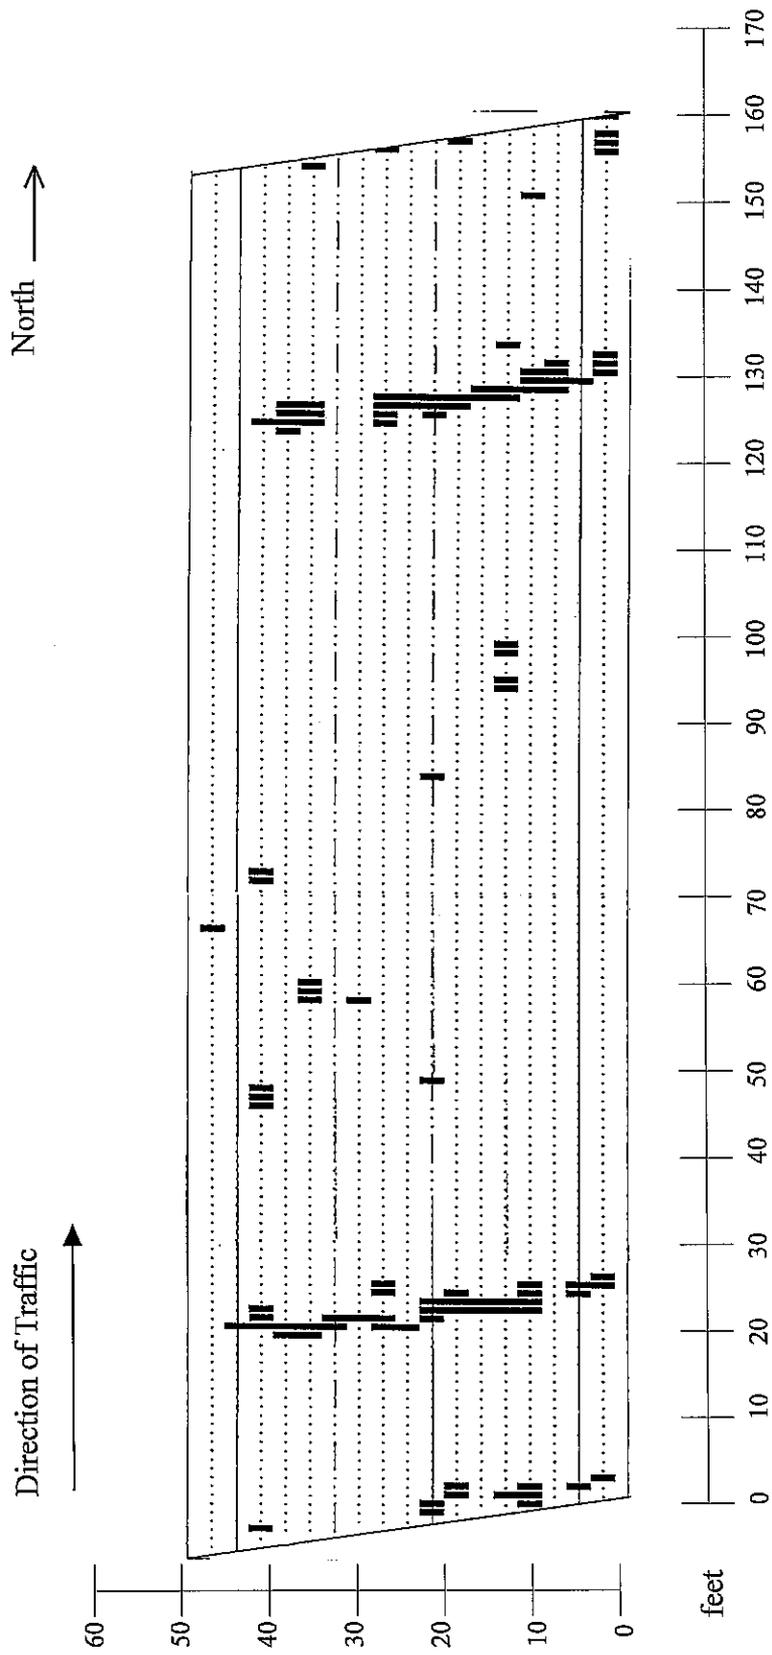
The results of the ground penetrating radar inspection of the Peoria Structure Number 072-0109 bridge deck can be seen in Appendix C, Figure C-12 and Figure C-13. Figure C-12 shows areas of delamination while Figure C-13 shows areas of scaling. Over the entire deck, 0.5% of the total area is scaled only, 3.7% of the total area is delaminated only, and 0.5% of the total area is both scaled and delaminated. For purposes of comparison to the other testing methods, delamination and scaling is not distinguished and total defected area is reported. The ground penetrating radar inspection of the bridge deck found 8 of the 12 distinct defects found by the chain drag inspection. The total proposed rehabilitation area due to defects is 379.3 ft² (35.2 m²) as compared with 64 ft² (5.9 m²) determined by chain drag.

Figure C-12. Peoria Structure Number 072-0109 ground penetrating radar delamination survey (from Penetradar final report⁸⁸). Dark areas indicate delaminations.

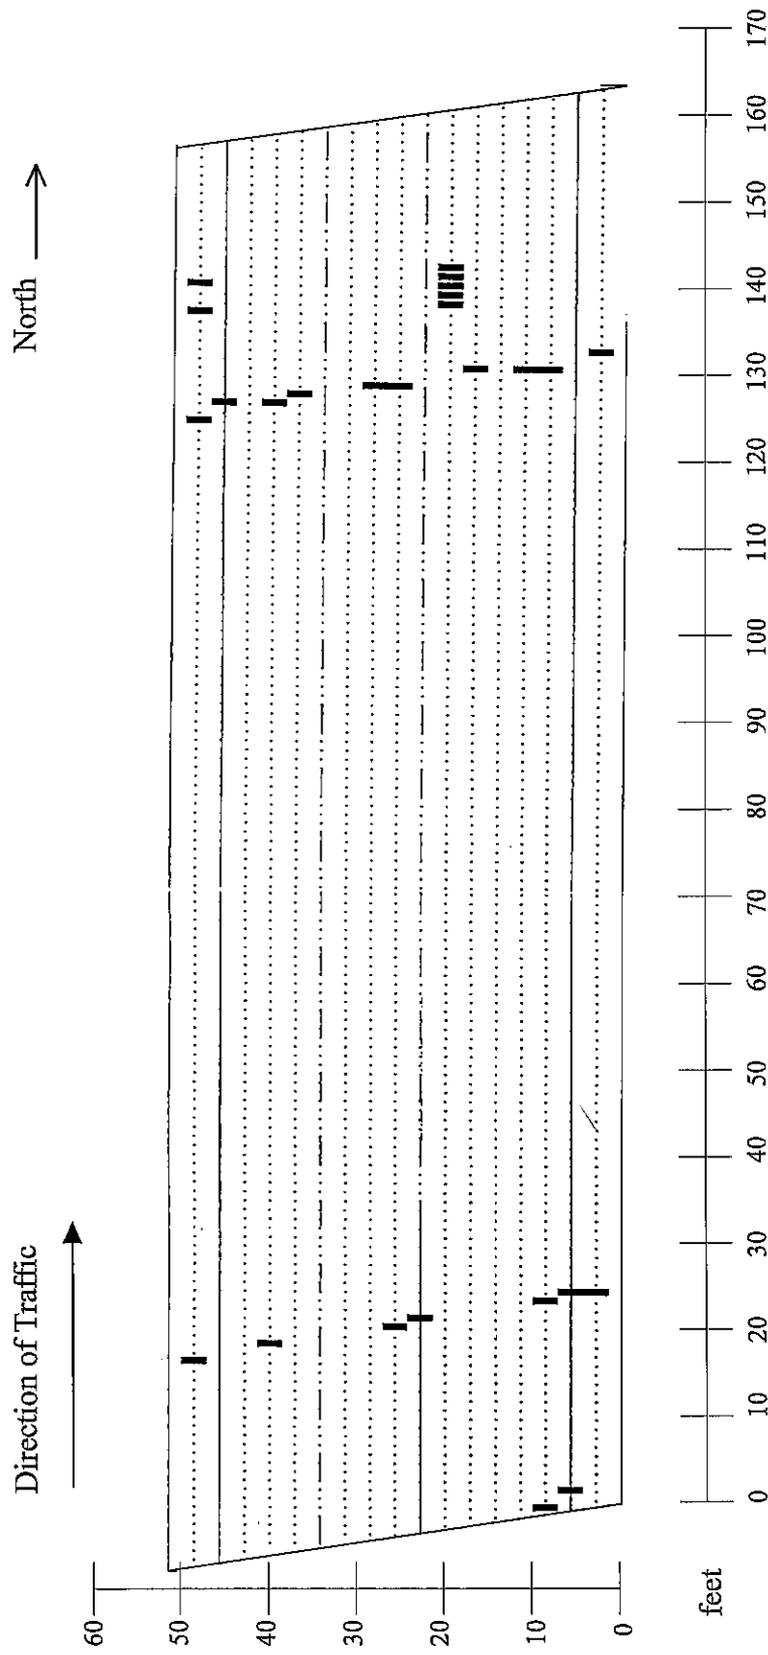
Figure C-13. Peoria Structure Number 072-0109 ground penetrating radar scaling survey (from Penetradar final report⁸⁸). Dark areas indicate delaminations.

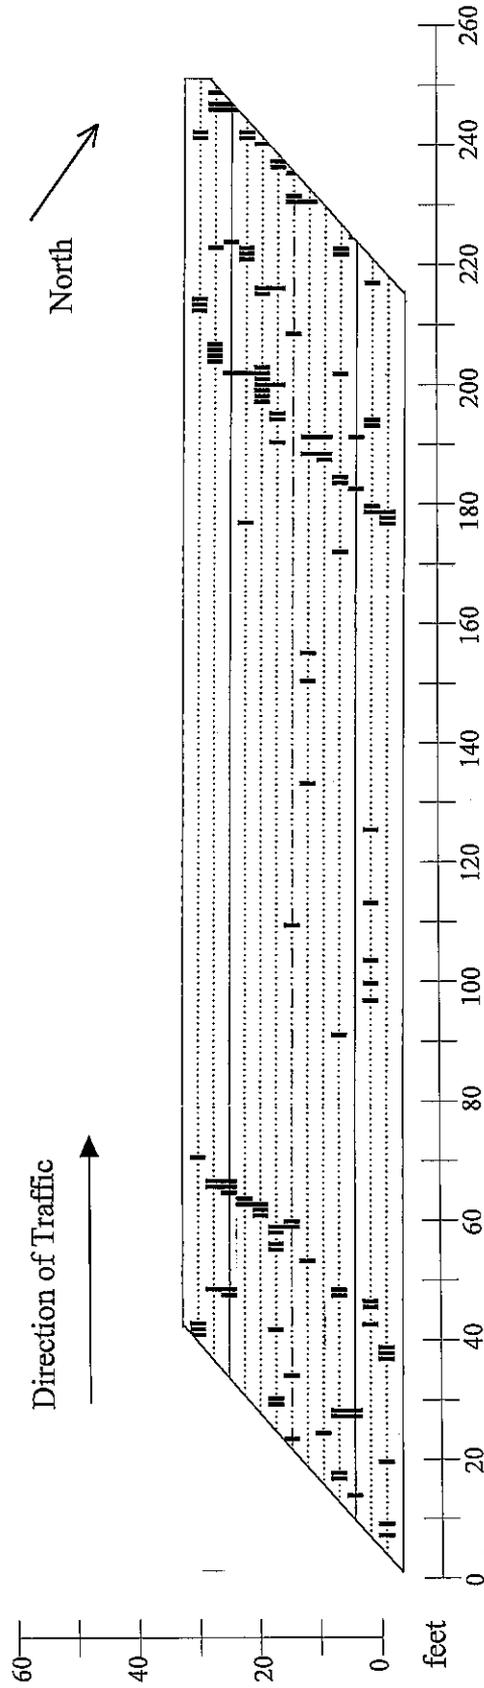
The results of the ground penetrating radar inspection of the Peoria Structure Number 072-0110 bridge deck can be seen in Appendix C, Figure C-14 and Figure C-15. Figure C-14 shows areas of delamination while Figure C-15 shows areas of scaling. Over the entire deck, 0.2% of the total area is scaled only, 4.2% of the total area is delaminated only, and 0.1% of the total area is both scaled and delaminated. For purposes of comparison to the other testing methods, delamination and scaling is not distinguished and total defected area is reported. The ground penetrating radar inspection of the bridge deck found 15 of the 34 distinct defects found by the chain drag inspection. The total proposed rehabilitation area due to defects is 394.0 ft² (36.6 m²) as compared with 169.0 ft² (15.7 m²) determined by chain drag.

Figure C-14. Peoria Structure Number 072-0110 ground penetrating radar delamination survey (from Penetradar final report⁸⁸). Dark areas indicate delaminations.

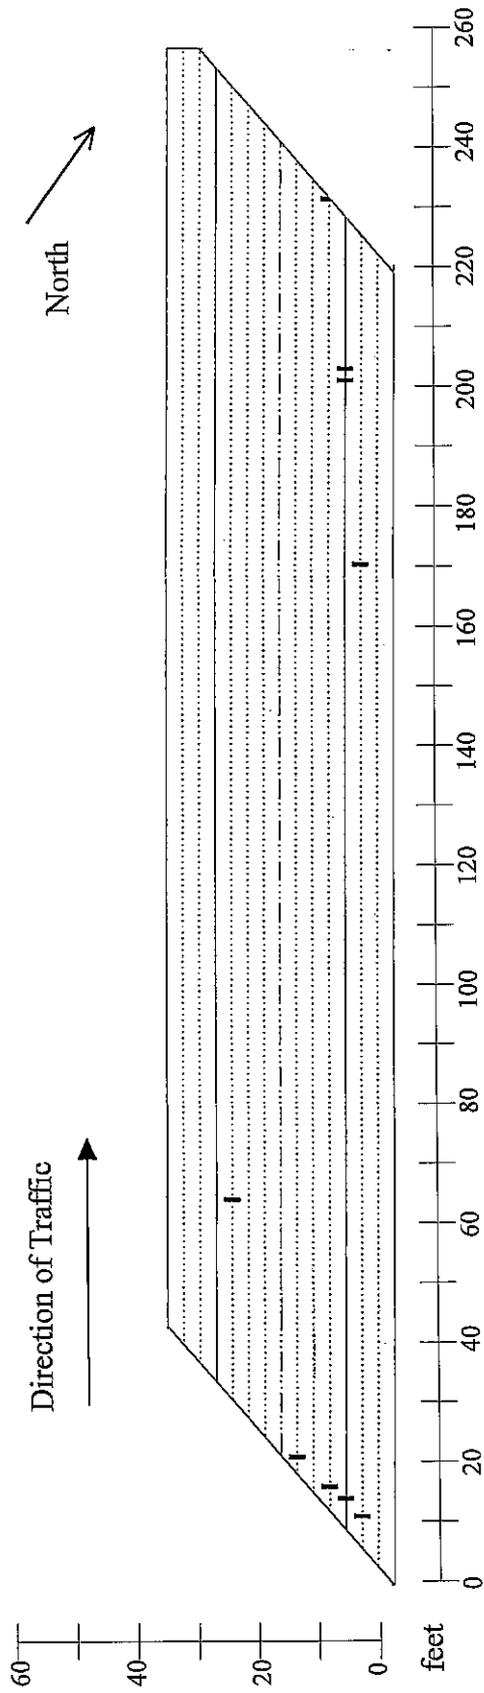
Figure C-15. Peoria Structure Number 072-0110 ground penetrating radar sealing survey (from Penetradar final report⁸⁸). Dark areas indicate delaminations.

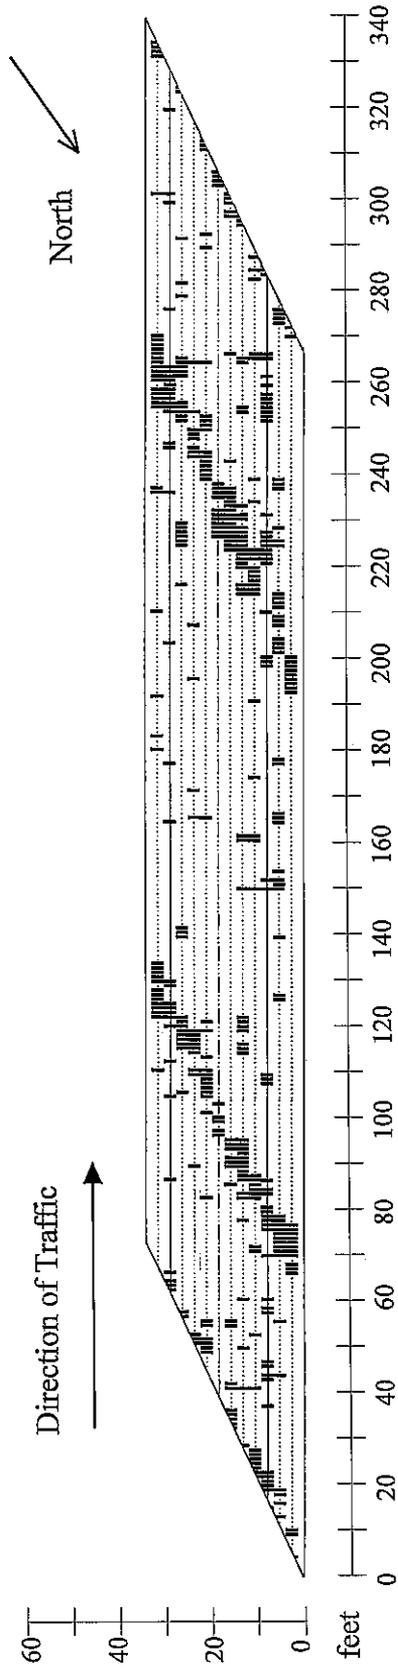
Figure C-16. Peoria Structure Number 072-0111 ground penetrating radar delamination survey (from Penetradar final report⁸⁸). Dark areas indicate delaminations.

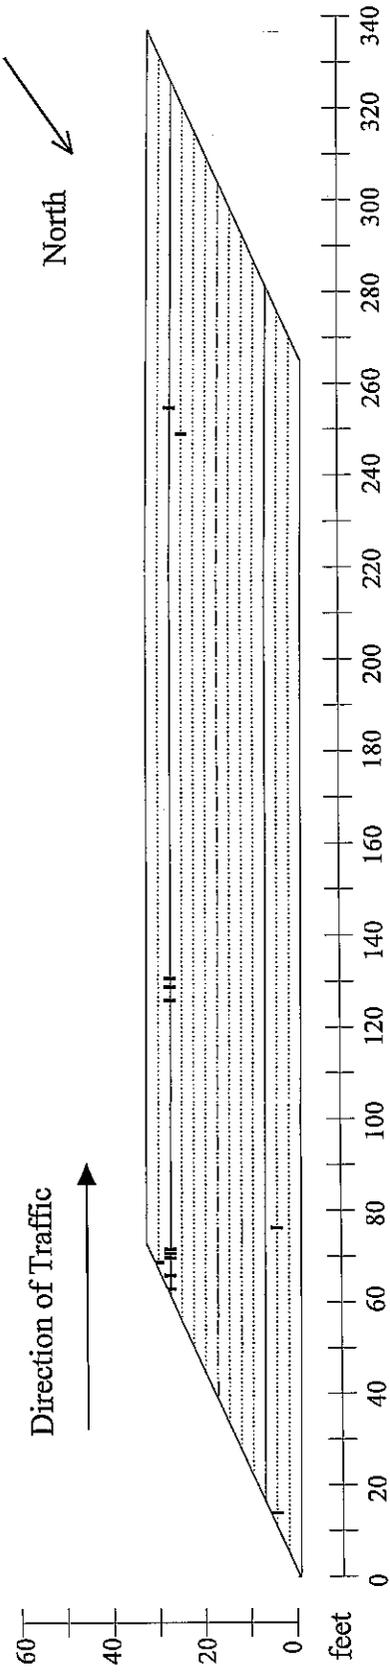
Figure C-17. Peoria Structure Number 072-0111 ground penetrating radar scaling survey (from Penetradar final report⁸⁸). Dark areas indicate delaminations.

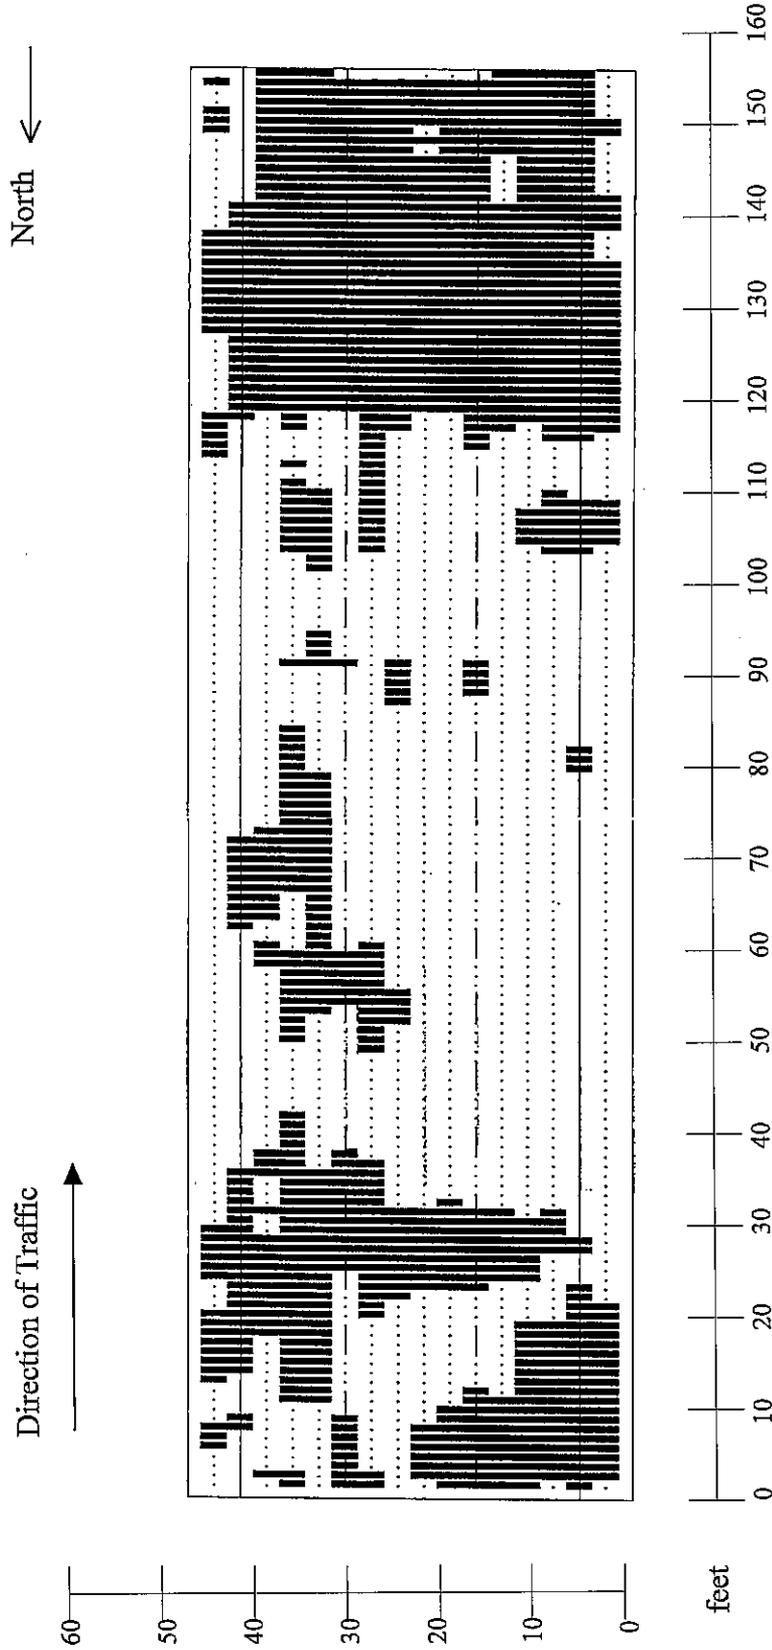
Figure C-18. Marion Structure Number 100-0005 ground penetrating radar delamination survey (from Penetradar final report⁸⁶). Dark areas indicate delaminations.

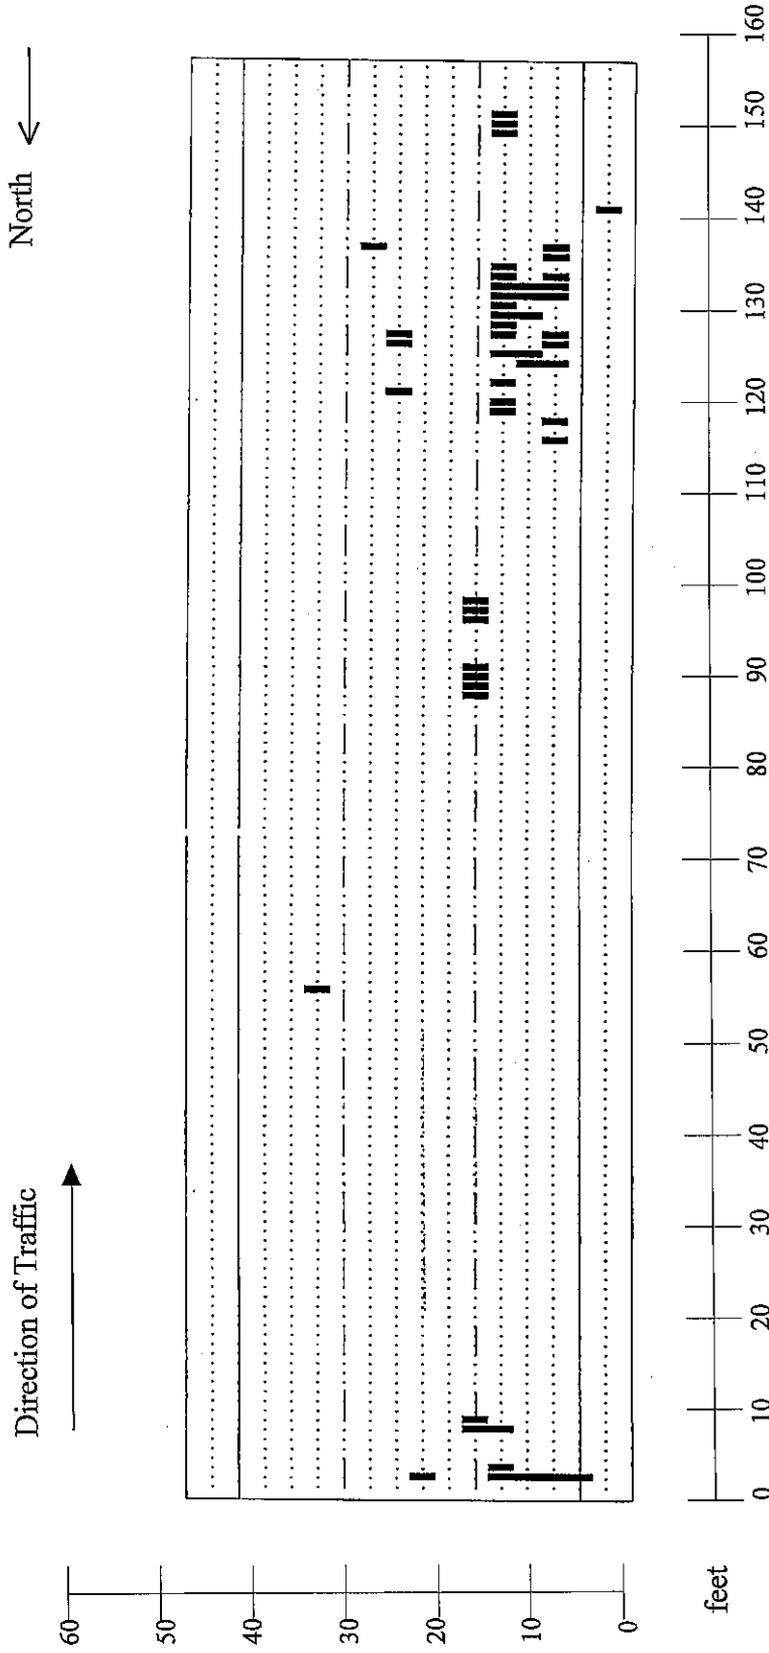
Figure C-19. Marion Structure Number 100-0005 ground penetrating radar scaling survey (from Penetradar final report⁸⁸). Dark areas indicate delaminations.

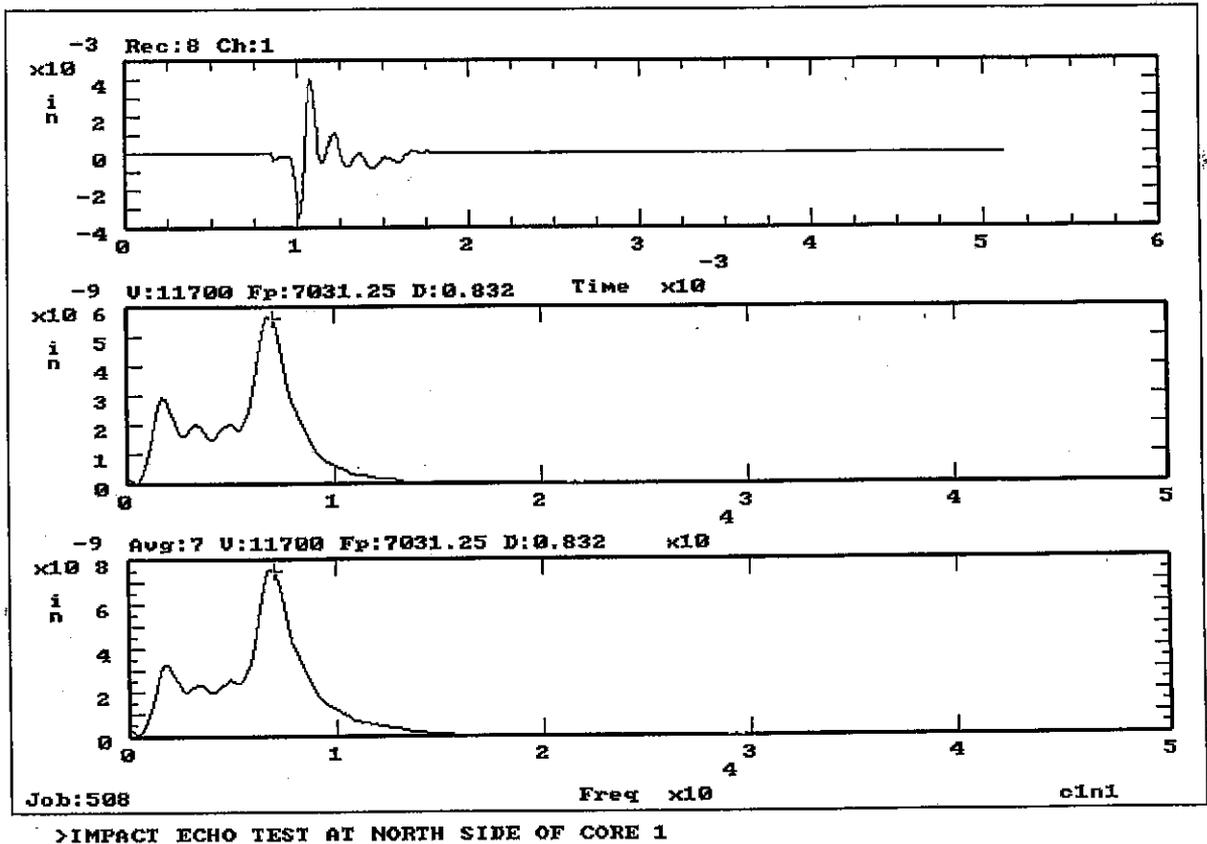
Figure D-2. Marion Structure Number 100-0005 handheld impact-echo test at north side of corehole 1 (from Olson final report⁸⁹).

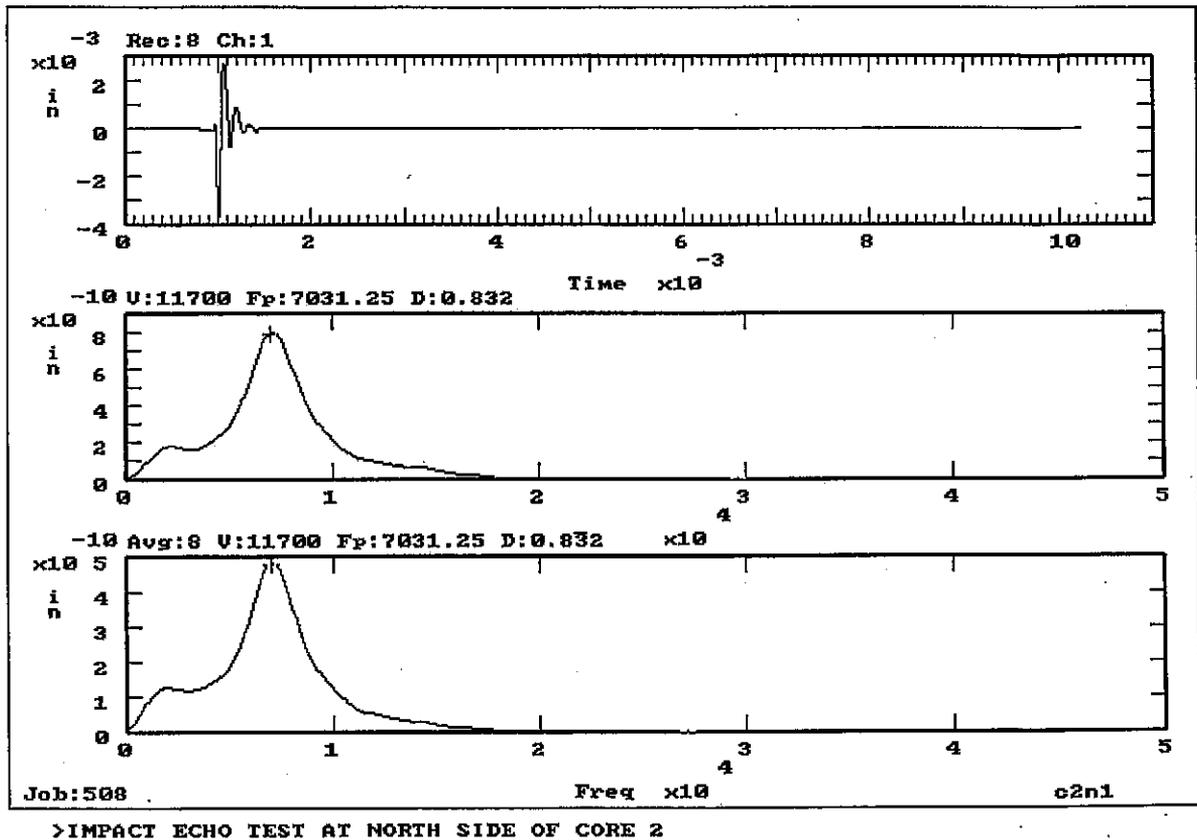
Figure D-3. Marion Structure Number 100-0005 handheld impact-echo test at north side of corehole 2 (from Olson final report⁸⁹).

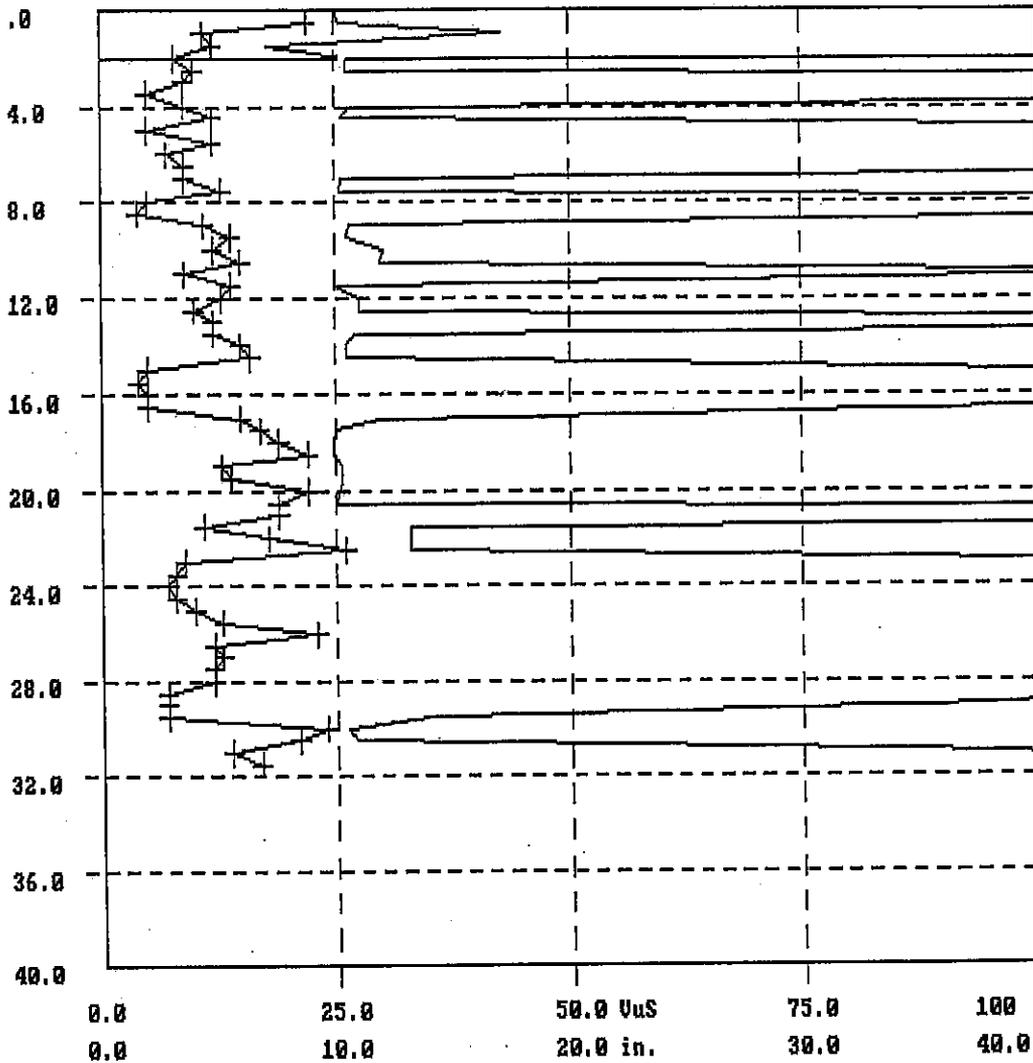
Figure D-4. Marion Structure Number 100-0005 handheld impact-echo thickness plots from 0 to 31.5 feet (9.60 m) along east scan line1-channel 2 (from Olson final report⁸⁹).

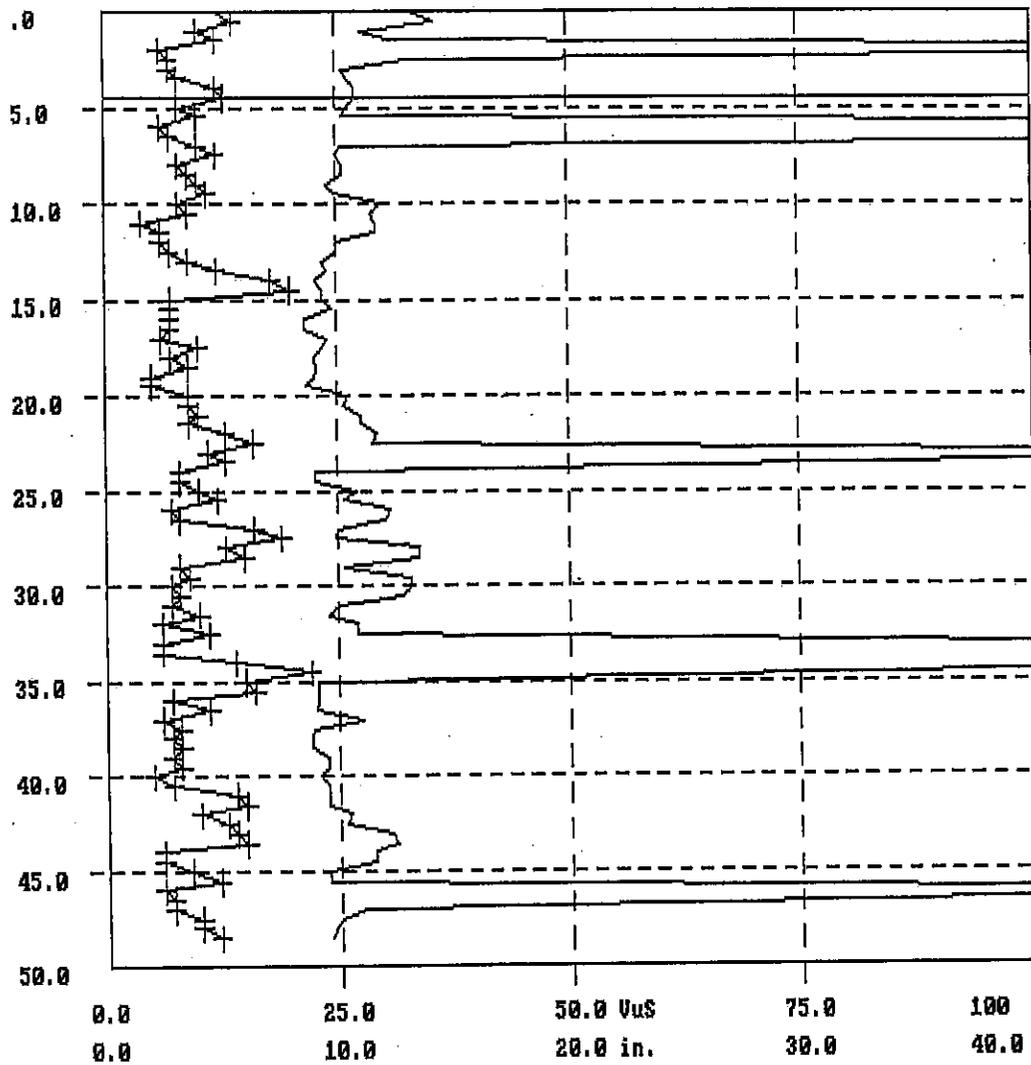
Figure D-5. Marion Structure Number 100-0005 handheld impact-echo thickness plots from 32.0 to 80.0 ft (9.75 to 24.4 m) along east scan line1-channel 2 (from Olson final report⁸⁹).

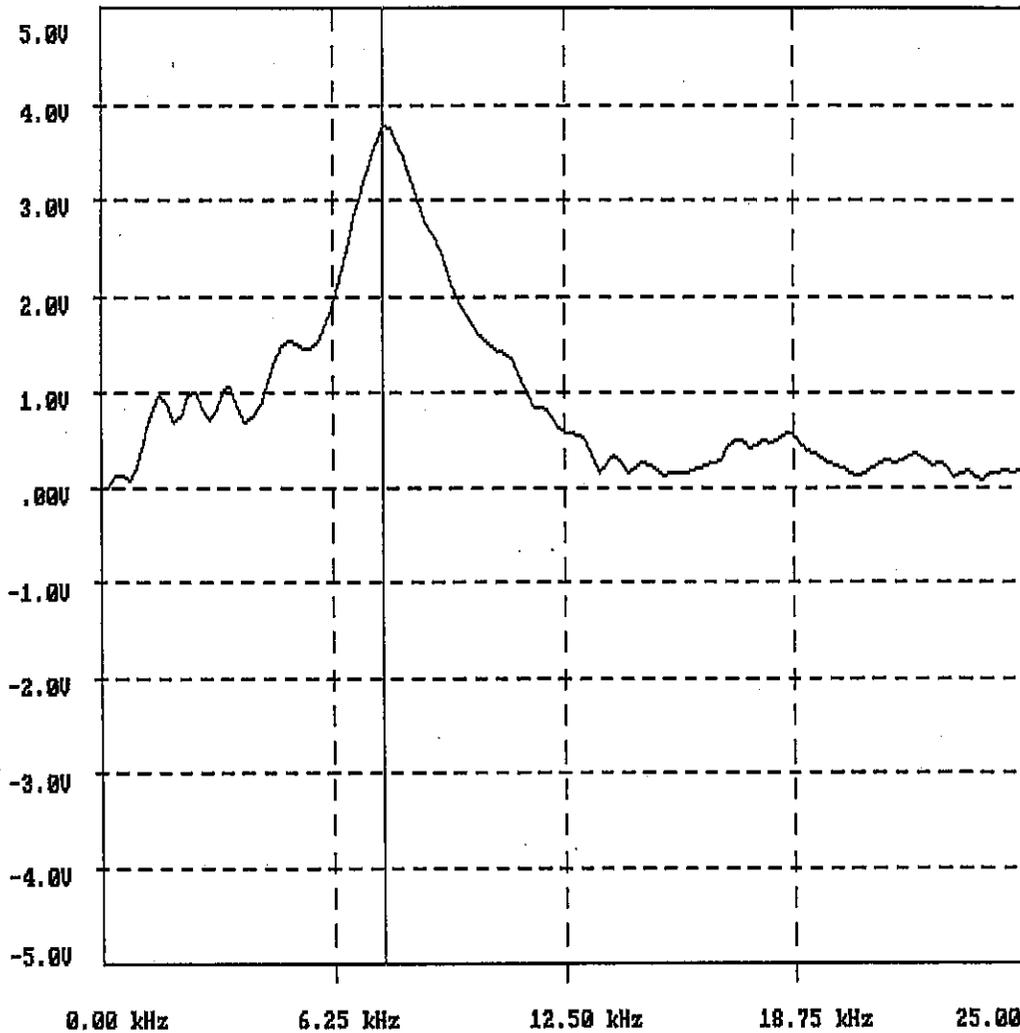
Figure D-6. Marion Structure Number 100-0005 impact-echo scanner example of good results from center scan line 2, transducer channel 3 (from Olson final report⁸⁹).

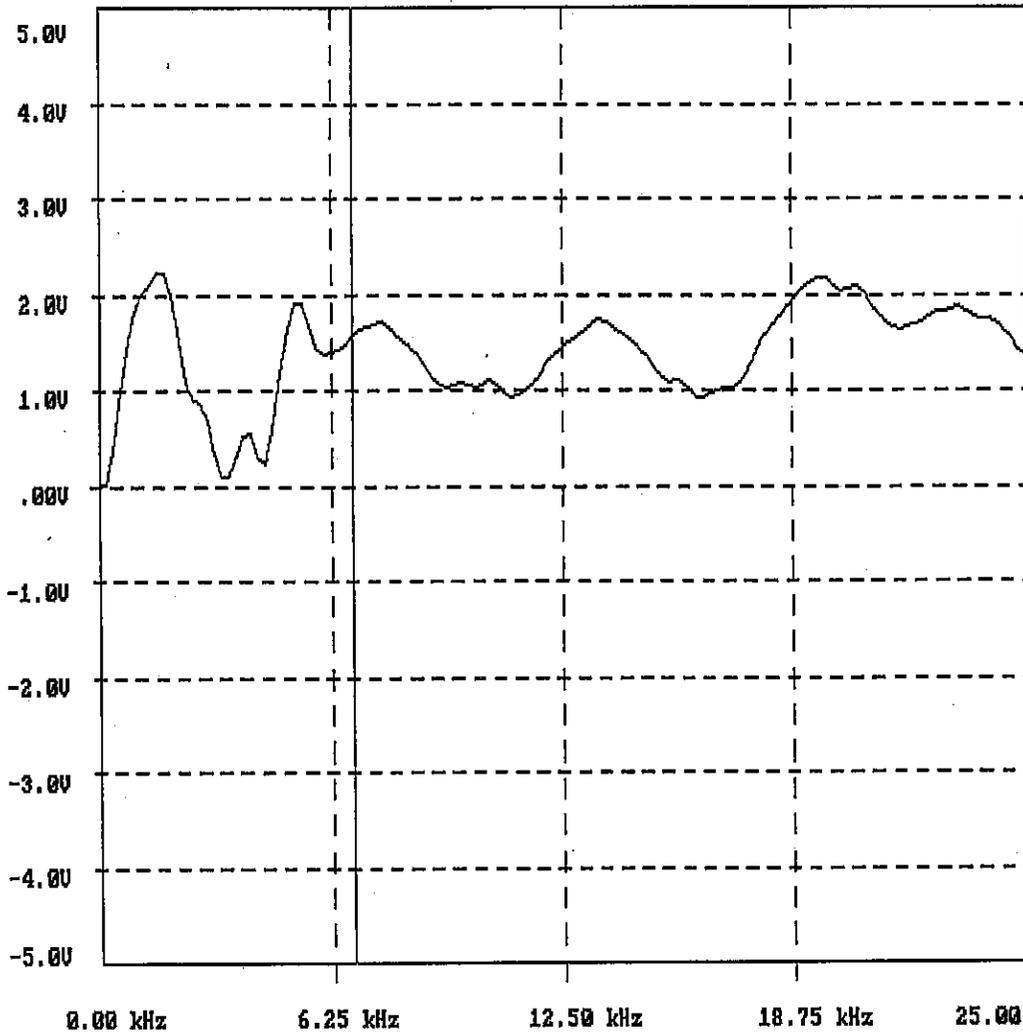
Figure D-7. Marion Structure Number 100-0005 impact-echo scanner example of poor results from center scan line 2, transducer channel 4 (from Olson final report⁸⁹).

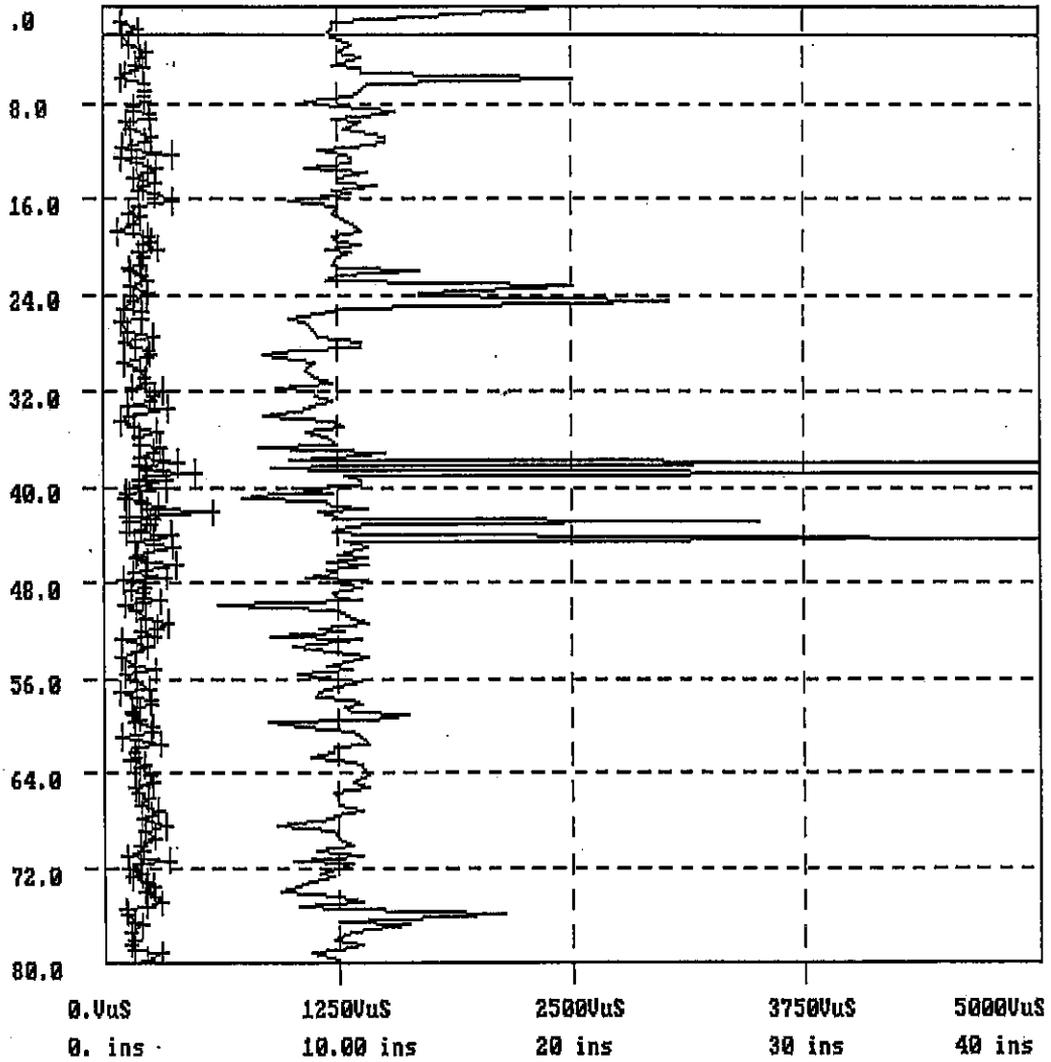
Figure D-8. Marion Structure Number 100-0005 impact-echo scanner example of good thickness results from center scan line 2, channel 3 (from Olson final report⁸⁹).

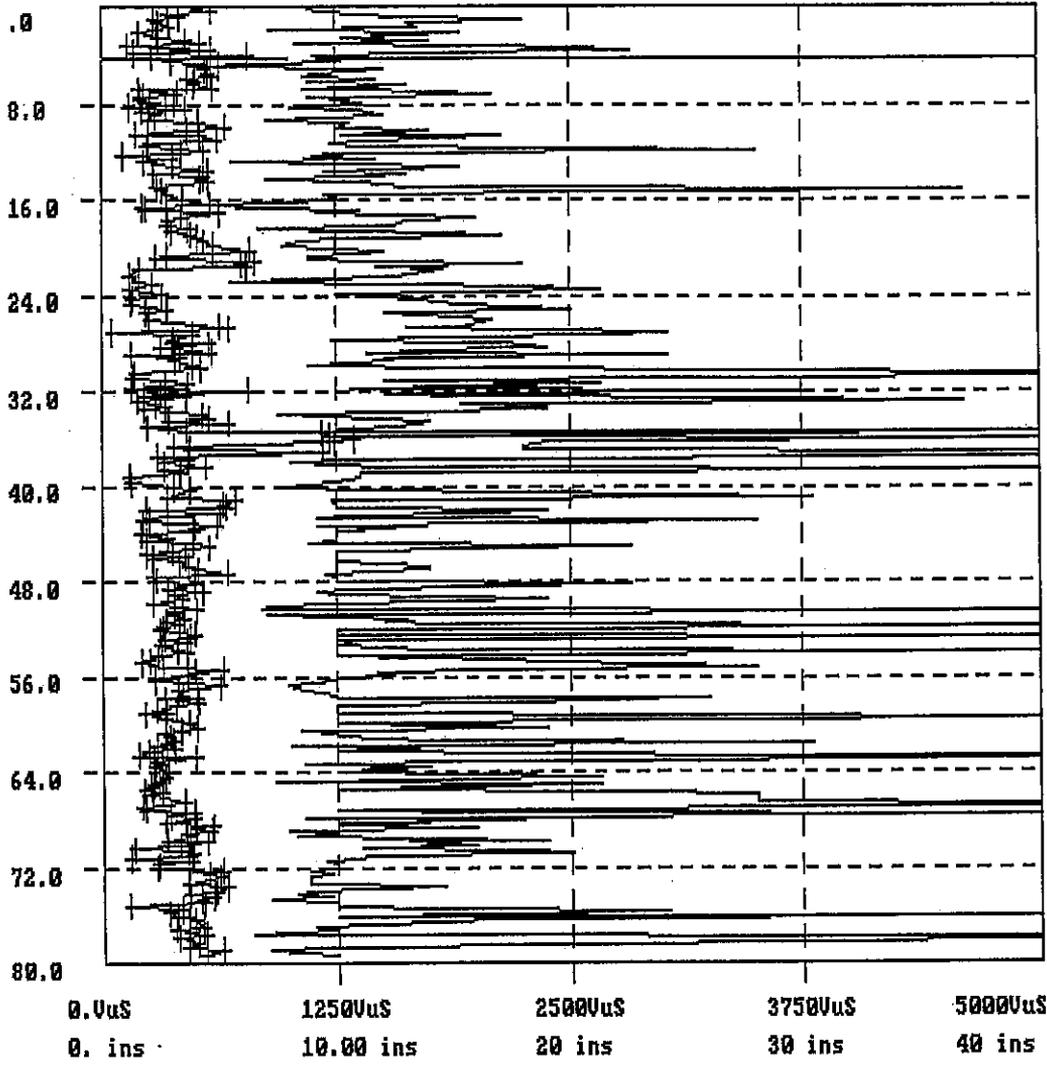
Figure D-9. Marion Structure Number 100-0005 impact-echo scanner example of poor thickness results from east scan line 1, channel 2 (from Olson final report⁸⁹).

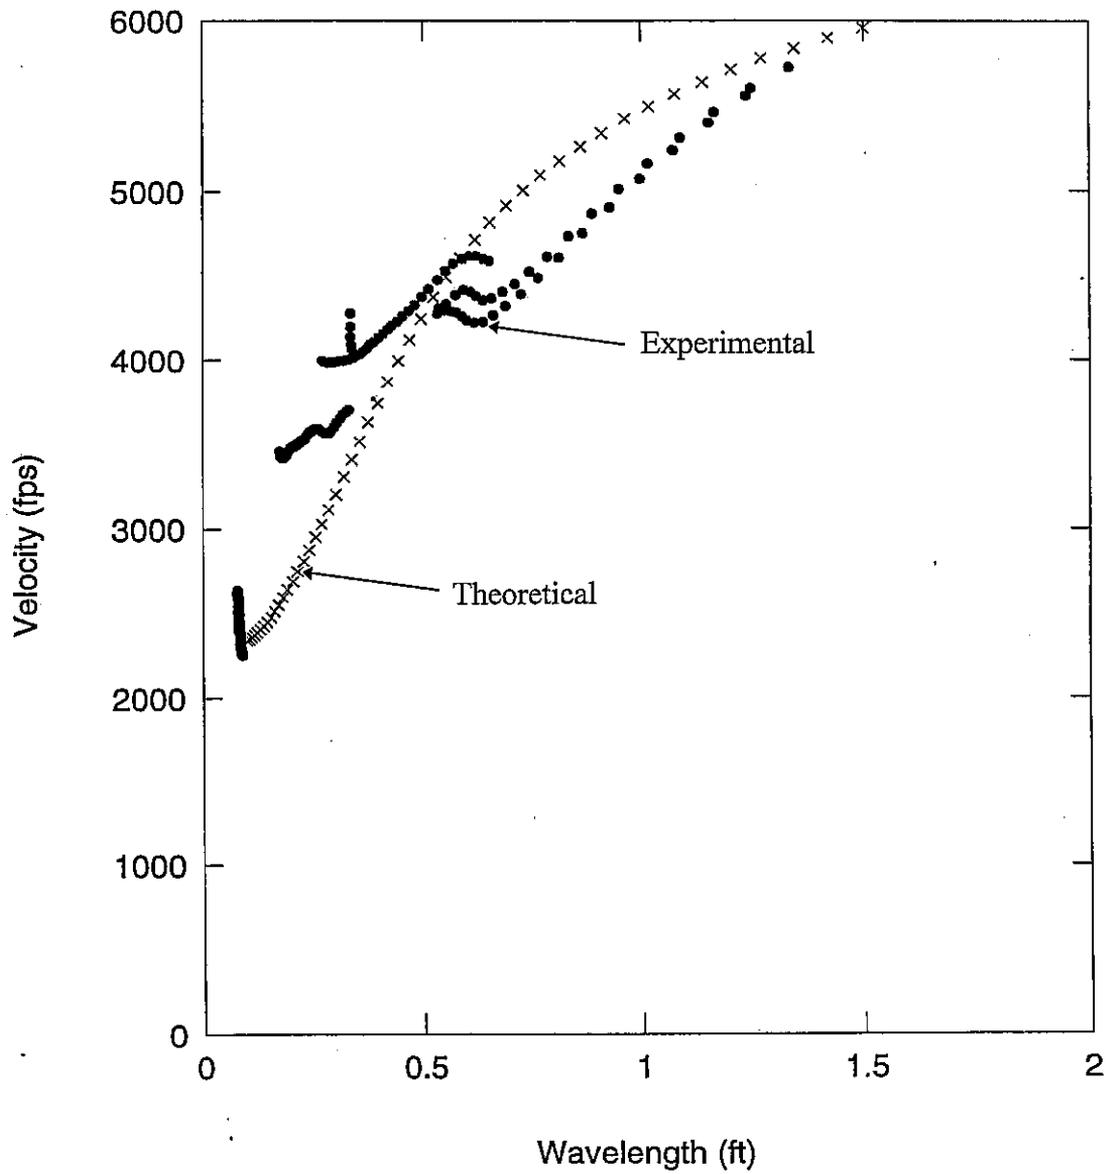
Figure D-10. Marion Structure Number 100-0005 spectral analysis of surface waves experimental and theoretical dispersion curves at core 2 (from Olson final report⁸⁹).
