ACCESS METHODS, TEST EQUIPMENT & MAINTENANCE OF TRAFFIC

NBI Calibration 2020

Access Methods, Test Equip. & Maint. of Traffic

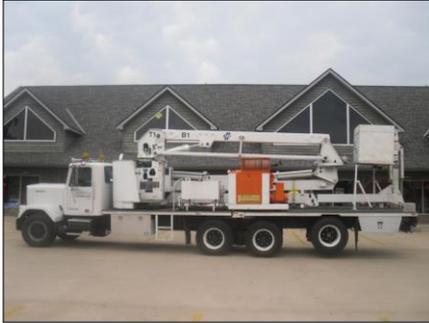
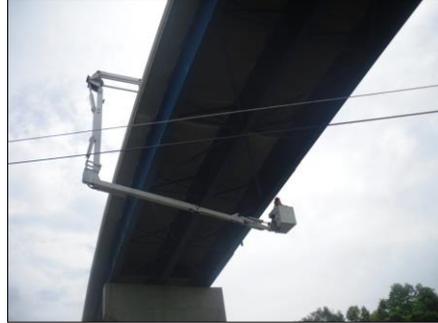
Under Bridge Inspection Trucks

- Under Bridge Inspection Trucks (UBIT)
- Platform Inspection Trucks
- Manlift (Scissor Lift and Boom Lifts)
- Bucket Truck
- Ladder
- Boat
- Technical Climbing

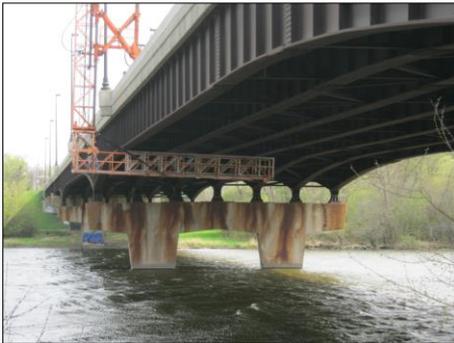
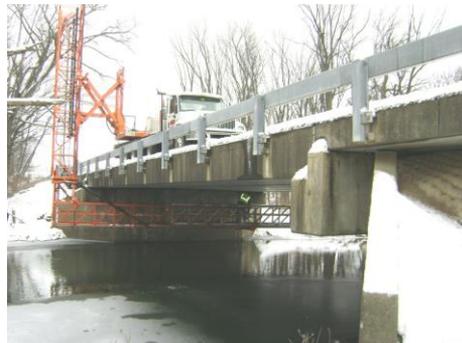
Platform Inspection Trucks

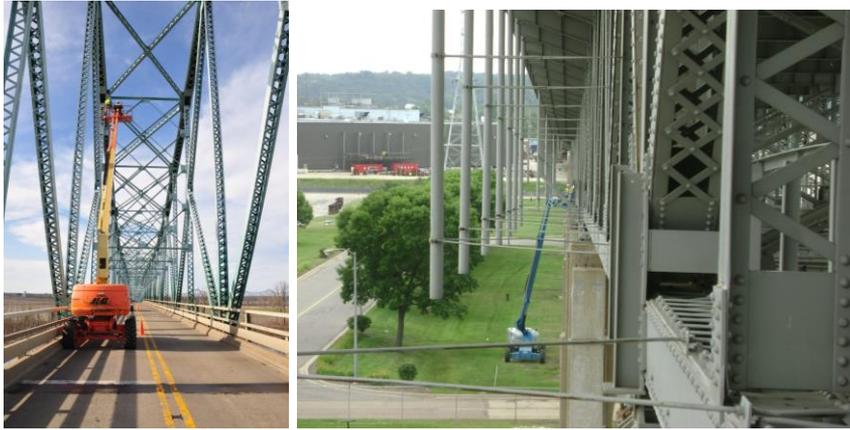
Manlift

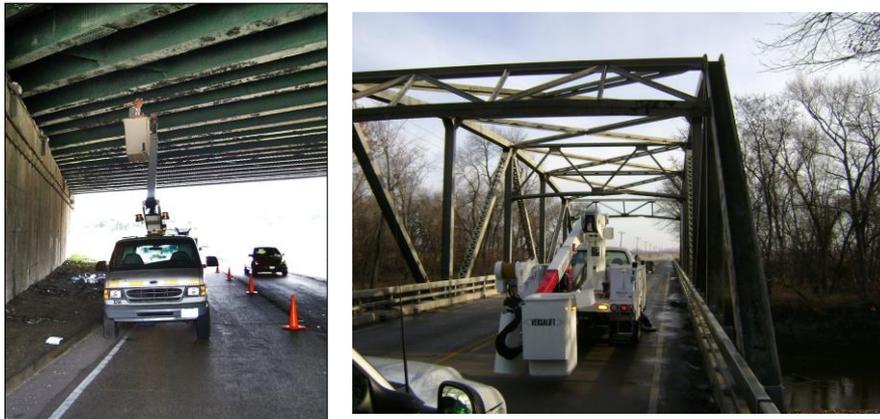
Bucket Truck

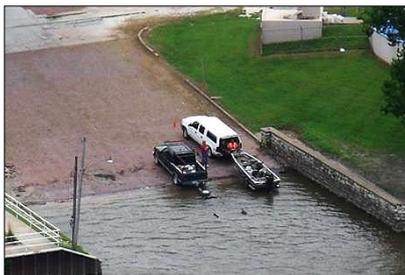
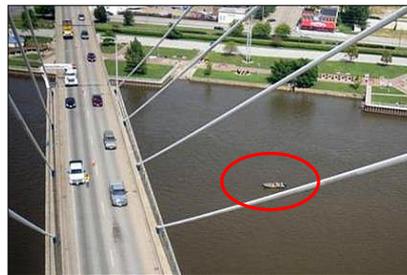
Boat

Boats provide access for water-level inspections including soundings for scour measurements.

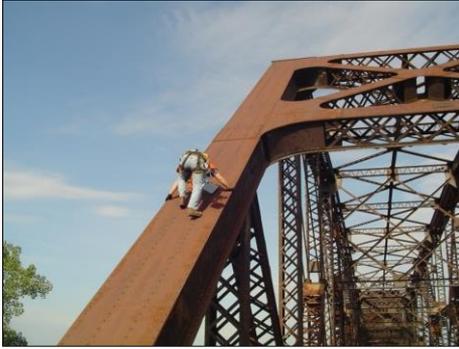
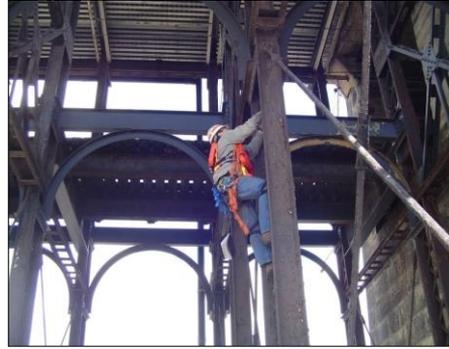
Technical Climbing

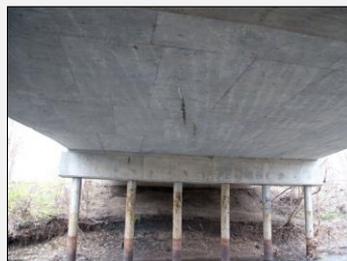
J-3

Cast in Place Conc. Slabs

- Common since early 1900's
- “Slab Superstructure” vs. “Deck”
 - Top of the slab superstructure serves as an integral deck
 - Slab superstructures span longitudinally vs. decks that usually span transversely
- Deck (Item 58) shall be rated same as Super (Item 59). The rating is based on the Super criteria

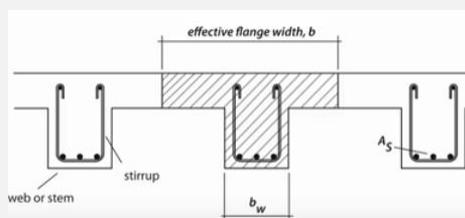
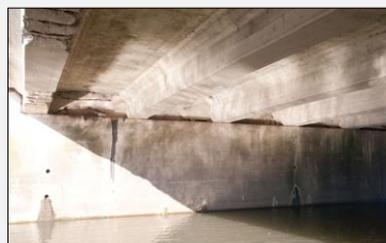
J-4

Concrete T-Beams

- Common in 1930's - 50's
- Monolithic deck and stem forms the shape of a letter “T”
- Typically cast-in-place construction
- Top flange is considered the Deck (Item 58)
- Deck and stem act together as the superstructure (Item 59)

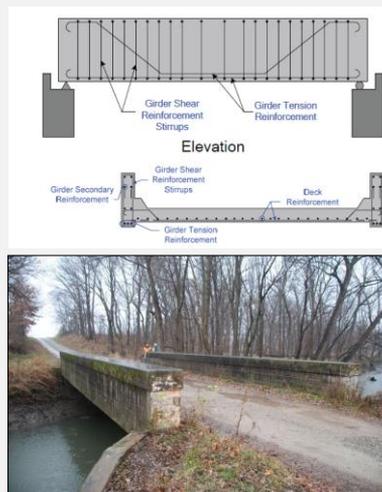
J-5

Concrete Through Girders

- Common in 1940's, rarely used now
- Monolithic deck supported by a two-girder system
- Deck is cast between girders
- Upper portions of through girders serve as bridge railing
- Even though it is a two-girder system, girders are not FCMs

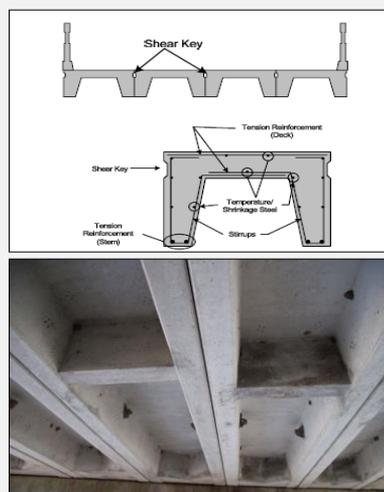
J-6

Concrete Channel Beam

- Appearance of bridge cross section resembles T-Beam
- Usually made of precast concrete
- Typically not prestressed
- Top flange is considered the Deck (Item 58)
- Deck and stems act together as superstructure (item 59)
- Deck is integral with the Super. Low Deck (Item 58) rating may adversely affect Super (Item 59) rating, however; Super rating will not affect Deck rating

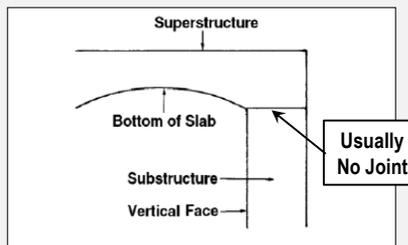
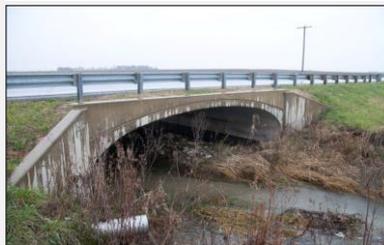
J-7

3-Sided Precast Structures

- Top may be arched or flat
- Most common version is precast concrete
- Top is considered the Superstructure (Item 59)
- Sides are considered the Substructure (Item 60)
- Deck (Item 58) is coded “N”

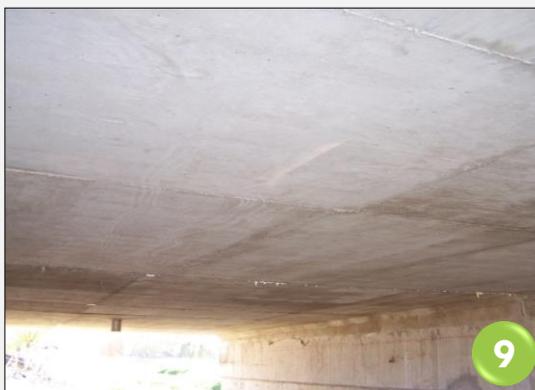
J-10

New Superstructure

- Slab
- No Defects

New superstructure – Typically first inspection only

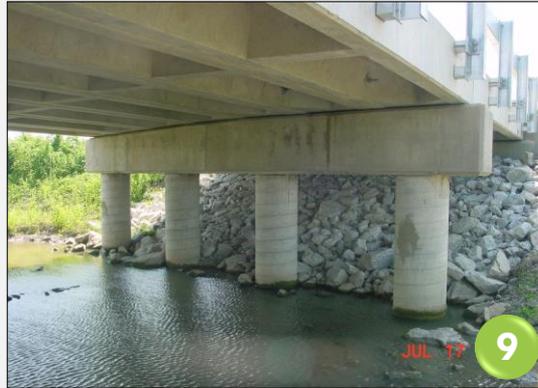
J-11

New Superstructure

- Channel Beam
- No Defects

New superstructure – Typically first inspection only

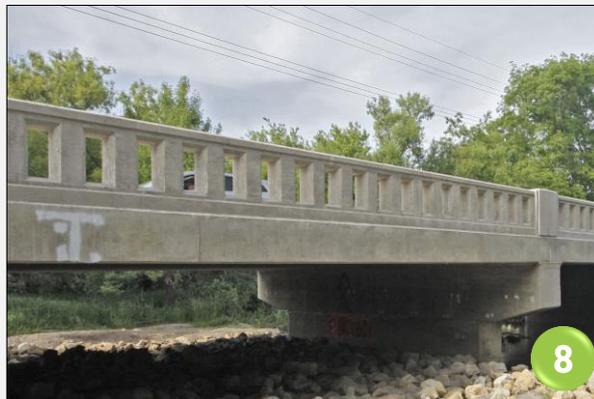
J-12

Very Good Condition

- Slab
- No significant defects

VERY GOOD. No significant defects, very minor shrinkage **cracks**, surface **scaling, spalling** or pop-outs which do not expose reinforcing steel.

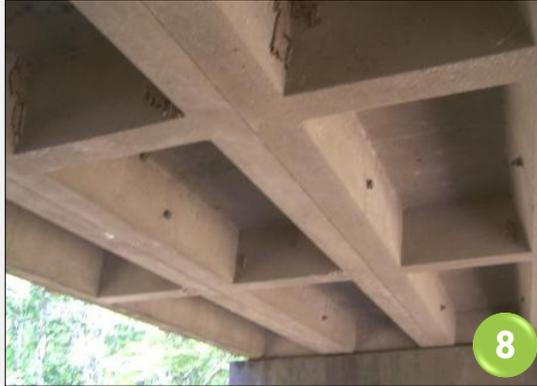
J-13

Very Good Condition

- Channel Beam
- Minor shrinkage cracks in legs

VERY GOOD. No significant defects, very minor shrinkage **cracks**, surface **scaling**, **spalling** or pop-outs which do not expose reinforcing steel.

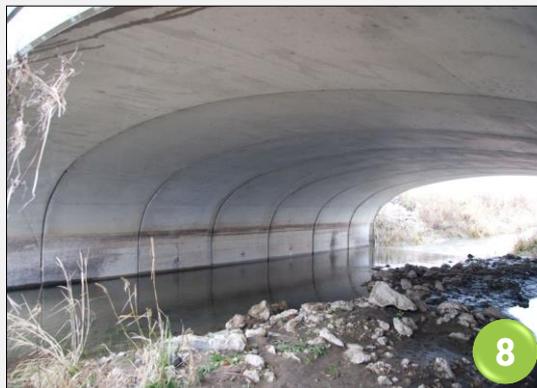
J-14

Very Good Condition

- 3-Sided Precast
- No significant defects

VERY GOOD. No significant defects, very minor shrinkage **cracks**, surface **scaling**, **spalling** or pop-outs which do not expose reinforcing steel.

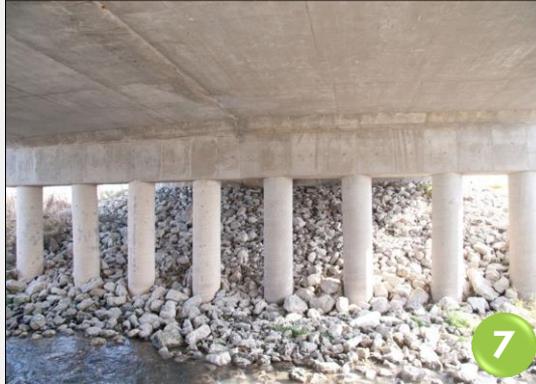
J-15

Good Condition

- Slab
- Minor non-structural cracks less than 0.03" present

GOOD. Isolated non-structural **cracks** up to 0.03", minor pop-outs or **spalls** without exposed primary reinforcing steel, stirrups may be exposed in a few locations.

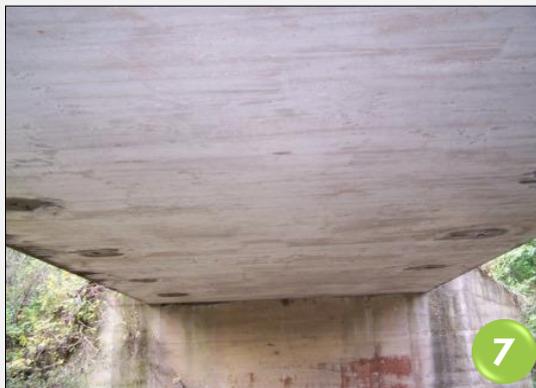
J-16

Good Condition

- Through Girder
- Minor spalling without exposed reinforcement

GOOD. Isolated non-structural **cracks** up to 0.03", minor pop-outs or **spalls** without exposed primary reinforcing steel, stirrups may be exposed in a few locations.

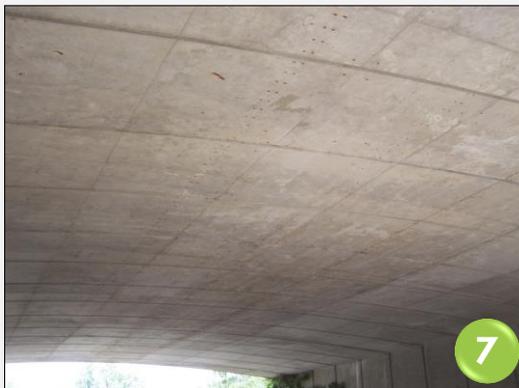
J-17

Good Condition

- 3-Sided Precast
- Non-structural cracks less than 0.03" present

GOOD. Isolated non-structural **cracks** up to 0.03", minor pop-outs or **spalls** without exposed primary reinforcing steel, stirrups may be exposed in a few locations.

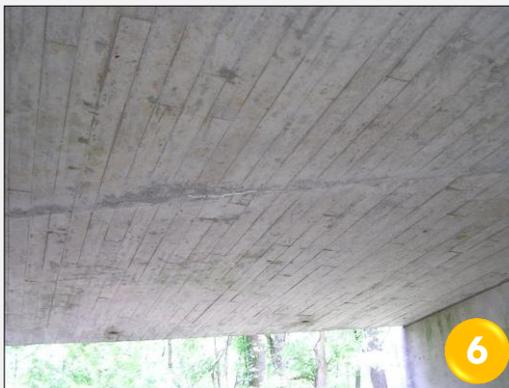
J-18

Satisfactory Condition

- Slab
- Non-structural cracks less than 0.06" present
- 7% of surface area is delaminated with leaching present over a 6' wide section

SATISFACTORY. Extensive non-structural **cracks** up to 0.06", isolated hairline structural **cracks, spalls and delaminations** may be present on up to 10% of a beams cross section or 6' width of a slab with exposed primary reinforcement with surface rust only, up to 20% of a beam cross section or 6' width of a slab may be map **cracked, spalled and delaminated**. Spalls and delaminations up to 5% on the sides of a beam cross section.

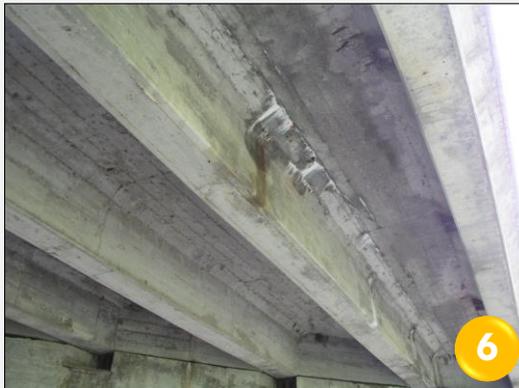
J-19

Satisfactory Condition

- T-Beam
- Non-structural cracks less than 0.06" present
- 9% of a beam surface area has spalls, delaminations, and leaching present

SATISFACTORY. Extensive non-structural **cracks** up to 0.06", isolated hairline structural **cracks, spalls and delaminations** may be present on up to 10% of a beams cross section or 6' width of a slab with exposed primary reinforcement with surface rust only, up to 20% of a beam cross section or 6' width of a slab may be map cracked, spalled and delaminated. Spalls and delaminations up to 5% on the sides of a beam cross section.

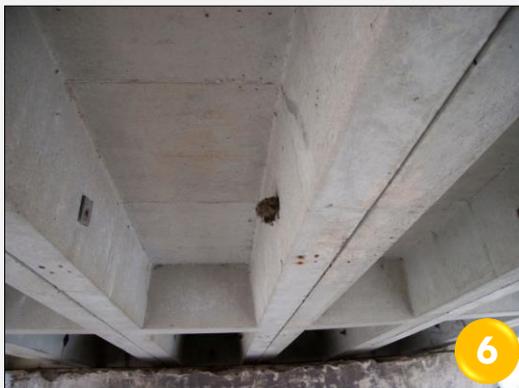
J-20

Satisfactory Condition

- Channel Beam
- Non-structural cracks less than 0.06" present
- 5% of a beams surface area has delaminations and map cracking
- Be sure cracks are due to delaminations!

SATISFACTORY. Extensive non-structural **cracks** up to 0.06", isolated hairline structural **cracks, spalls and delaminations** may be present on up to 10% of a beams cross section or 6' width of a slab with exposed primary reinforcement with surface rust only, up to 20% of a beam cross section or 6' width of a slab may be map cracked, spalled and delaminated. Spalls and delaminations up to 5% on the sides of a beam cross section.

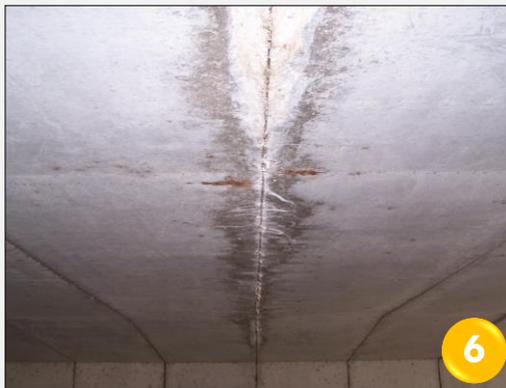
J-21

Satisfactory Condition

- 3-Sided Precast
- Tight non-structural cracks less than 0.06" present
- Leaching keyway

SATISFACTORY. Extensive non-structural cracks up to 0.06", isolated hairline structural cracks, spalls and delaminations may be present on up to 10% of a beams cross section or 6' width of a slab with exposed primary reinforcement with surface rust only, up to 20% of a beam cross section or 6' width of a slab may be map cracked, spalled and delaminated. Spalls and delaminations up to 5% on the sides of a beam cross section.

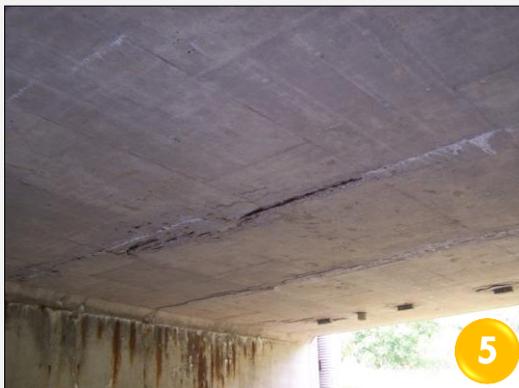
J-22

Fair Condition

- Slab
- 8% spalls and delaminations present
- Less than 10% section loss in reinforcement over 6' width

FAIR. Non-structural cracks greater than 0.06", structural cracks up to 0.03", spalling with section loss of reinforcing steel up to 10% in a beam or 6' width of slab, up to 10% of compression surface area spalled or delaminated in a beam cross section or 6' width of slab. Up to 10% section loss of the concrete cross section.

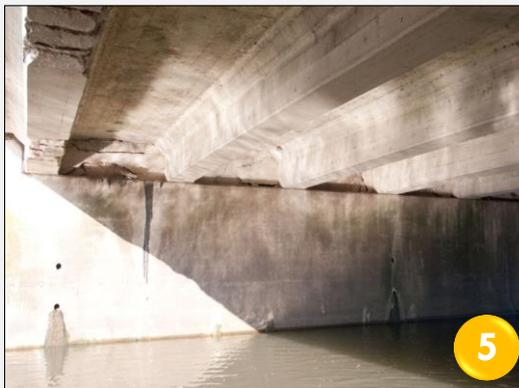
J-23

Fair Condition

- T-Beam
- Spalling and delaminations present
- 10% section loss in beam primary reinforcement

FAIR. Non-structural cracks greater than 0.06", structural cracks up to 0.03", **spalling with section loss** of reinforcing steel up to 10% in a beam or 6' width of slab, up to 10% of compression surface area spalled or delaminated in a beam cross section or 6' width of slab. Up to 10% section loss of the concrete cross section.

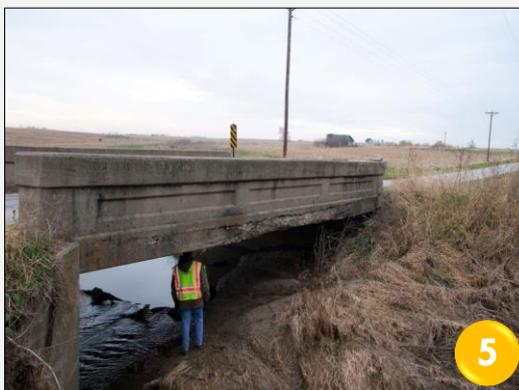
J-24

Fair Condition

- Through Girder
- Isolated structural cracks less than 0.03" wide
- Spalling with 6% section loss in beam primary reinforcement

FAIR. Non-structural cracks greater than 0.06", **structural cracks** up to 0.03", **spalling with section loss** of reinforcing steel up to 10% in a beam or 6' width of slab, up to 10% of compression surface area spalled or delaminated in a beam cross section or 6' width of slab. Up to 10% section loss of the concrete cross section.

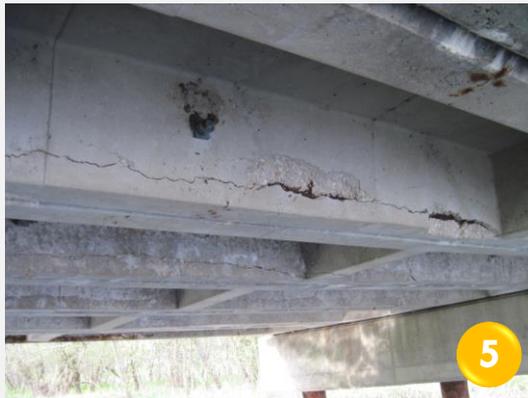
J-25

Fair Condition

- Channel Beam
- Map cracking, delaminations, and leaching present on 10% of beam surface
- No significant section loss in exposed steel

FAIR. Non-structural cracks greater than 0.06", structural cracks up to 0.03", **spalling** with section loss of reinforcing steel up to 10% in a beam or 6' width of slab, up to 10% of compression surface area spalled or delaminated in a beam cross section or 6' width of slab. Up to 10% section loss of the concrete cross section.

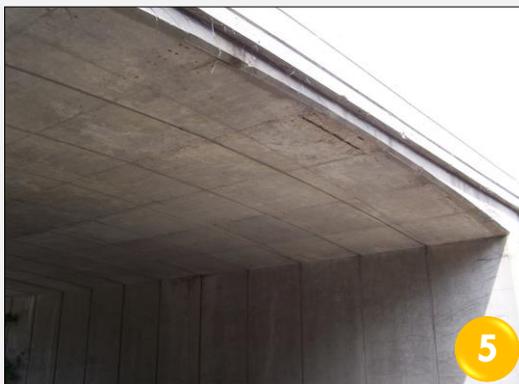
J-26

Fair Condition

- 3-Sided Precast
- 8% of surface area is spalled or delaminated
- 6% section loss in reinforcement

FAIR. Non-structural cracks greater than 0.06", structural cracks up to 0.03", **spalling with section loss** of reinforcing steel up to 10% in a beam or 6' width of slab, up to 10% of compression surface area spalled or delaminated in a beam cross section or 6' width of slab. Up to 10% section loss of the concrete cross section.

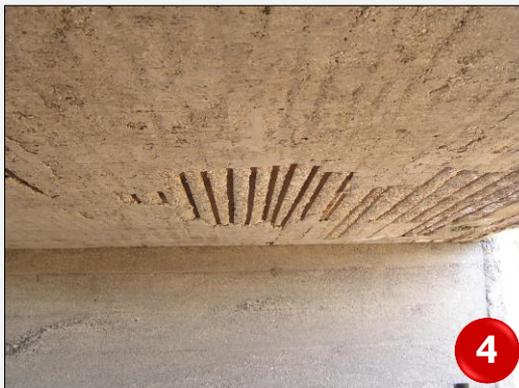
J-27

Poor Condition

- Slab
- Spalling with exposed reinforcement present
- 15% section loss in primary reinforcement over a 6' width

POOR. Flexural or shear cracks up to 0.06", primary reinforcing steel exposed with **section loss** up to 30% in a 6' width of slab or in a beam cross section, up to 50% of the compression surface area **spalled or delaminated**, channel beams spalled or delaminated up to 30% section loss of the beam concrete cross section around the bottom primary reinforcement steel but not within 4' of beam ends.

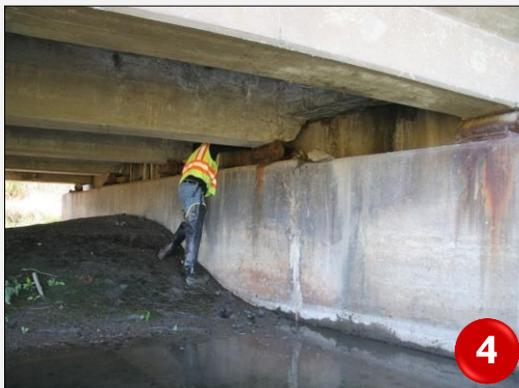
J-28

Poor Condition

- T-Beam
- Structural cracks near beam ends less than 0.06" in width
- Delaminations and widespread leaching present
- 25% section loss in beam primary reinf.

POOR. Flexural or shear **cracks** up to 0.06", primary reinforcing steel exposed with **section loss** up to 30% in a 6' width of slab or in a beam cross section, up to 50% of the compression surface area **spalled or delaminated**, channel beams spalled or delaminated up to 30% section loss of the beam concrete cross section around the bottom primary reinforcement steel but not within 4' of beam ends.

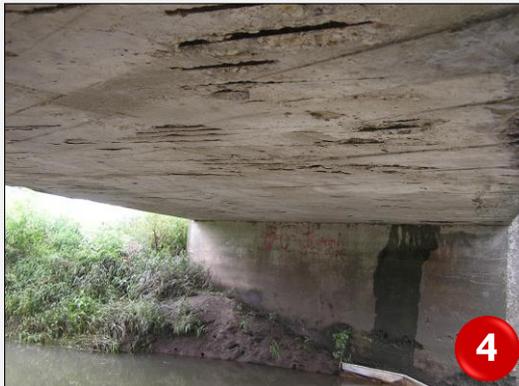
J-29

Poor Condition

- Through Girder
- Spalled concrete with exposed reinforcement
- 20% section loss in exposed primary reinforcement

POOR. Flexural or shear cracks up to 0.06", primary reinforcing steel exposed with **section loss** up to 30% in a 6' width of slab or in a beam cross section, up to 50% of the compression surface area spalled or delaminated, channel beams spalled or delaminated up to 30% section loss of the beam concrete cross section around the bottom primary reinforcement steel but not within 4' of beam ends.

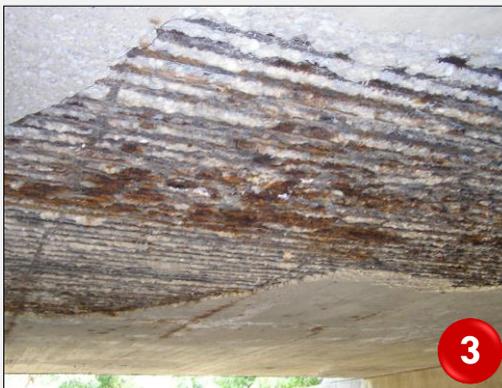
J-30

Serious Condition

- Slab
- Concrete spalling with reinforcement exposed
- 35% section loss in exposed primary reinforcement
- Concrete cores may be needed

SERIOUS. Primary reinforcing steel exposed with **section loss** up to 50% on a 6' width for slabs or cross section for beams, up to 100% section loss of compression surface area in a 6' width of slab or beam cross section, up to 50% section loss of the concrete cross section of a beam, channel beams spalled or delaminated around the bottom primary reinforcement steel within 4' of beam ends.

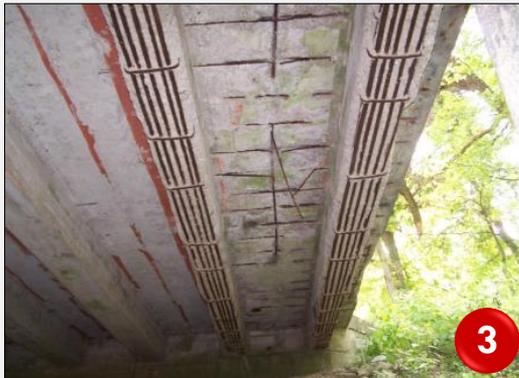
J-31

Serious Condition

- T-Beam
- Concrete spalling with reinforcement exposed
- 40% section loss in exposed primary reinforcement

SERIOUS. Primary reinforcing steel exposed with **section loss** up to 50% on a 6' width for slabs or cross section for beams, up to 100% section loss of compression surface area in a 6' width of slab or beam cross section, up to 50% section loss of the concrete cross section of a beam, channel beams spalled or delaminated around the bottom primary reinforcement steel within 4' of beam ends.

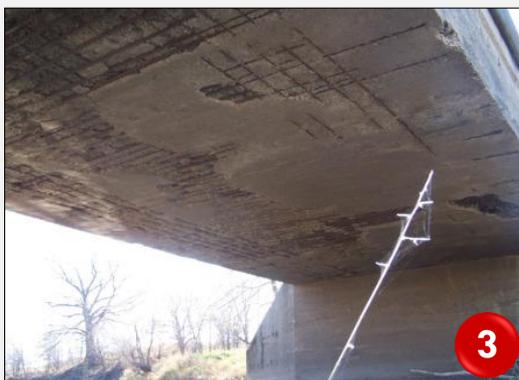
J-32

Serious Condition

- Through Girder
- Concrete spalling with reinforcement exposed
- 35% section loss in exposed primary reinforcement

SERIOUS. Primary reinforcing steel exposed with **section loss** up to 50% on a 6' width for slabs or cross section for beams, up to 100% section loss of compression surface area in a 6' width of slab or beam cross section, up to 50% section loss of the concrete cross section of a beam, channel beams spalled or delaminated around the bottom primary reinforcement steel within 4' of beam ends.

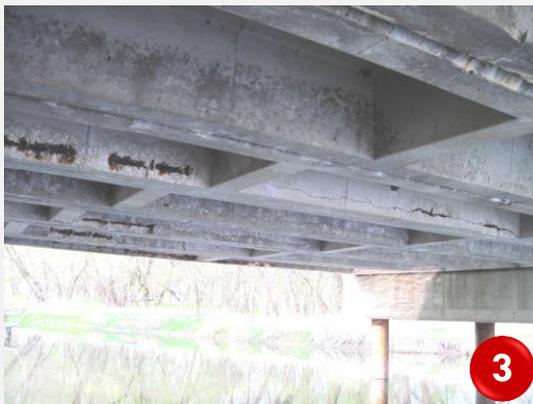
J-33

Serious Condition

- Channel Beam
- Concrete spalling with reinforcement exposed
- 35% section loss in exposed primary reinforcement

SERIOUS. Primary reinforcing steel exposed with **section loss** up to 50% on a 6' width for slabs or cross section for beams, up to 100% section loss of compression surface area in a 6' width of slab or beam cross section, up to 50% section loss of the concrete cross section of a beam, channel beams spalled or delaminated around the bottom primary reinforcement steel within 4' of beam ends.

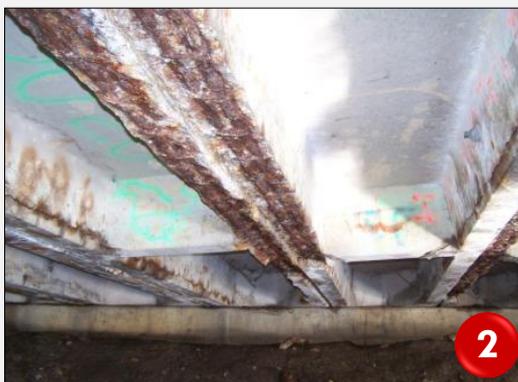
J-34

Critical Condition

- Channel Beam
- Concrete spalling with reinforcement exposed
- 40% section loss in primary reinforcement
- Broken stirrups at beam ends
- Bureau of Bridges and Structures should be notified immediately!

CRITICAL. Similar to the description for a condition rating of "3" although more extensive with over 50% **loss of reinforcing steel**, channel beams fully delaminated or **spalled at ends with broken stirrups**, requires special feature inspections, temporary support or repairs may be required to remain open to traffic. The Bureau of Bridges and Structures shall be notified immediately.

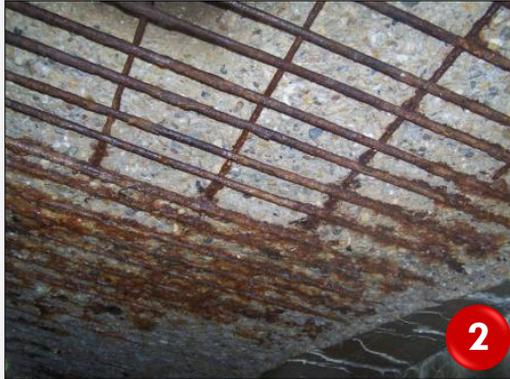
J-35

Critical Condition

- Slab
- Large spall with two layers of exposed reinforcement
- 50% section loss in bottom reinforcement
- Full-depth hole through slab above reinforcement
- Middle third of soffit is delaminated and sagging

CRITICAL. Similar to the description for a condition rating of “3” although more extensive with over 50% loss of reinforcing steel, channel beams fully delaminated or spalled at ends with broken stirrups, requires special feature inspections, temporary support or repairs may be required to remain open to traffic. The Bureau of Bridges and Structures shall be notified immediately.

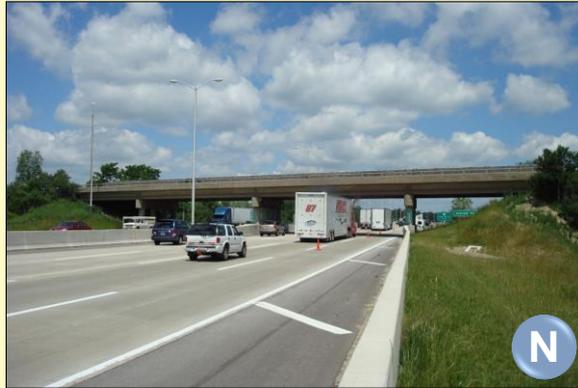
O-5

Item 71 – Waterway Adequacy

Interstate	Other Principal and Minor Arterials and Major Collectors	Minor Collectors, Local	Description
N	N	N	Bridge not over a waterway.

- Appraises the waterway opening with respect to passage of flow through the bridge
- Site conditions may warrant higher or lower ratings than indicated by the hydraulic table
- Requires knowledge of the history of high water elevations at the site

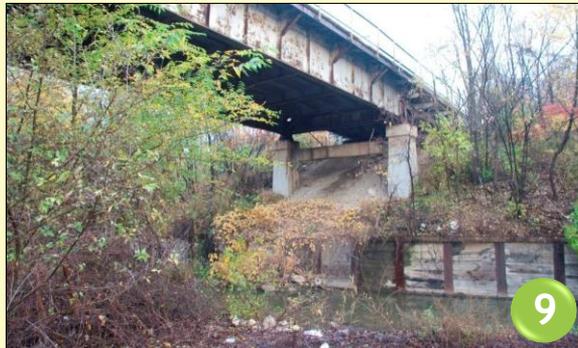
O-6

Item 71 – Waterway Adequacy

Interstate	Other Principal and Minor Arterials and Major Collectors	Minor Collectors, Local	Description
9	9	9	Bridge deck and roadway approaches above flood water elevations (high water). Chance of overtopping is remote.

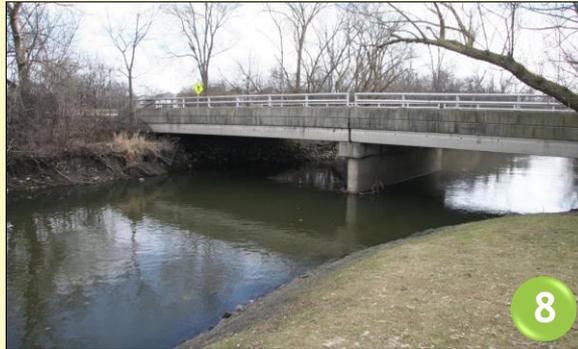
O-7

Item 71 – Waterway Adequacy

Interstate	Other Principal and Minor Arterials and Major Collectors	Minor Collectors, Local	Description
8	8	8	Bridge deck above roadway approaches. Slight chance of overtopping roadway approaches.

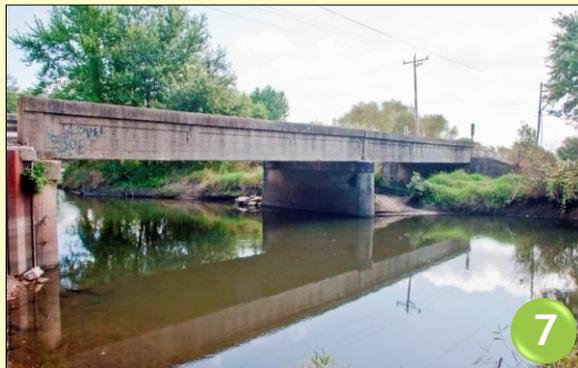
O-8

Item 71 – Waterway Adequacy

Interstate	Other Principal and Minor Arterials and Major Collectors	Minor Collectors, Local	Description
6	6	7	Slight chance of overtopping bridge deck and roadway approaches.

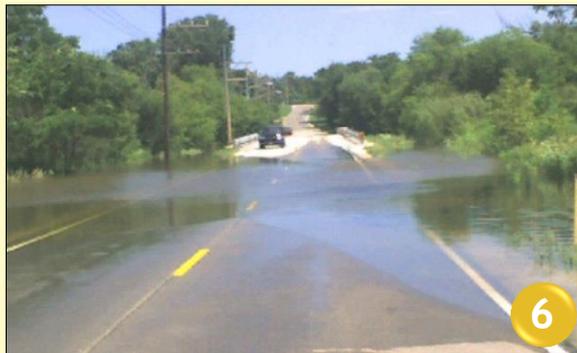
O-9

Item 71 – Waterway Adequacy

Interstate	Other Principal and Minor Arterials and Major Collectors	Minor Collectors, Local	Description
4	5	6	Bridge deck above roadway approaches. Occasional overtopping of roadway approaches with insignificant traffic delays.

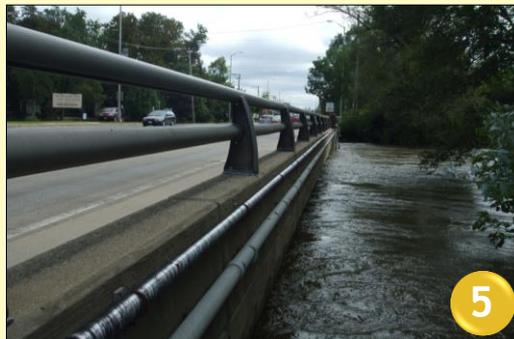
O-10

Item 71 – Waterway Adequacy

Interstate	Other Principal and Minor Arterials and Major Collectors	Minor Collectors, Local	Description
3	4	5	Bridge deck above roadway approaches. Occasional overtopping of roadway approaches with significant traffic delays. *

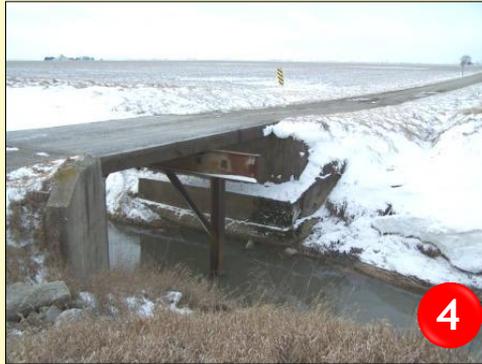
O-11

Item 71 – Waterway Adequacy

Interstate	Other Principal and Minor Arterials and Major Collectors	Minor Collectors, Local	Description
2	3	4	Occasional overtopping of bridge deck and roadway approaches with significant traffic delays. *

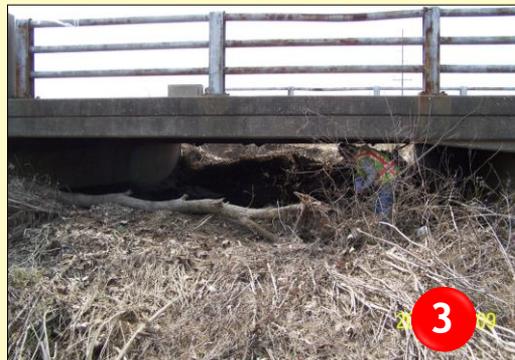
O-12

Item 71 – Waterway Adequacy

Interstate	Other Principal and Minor Arterials and Major Collectors	Minor Collectors, Local	Description
2	2	3	Frequent overtopping of bridge deck and roadway approaches with significant traffic delays. *

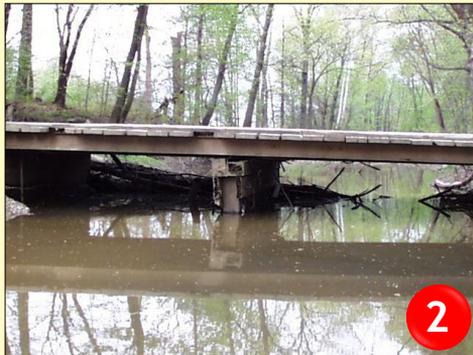
O-13

Item 71 – Waterway Adequacy

Interstate	Other Principal and Minor Arterials and Major Collectors	Minor Collectors, Local	Description
2	2	2	Occasional or frequent overtopping of bridge deck and roadway approaches with severe traffic delays. *

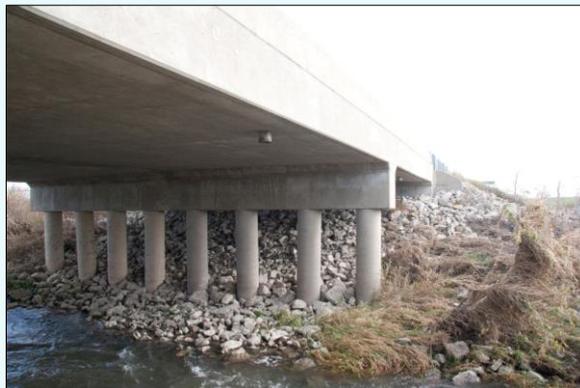
L-2

Typical Elements

- Abutments
- Piers
- Piles
- Footings
- Fenders

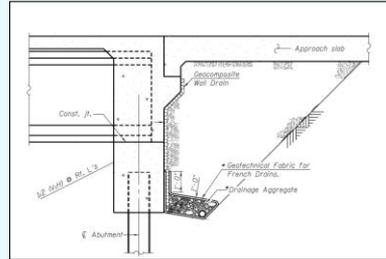
- **Integral Abutment**

Substructure is the portion of the bridge below the intersection of the bottom of the superstructure with the vertical wall face

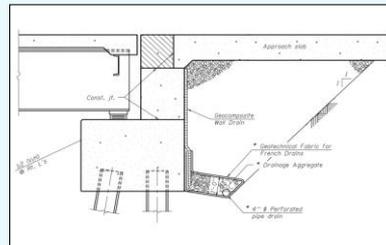
- **Non-Integral Abutment**

- Substructure is the portion below the bearings
- Includes backwalls

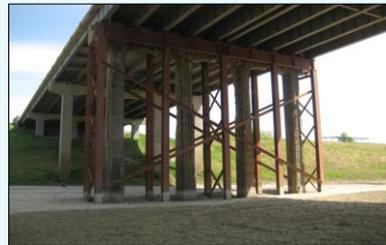
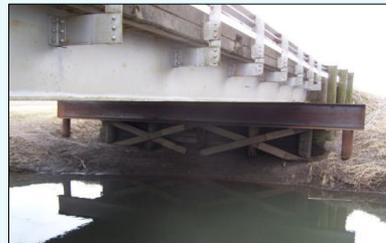
L-4

Temporary Shoring

- If left in place for 5 yrs. or more, temporary supports are considered the Substructure
- The rating coded for Item 60 would be based on the criteria for the material used for the former “temporary” support
- Steel shoring, similar to the example in the lower photo, becomes a Fracture Critical Member in the Substructure

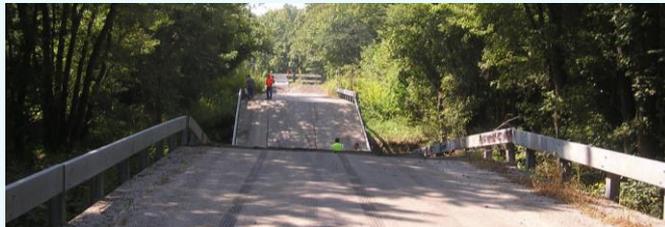
L-6

IL County Bridge Failure

- Pier collapsed on 4 span bridge in September 2013
- Collapse immediately preceded by a < legal loads truck crossing bridge
- Failure of deteriorated piling was the cause

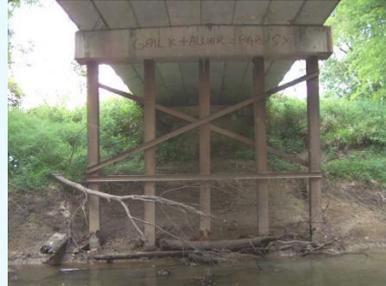
L-7

- Exposed steel H-Piles
- Accelerated deterioration and section loss occurred
 - At the water line
 - In areas with frequent wetting and drying
- Difficult location to easily see during inspection

Pier similar to the one that failed

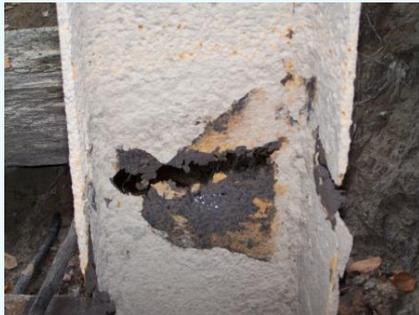
Steel H-piling

Heavy section loss

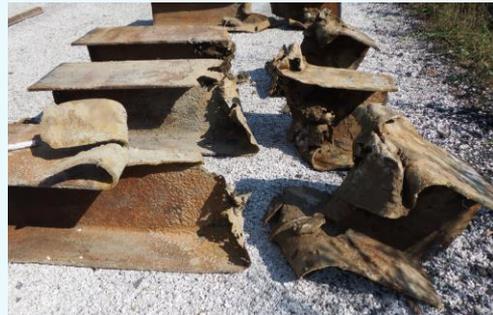
Failed pile sections

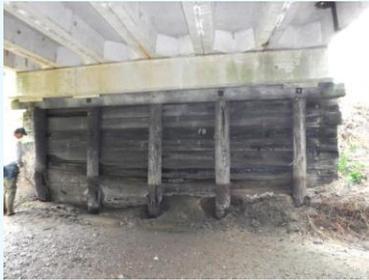
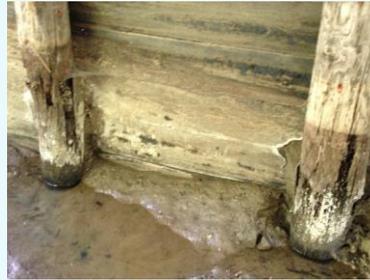
L-9

Pile Deterioration Problems

- Damaged Timber Piling
- Heavy deterioration found just below the mud-line

- **Check condition of piles at / below water / mud-line (12"-18")**
- **Return later to inspect during a low water period if necessary**
- **Timber Piles**
 - Sound piles with hammer full height
 - Core piles if hollow to determine section loss %
- **Steel Piles**
 - Also check top of pile at bottom of cap
 - Take thickness readings if necessary to determine section loss %
- **See IDOT CL 2014-15 on Exposed Bridge Piling**

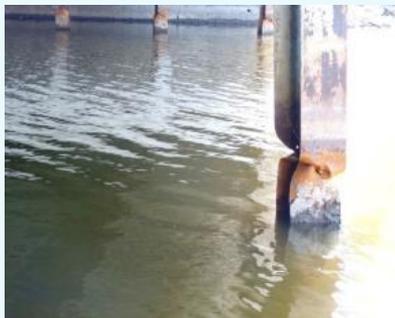
2016 State Rte. Bridge closure in **Ohio** due to deteriorated exposed steel piles at the water line. SUBSTRUCTURE Rating was a "7".

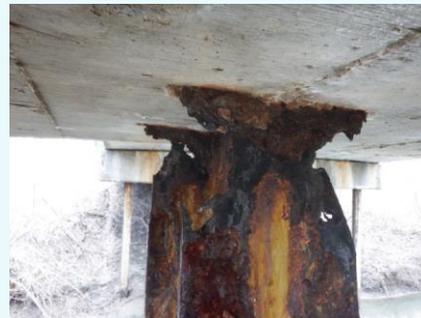
2016 Local Rte. Bridge closure in **Illinois** due to deteriorated exposed steel piles just below the pier cap.

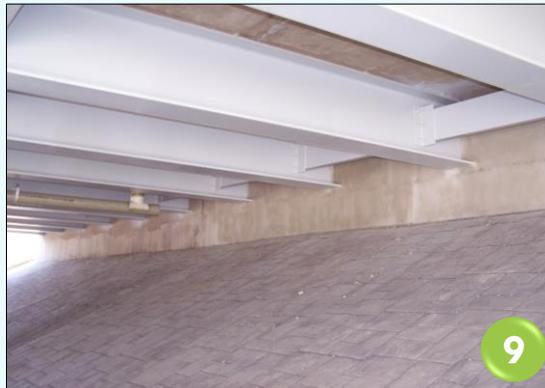
L-16

Note Integral Abutment

New substructure.

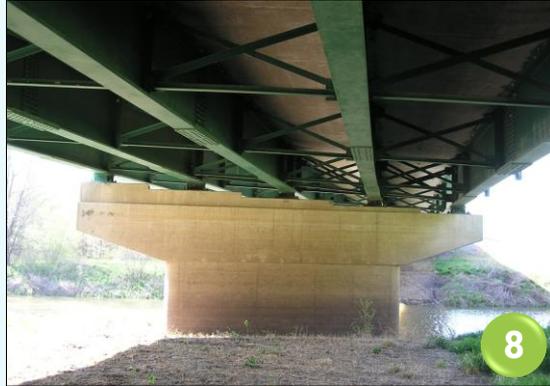
L-18

Light surface scaling

VERY GOOD. No significant defects. Shrinkage cracks, very light surface **scaling**, spalling or pop-outs which do not expose reinforcing steel. Insignificant damage caused by drift or collision with no misalignment and no corrective action warranted.

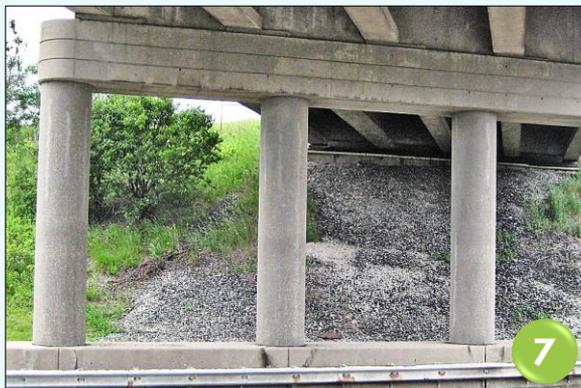
L-21

Minor cracking and scaling of the underside of the pier cap

GOOD. Minor **cracking**, spalls or **scaling** with few incidences of exposed reinforcement with only surface rust. Minor scour may have occurred at the foundation.

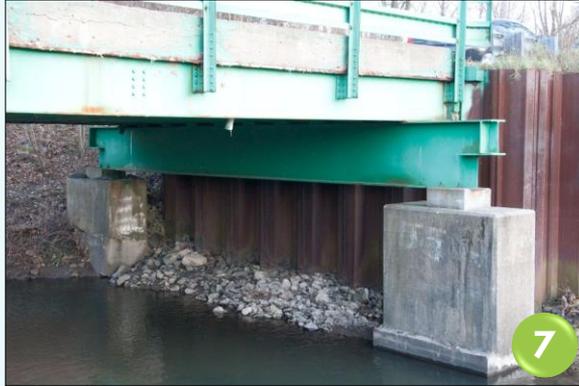
- Minor cracking and scaling on piers
- Minor scour
- Very minor surface rust on FCM cap beam
- Steel sheet piling in good condition

GOOD. Minor **cracking**, spalls or **scaling** with few incidences of exposed reinforcement with only surface rust. Minor **scour** may have occurred at the foundation.

GOOD (Steel). Some **light surface rust**, minor scour may have occurred.

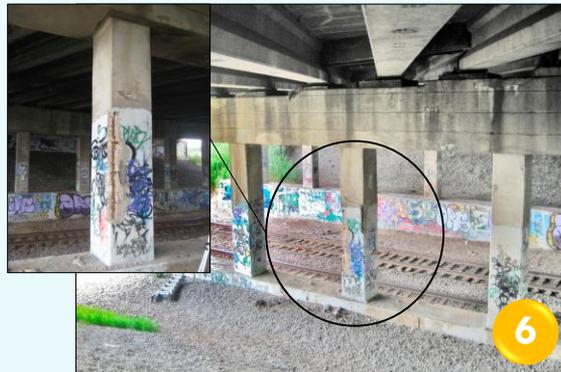
L-25

- Minor spall on the corner of one bent with exposed reinforcement
- Minor spalls on concrete cap with no reinforcement exposed

SATISFACTORY. Moderate deterioration or disintegration, **spalls**, cracking and leaching on concrete or masonry units with up to 2% section loss or loss of bearing area. Shallow, local scour may have occurred near foundations with exposure of top of pile supported footings, less than 2' deep scour around pile bents. No exposed piles.

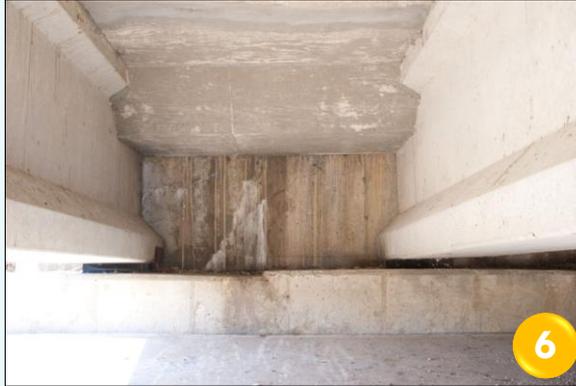
L-26

The concrete backwall has leaching cracks throughout

SATISFACTORY. Moderate deterioration or disintegration, spalls, **cracking** and leaching on concrete or masonry units with up to 2% section loss or loss of bearing area. Shallow, local scour may have occurred near foundations with exposure of top of pile supported footings, less than 2' deep scour around pile bents. No exposed piles.

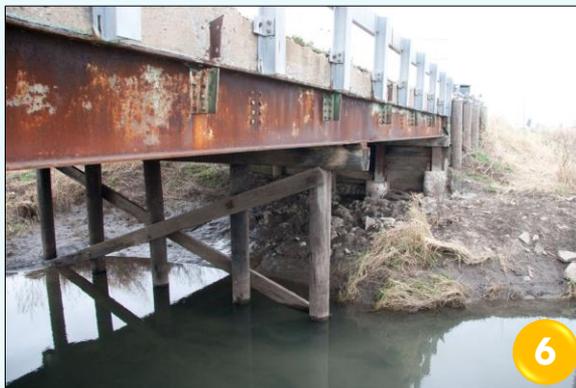
L-27

- Defects include surface decay with cracking and splitting of timber piles
- Sound piles to check for hollow sections

SATISFACTORY. **Surface decay, cracking, splitting** of timber, fire damage limited to surface scorching of timber with up to 2% section loss, shallow, local scour may have occurred near foundations. No exposed piles.

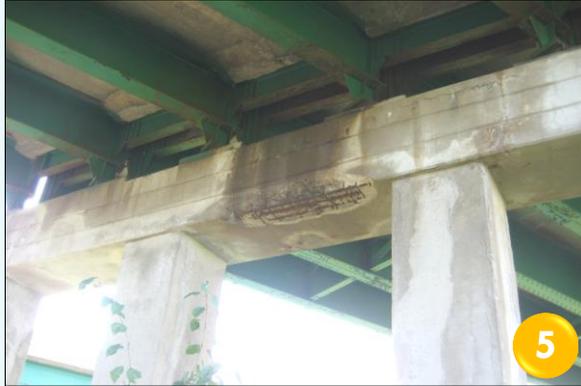
L-29

- Large areas of cap are spalled with exposed reinforcement
- Section loss is 10% of total primary reinforcement in section

FAIR. Large portions of concrete or masonry units are **spalled**, scaled, or **delaminated** with exposed reinforcing steel up to 10% loss of concrete (horizontal cross section), up to 10% **loss of reinforcement** steel, extensive map cracking with leaching, spread footings with no undermining on soil and up to 5% undermining on rock, less than 2' of exposed piles or seal coat below pile supported footings, less than 6' deep scour around pile bents, up to 10% section loss of bearing seats or piles.

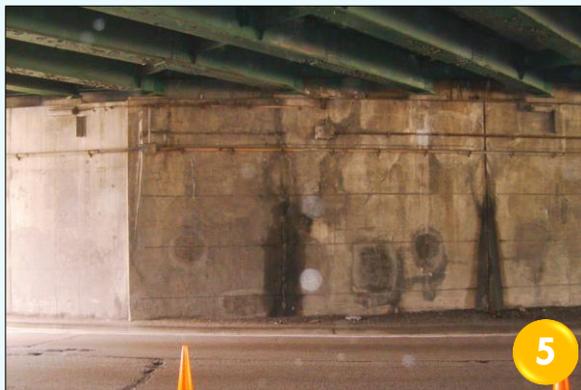
L-30

- Large areas of spalled and delaminated concrete on face of abutment
- Minor vertical cracks throughout

FAIR. Large portions of concrete or masonry units are **spalled**, scaled, or **delaminated** with exposed reinforcing steel up to 10% loss of concrete (horizontal cross section), up to 10% loss of reinforcement steel, extensive map **cracking** with leaching, spread footings with no undermining on soil and up to 5% undermining on rock, less than 2' of exposed piles or seal coat below pile supported footings, less than 6' deep scour around pile bents, up to 10% section loss of bearing seats or piles.

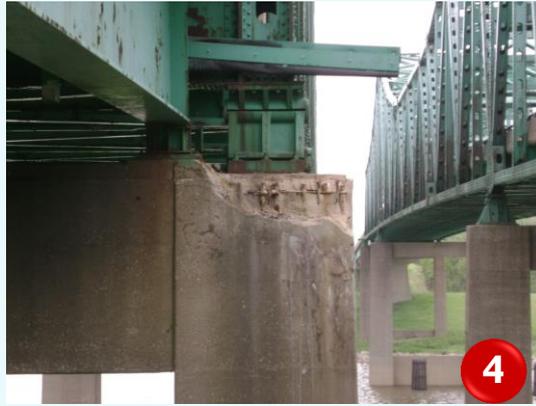
L-32

Item 60 – Substructure Condition

Poor Condition

- Active cracks and spalls noted
- 22% loss in concrete cross section

POOR. Active cracks in concrete and masonry units that indicate a reduction in the substructure unit's capacity to support the superstructure loads, up to 30% section loss of bearing seat(s) or pile(s), section loss of primary steel reinforcement up to 30%. Section loss of concrete up to 30%, undermining of spread footing which may be affecting the stability of the unit but no significant settlement has yet occurred, worst condition or combination of deterioration stated in condition rating "5". If the rating of this item is due to scour, the rating for Item 113 shall be re-evaluated.

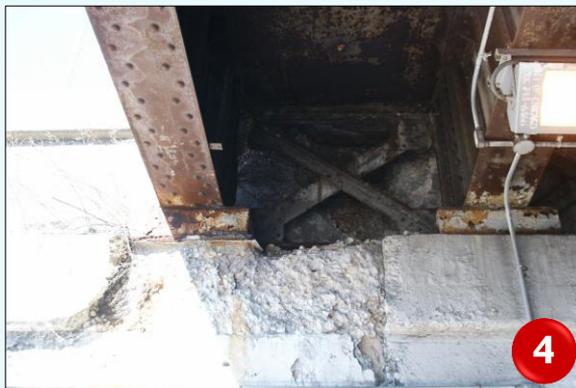
L-33

Item 60 – Substructure Condition

Poor Condition

- Large area of spalled concrete under exterior beam
- Integrity of bearing seat reduced due to spalls

POOR. Active cracks in concrete and masonry units that indicate a reduction in the substructure unit's capacity to support the superstructure loads, up to 30% section loss of bearing seat(s) or pile(s), section loss of primary steel reinforcement up to 30%. Section loss of concrete up to 30%, undermining of spread footing which may be affecting the stability of the unit but no significant settlement has yet occurred, worst condition or combination of deterioration stated in condition rating "5". If the rating of this item is due to scour, the rating for Item 113 shall be re-evaluated.

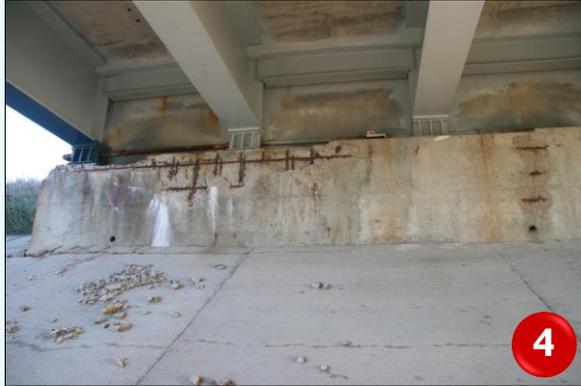
L-34

Item 60 – Substructure Condition

Poor Condition

- Widespread spalling of concrete on face of abutment
- Integrity of bearing seat reduced due to spalls up to 25%

POOR. Active cracks in concrete and masonry units that indicate a reduction in the substructure unit's capacity to support the superstructure loads, up to 30% **section loss** of bearing seat(s) or pile(s), section loss of primary steel reinforcement up to 30%. **Section loss** of concrete up to 30%, undermining of spread footing which may be affecting the stability of the unit but no significant settlement has yet occurred, worst condition or combination of deterioration stated in condition rating "5". If the rating of this item is due to scour, the rating for Item 113 shall be re-evaluated.

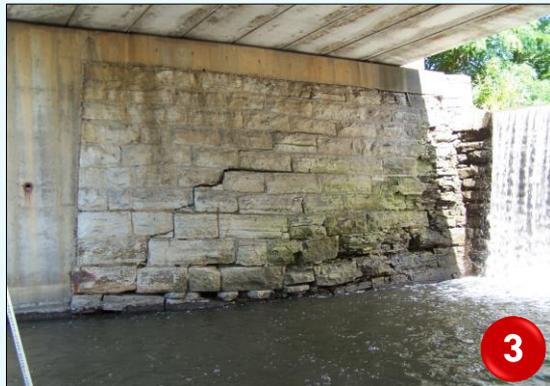
L-35

Item 60 – Substructure Condition

Serious Condition

- Abutment undermined by scour
- Abutment stability affected

SERIOUS. Section losses up to 50%, loss of bearing seat area to cause more than 2" drop, adjacent column ties are broken causing the vertical reinforcement to be ineffective, severe **scour** or undermining of footings affecting the stability of the unit with some **settlement** of the substructure. If the rating of this item is due to **scour**, the rating for Item 113 shall be re-evaluated.

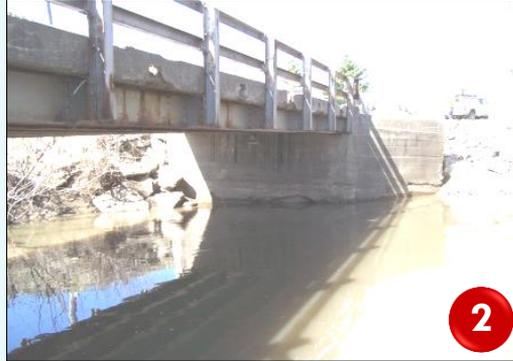
L-36

Item 60 – Substructure Condition

Critical Condition

- Abutment undermined by scour
- Abutment corner has settled approximately 6"

CRITICAL. Conditions worse than condition rating of "3", section loss greater than 50%, special feature inspection is required to allow bridge to remain open, measurable lateral or vertical movement, unstable structures. The Bureau of Bridges and Structures shall be notified immediately. If the rating of this item is due to scour, the rating for Item 113 shall be re-evaluated.

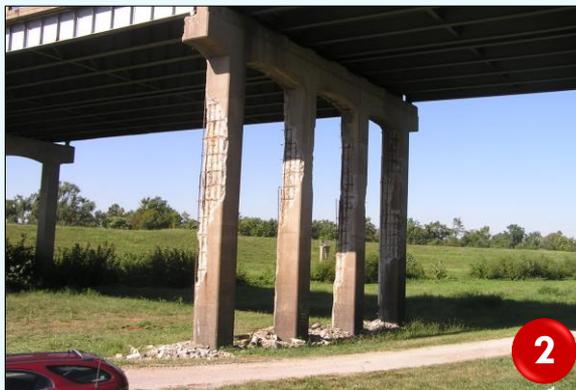
L-37

Item 60 – Substructure Condition

Critical Condition

- Concrete section loss of 55% in pier column
- Special Inspection required

CRITICAL. Conditions worse than condition rating of "3", section loss greater than 50%, special feature inspection is required to allow bridge to remain open, measurable lateral or vertical movement, unstable structures. The Bureau of Bridges and Structures shall be notified immediately. If the rating of this item is due to scour, the rating for Item 113 shall be re-evaluated.

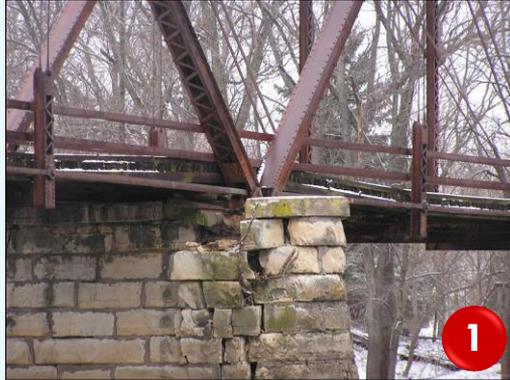
L-38

Item 60 – Substructure Condition

Failure Imminent

Notify the Bureau of Bridges and Structures immediately

Substructure in **“imminent failure”** condition requiring bridge closure or temporary measures to allow structure to remain open.

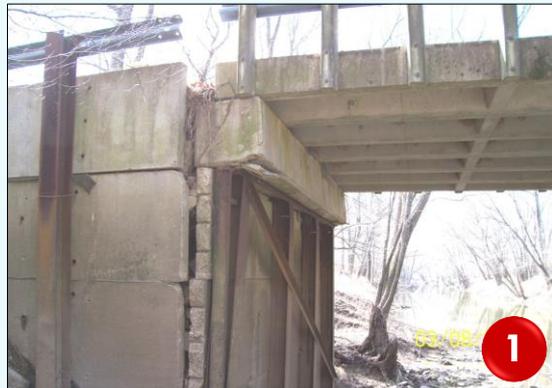
L-39

Item 60 – Substructure Condition

Failure Imminent

- Tops of steel piles are cracked
- Abutment cap has displaced laterally causing instability
- Notify the Bureau of Bridges and Structures immediately

Substructure in **“imminent failure”** condition requiring bridge closure or temporary measures to allow structure to remain open.

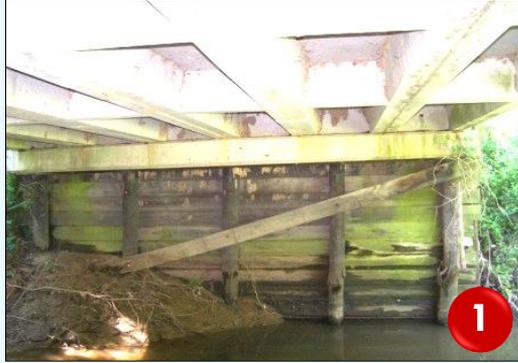
L-40

Item 60 – Substructure Condition

Failure Imminent

- 3 exposed piles have 100% section loss
- The 2 remaining piles are obscured by debris and may have similar loss of section
- Notify the Bureau of Bridges and Structures immediately

Substructure in **“imminent failure”** condition requiring bridge closure or temporary measures to allow structure to remain open.
