ACCESS METHODS, TEST EQUIPMENT & MAINTENANCE OF TRAFFIC

NBI Calibration 2020

Access Methods, Test Equip. & Maint. of Traffic

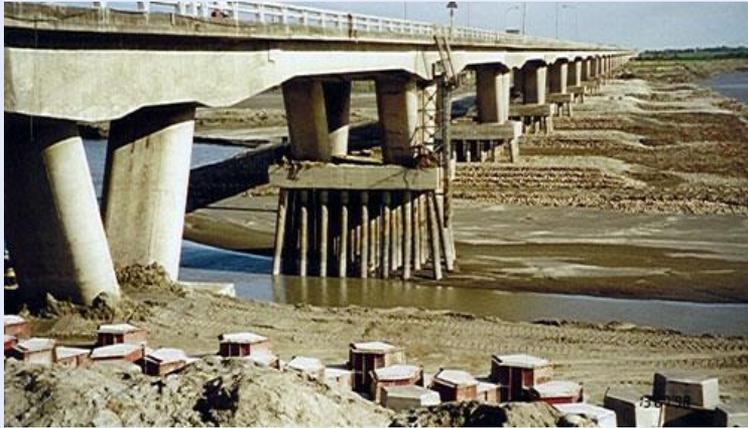
M-5

Scour Review

General Scour/Degradation

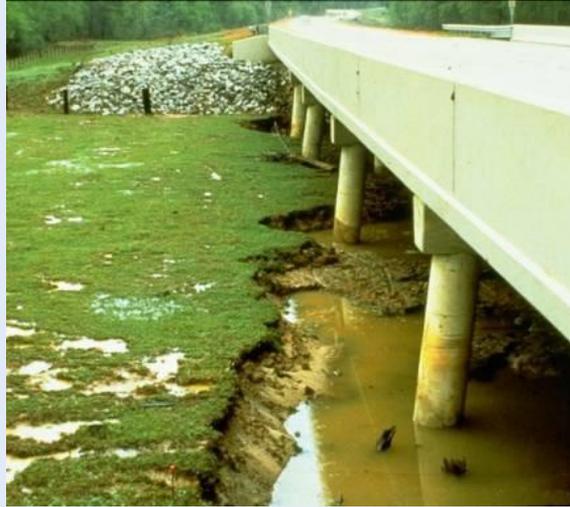
M-7

- This is the lowering of the streambed under the bridge only, resulting from accelerated stream flow due to reduced waterway opening
- Occurs when the bridge waterway opening is restrictive
- Can be caused by:
 - Embankments
 - Debris or Vegetation
 - Substructure units
 - Ice

Scour Review

Contraction Scour

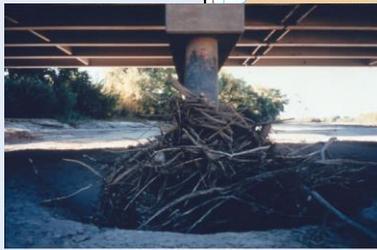
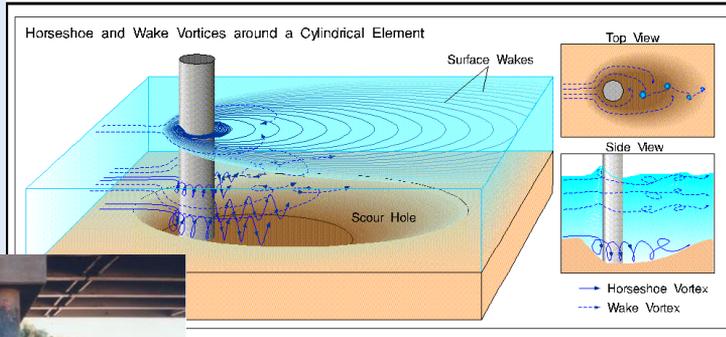
M-9

- This is the lowering of the streambed adjacent to an obstruction in the waterway.
- Often much greater than general scour (up to 10 times)
- Often caused by:
 - Abutments
 - Wide, long, unusually shaped or poorly skewed piers
 - Streamflow depth (as depth increases vortex action is magnified)
 - Debris or Ice accumulation

Local Scour

(images from USGS)

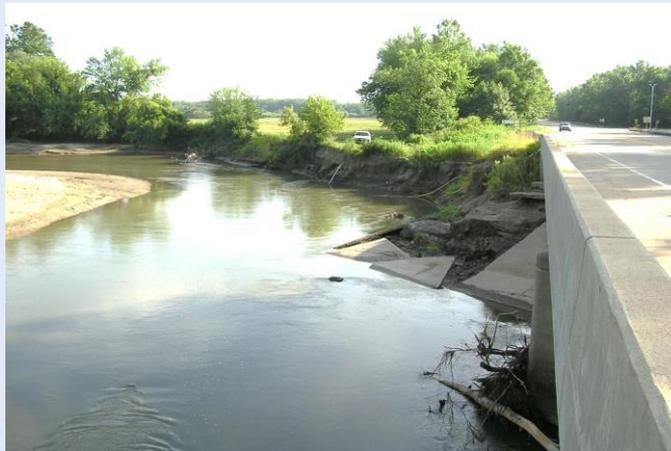
M-11

- This is the relocation of the channel over time due to lateral scour of the embankment.
- Lateral stream migration process:
 - Bank damage
 - Sloughing bank
 - Undermined bank
 - Channel misalignment

Scour Review

Lateral Stream Migration

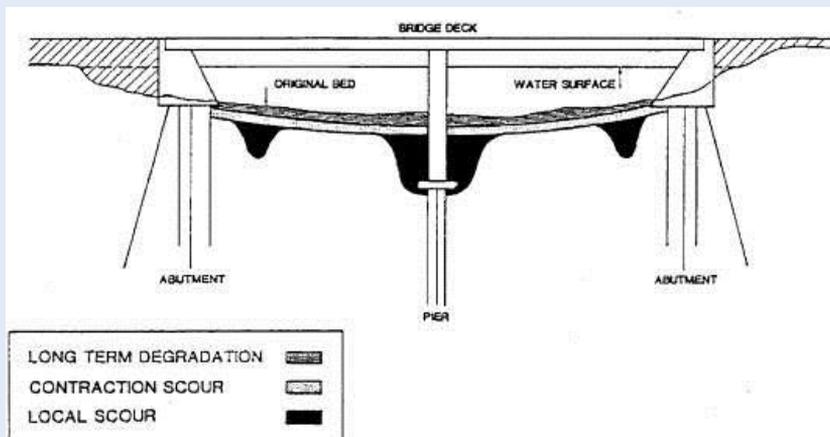
M-12

Scour Review

Types Of Scour

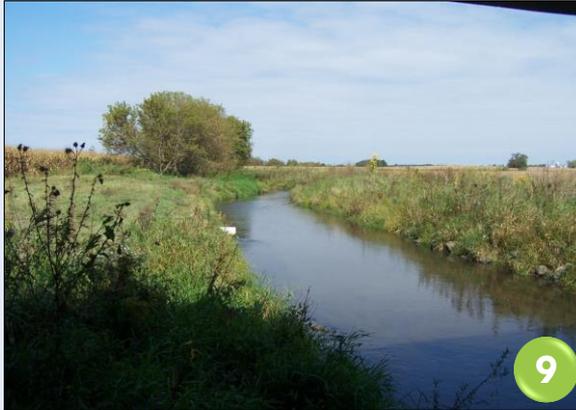
M-19

Item 61 – Channel Conditions

Excellent Condition

- The Channel is well aligned
- Banks are vegetated

EXCELLENT. There are no noteworthy deficiencies that affect the condition of the channel.

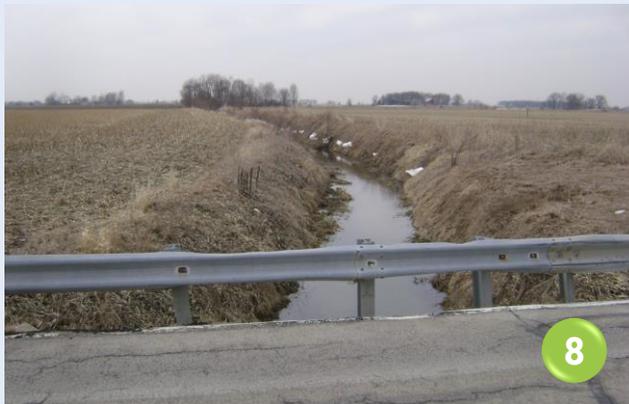
M-20

Item 61 – Channel Conditions

Very Good Condition

- The Channel is well aligned
- Banks are vegetated

VERY GOOD. Banks are protected or well vegetated. River control devices such as spur dikes and embankment protection are not required or are in a stable condition.

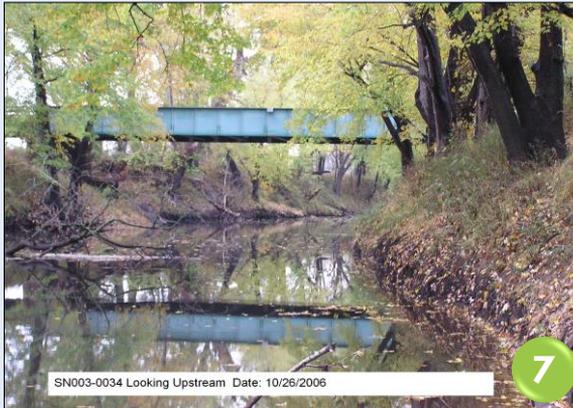
SN003-0034 Looking Upstream Date: 10/26/2006

Item 61 – Channel Conditions

Good Condition

- The Channel is well aligned
- Banks are in need of minor repair with removal of fallen trees
- Drift not affecting waterway opening

GOOD. Bank protection is in need of minor repairs. River control devices and embankment protection have a little minor damage. Banks and/or channel may have minor amounts of **drift** not affecting the waterway opening.

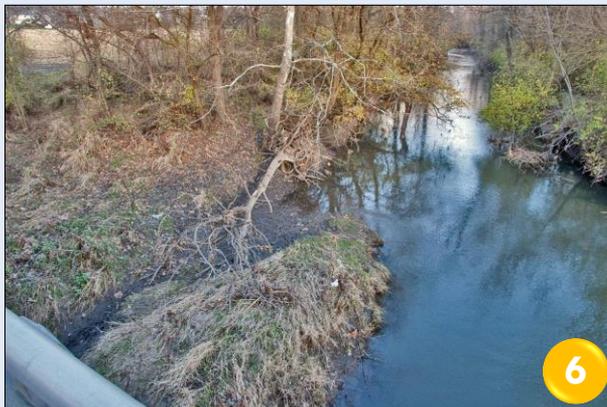
M-22

Item 61 – Channel Conditions

Satisfactory Condition

- Minor streambed movement evident
- Banks are beginning to slump

SATISFACTORY. **Bank is beginning to slump.** River control devices and embankment protection have widespread minor damage. There is minor **streambed movement** evident. Debris is restricting the waterway slightly.

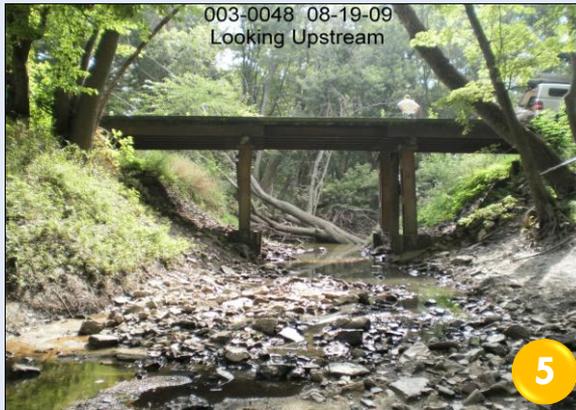
M-23

Item 61 – Channel Conditions

Fair Condition

- Bank protection is being eroded
- Fallen trees are restricting the channel

FAIR. Bank protection is being **eroded**. River control devices and/or embankment have major damage. Trees and brush restrict the channel.

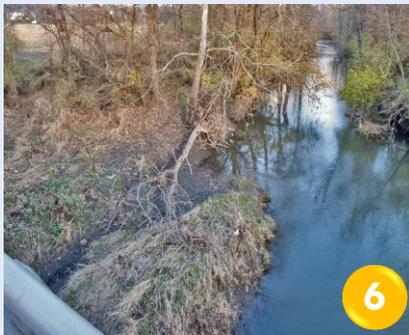
Debris is restricting waterway slightly.

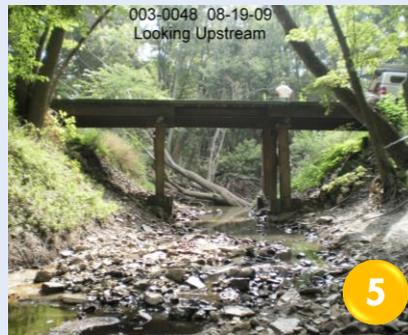
Trees and brush restrict channel.

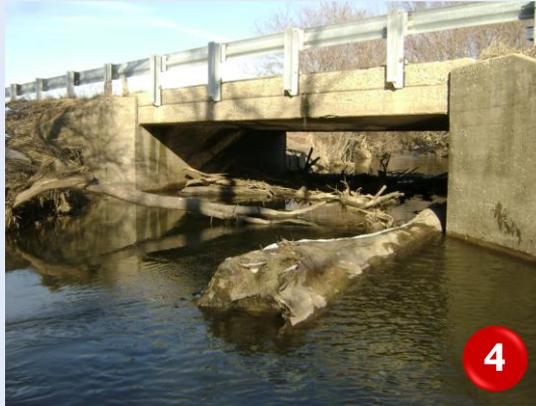
M-25

Item 61 – Channel Conditions

Poor Condition

Debris is severely restricting the waterway.

POOR. Bank and embankment protection is severely undermined. River control devices have severe damage. **Deposits of debris in the waterways are severely restricting the opening.**

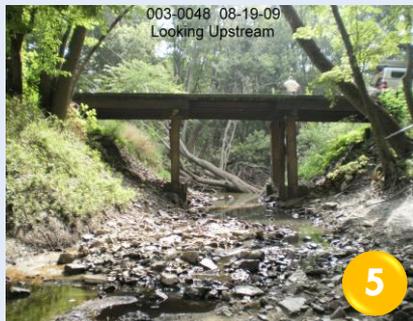
Bank protection is being eroded.

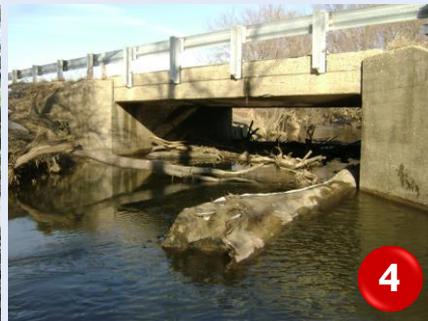
Debris is severely restricting the waterway.

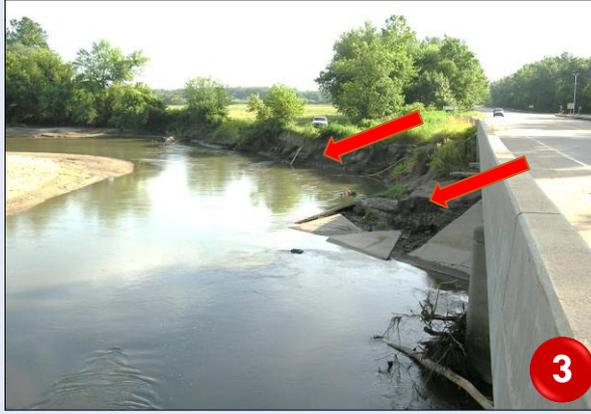
M-27

Item 61 – Channel Conditions

Serious Condition

- Channel has shifted toward road
- Bank protection has failed
- Road and abutment threatened by erosion

SERIOUS. Bank **protection has failed**. River control devices have been destroyed. Streambed aggradation, degradation or **lateral movement has changed the waterway to now threaten the bridge and/or approach roadway.**

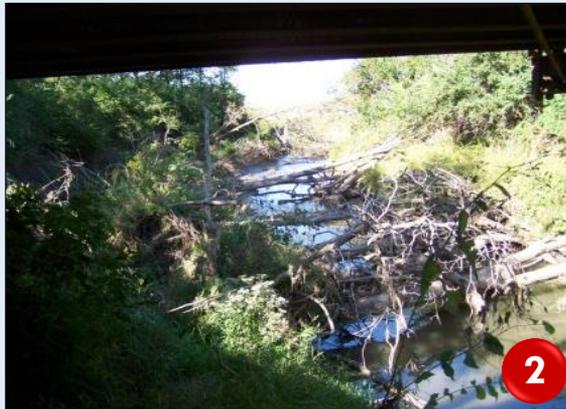
M-28

Item 61 – Channel Conditions

Critical Condition

- Photo 1 of 2
- Banks are severely eroded
- Fallen trees are blocking channel

CRITICAL. The waterway has changed to the extent the bridge is near a state of collapse.

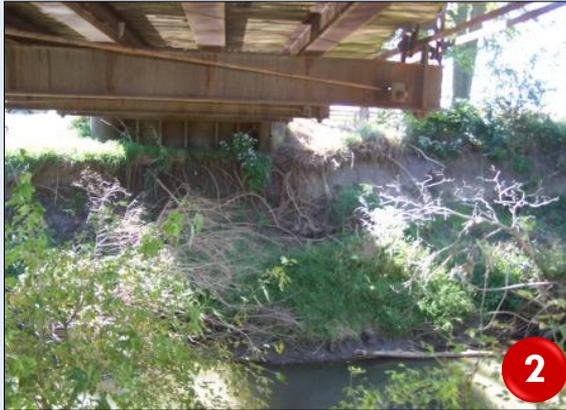
M-29

Item 61 – Channel Conditions

Critical Condition

- Photo 2 of 2
- Bank erosion and debris in stream have redirected stream flow towards abutment
- Scour is undermining abutment and exposing caissons

CRITICAL. The waterway has changed to the extent the bridge is near a state of collapse.
