ROUNDBABOUTS: HOW THEY WORK FOR PEDESTRIANS

Roundabouts:

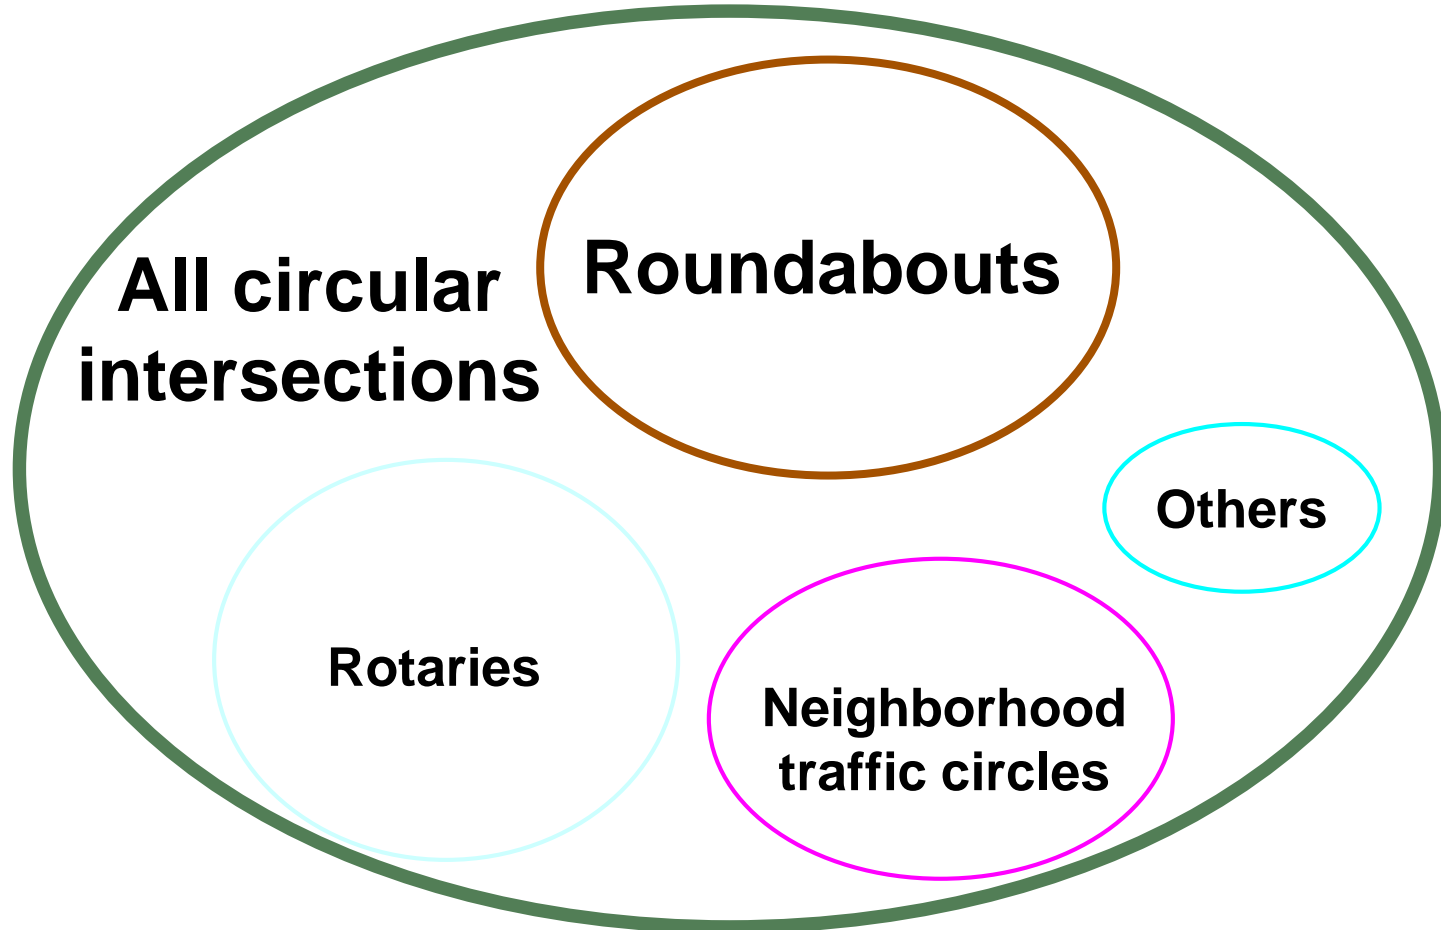
8-4

Roundabouts are a type (or subset) of circular intersections

Bottom Line: Not all circular intersections are roundabouts!!

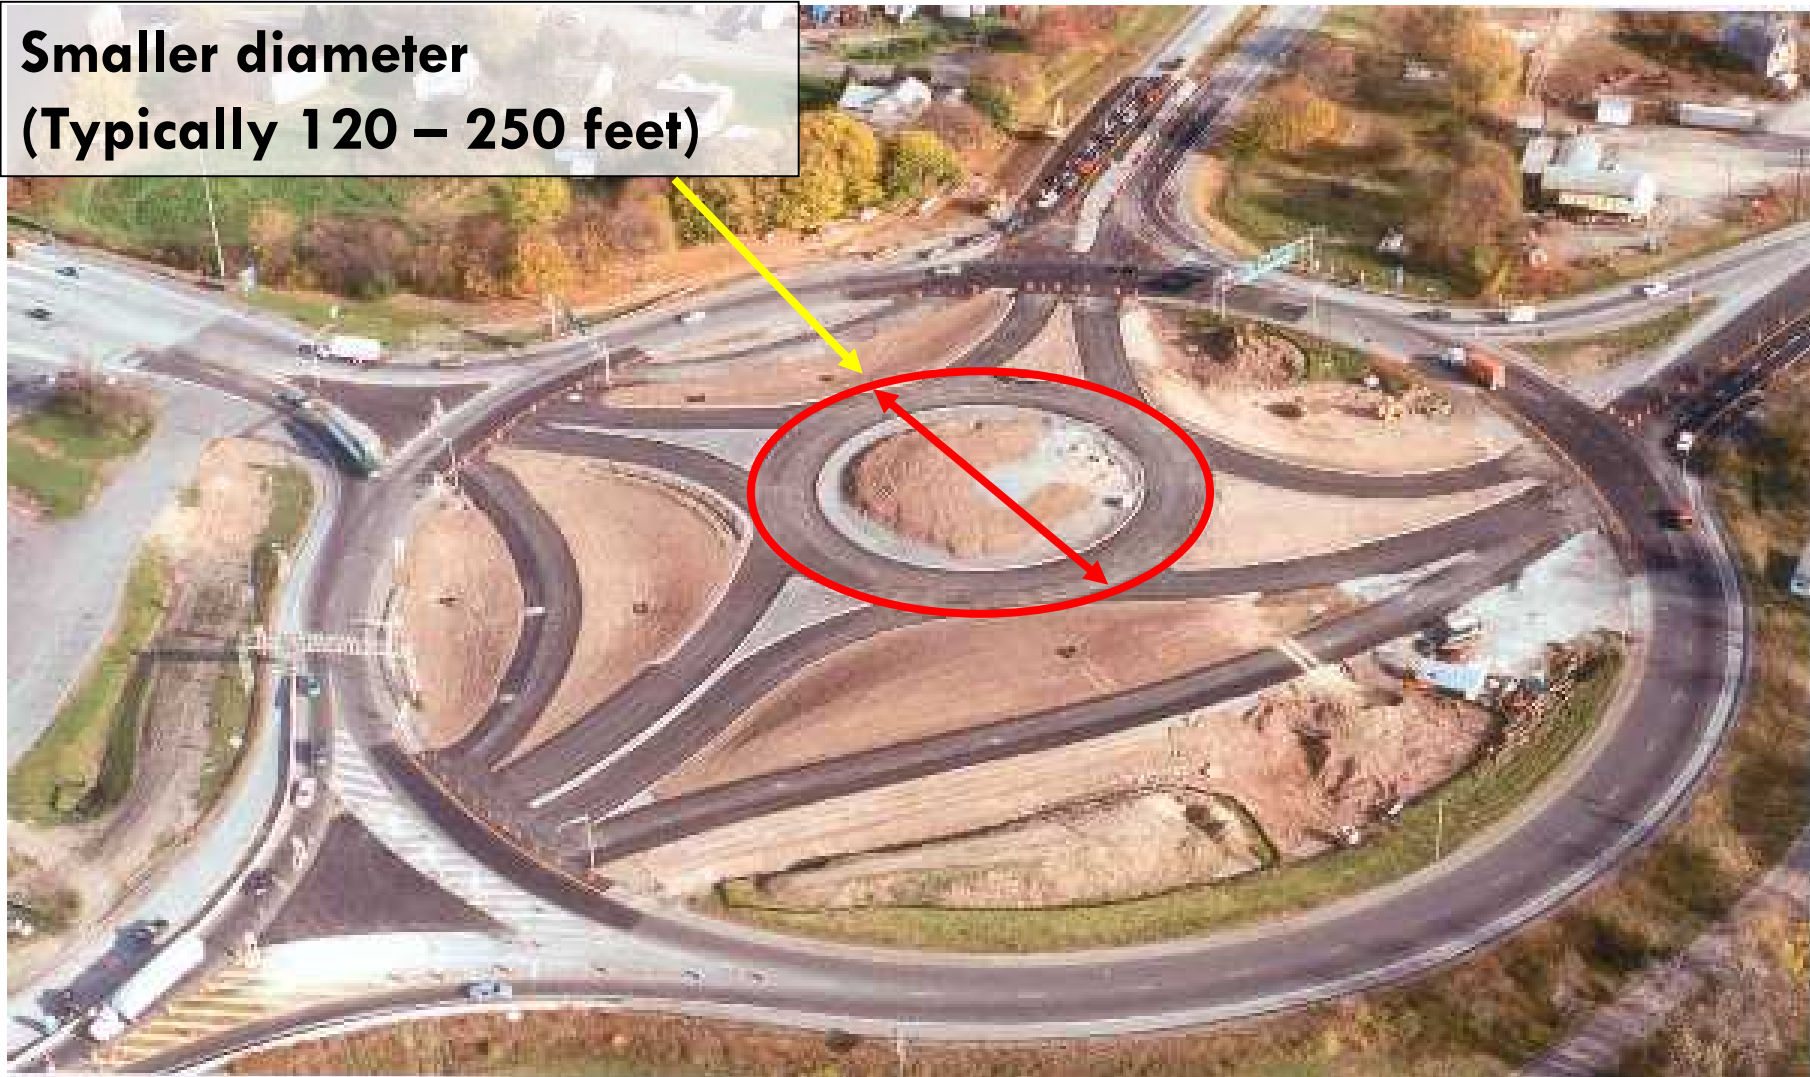
8-7

Rotary Reconstructed to Roundabout

**Smaller diameter
(Typically 120 – 250 feet)**

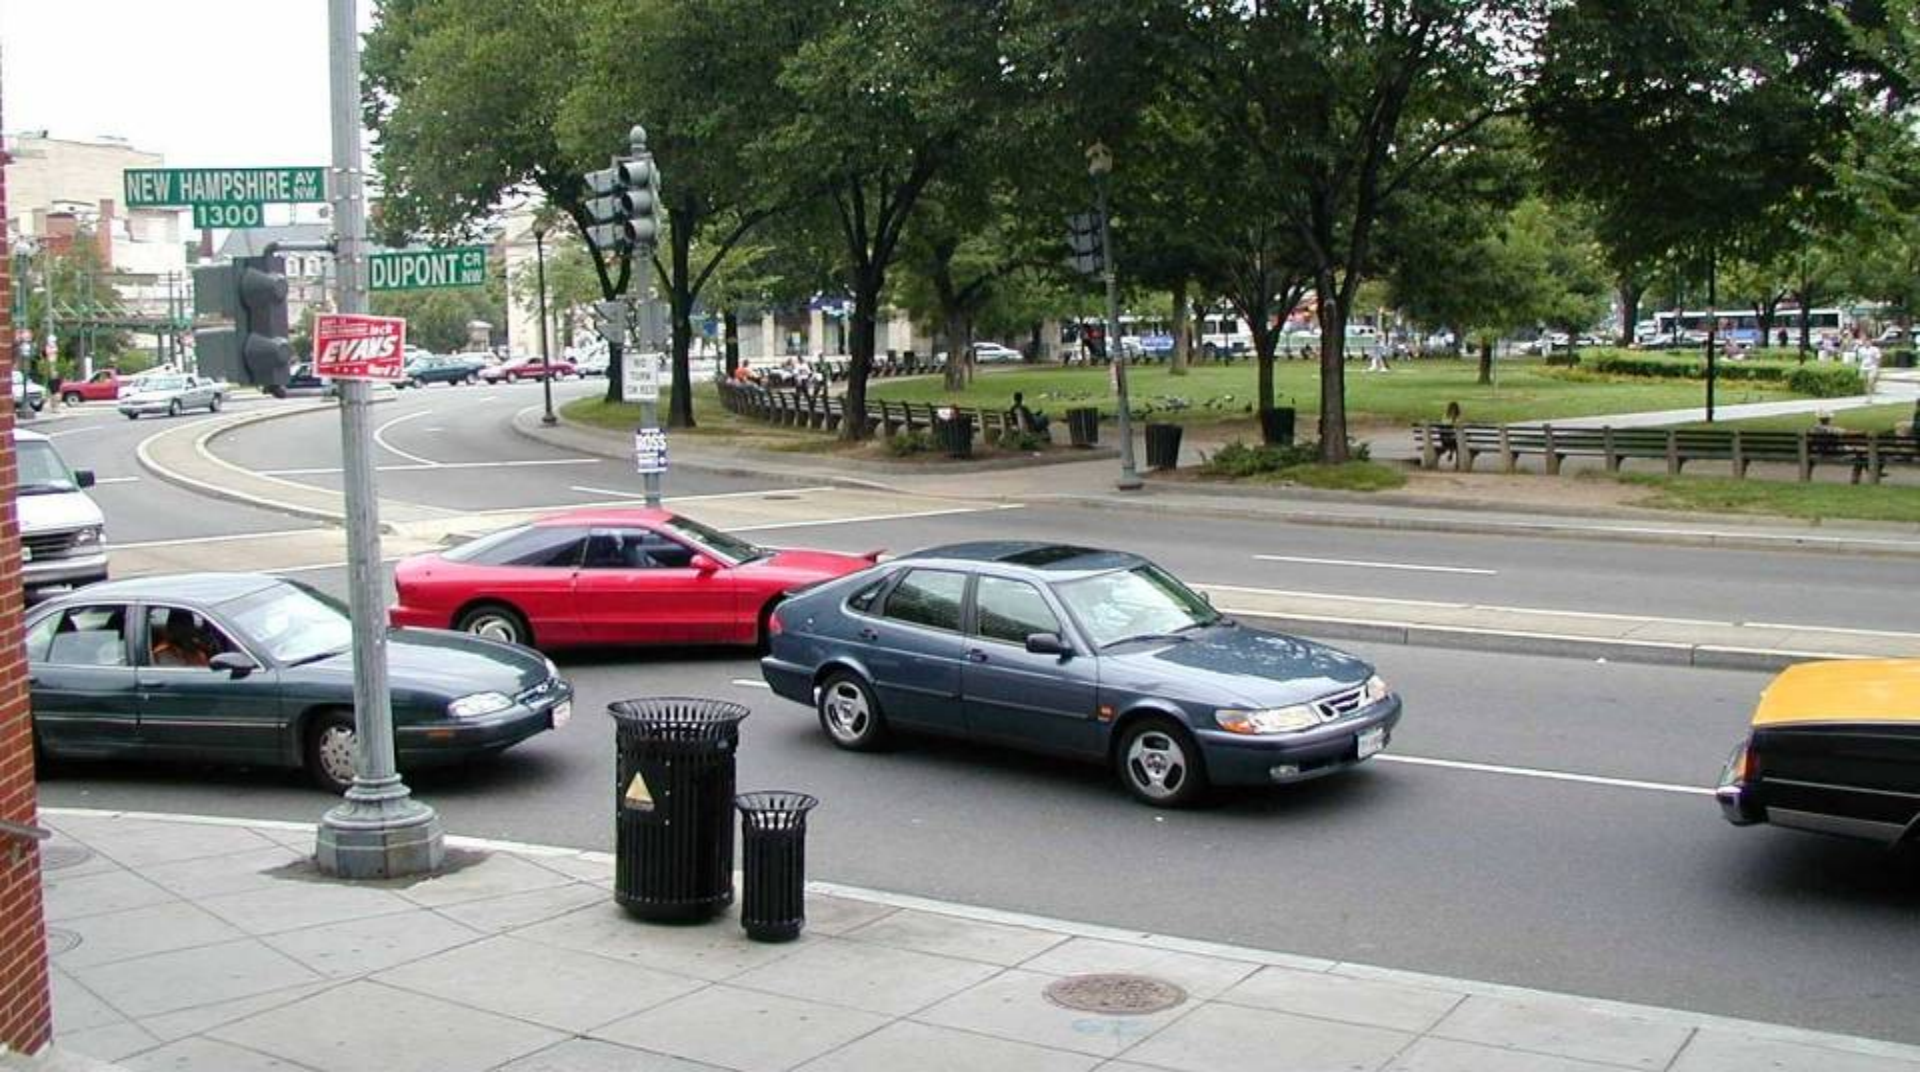
8-8

A roundabout is not:

2. A Washington DC style circle, with traffic signal controls

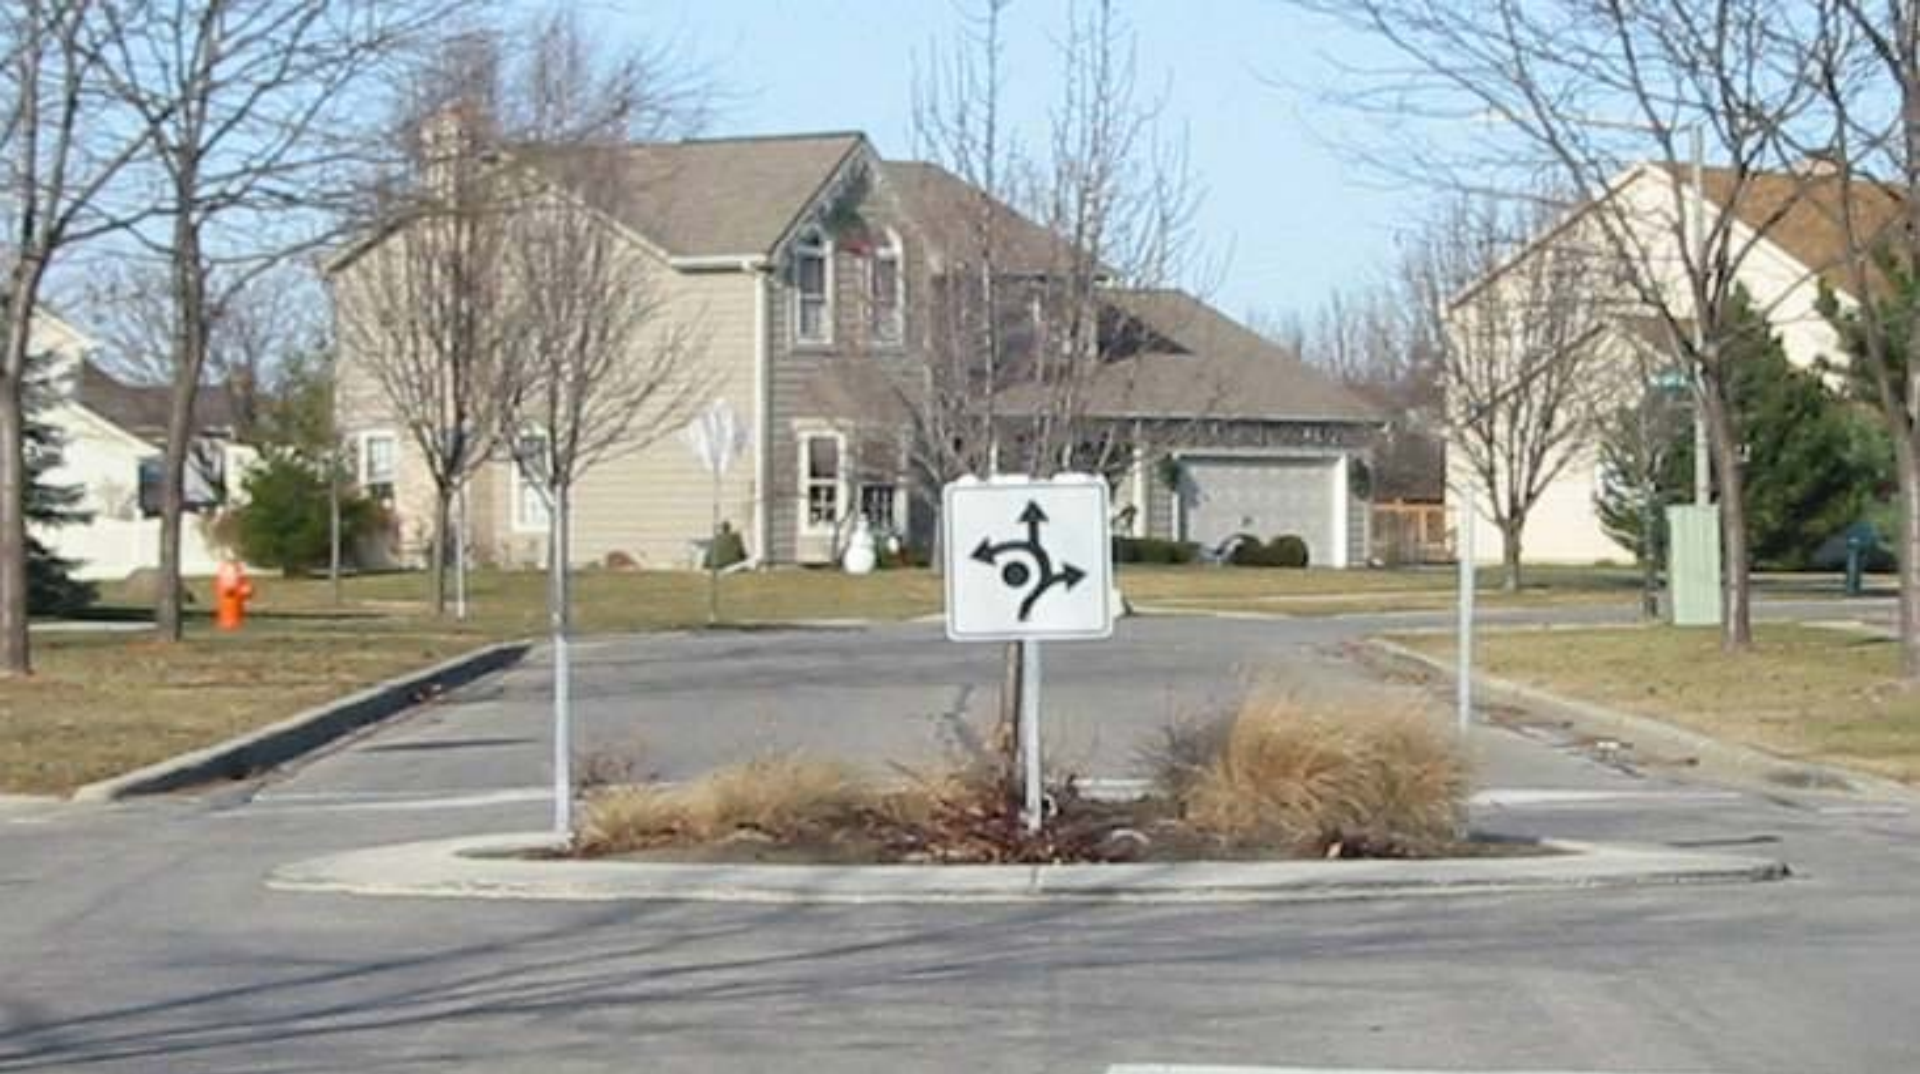
8-9

A roundabout is not:
3. A traffic-calming mini circle

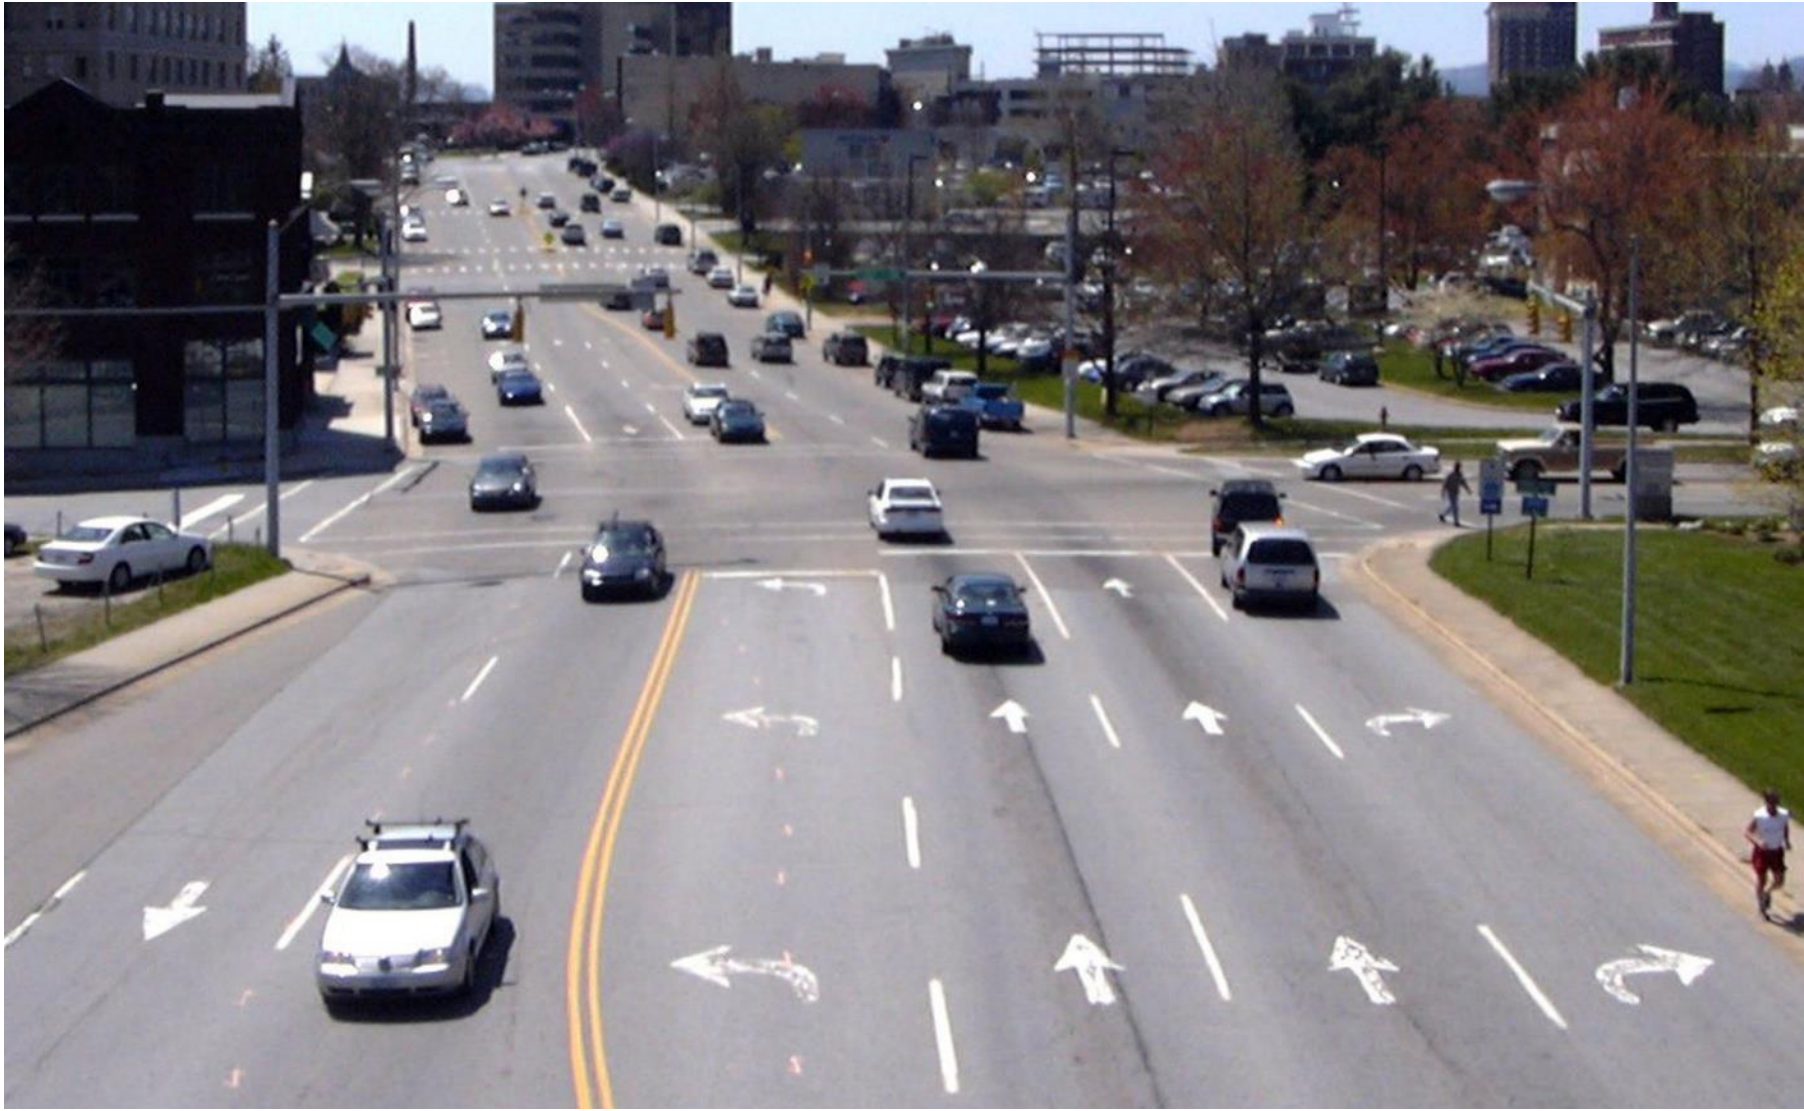
8-11

Before and After Example

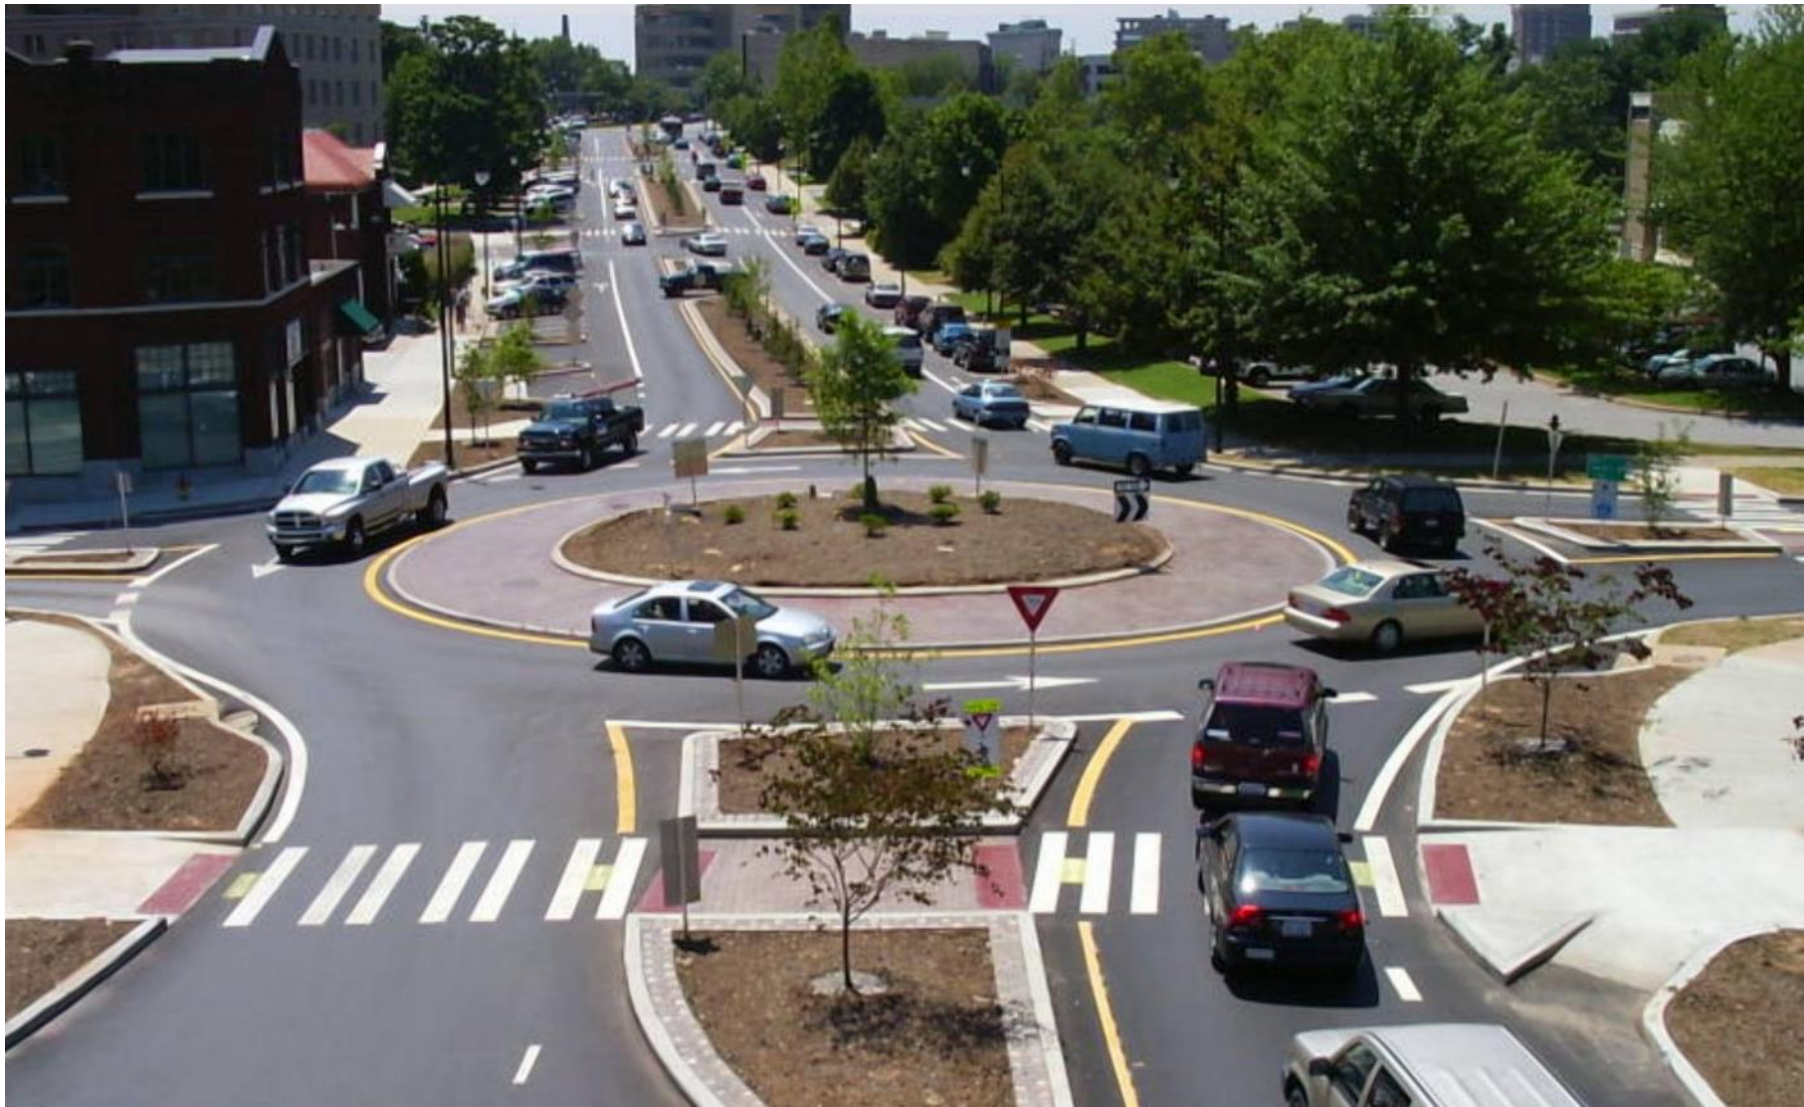
8-12

Before and After Example

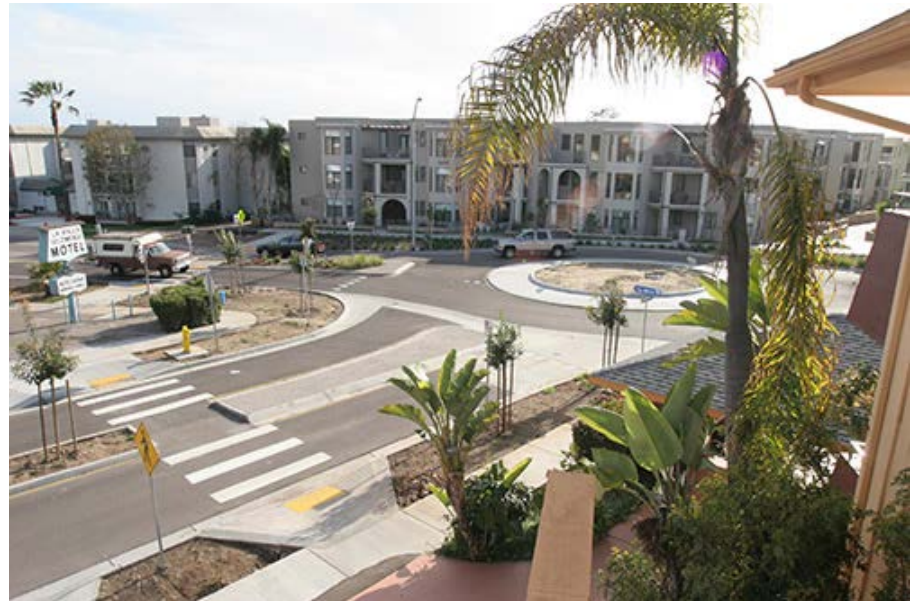
8-13

Advantages for Pedestrians

- ❑ Reduced vehicle speeds
- ❑ Reduced number of conflict points
- ❑ Shorter crossing distances
- ❑ Splitter island provides a refuge – ped crosses one direction of traffic at a time
- ❑ Crosswalk is placed one car length back

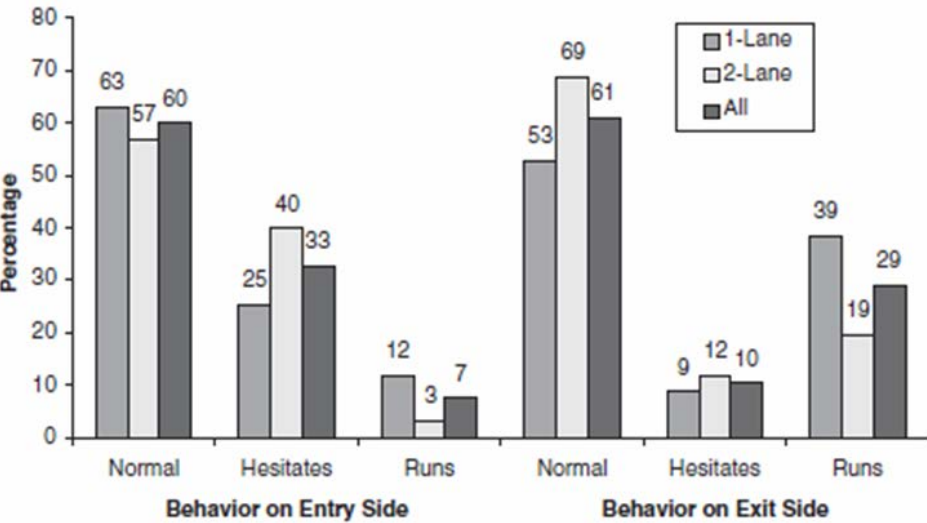
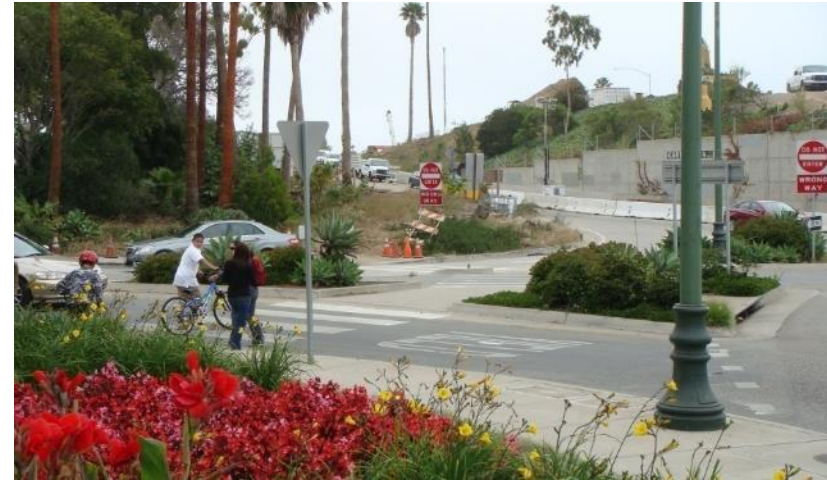
Figure 59. Pedestrian crossing behaviors when a vehicle was present and the crossing began on the entry side.

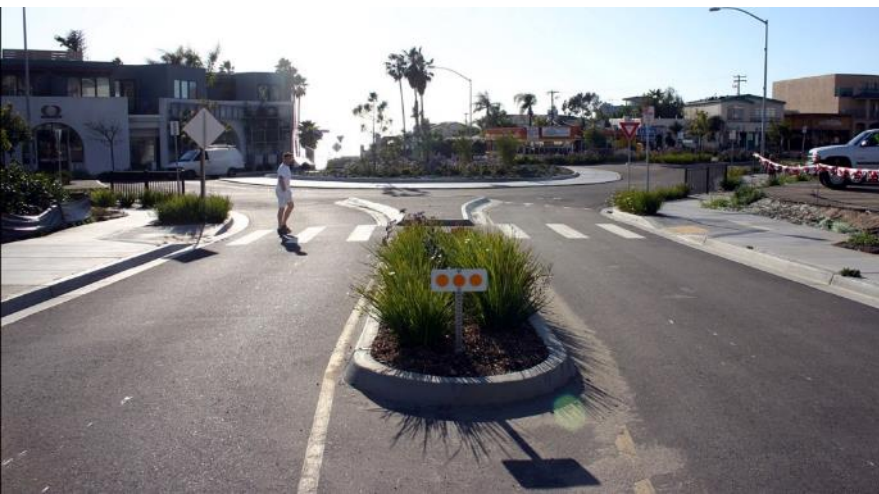
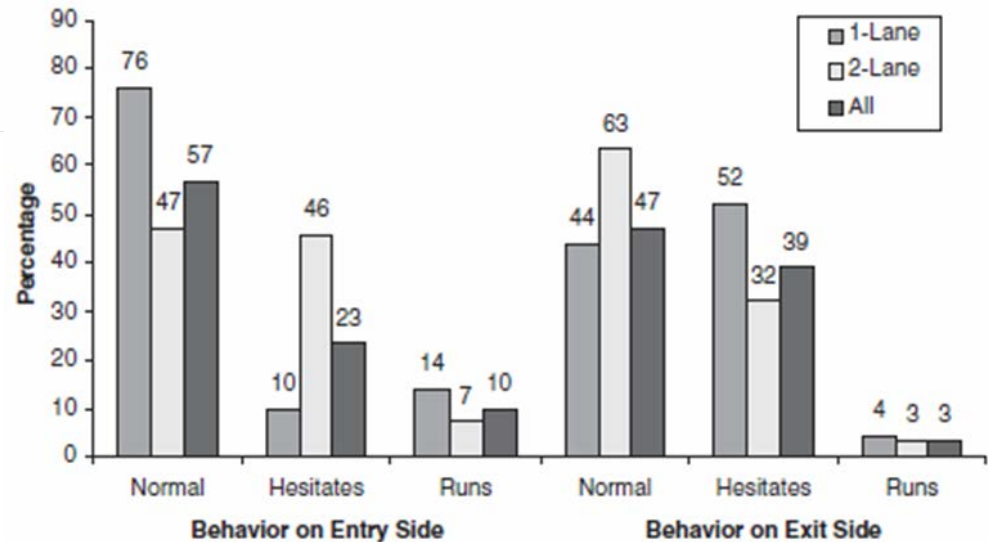
Figure 60. Pedestrian crossing behaviors when a vehicle was present and the crossing began on the exit side.

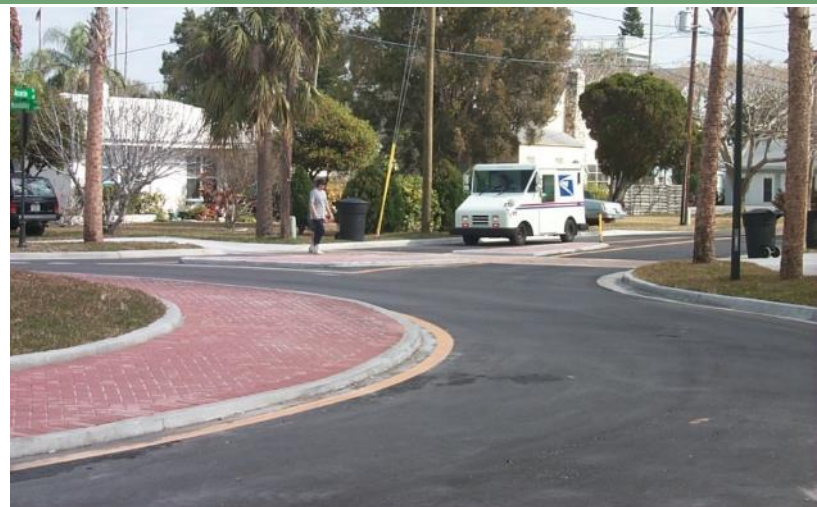
Figure 62. Yielding behavior of motorists when the pedestrian crossing begins on the entry side.

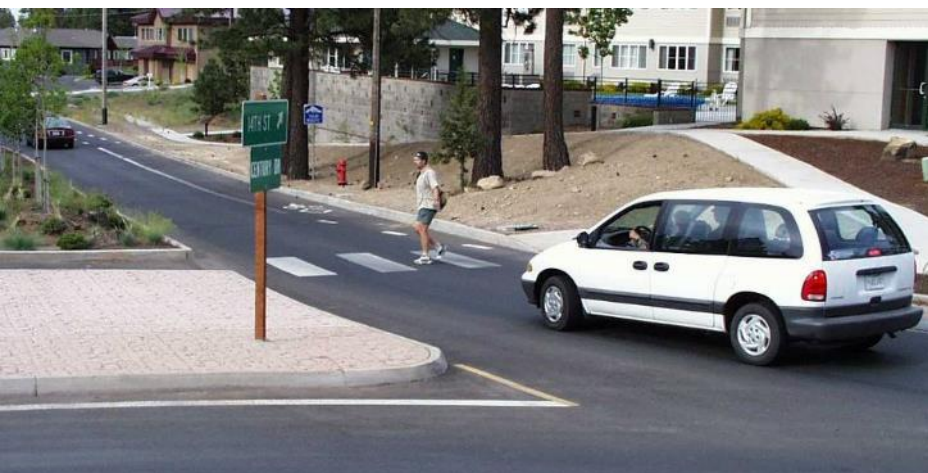
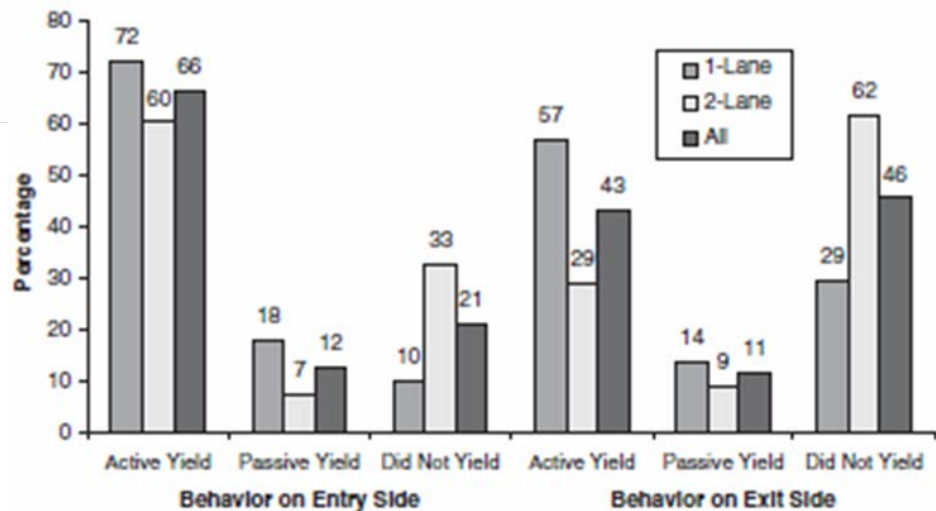
Figure 63. Yielding behavior of motorists when the pedestrian crossing begins on the exit side.

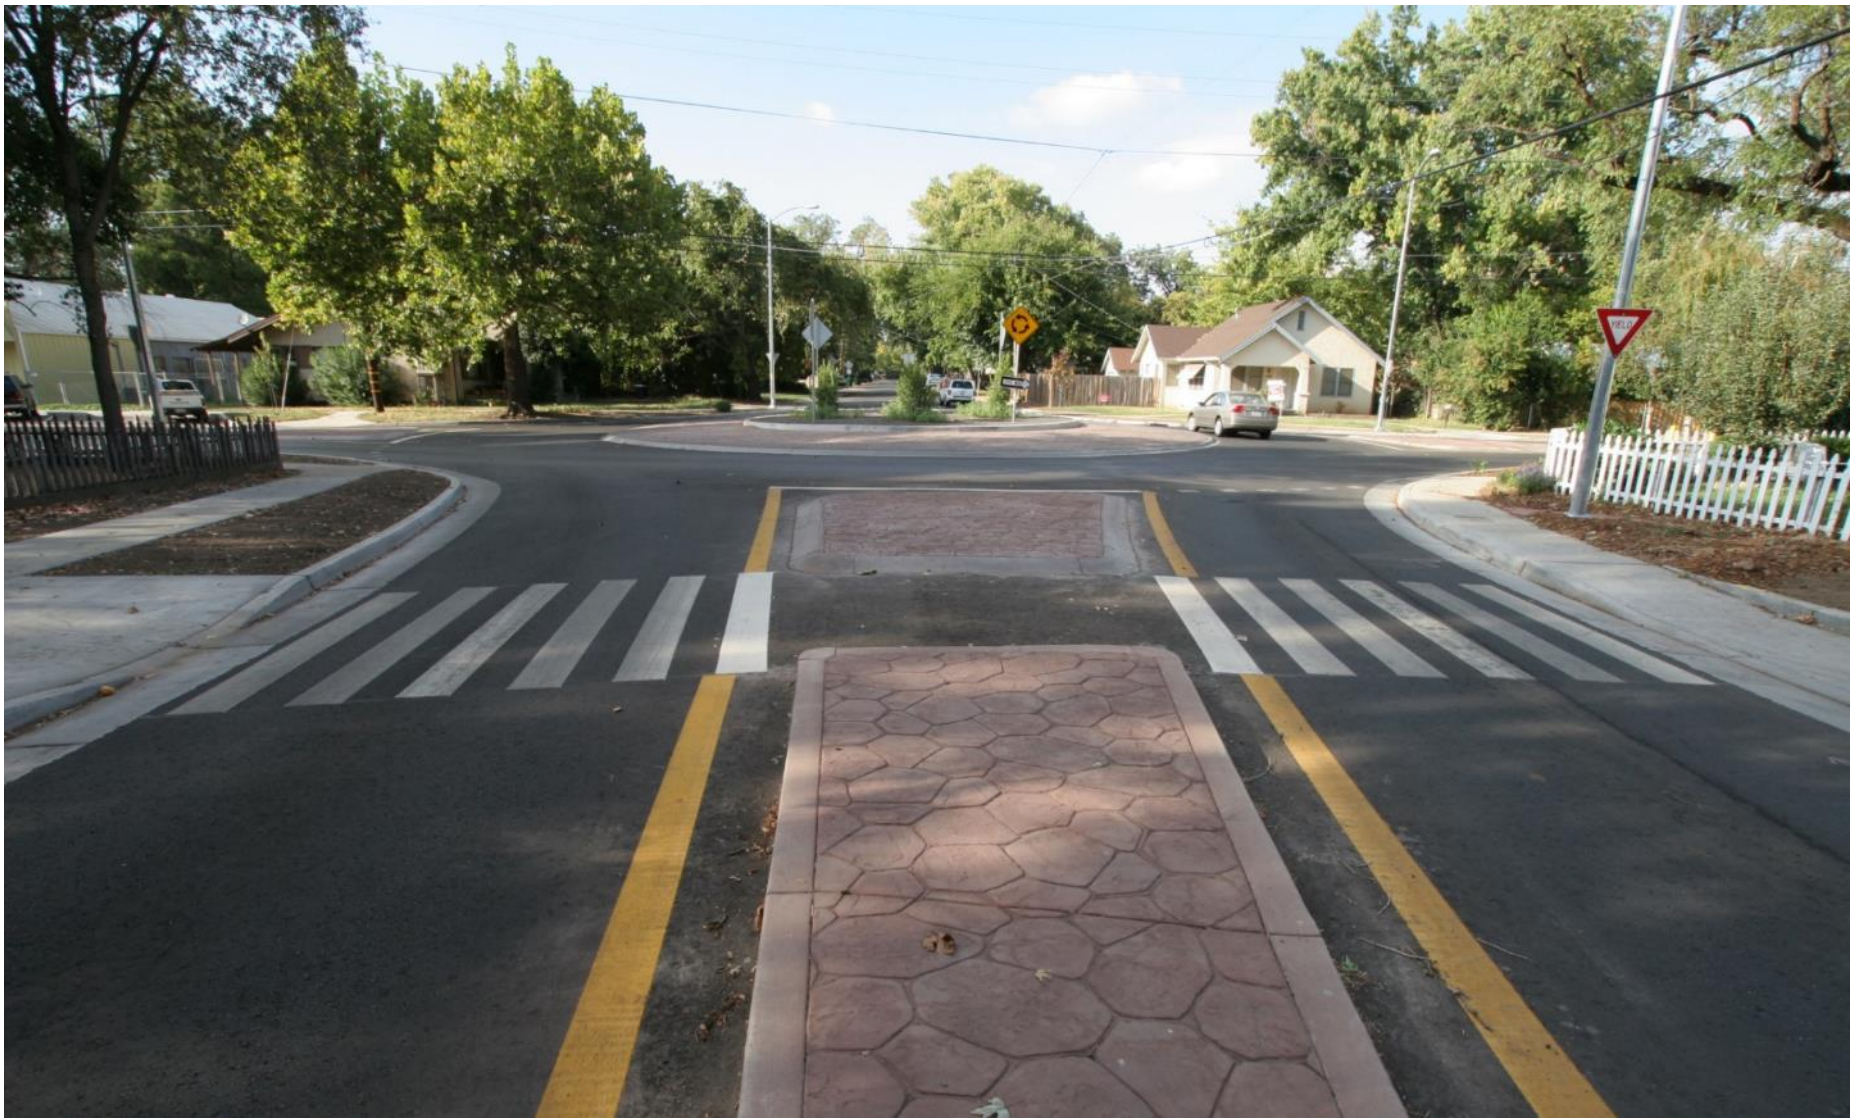
8-19

Narrow entry slows drivers

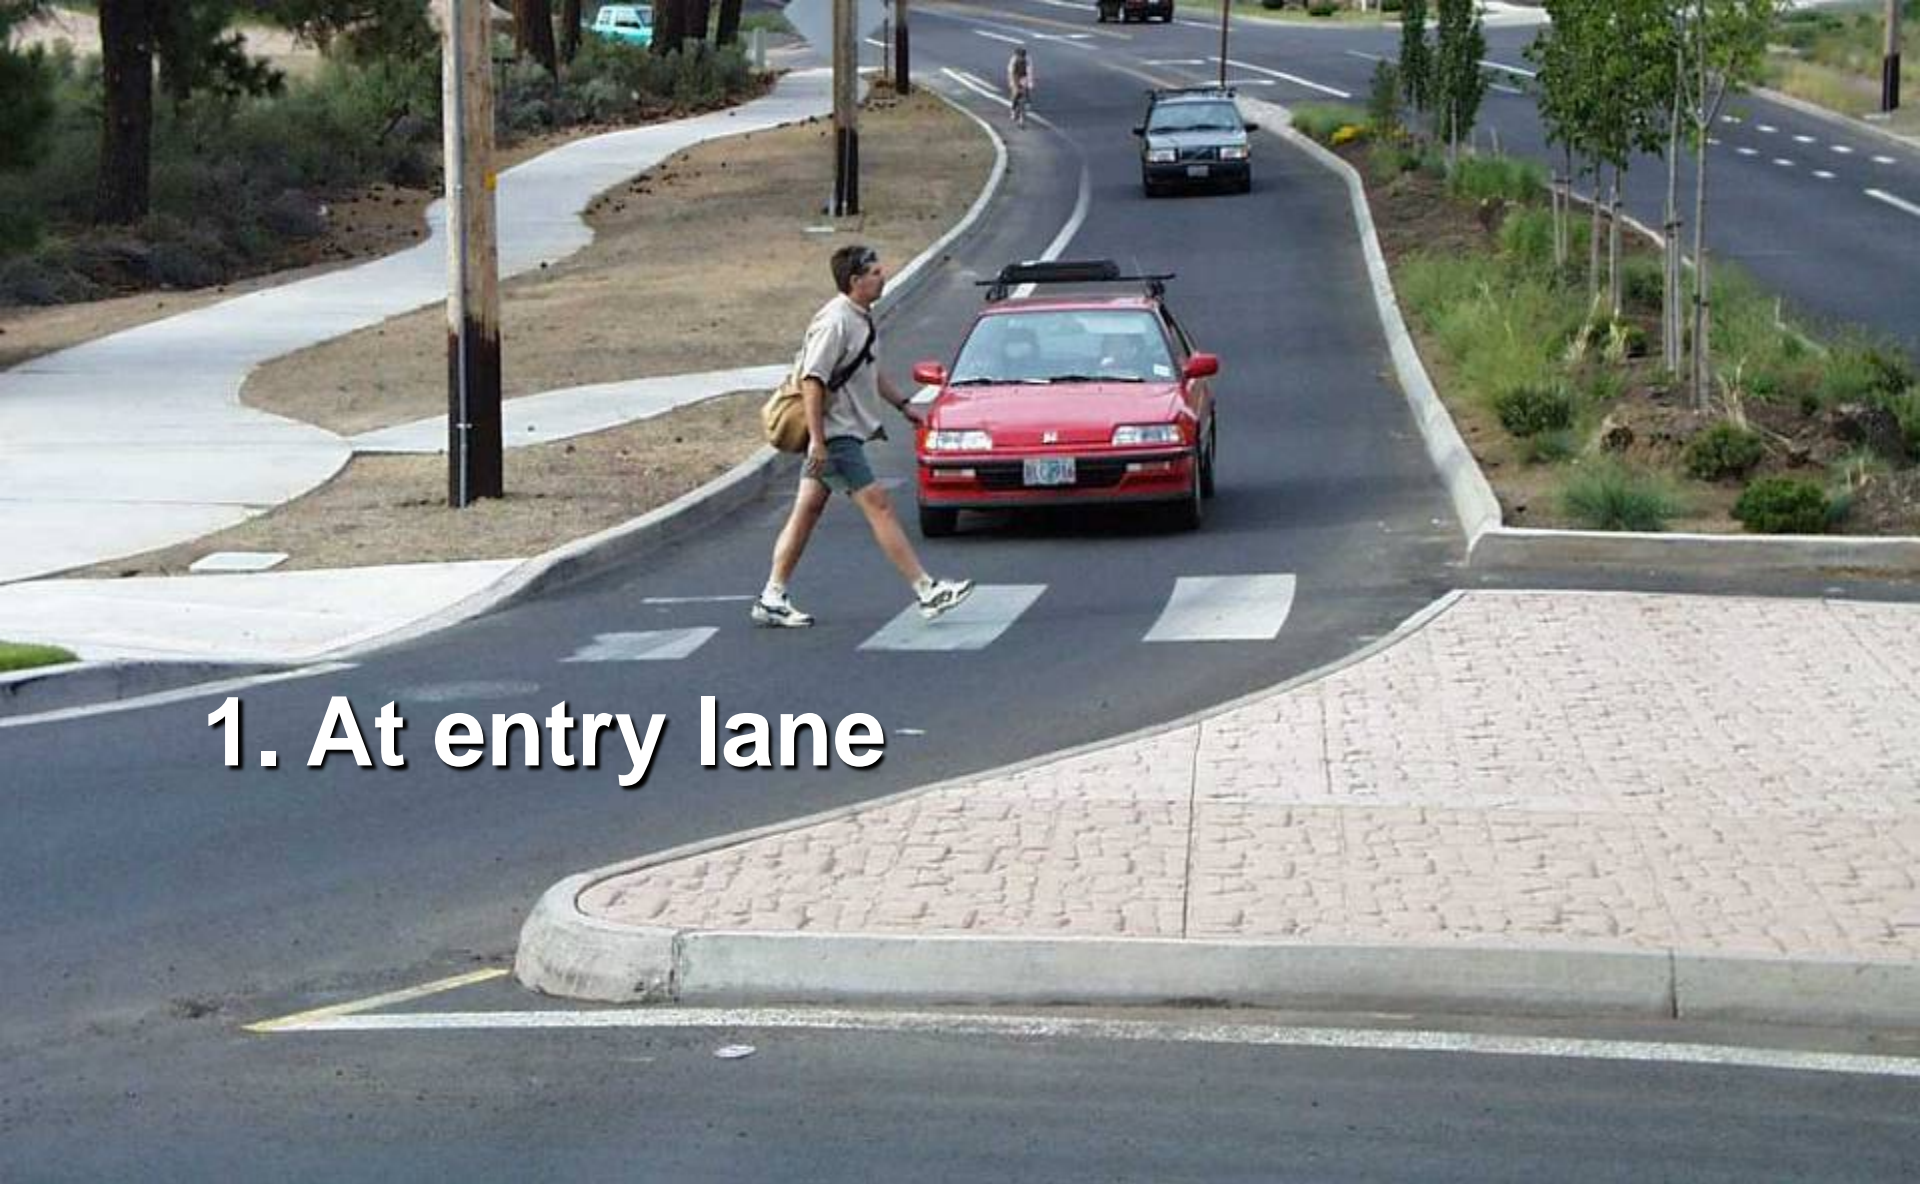
1. At entry lane

Well defined crossings & splitter islands

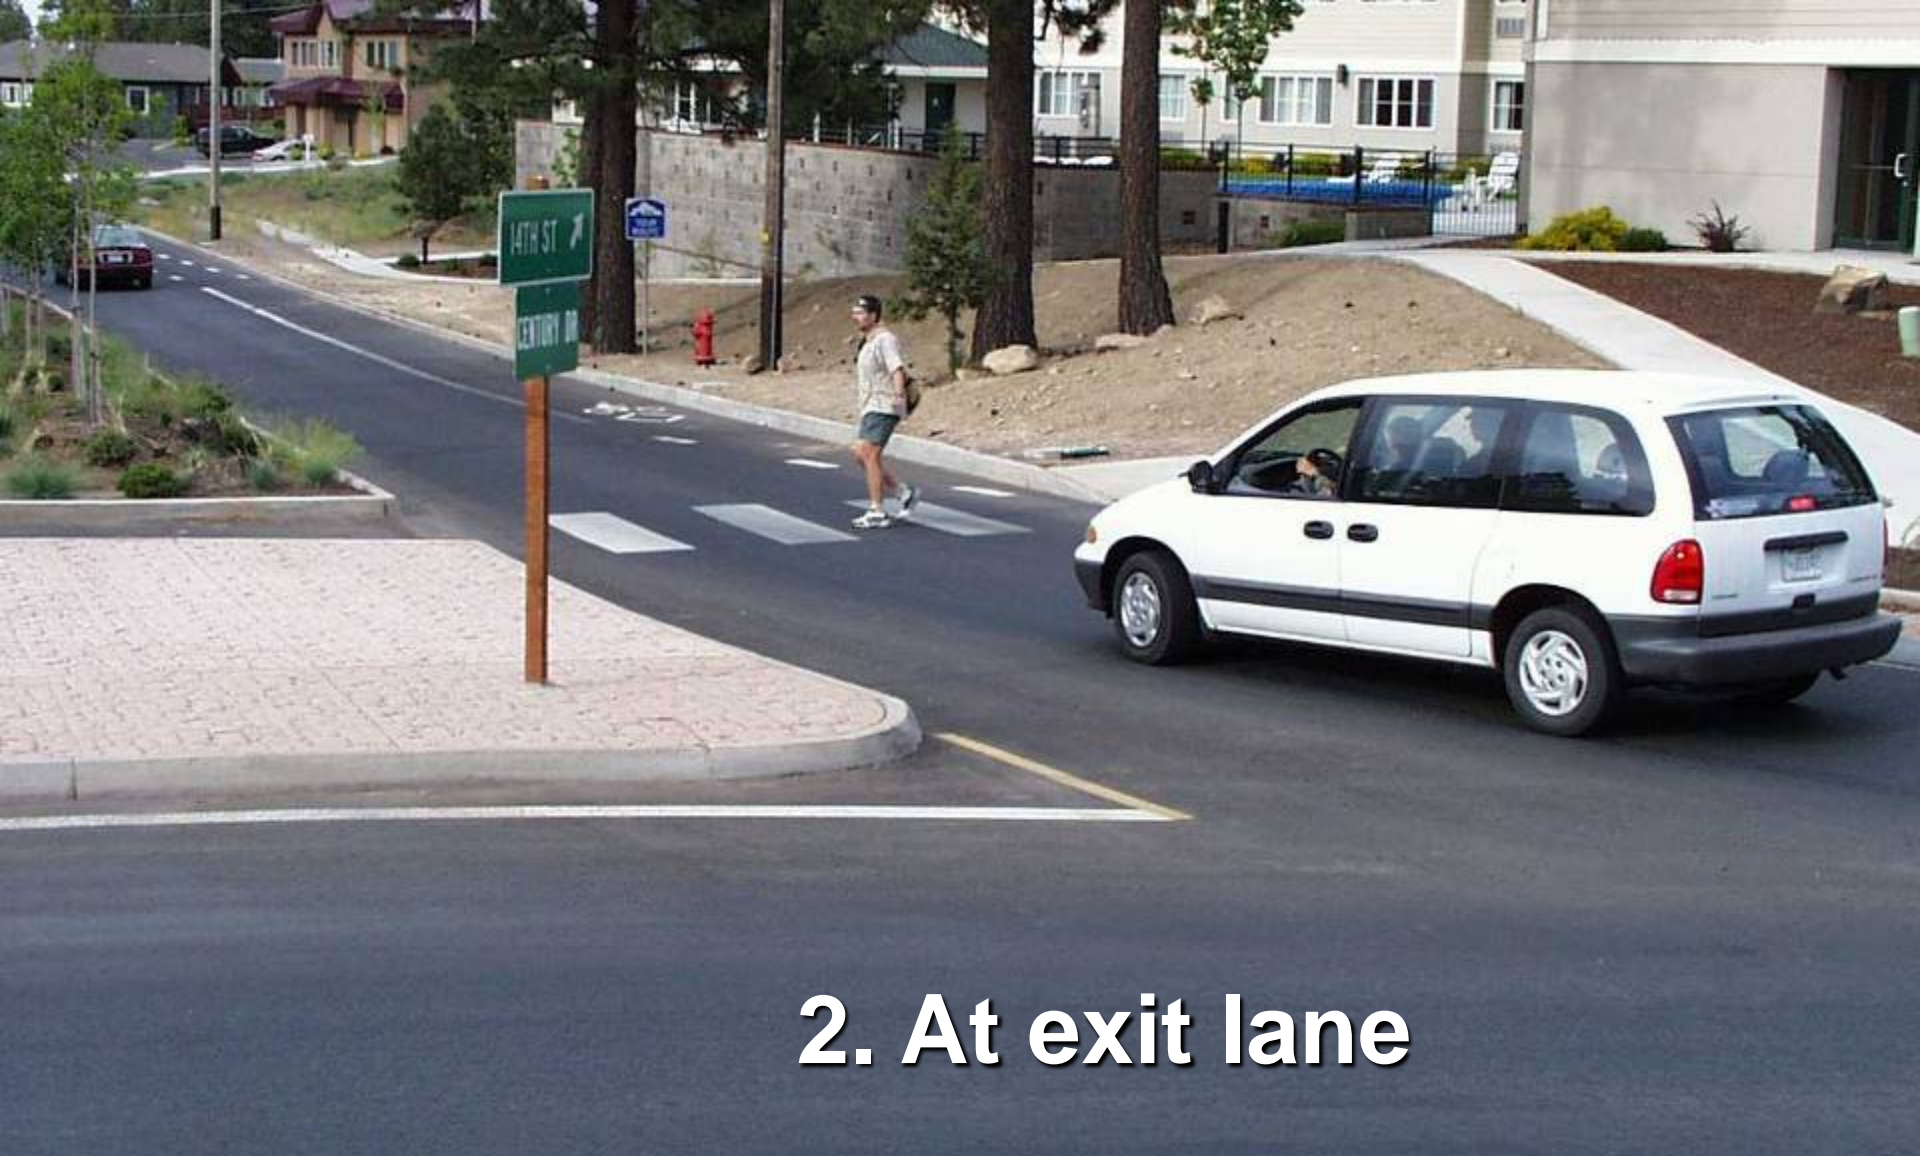
2. At exit lane

Well defined crossings & splitter islands

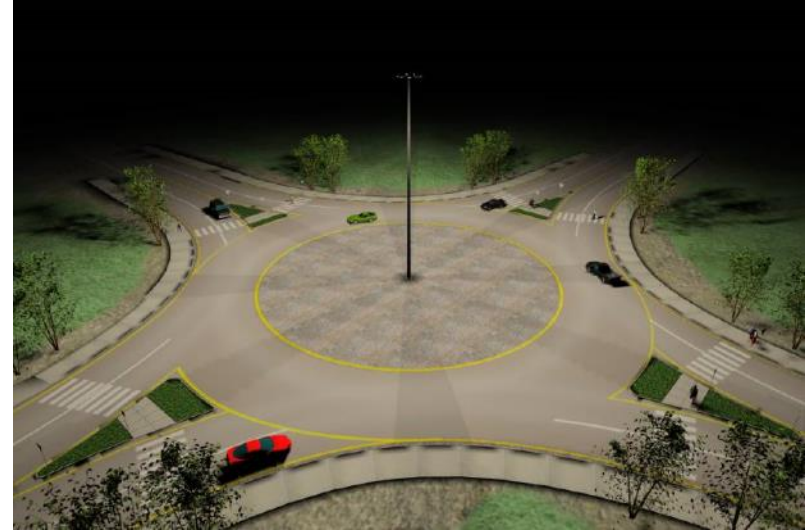
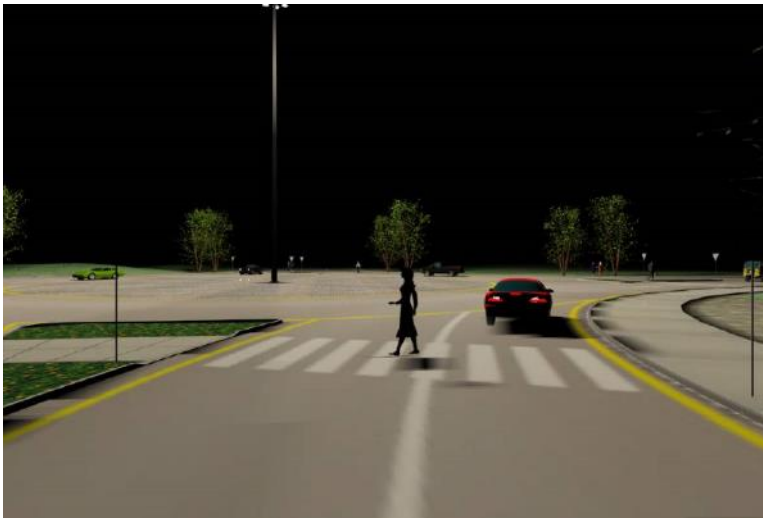
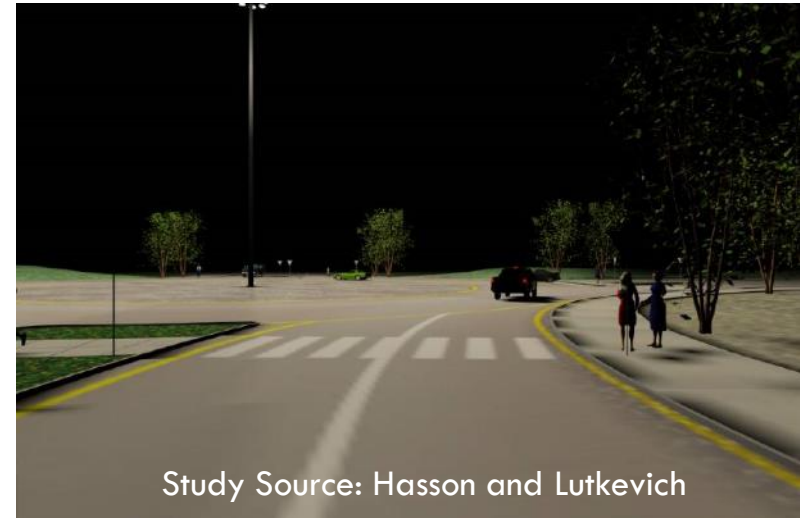
- ❑ Center Mounted Lighting:
- ❑ Peds visible only as silhouettes
- ❑ Signs not visible
