ROUNDBABOUTS: HOW THEY WORK FOR PEDESTRIANS

Roundabouts:

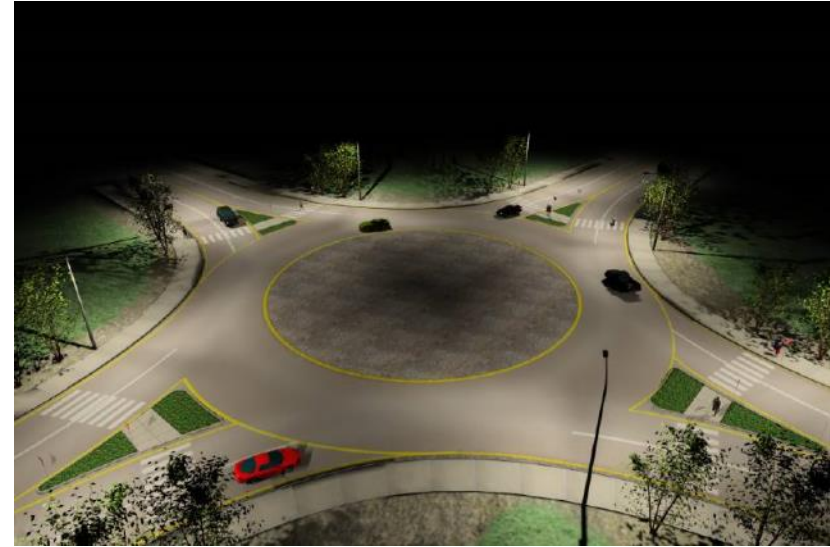
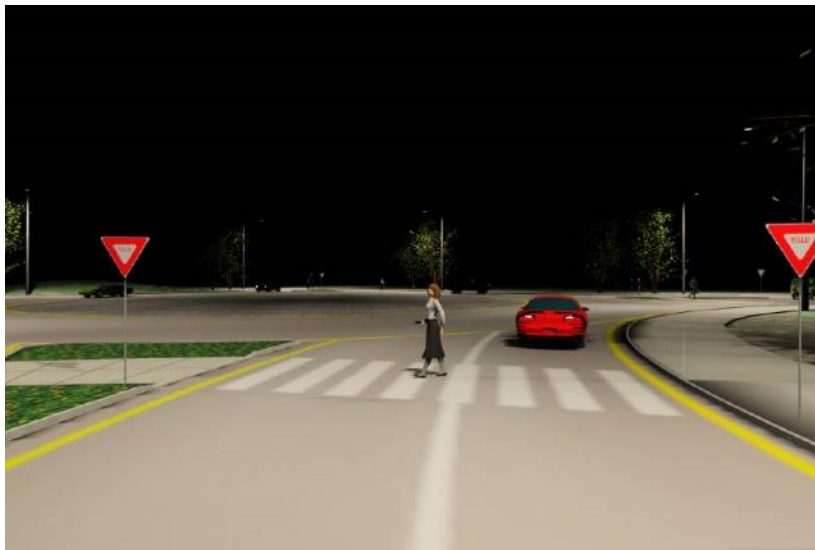
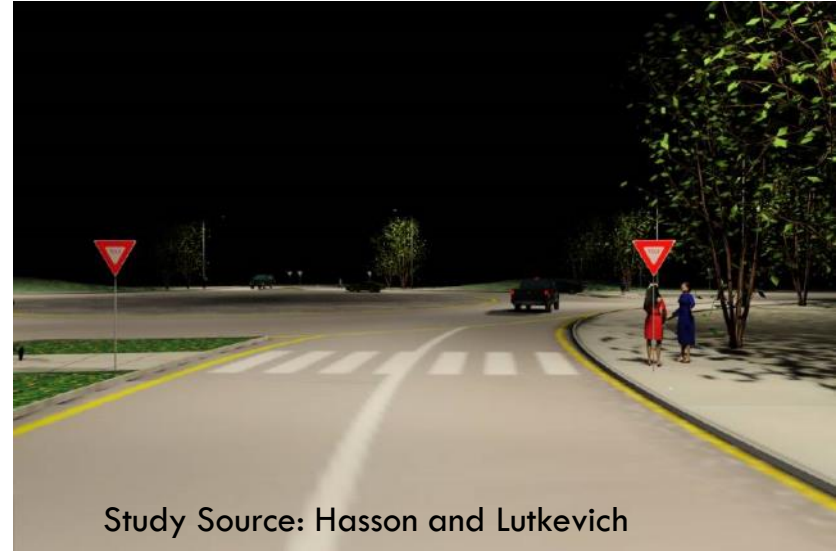
- ❑ Approach Mounted Lighting:
- ❑ Peds illuminated
- ❑ Signs illuminated

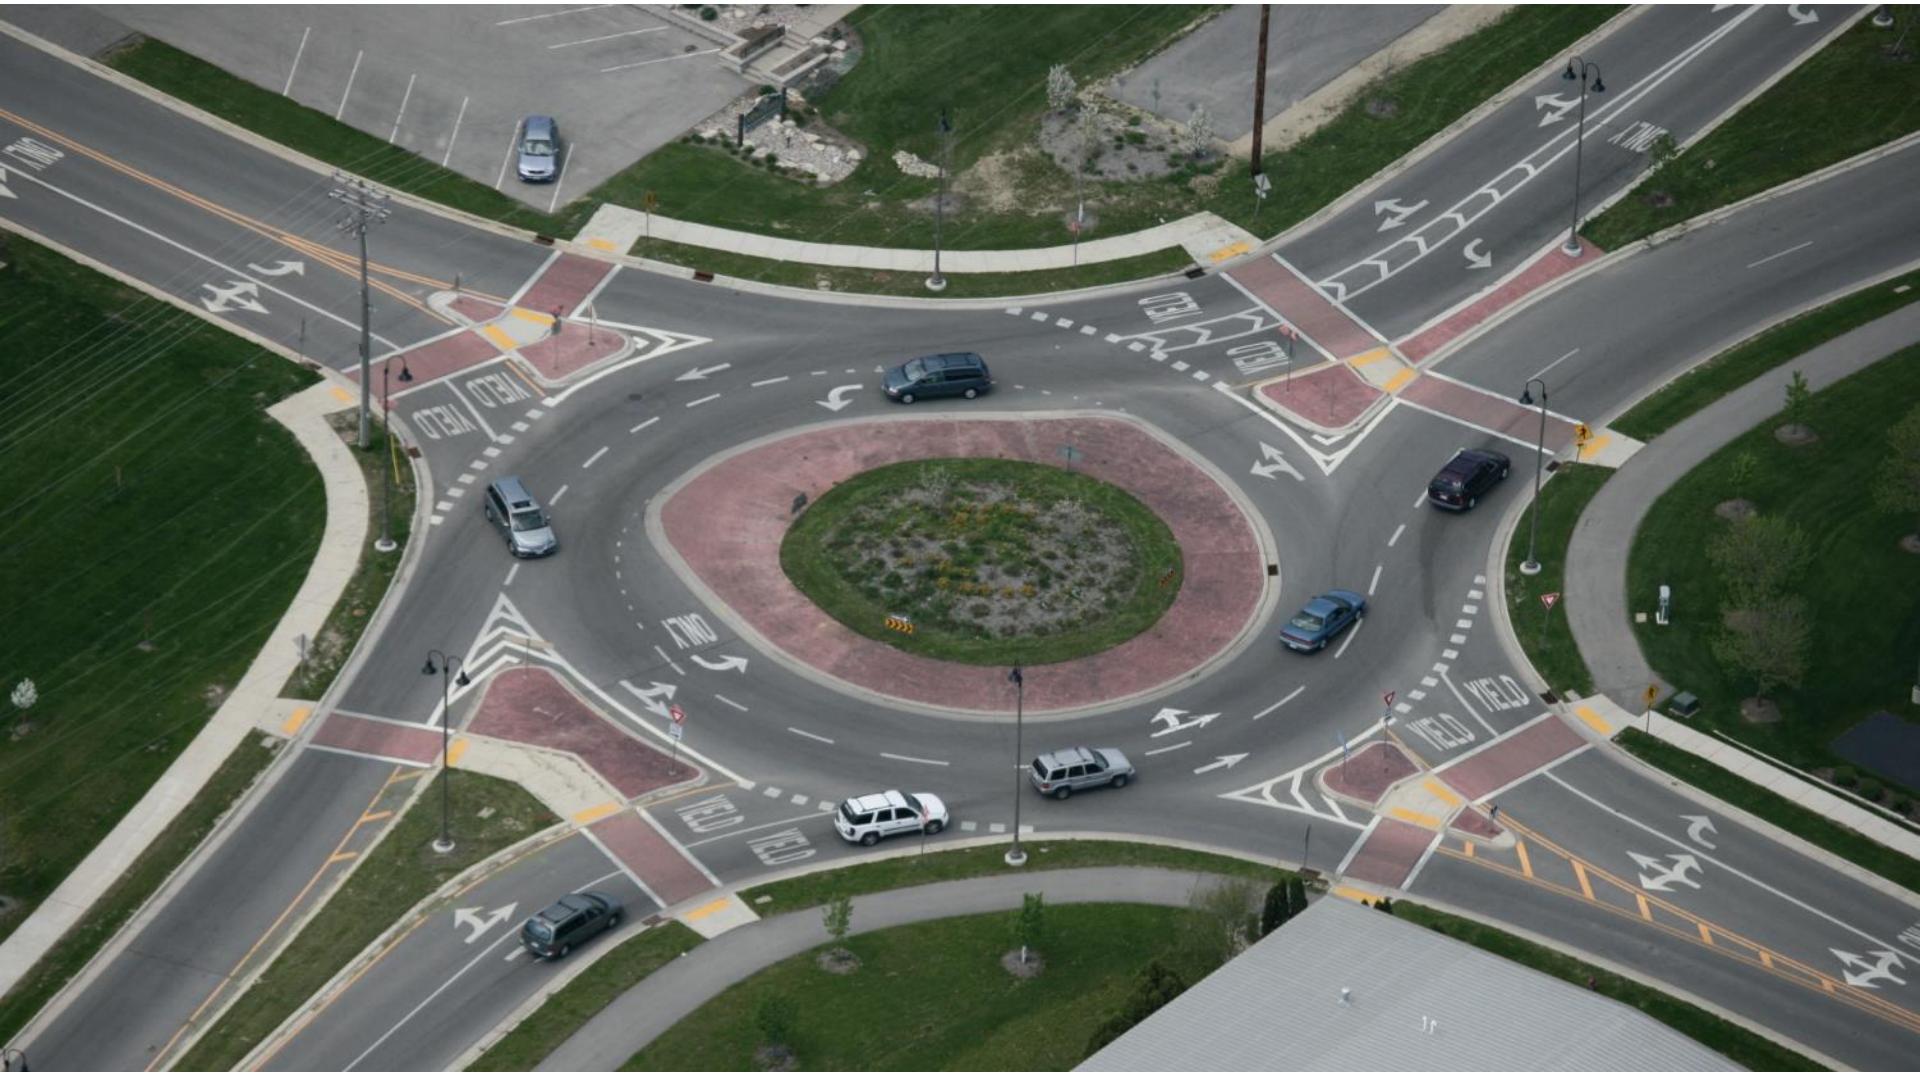
8-25

Multi-lane roundabouts have potential for “multiple threat” and higher speeds

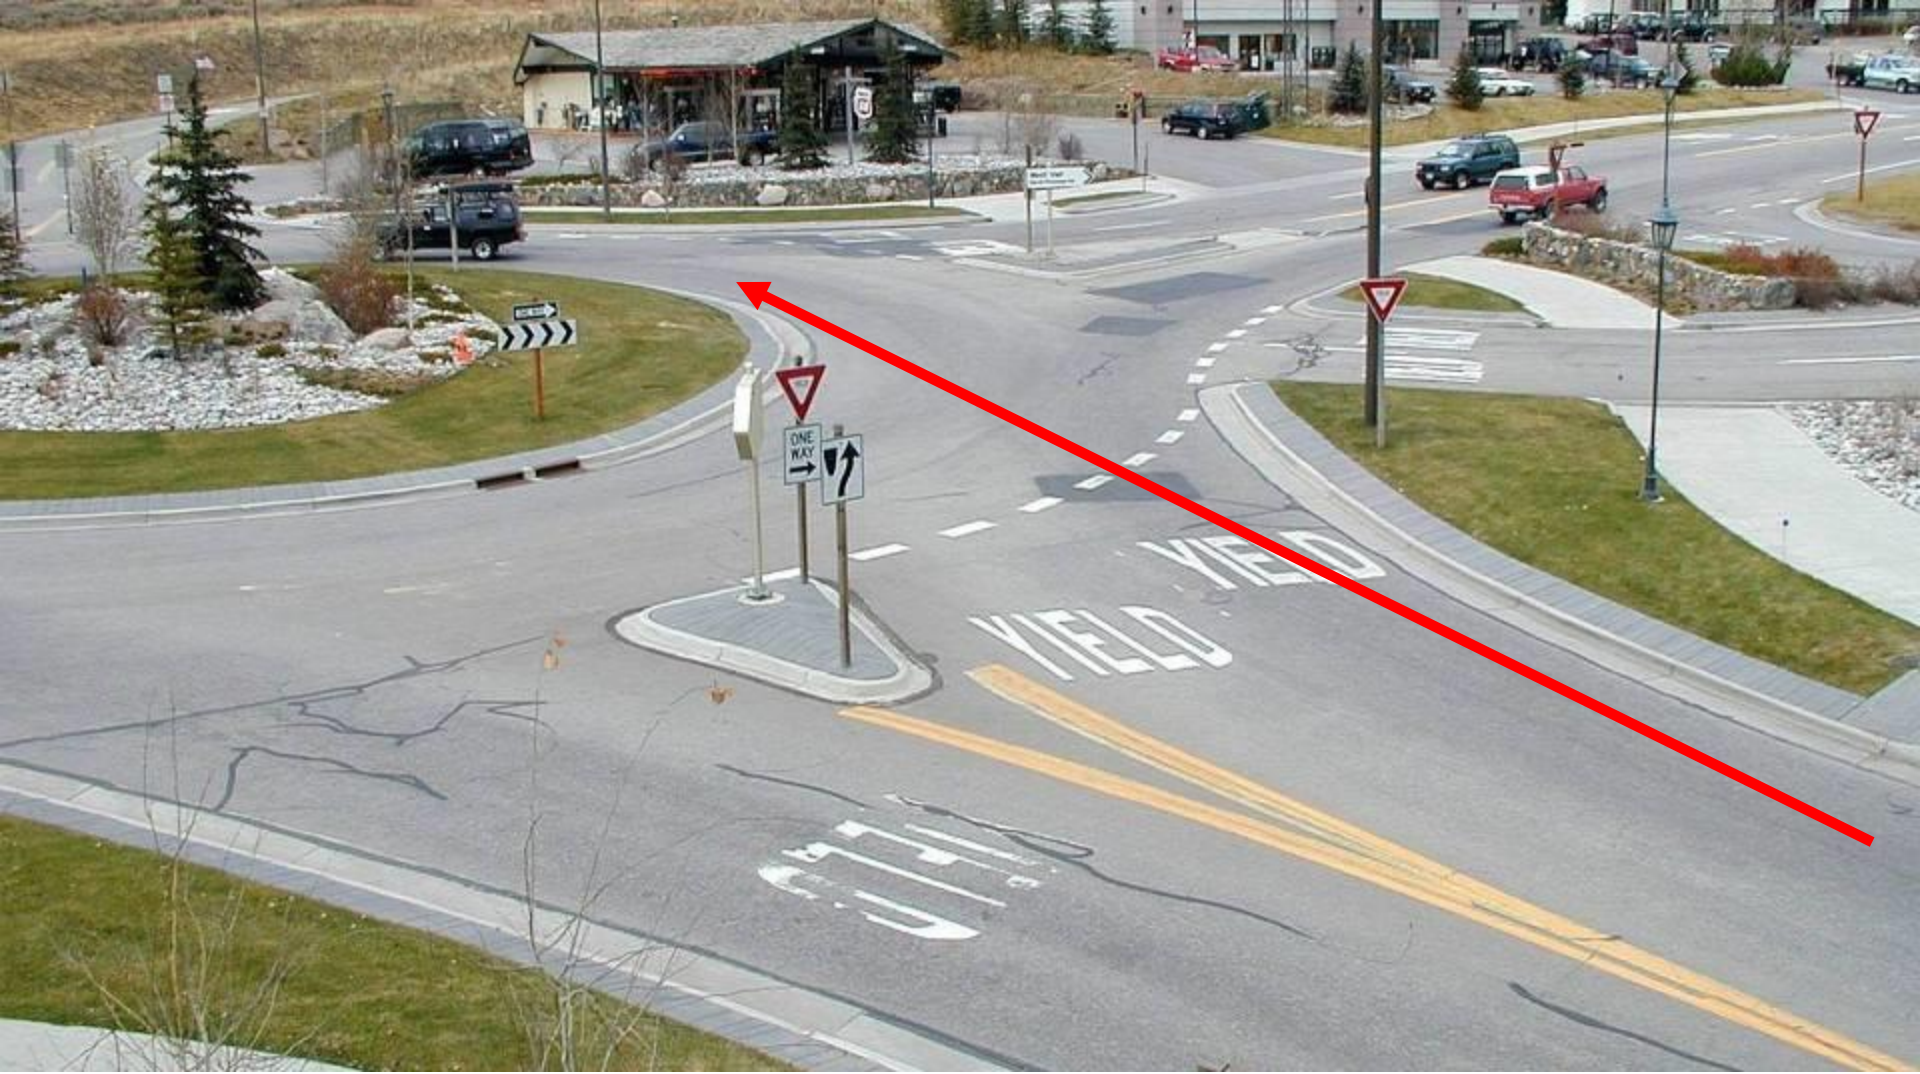
8-26

Drivers may take a straighter, faster path on entry and exit, resulting in higher speeds – lane markings are recommended to minimize this

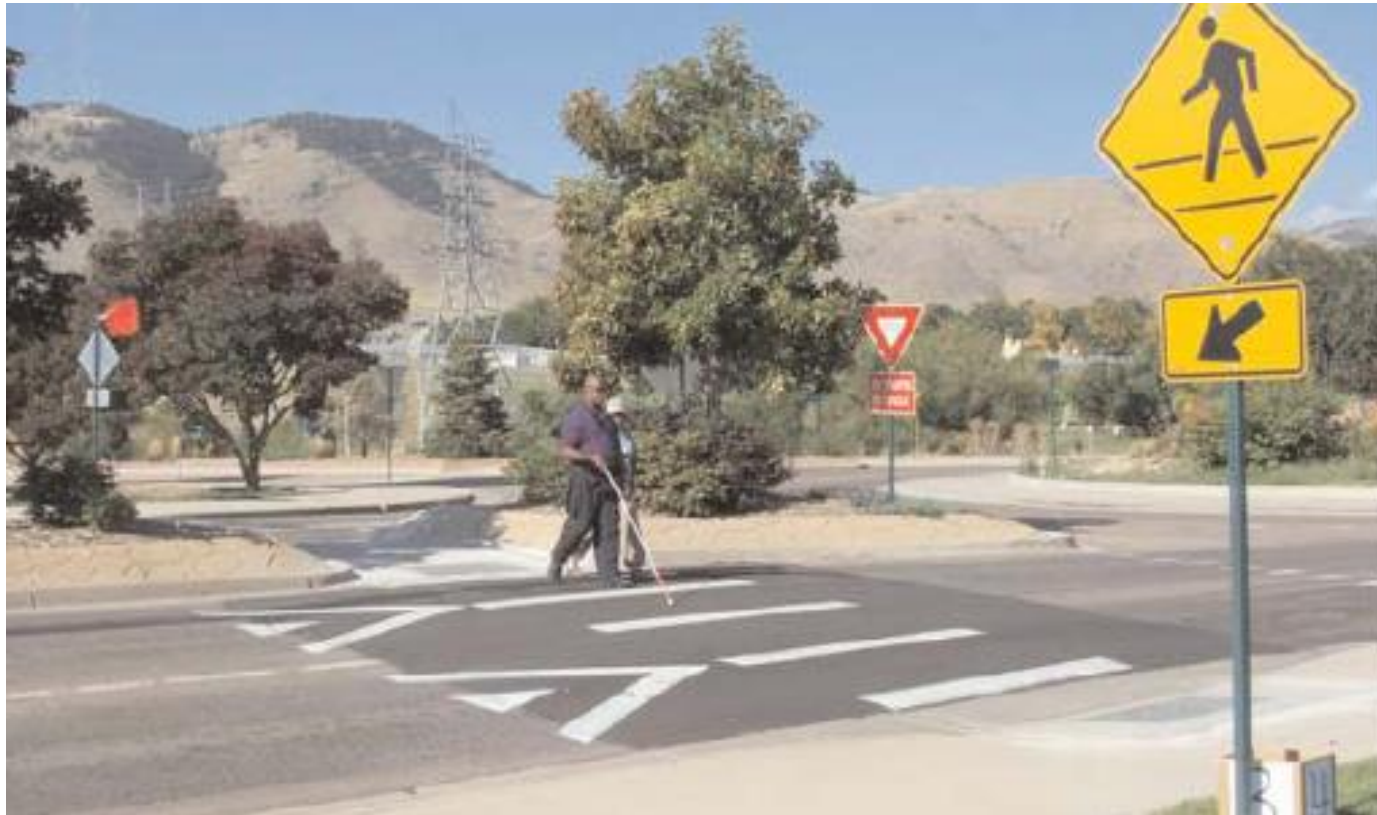
8-27

Roundabout concerns for peds with vision impairments:

- ❑ Circulating traffic masks the sound cues used to identify gaps and masks the sound of yielding vehicles
- ❑ Problems are much worse at multi-lane roundabouts

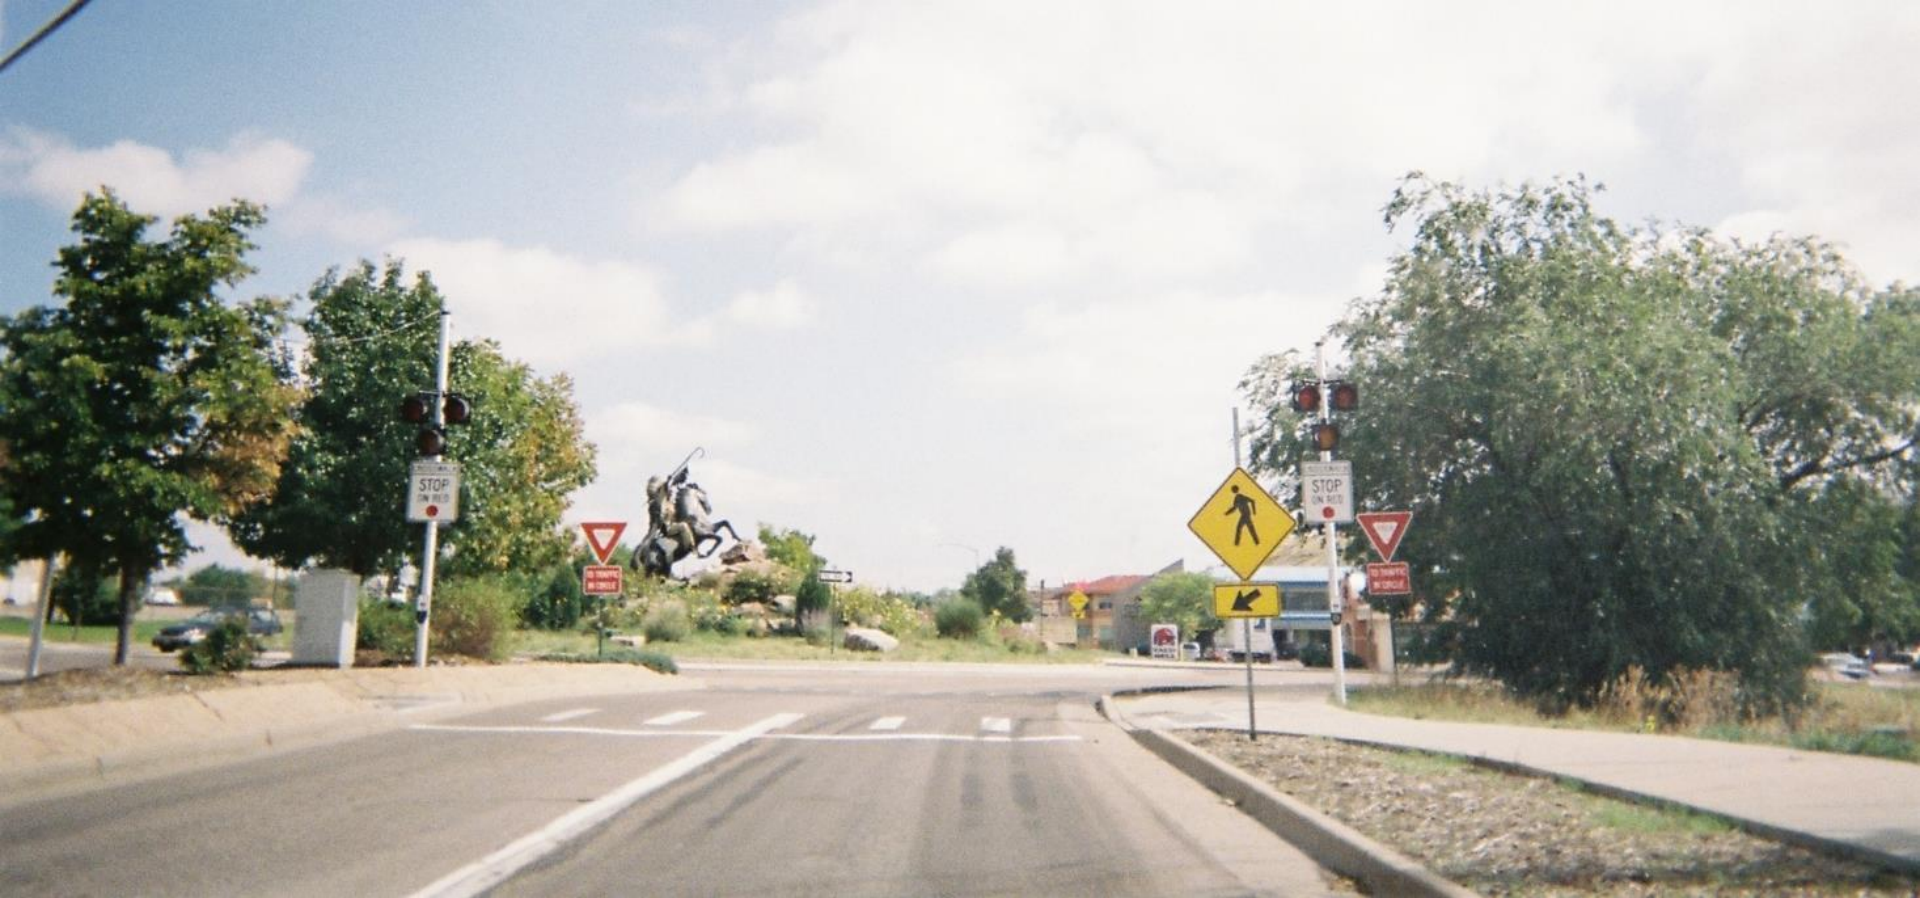
8-29

Pedestrian Hybrid Beacon at Two-lane Roundabout

- Public Right-of-Way Accessibility Guidelines (PROWAG, proposed rule July 26, 2011) require signals at multi-lane roundabout approaches:
 - Pedestrian Hybrid Beacon (HAWK)
 - Regular Red-Yellow-Green Signal
- Research – other solutions may work:
 - Raised Crosswalk
 - Rectangular Rapid Flash Beacon
 - Ped signal may rest in dark (optional use by peds)

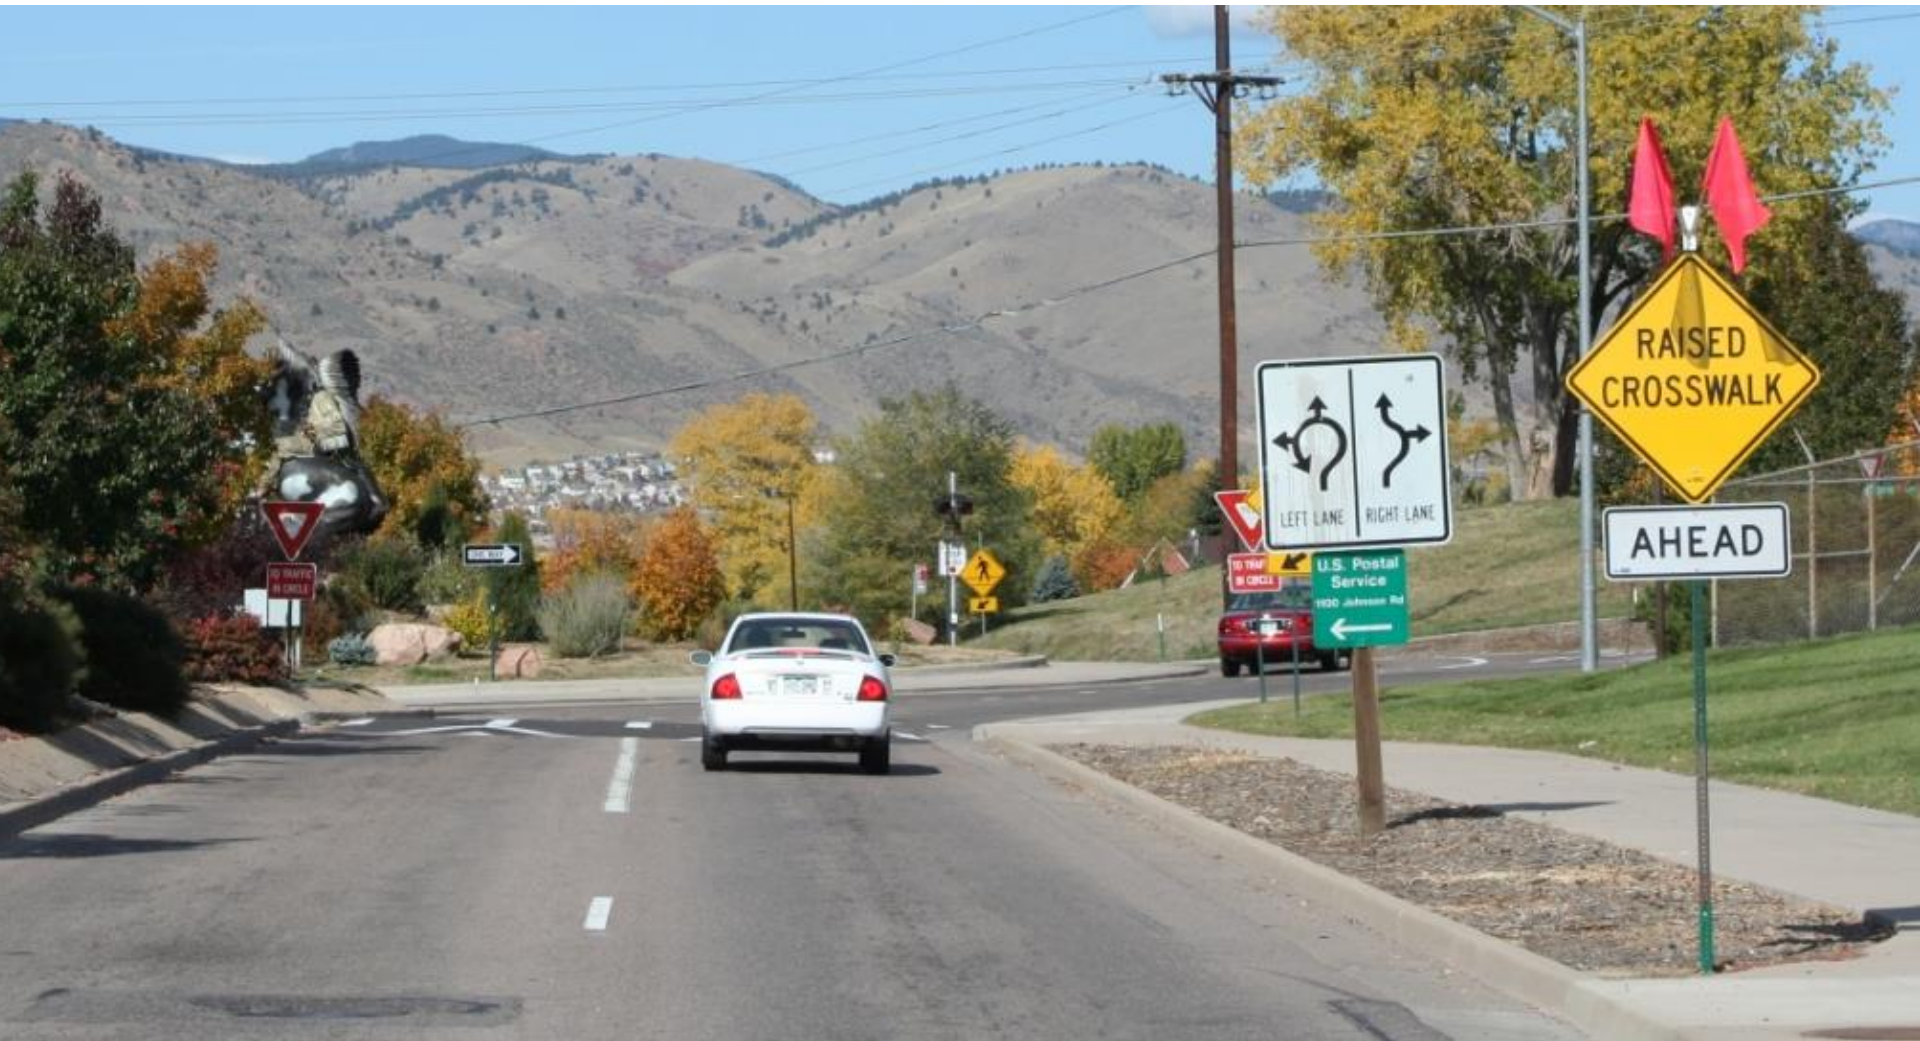
8-30

Raised Crosswalk at Two-lane Roundabout

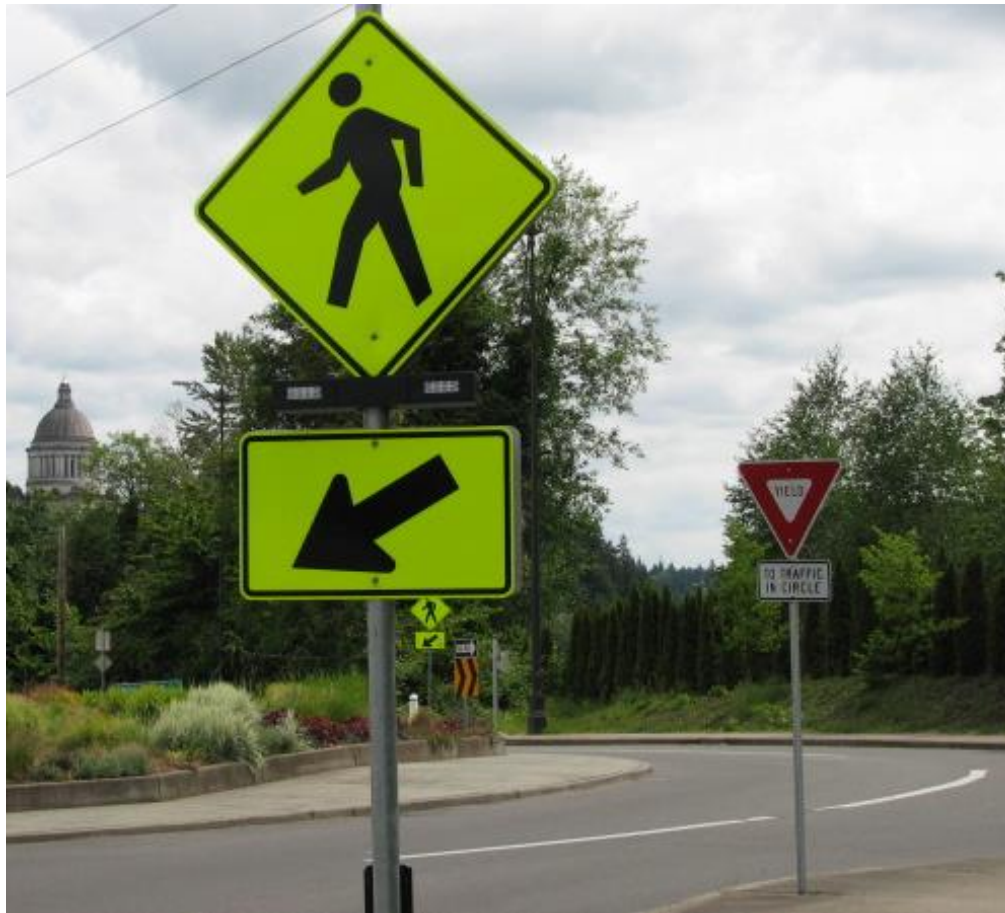
8-31

Rectangular Rapid Flash Beacon at Multilane Roundabout

- FHWA study found some benefits to accessibility after RRFB installation at multilane roundabouts
- Other impacts (volume, speeds, configuration) also impact yielding

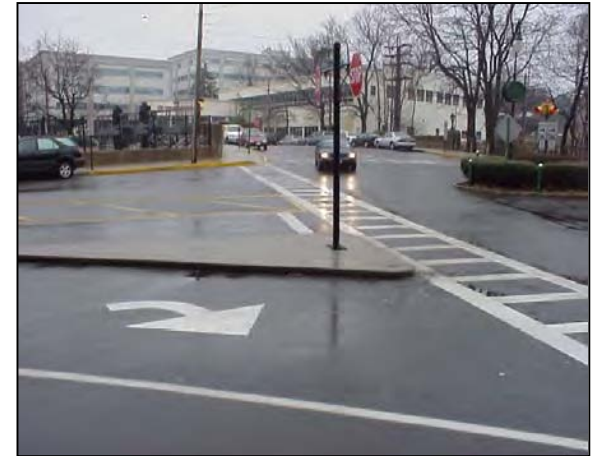
Before

- City received traffic calming grant from state DOT
 - Goal: calm traffic, enhance visibility of pedestrians, & improve crosswalk safety
- 4-way STOP replaced by roundabout
 - Contrasting pavement color, curb extensions, fencing, and islands used to direct traffic
- Other locations: illuminated pedestrian crossings and speed awareness devices installed
- Cost: \$365,000 for the roundabout, \$275,000 for the other improvements

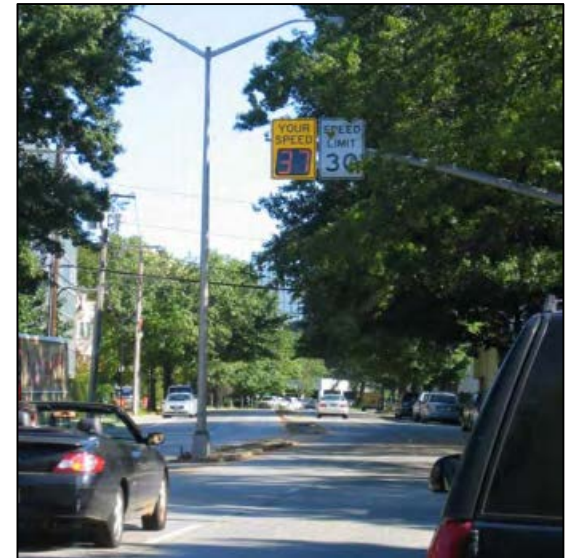
Speed awareness device installed at same time as roundabout
