**INFRASTRUCTURE CONDITIONS  
ASSESSMENT**

**AMERICA'S CENTRAL PORT**

**MADISON, VENICE, AND  
GRANITE CITY, ILLINOIS**

December 30, 2021

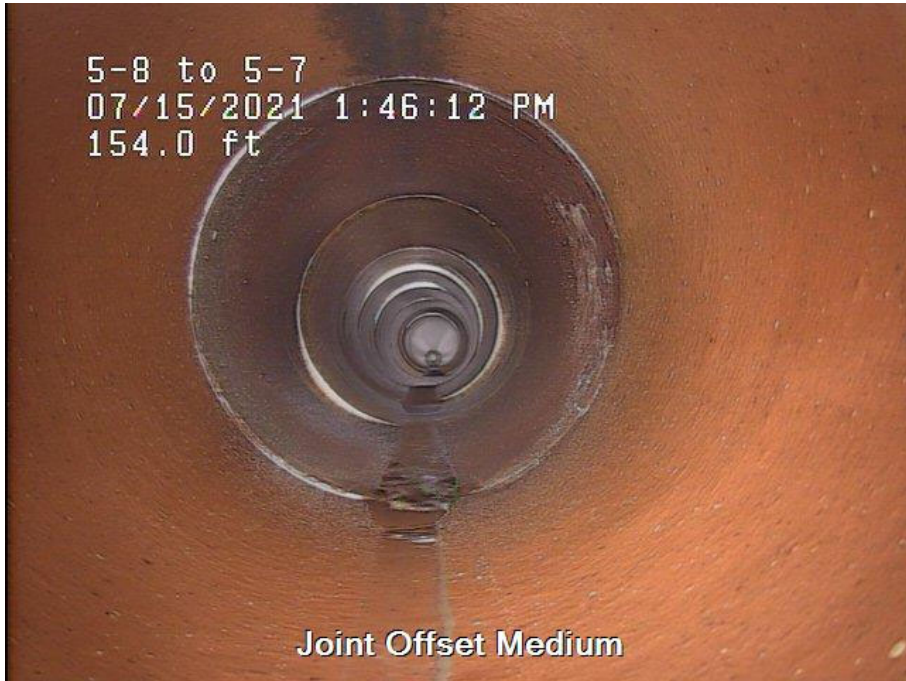
**Example: Joint Offset Medium**

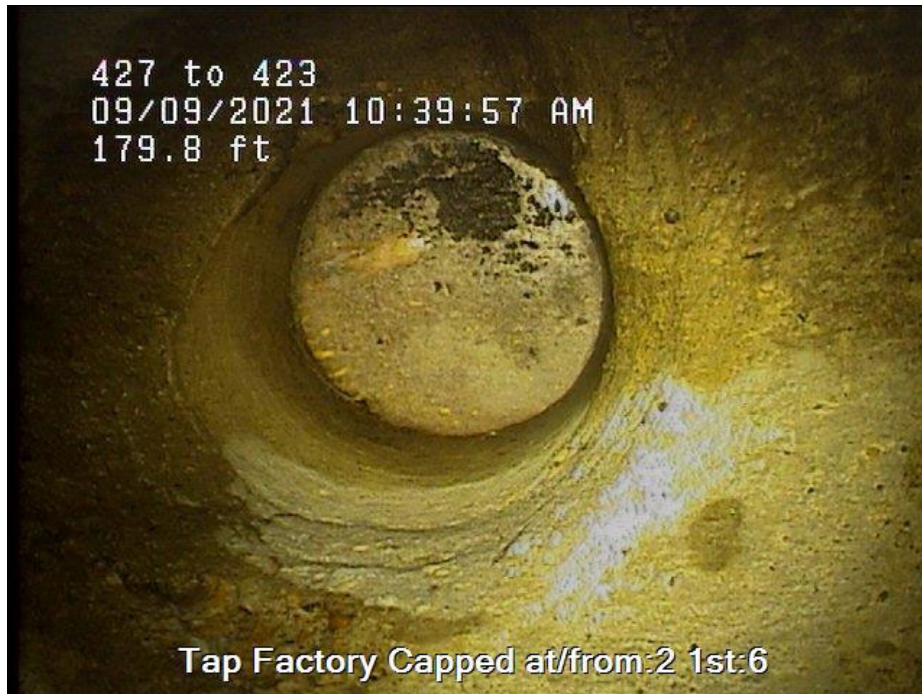
**Example: Tap – Factory Capped**

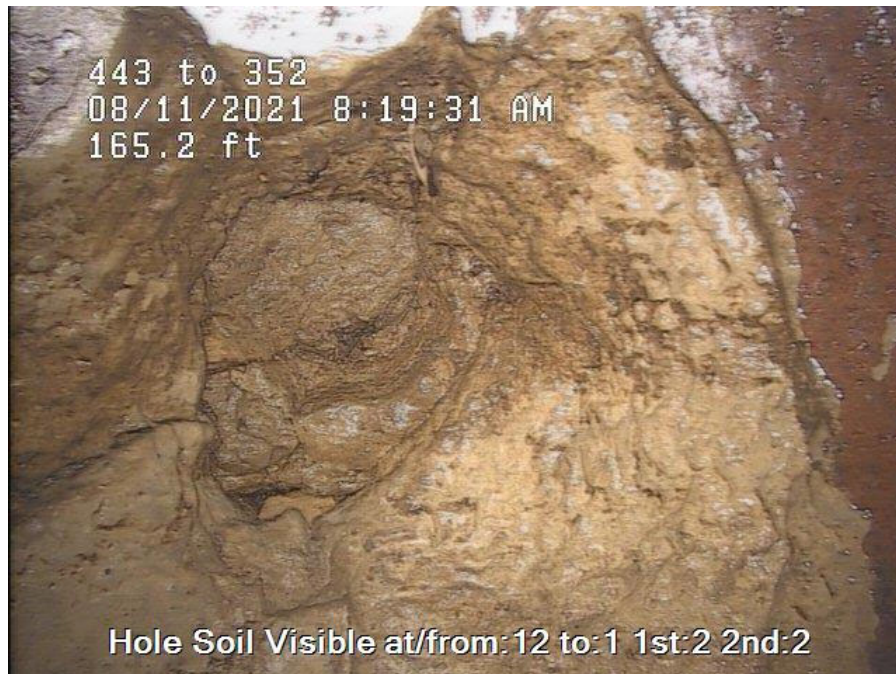
**Example: Hole / Void**

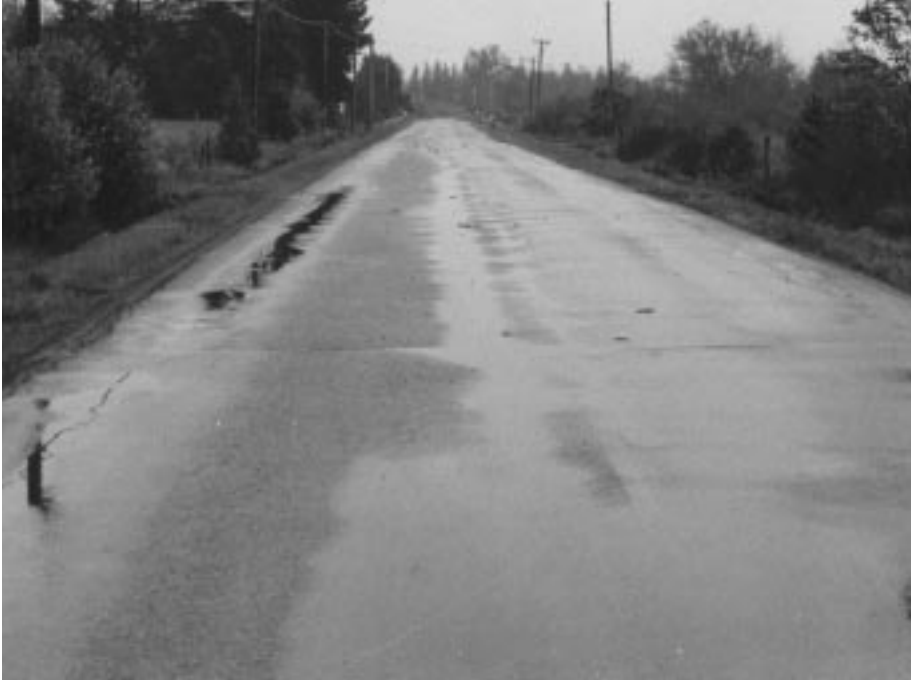
◀  
Even slight rutting is evident after a rain.

Rutting is displacement of material, creating channels in wheelpaths. It is caused by traffic compaction or displacement of unstable material. Severe rutting (over 2") may be caused by base or subgrade consolidation. Repair minor rutting with overlays. Severe rutting requires milling the old surface or reconstructing the roadbed before resurfacing.

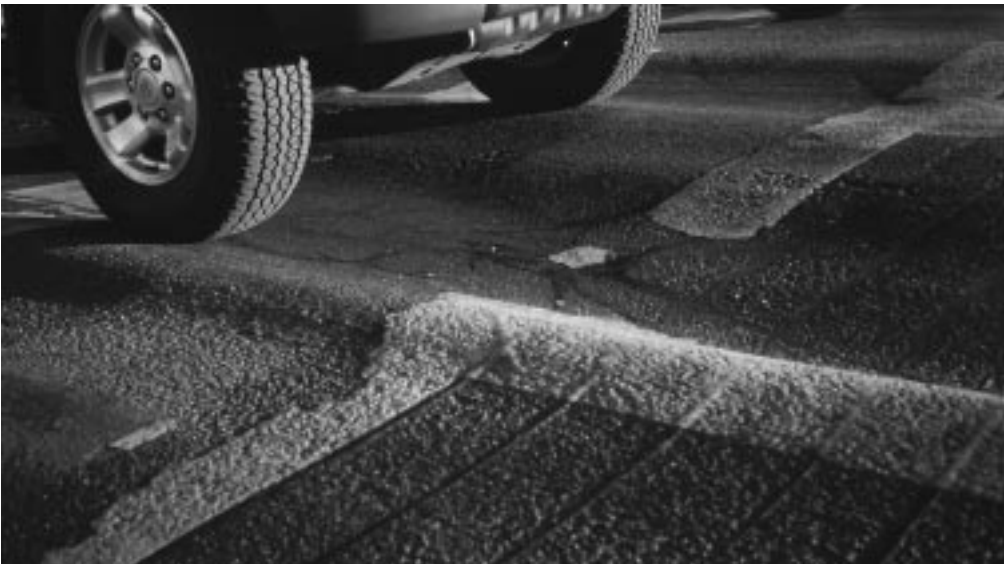
◀  
Severe rutting over 2" caused by poor mix design.

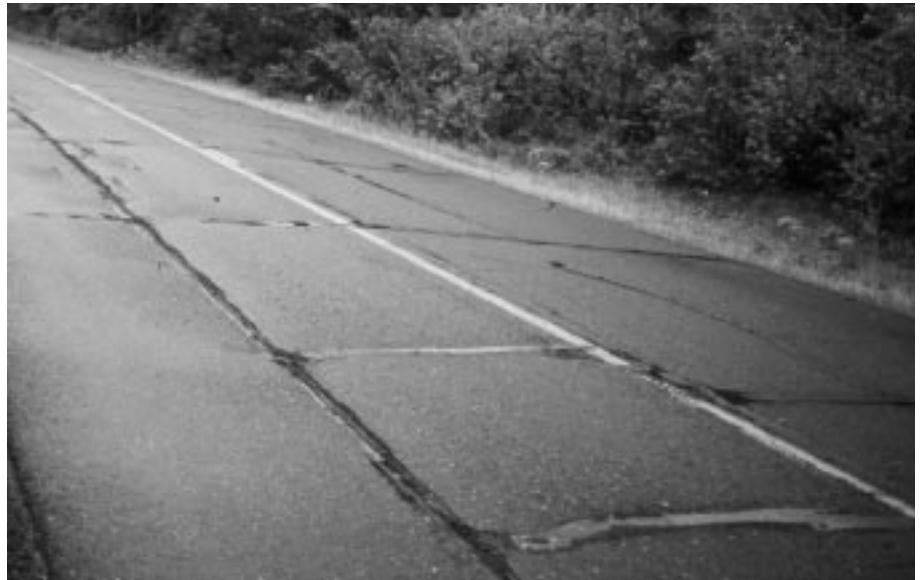
Cracks in overlays reflect the crack pattern in the pavement underneath. They are difficult to prevent and correct. Thick overlays or reconstruction is usually required.

►  
**Concrete joints reflected through bituminous overlay.**

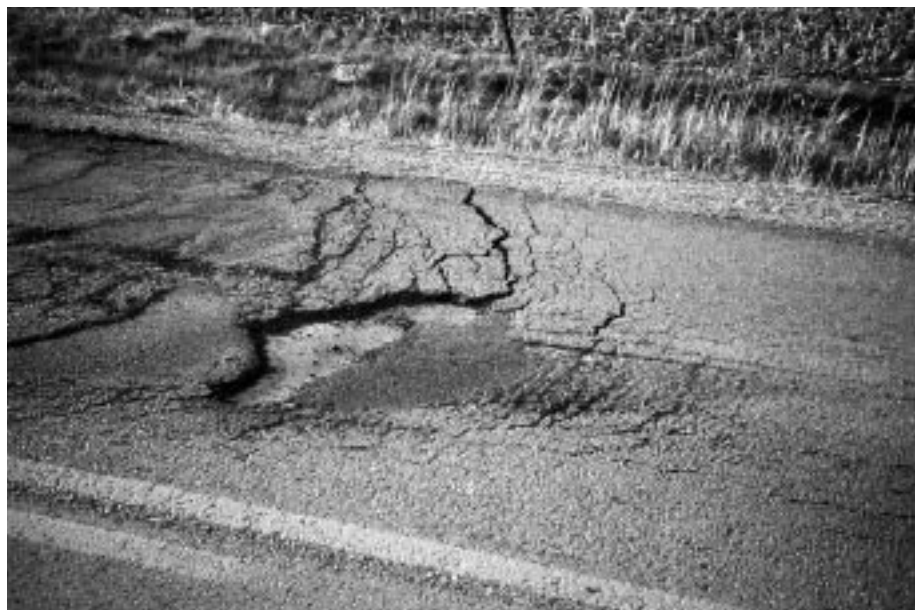
►  
**Loss of bond between pavement layers allows traffic to break loose pieces of surface.**

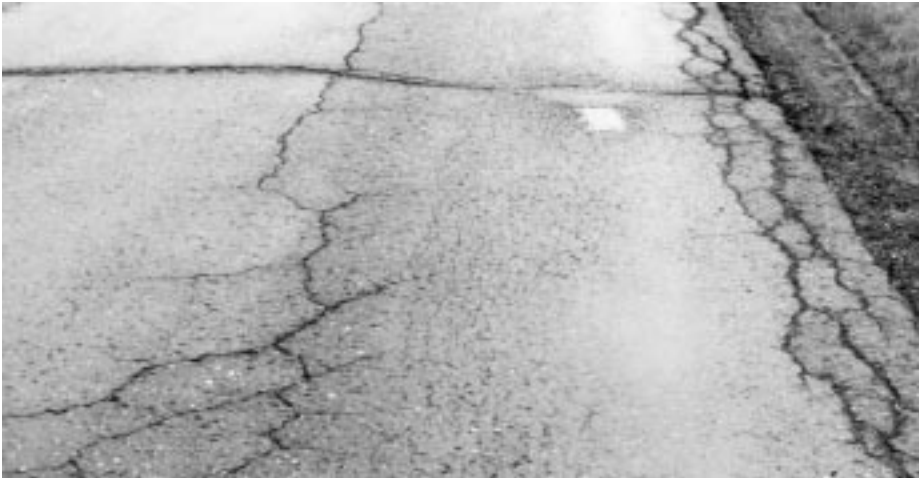
Edge cracking from weakened subbase and traffic loads. ▼

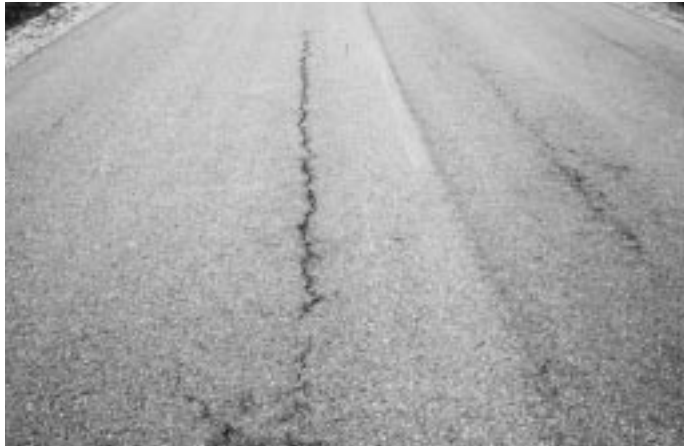
▶  
First stage of wheelpath cracking caused by heavy traffic loads.

Filling and sealing cracks will reduce moisture penetration and prevent further subgrade weakening. Multiple longitudinal cracks in the wheel path or pavement edge indicate a need for strengthening with an overlay or reconstruction.

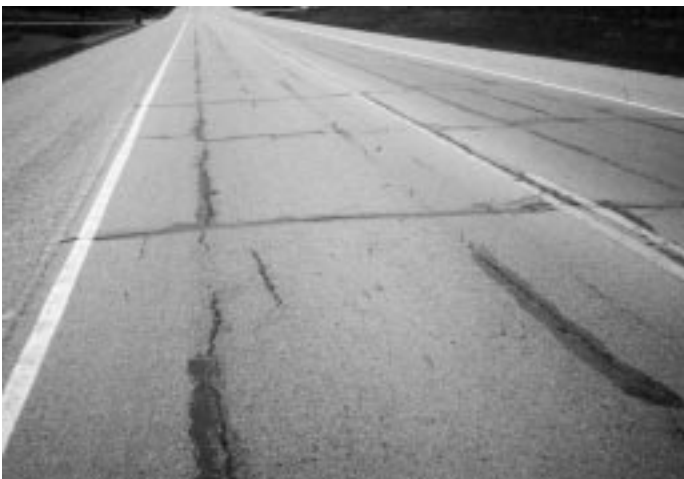
Load-related cracks in wheel path plus centerline cracking. ▼

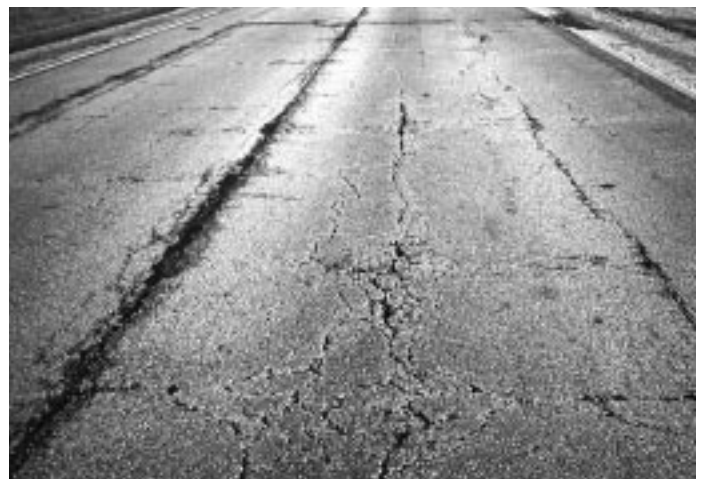
Multiple open cracks at center line, wheelpaths and lane center. ▼

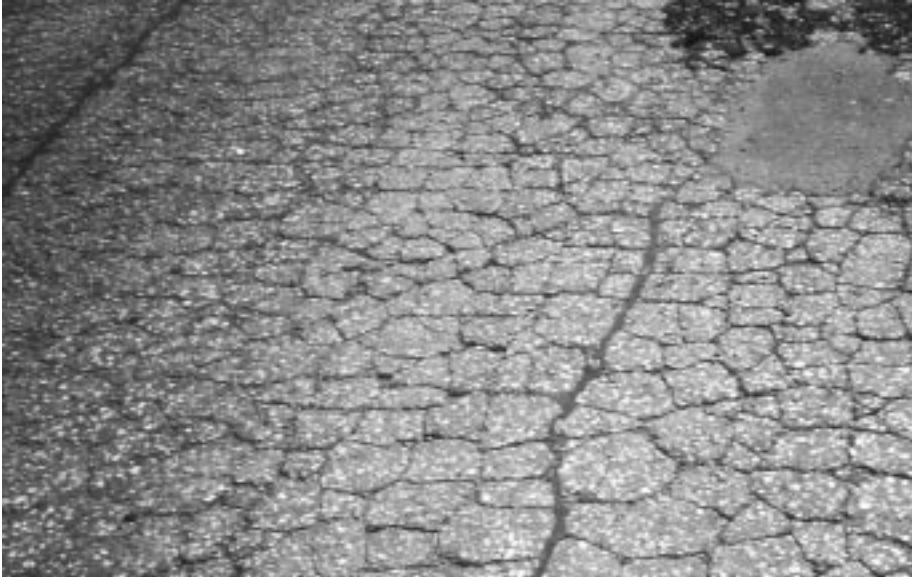
◀  
**Alligator crack pattern. Tight cracks and one patch.**

Interconnected cracks forming small pieces ranging in size from about 1" to 6". This is caused by failure of the surfacing due to traffic loading (fatigue) and very often also due to inadequate base or subgrade support. Repair by excavating localized areas and replacing base and surface. Large areas require reconstruction. Improvements in drainage may often be required.

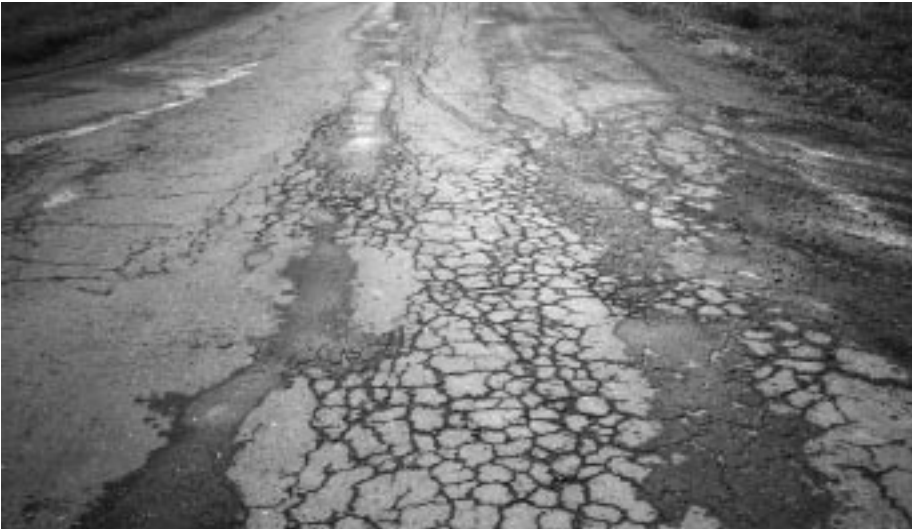
◀  
**Characteristic "chicken wire" crack pattern shows smaller pavement pieces and patching.**

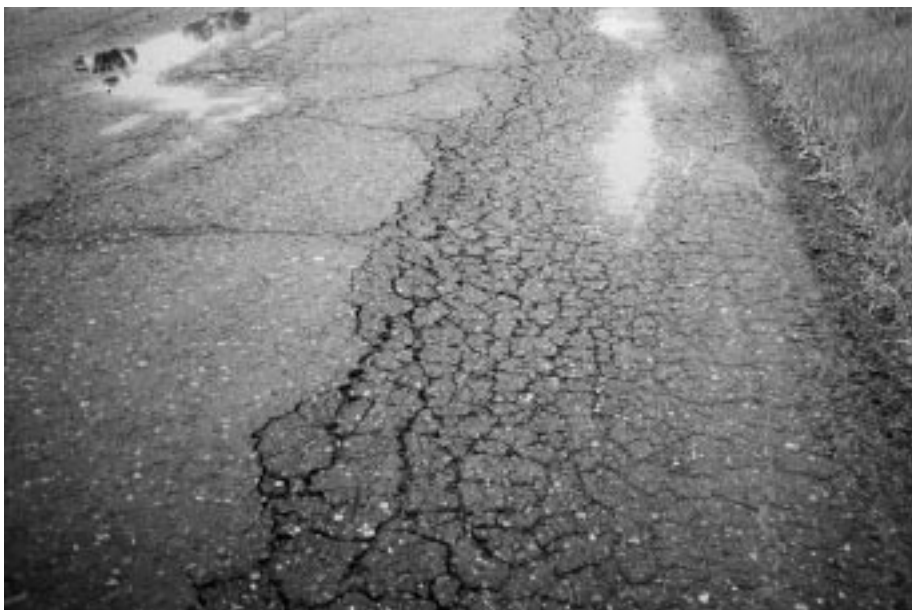
◀  
**Open raveled alligator cracking with settlement along lane edge most likely due to very soft subgrade.**

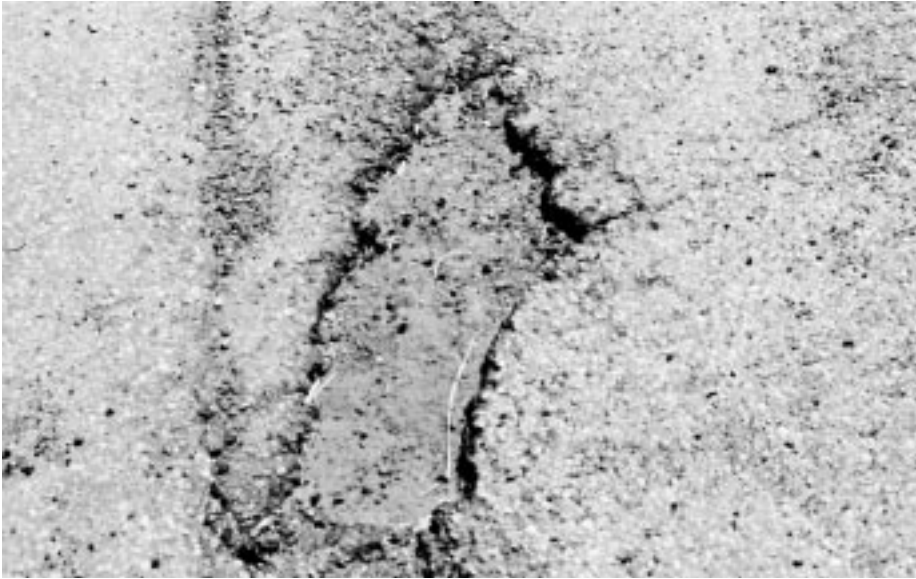
◀  
**Small pothole where top course has broken away.**

Holes and loss of pavement material caused by traffic loading, fatigue and inadequate strength. Often combined with poor drainage. Repair by excavating or rebuilding localized potholes. Reconstruction required for extensive defects.

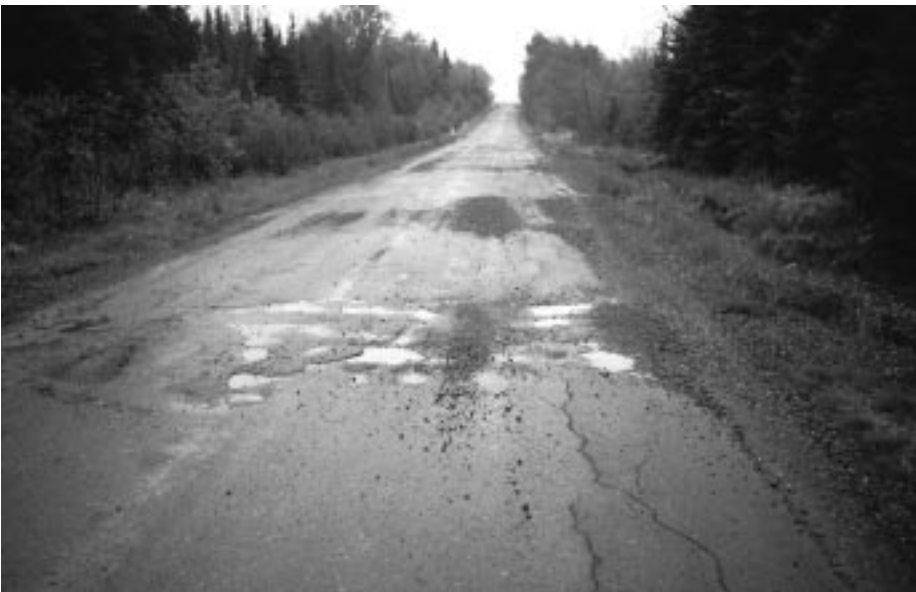
◀  
**Multiple potholes show pavement failure, probably due to poor subgrade soils, frost heave, and bad drainage.**

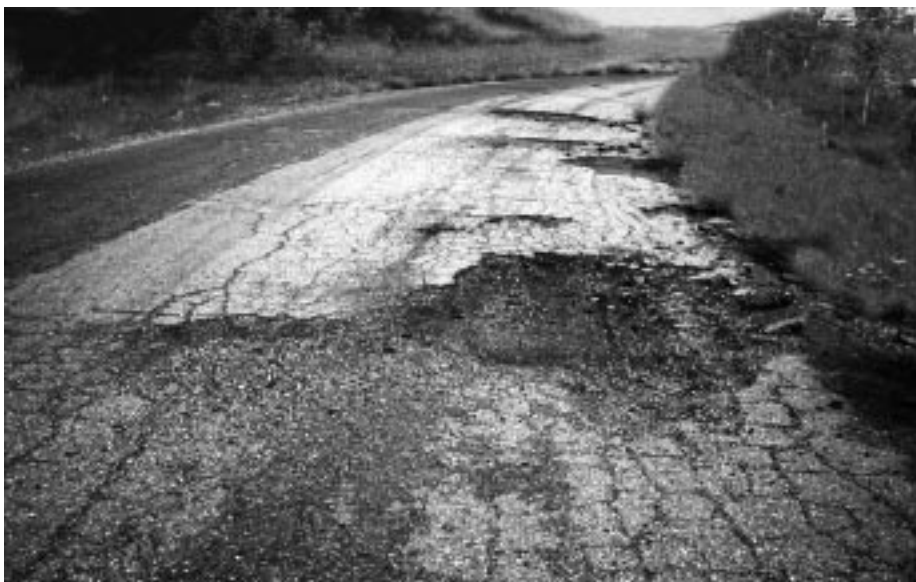
◀  
**Large, isolated pothole, extends through base. Note adjacent alligator cracks which commonly deteriorate into potholes.**

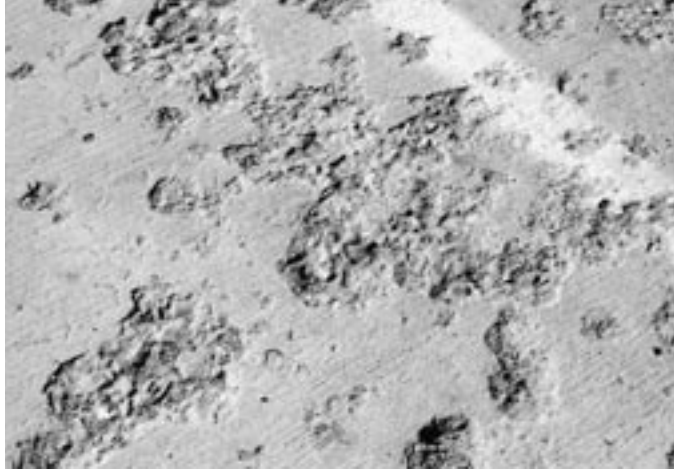
► Moderate surface scaling. Loss of mortar and fines from the surface beginning to expose larger aggregate.

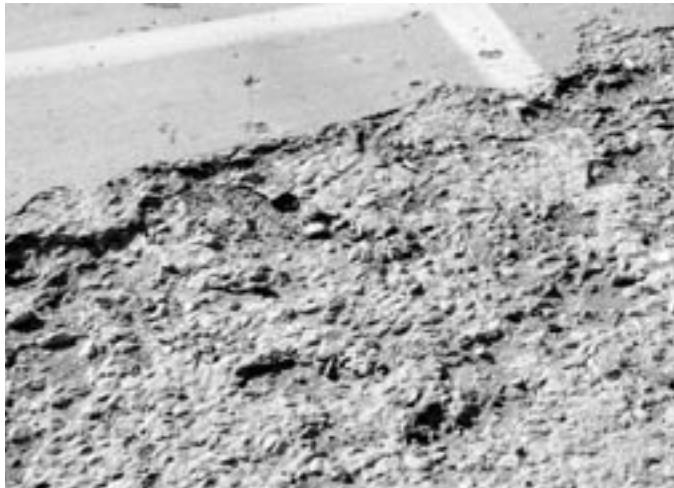
► Severe scaling. Some larger aggregate is loose.

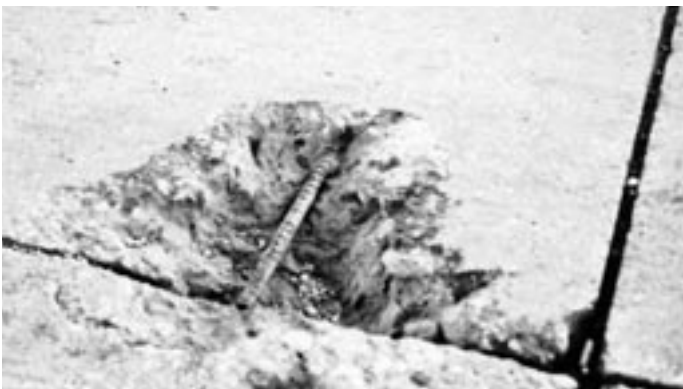
Reinforcing bar exposed. Shallow concrete cover caused large spall to develop around it. ▼

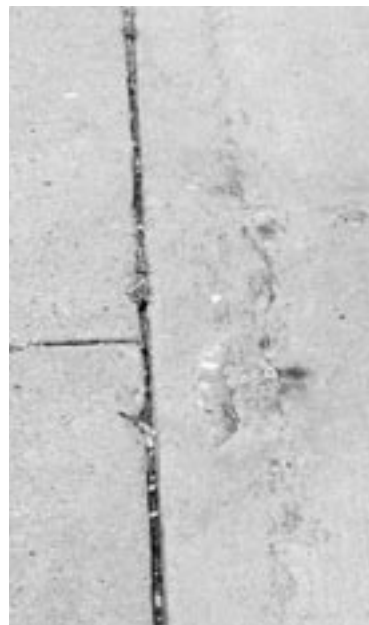
◀ Wire reinforcing mesh placed close to surface. Corrosion of the reinforcing steel causes the surface mortar to spall. Very difficult to patch and repair.

break and dislodge the concrete. Often you can see rust stains in the surface cracks before spalling occurs. Can be temporarily patched with asphalt. Permanent repairs are difficult and usually involve replacing the steel and making a partial depth or full depth concrete repair.

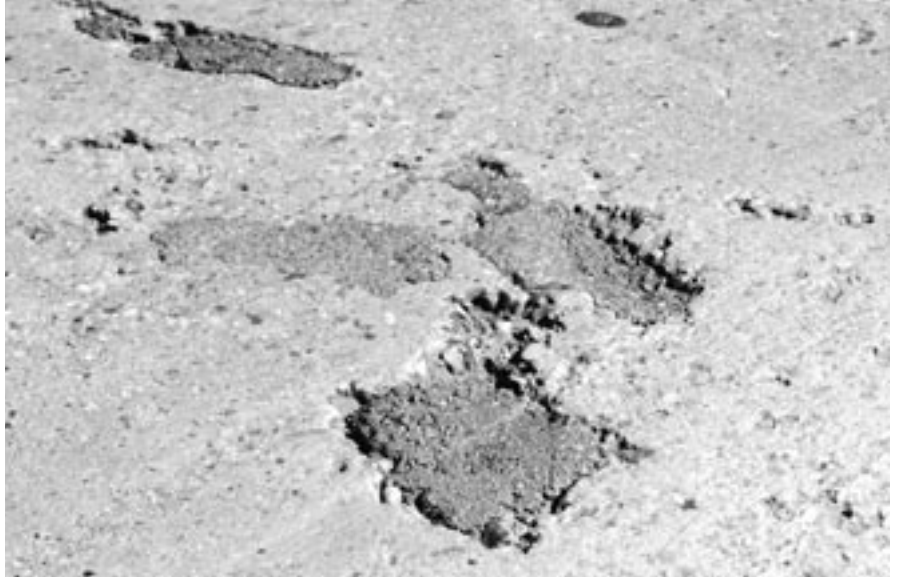
▶  
Small surface  
spalls that  
have been  
patched.

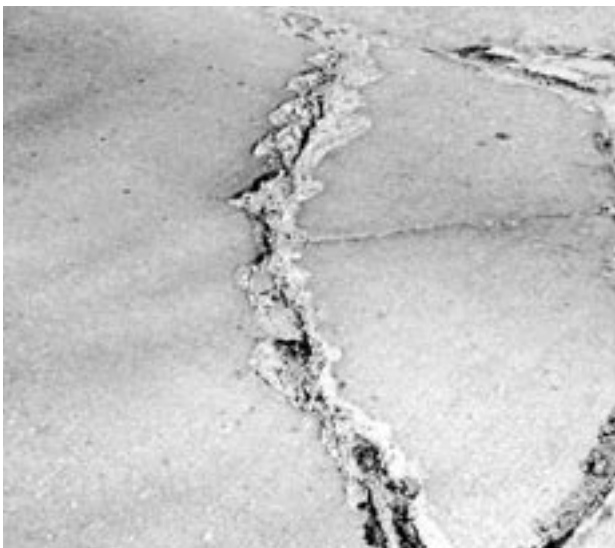
▼ A severely  
spalled crack.

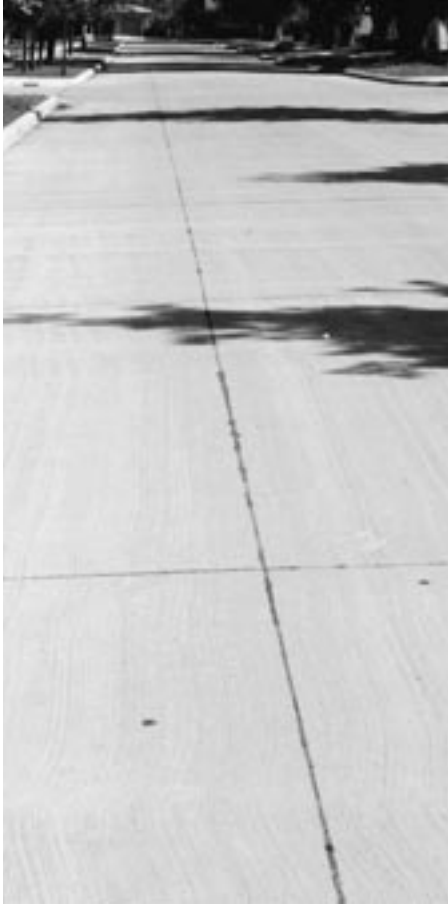
▲ Joint open about 1/2".

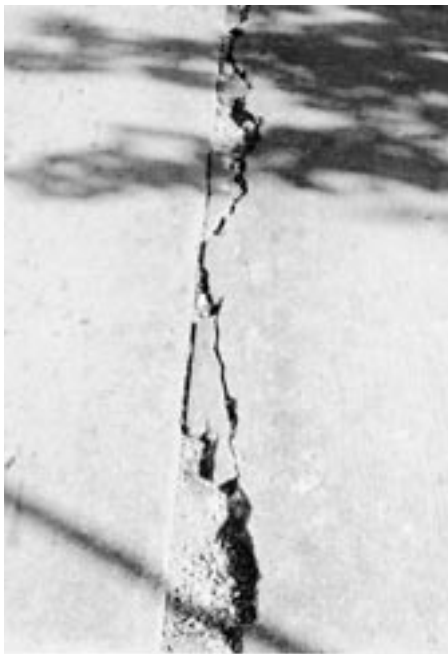
▲ Additional joint cracking, spalling, and broken pavement. Full depth repair is needed.

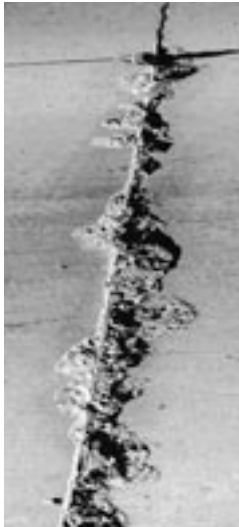
▶ **Severe spalling of a transverse joint.**

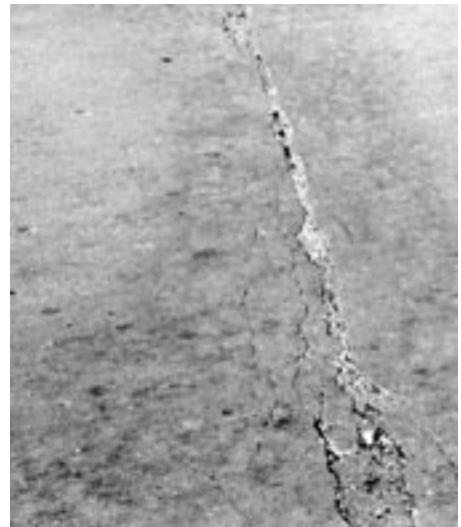
▶▶ **Cracks parallel to joint. Dark color next to transverse joint likely indicates D-cracking and additional deterioration. Full depth repair required.**

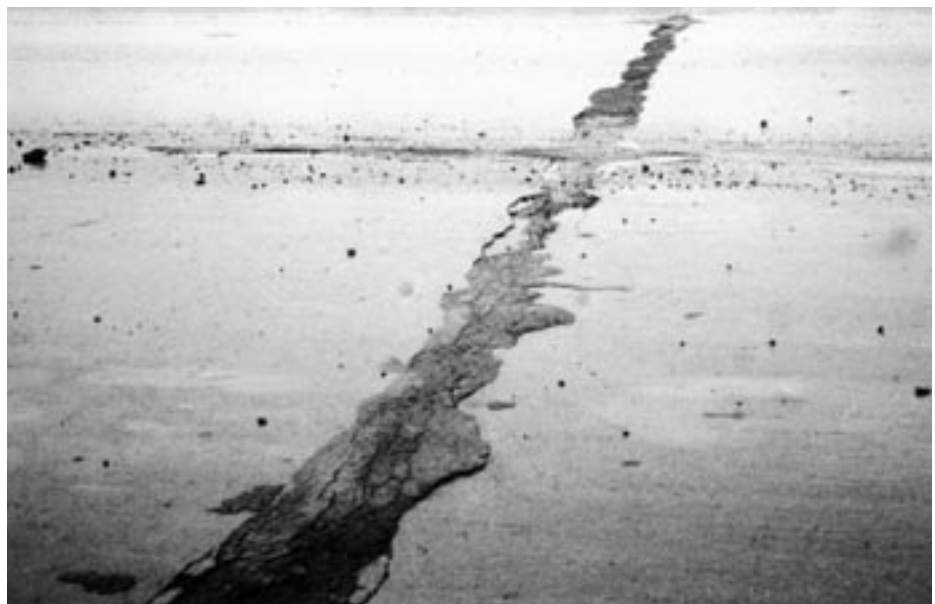
▶ **Severe spalling has required temporary patching. Complete joint replacement is necessary.**

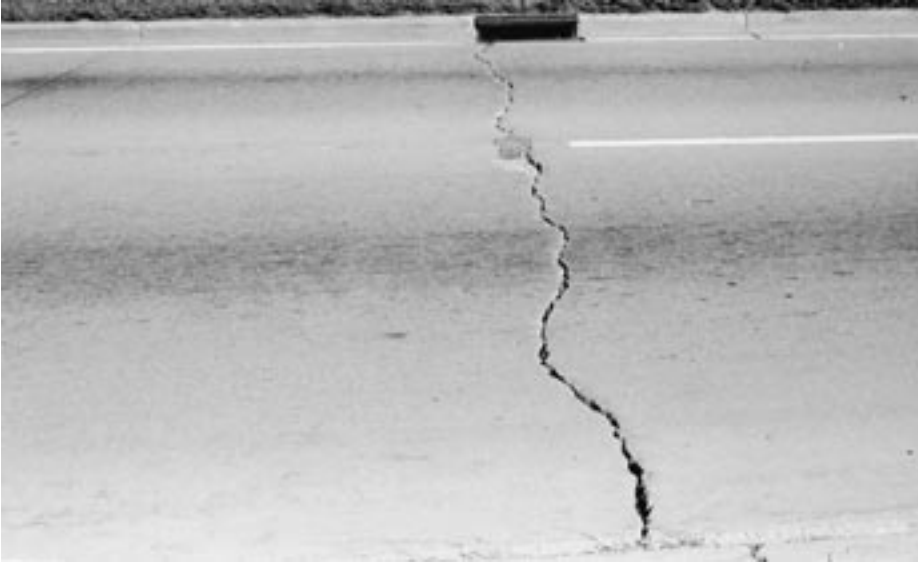
**Transverse,  
open crack.**

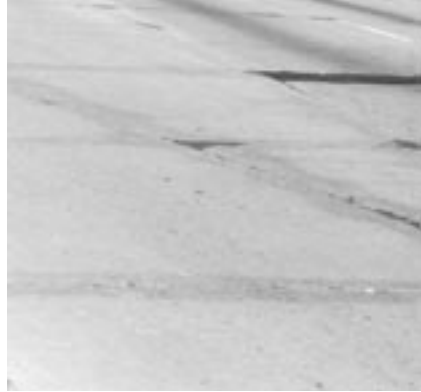
Surface discoloration near joints and cracks indicates D-cracking and severe slab deterioration.

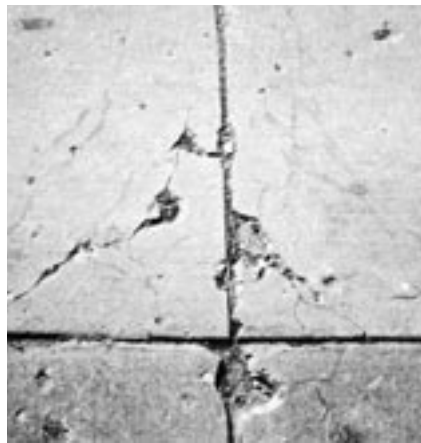
Multiple crack patterns adjacent to joints. Common D-cracking pattern.

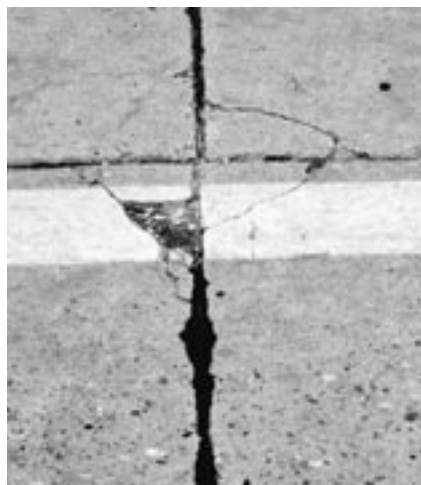
Corner cracking with broken concrete pieces.

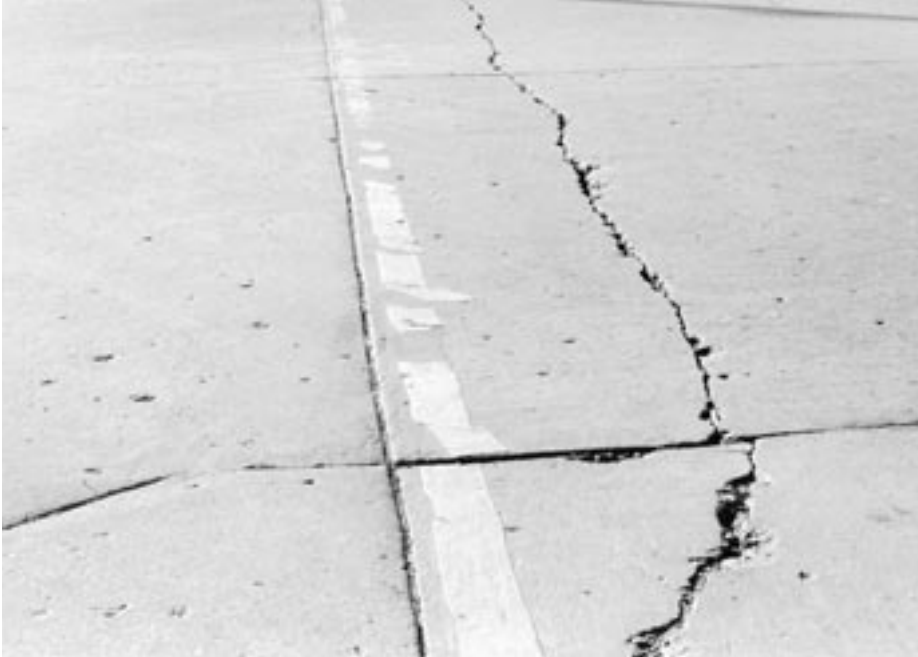
**Meander crack roughly parallel to longitudinal joint.**

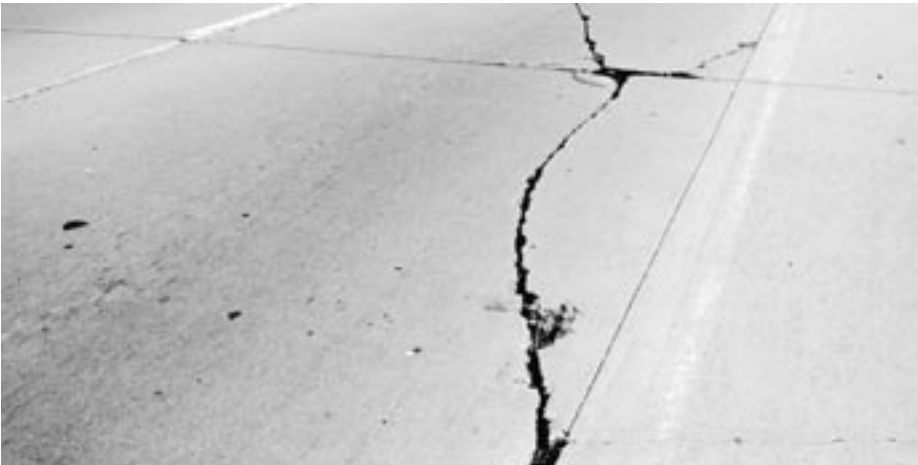
**Meander crack caused by settlement. Lack of maintenance allows water to intrude and debris to collect in crack.**

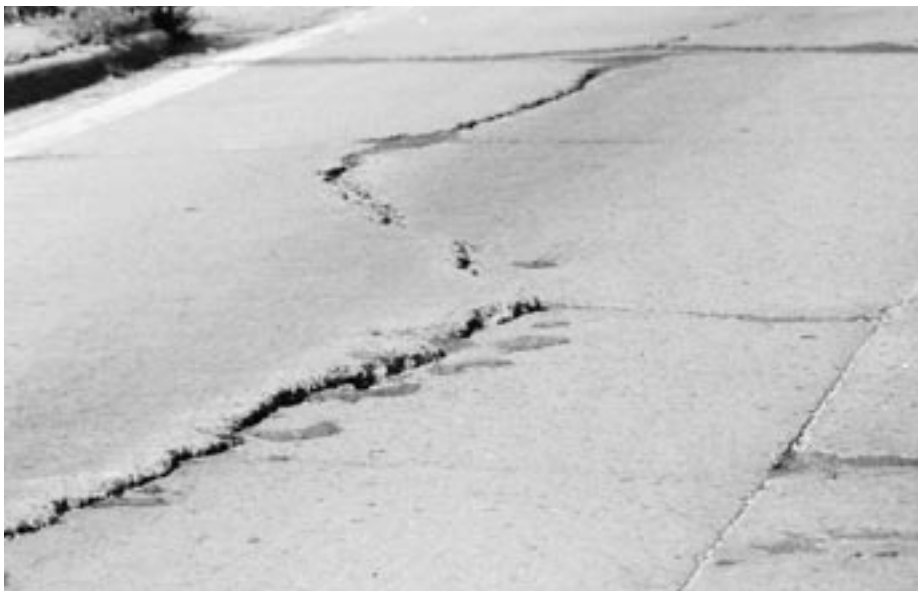
**Faulting and spalling of a meander crack.**

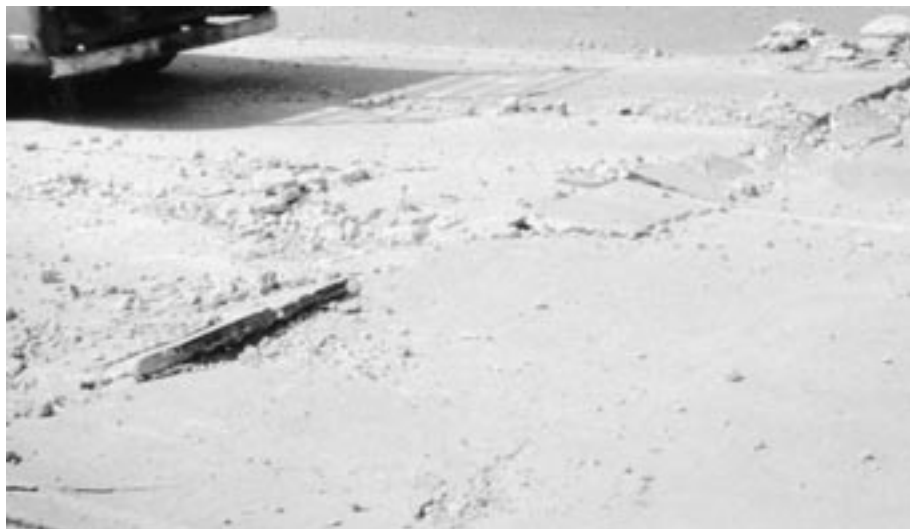
▲ Minor faulting of transverse joints. Aggravated by heavy traffic. Surface grinding will improve ride.

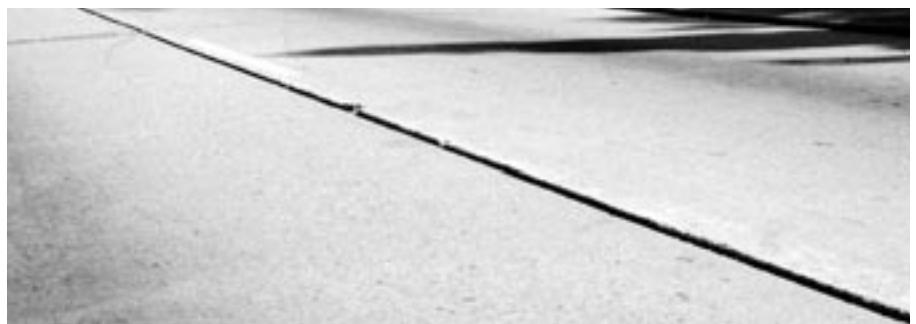
▲ Faulted longitudinal joint.

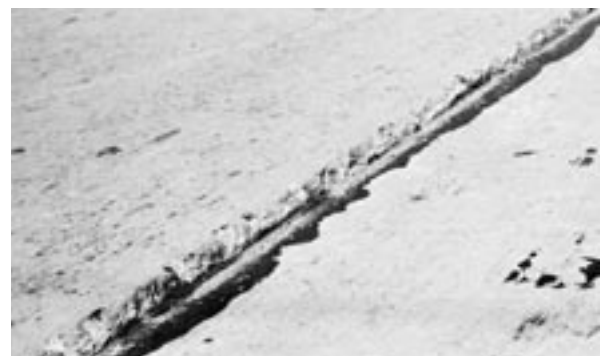
▶ Severely faulted joint. Slab jacking is necessary.

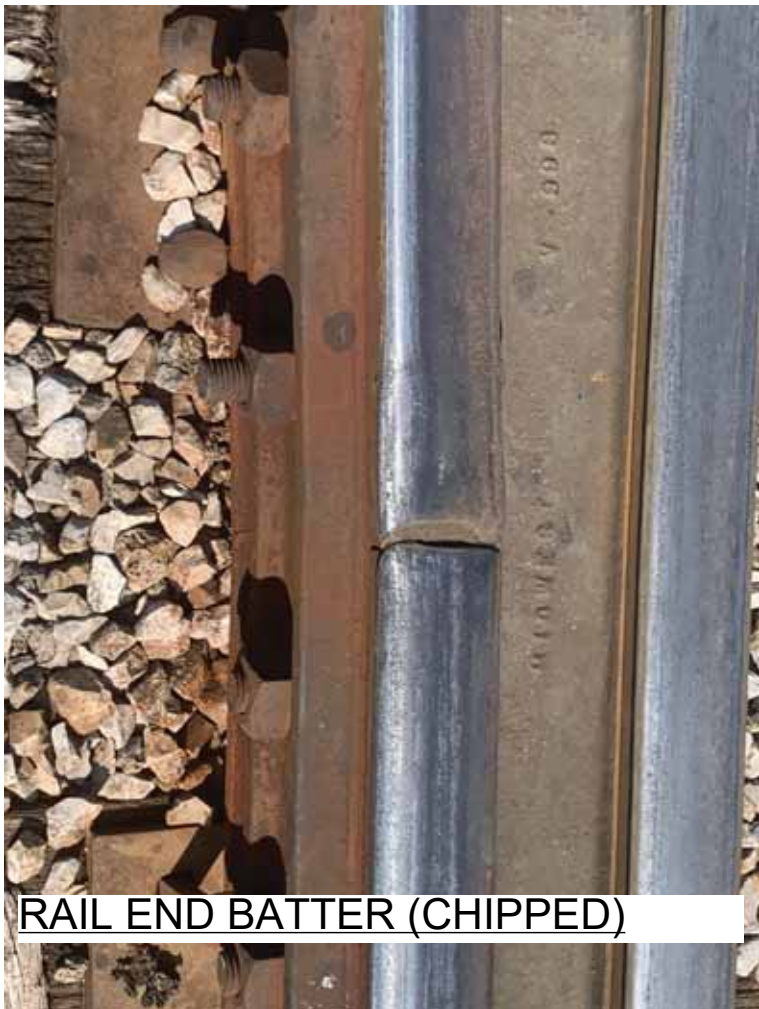
RAIL END BATTER (CHIPPED)

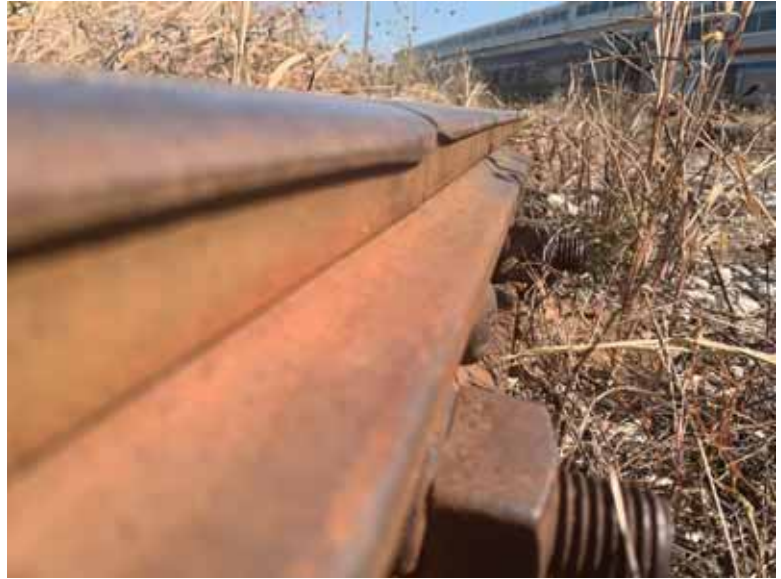
RAIL GAUGE FLOW

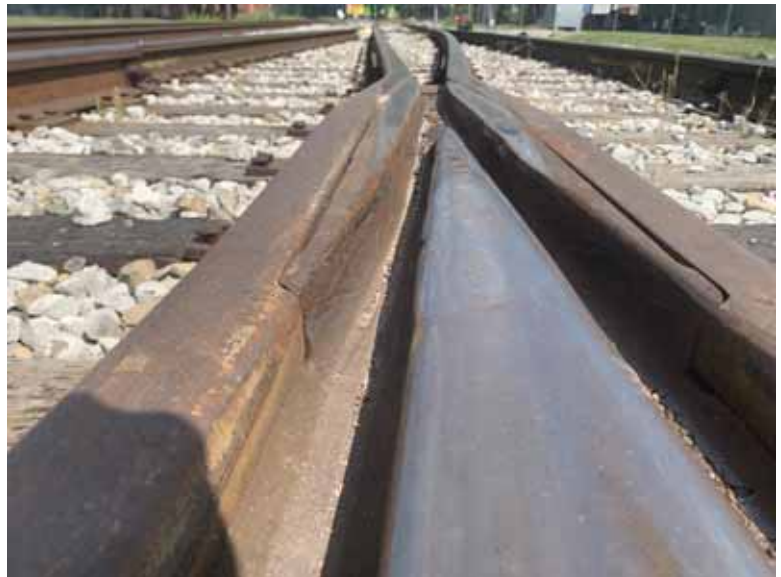
DEFORMED FROG POINT AND WING RAIL

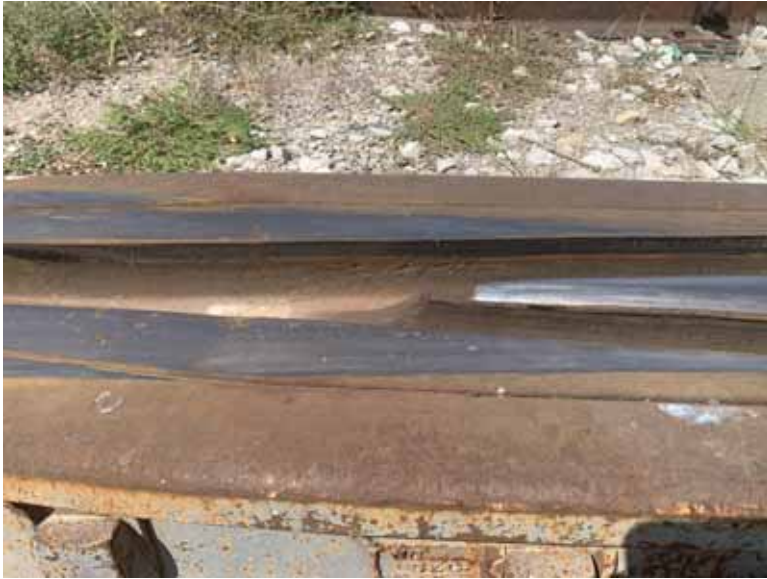
FROG POINT CHIPPED

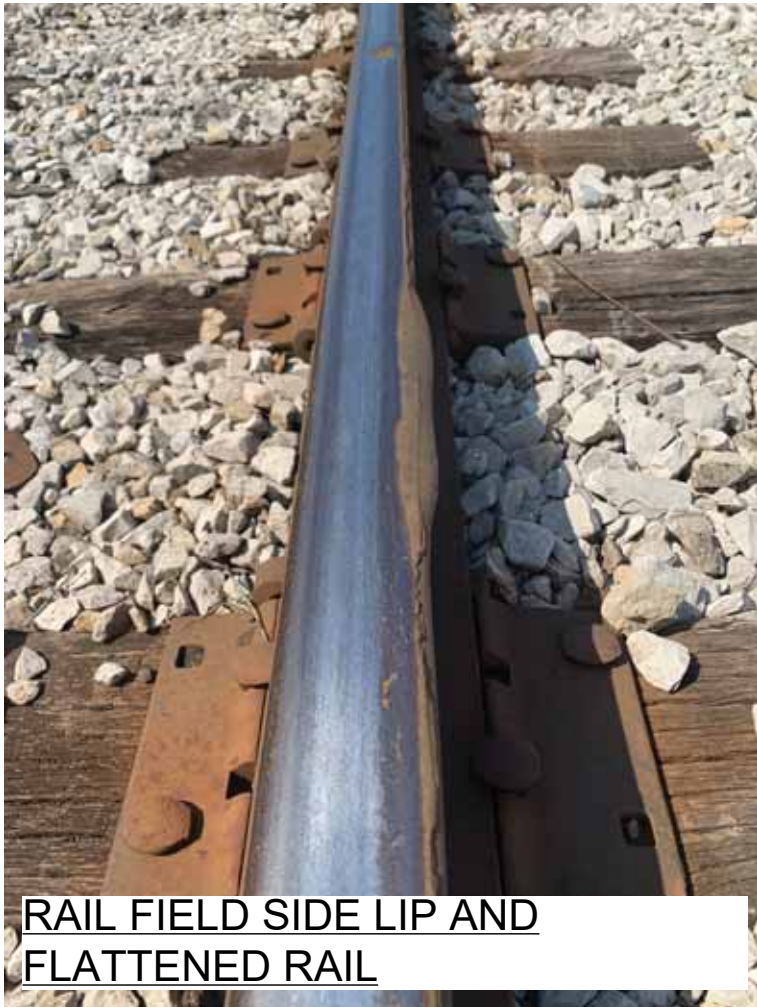
RAIL FIELD SIDE LIP AND  
FLATTENED RAIL

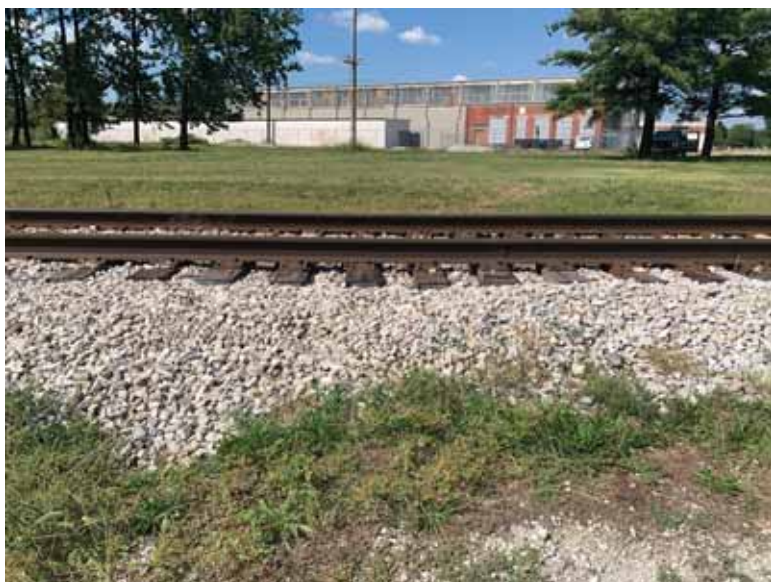
SHALLOW BALLAST TIE CRIBS

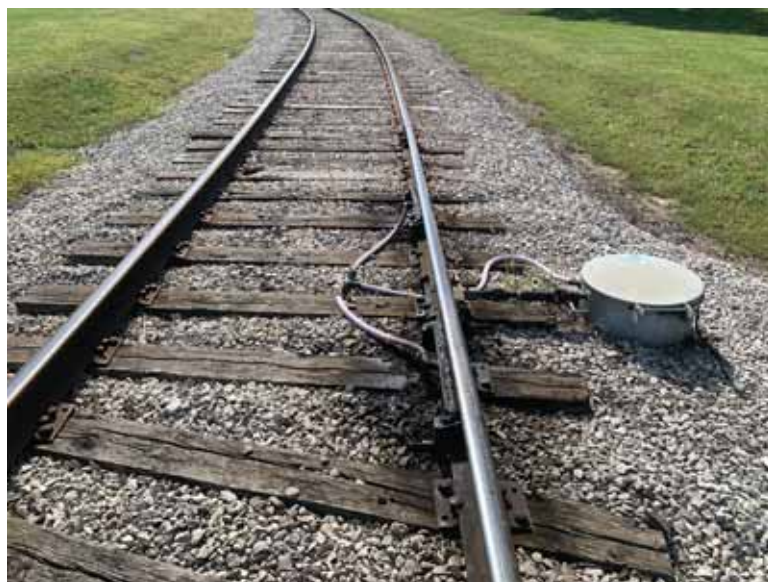
NON-FUNCTIONING LUBRICATION MODIFIER

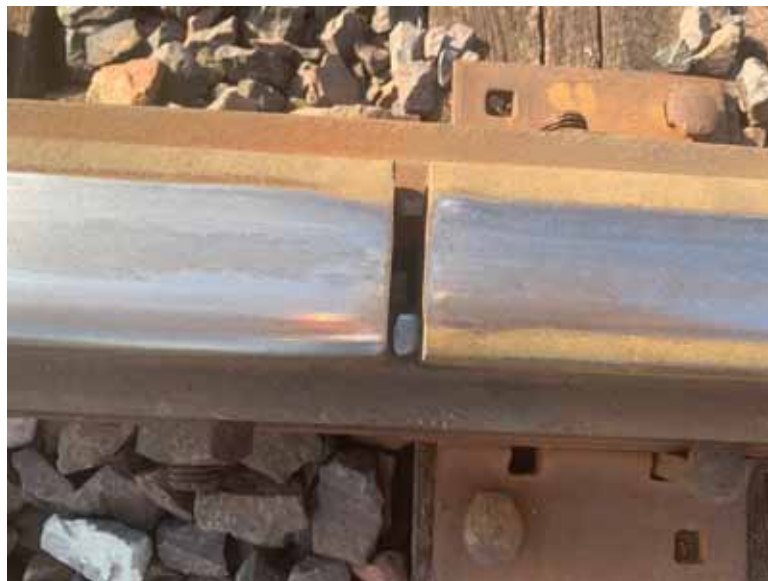
EXCESSIVE RAIL JOINT GAP WITH VISIBLE SIGNS OF MOVEMENT

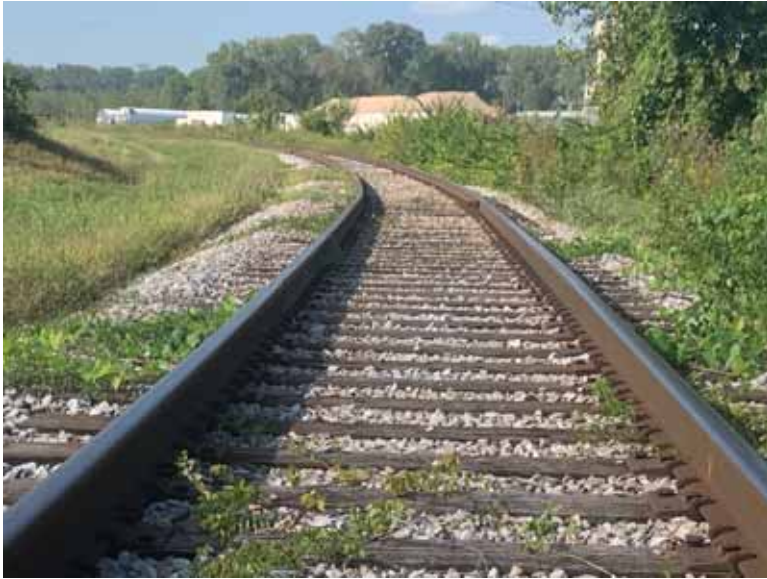
LIGHT VEGETATION

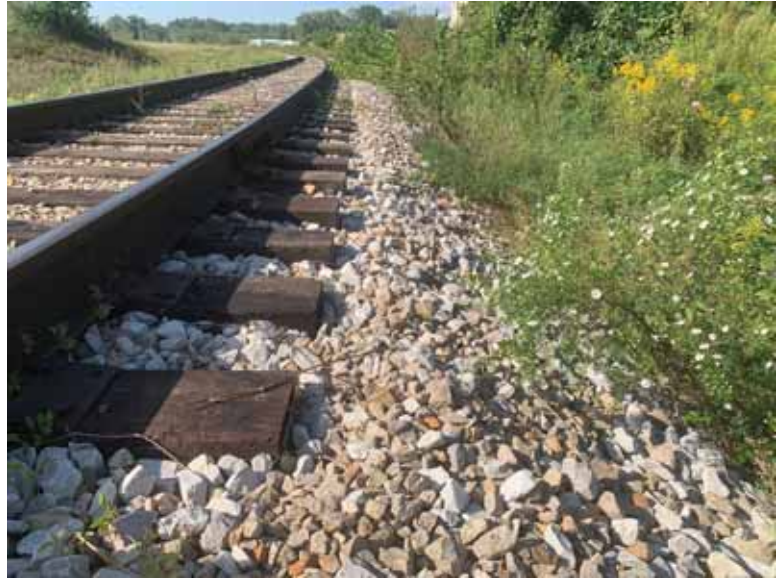
LATERAL TRACK MOVEMENT IN BALLAST SHOULDERS

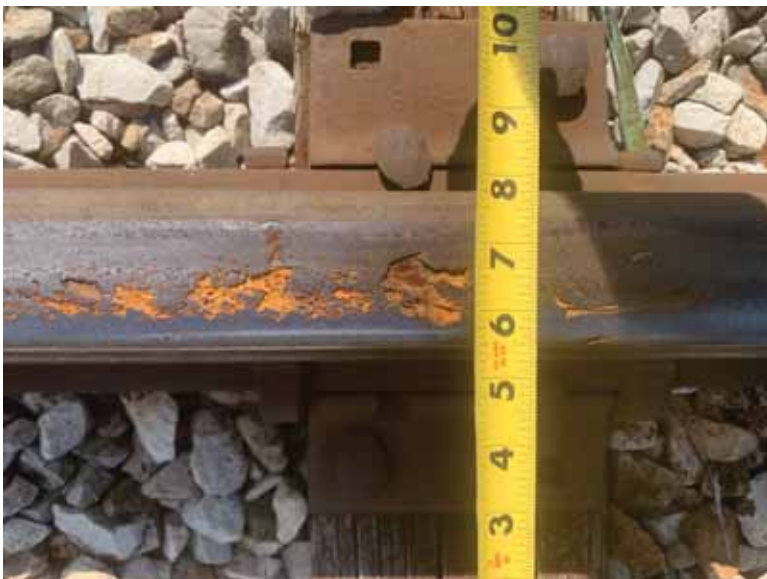
SEVERE RAIL SPALLING WITH FLAKING
