**INFRASTRUCTURE CONDITIONS  
ASSESSMENT**

**AMERICA'S CENTRAL PORT**

**MADISON, VENICE, AND  
GRANITE CITY, ILLINOIS**

December 30, 2021

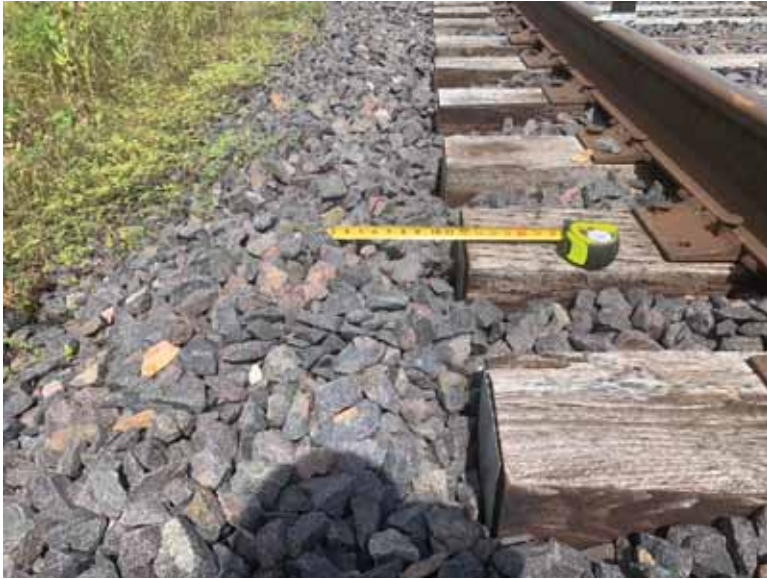
LATERAL TRACK MOVEMENT IN BALLAST SHOULDERS

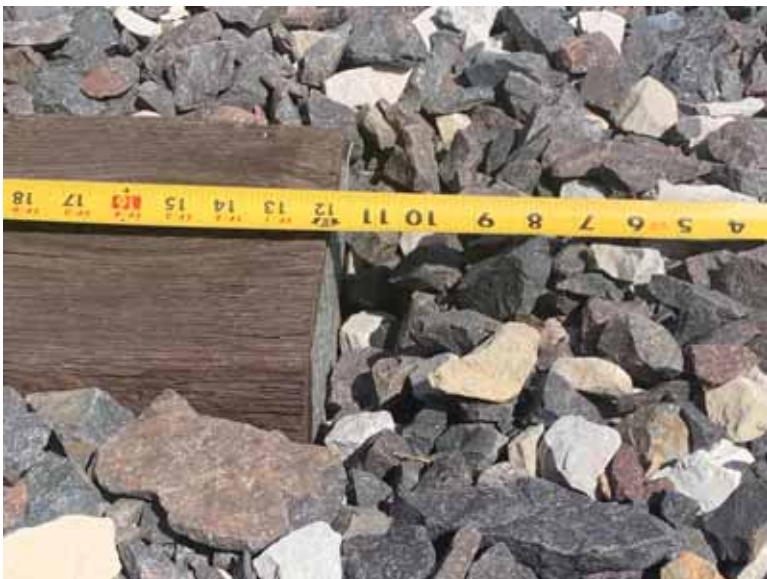
LATERAL TRACK MOVEMENT IN BALLAST SHOULDERS

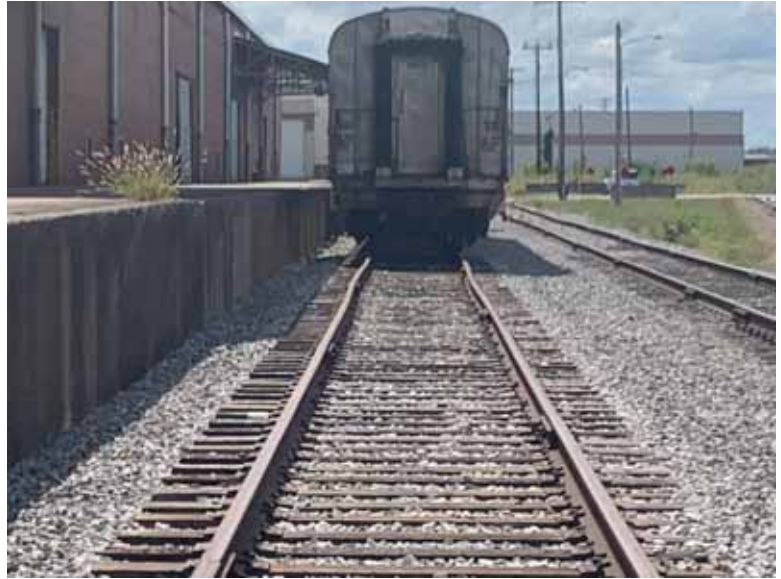
TRACK MISALIGNMENT (KINK)

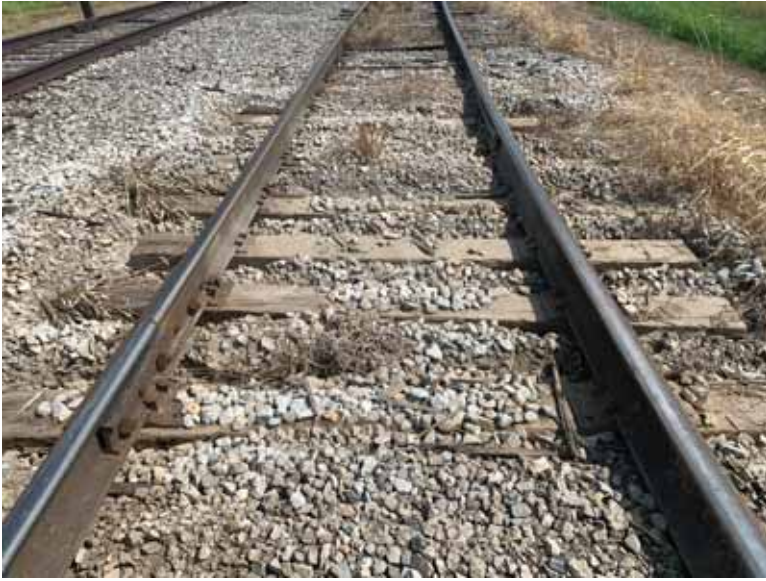
FOULED BALLAST AND MUD PUMPING

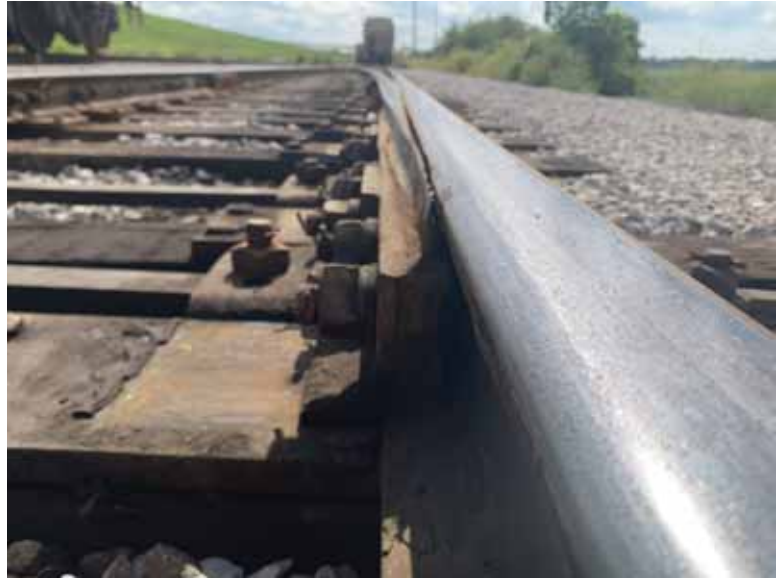
EXCESSIVE SWITCH POINT WEAR
